# Article Static Liquefaction Causes the Flow Failure of a Tailings Dam: A Case Study of El Descargador, Cartagena–La Unión Mining Region, SE Spain (October 1963)

Keywords: dam collapse; flow failure; mine tailings; electrical resistivity imaging

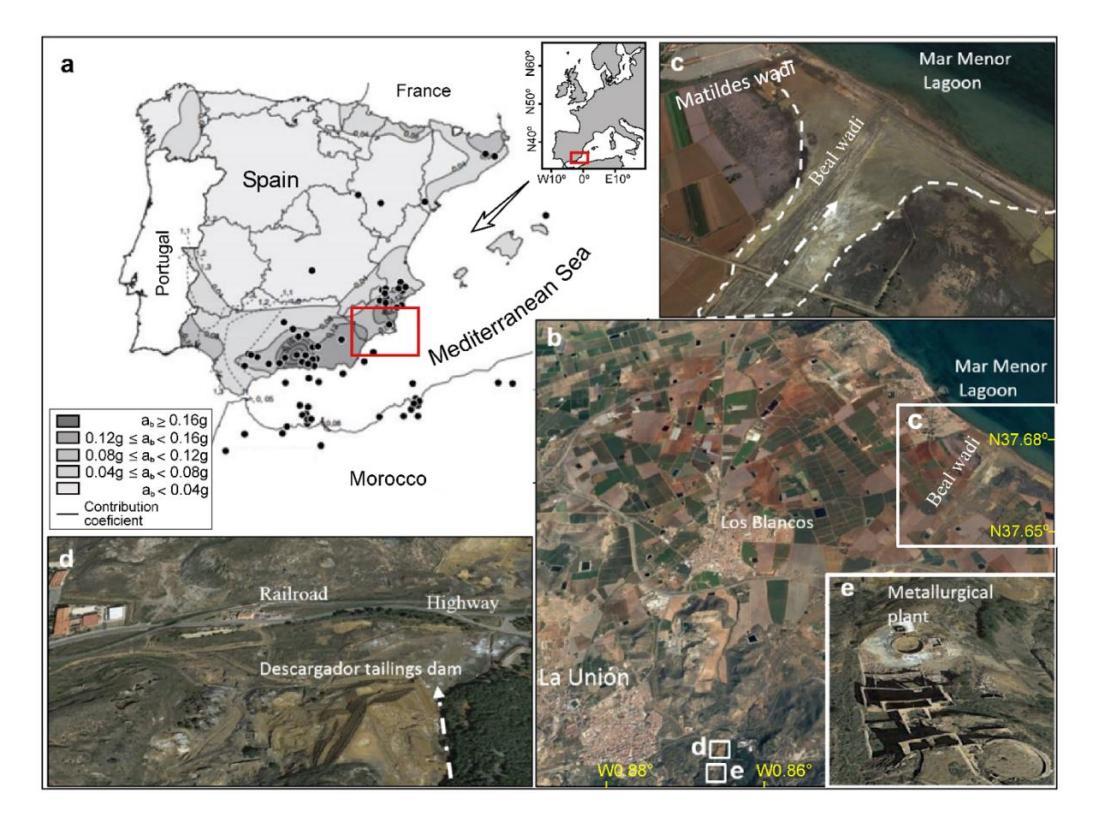
El Descargador tailings dam failed catastrophically at 7:45 on Monday, 14 October 1963, causing an environmental disaster in the Cartagena–La Unión mining district, in the province of Murcia, Spain (Figures 1 and 2). The Cartagena–La Unión mining district is part of the easternmost foothills of the Betic mountain ranges, and it is well known as a highly productive area of metals such as lead, zinc, iron, manganese and silver since ancient times [1]. The tailings dam was part of a large underground mining complex that had been in operation for more than nine years in La Unión municipality. The El Descargador tailings dam stored tailings from the Belleza mining group. This group is integrated by the following Fortuna, Felicidad, Maestra, Belleza, Resucitada, Pronta, Virgendel Carmen, Convención and Ferrocarril mining concessions. The activity of the Belleza group included the exploitation of pyrite (12%), sphalerite (10%) and galena (7%). The flotation process of the mine had a capacity of 300 tons of mineral per day. The 75% of the ore entering the flotation process was discharged into the dam as tailings. Considering the volume of daily

**Figure 1.** (a) Location of studied area on the Spanish seismic base map; source: NCSR-2 (2004) at Region of Murcia, (b) El Descargador tailings dam and its area of influence, (c) Beal wadis and the oxidation products of sulphides can be seen in white color in the area covered by tailings, (d) Cartagena–Cabo de Palos highway and the Cartagena–Los Blancos railroad affected by flow failure and (e) abandoned metallurgical plant. The discontinuous arrow indicates the direction of the runoff. Base maps orthorectified aerial photographs; source Spanish National Geographic Institute (IGN). Schemes follow the same formatting.

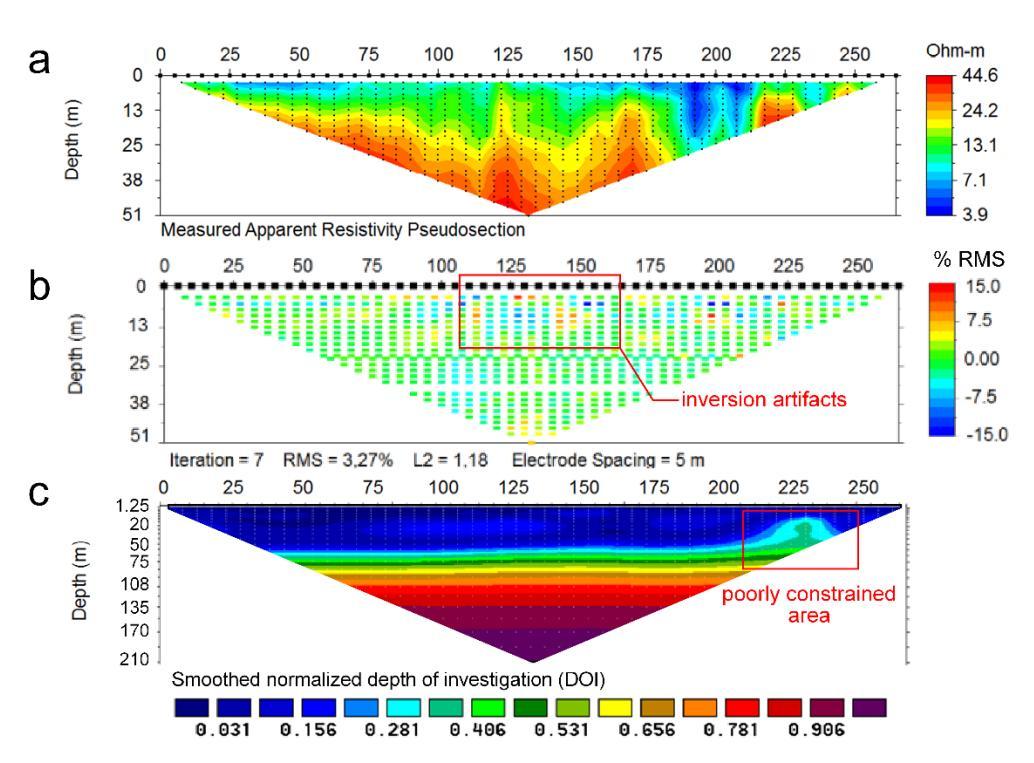
More rigorous cutoff criteria were not imposed, since some features are interpreted as inversion artifacts that could offer relevant information on the presence of fractures [28,57–59]. The final model residuals do not exceed an RMS of 5%. On the other hand, the DOI-index was computed with Res2DInv software (Geotomo) to identify the depth at which the resistivity images were poorly constrained by the data [60]. Two constant resistivity-starting models of 0.1 and 10 times the average of the measured apparent resistivity were used for the calculation. The average of apparent resistivities was 17  $\Omega$ m (ERI1) and 16  $\Omega$ m (ERI2) in this case. Several authors advise a DOI cutoff value of 0.1 to 0.2 or, alternatively, considering the limit according to the maximum gradient [60,61]. Based on both criteria, it is possible to identify poorly constrained sectors, as those located in the northern sector of ERI1, at position x = 250 m (Figure 5c), which should be interpreted with extreme caution.

**Figure 5.** Quality assessment of the ERI1 profile, (**a**) recorded pseudosection, (**b**) Data misfit pseudosection representing the relative data error between the calculated and the measured apparent resistivity records (model residuals), (**c**) Depth of investigation index (DOI) computed as the difference between subsequent inversions setting the starting models to 1.7 and 170  $\Omega$ m, respectively.
