The Memorial Chapel (Formerly Holy Trinity Church) in the Tempio Evangelico Valdese (Florence): Surveys and Characterization of Decorative Plasters for a Conservative Recovery

Abstract: This study focuses on the Memorial Chapel, a historical site located inside the *Tempio Evangelico Valdese* in Florence. In 1843, the first Anglican church in Florence, known as Holy Trinity Church, was built by D. Giraldi. Around 1892, G. F. Bodley began the reconstruction of a new building of neo-Gothic style at the same site, which was completed in 1904. This new church had a space dedicated to memory called Memorial Chapel. In 1967, the monumental complex was acquired by the Waldensians, now known as the *Tempio Evangelico Valdese*. This interdisciplinary investigation aimed to study the most damaged painted walls of the chapel. For this purpose, samples of decorative plaster mortars were collected from various points, after carrying out a digital mapping of the degraded areas. Mineralogical, petrographic, optical, chemical, and microchemical analyses were performed. This study made it possible to highlight the composition and the characteristics of the different layers of the plaster mortars,

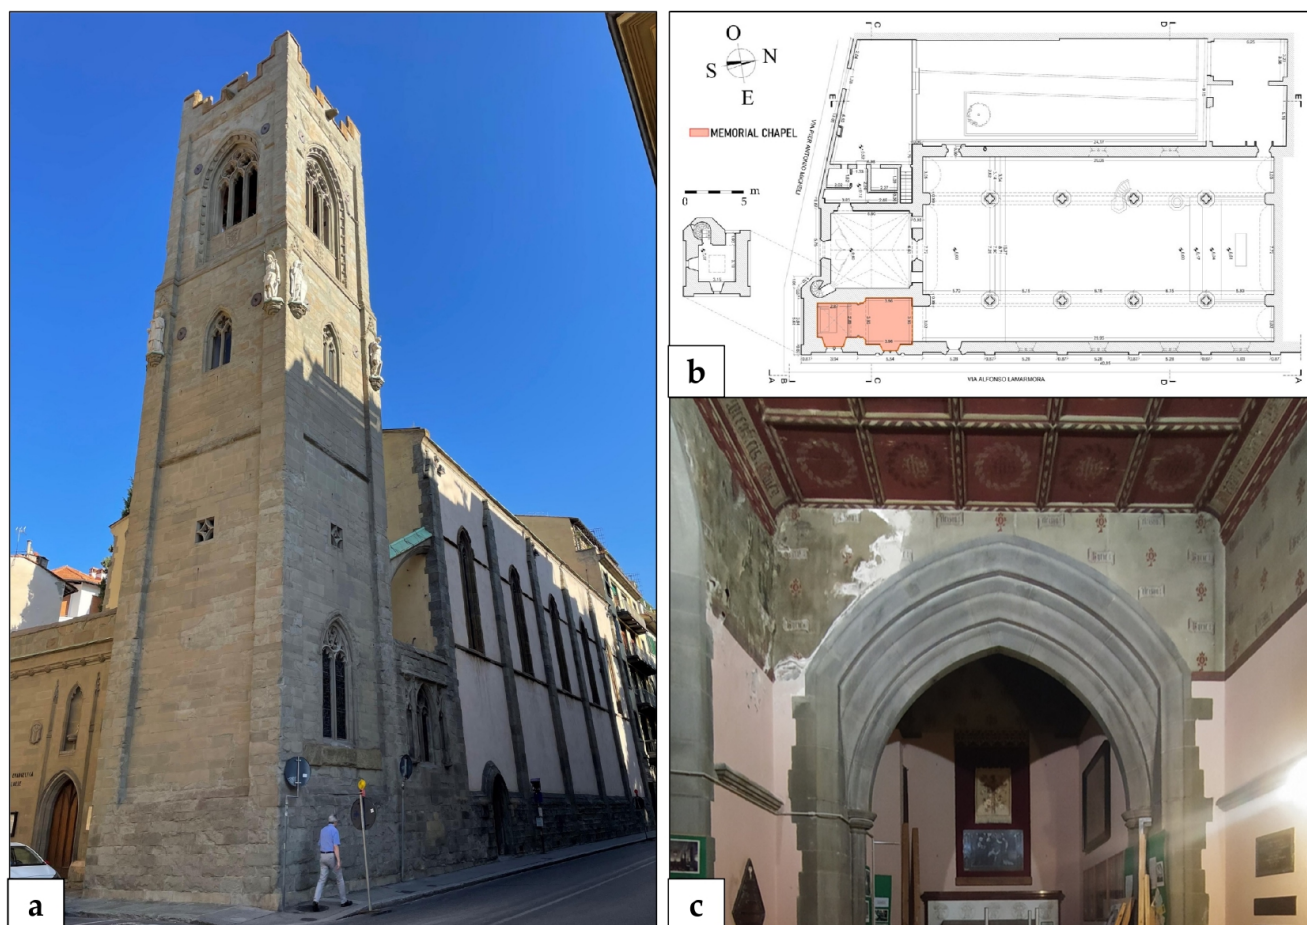
Figure 1. *Tempio Evangelico Valdese* in Florence, where the Memorial Chapel is located (a). Plan of the neo-Gothic Anglican church from an architectural survey conducted by architects M. Di Benedetto and F. Nobili (2021); position of the Memorial Chapel is in red (b). Investigated plastered walls of the chapel (c).

In the wall paintings of the chapel, Bodley expressed his admiration for the picturesque Middle Ages, referring to the Decorated or ornate Gothic style prevalent in the late 13th century, characterized by rich English colors and decorations (Figure 1c). He enlisted the painters Malesci and Pistolesi who, between 1894 and 1895, decorated the walls of the church with stenciled phytomorphic red designs and scrolls bearing the words “*Kyrie eleison*” (Lord have mercy) on a green backdrop, which today are hidden under a new layer of paint [15].
