Article **Reviewing Interference for All Modes of Products for Failure Avoidance**

Kenji Iino ^{1,2,*} and Masayuki Nakao ³

Citation: Iino, K.; Nakao, M. Reviewing Interference for All Modes of Products for Failure Avoidance. *Sustainability* 2022, *14*, 1743. https://doi.org/10.3390/su14031743

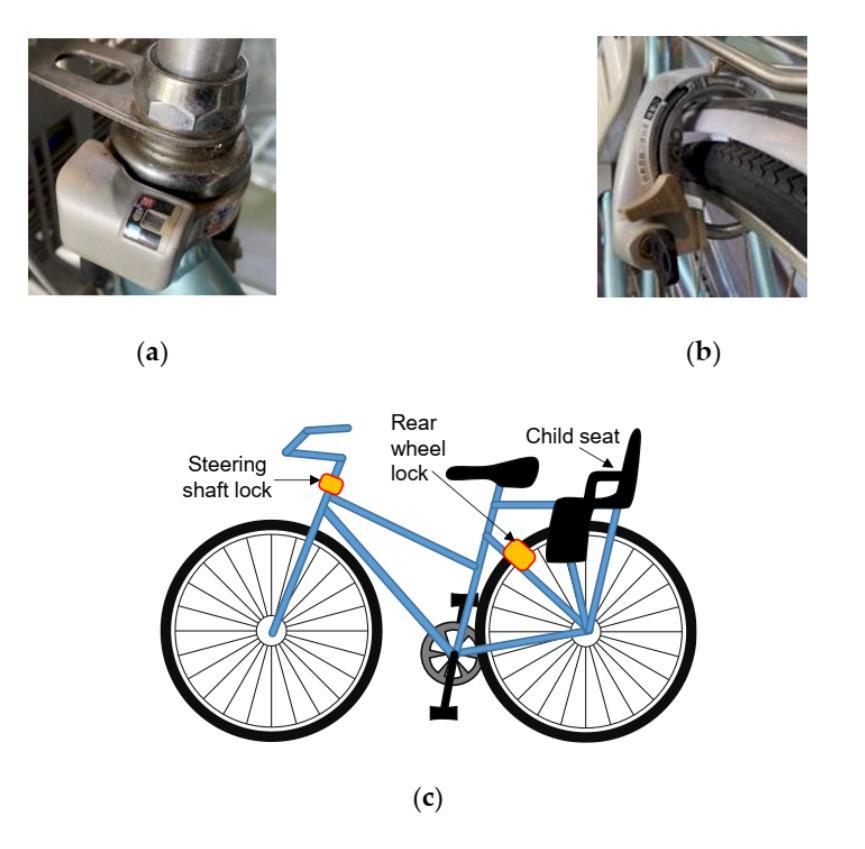
Figure 2. Bicycle with the "single action double lock" feature. (**a**) Lock that fixes steering shaft rotation [6]. (**b**) Lock that blocks rear wheel rotation [6]. (**c**) Typical locations of two locks on a bicycle.

Figure 2 shows locations of the two locks, and separate photographs of the actual locks. When the rider parks the bicycle and engages the rear wheel lock, the action pushes a cable connected to the steering shaft lock that also locks the steering shaft rotation.

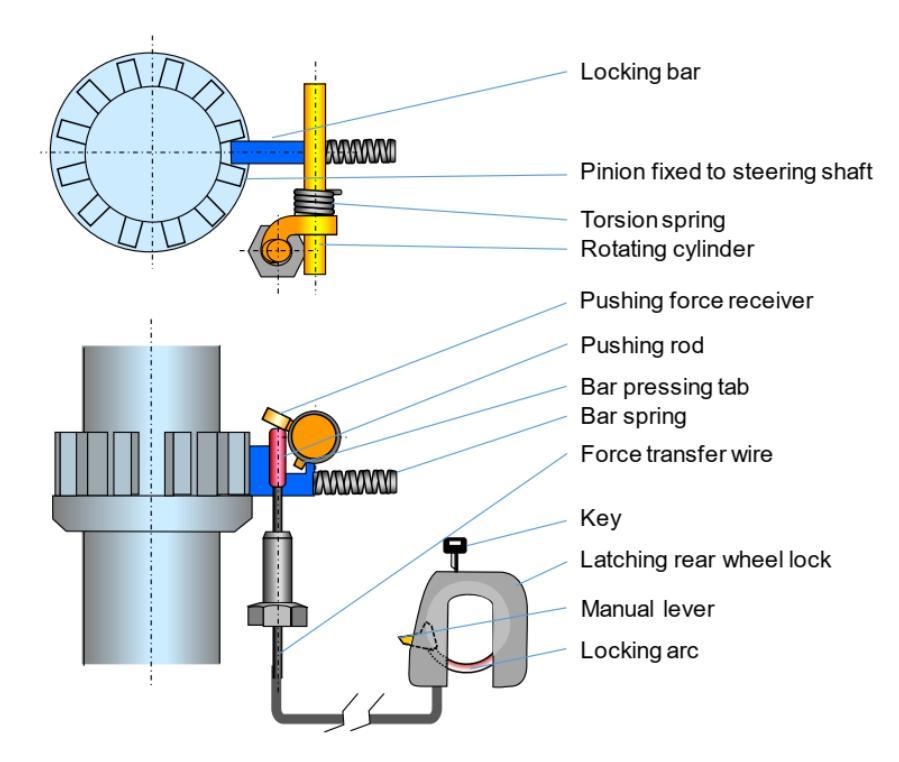
Figure 3. Single action double lock parts ([6] based on [7]).

The single action double lock mechanism has parts shown in Figure 3 [7]. A housing case holds the steering shaft lock parts in position. A window shows the lock status. The upper left photo in Figure 2 shows this case. It is the gray box with a black indicator window.

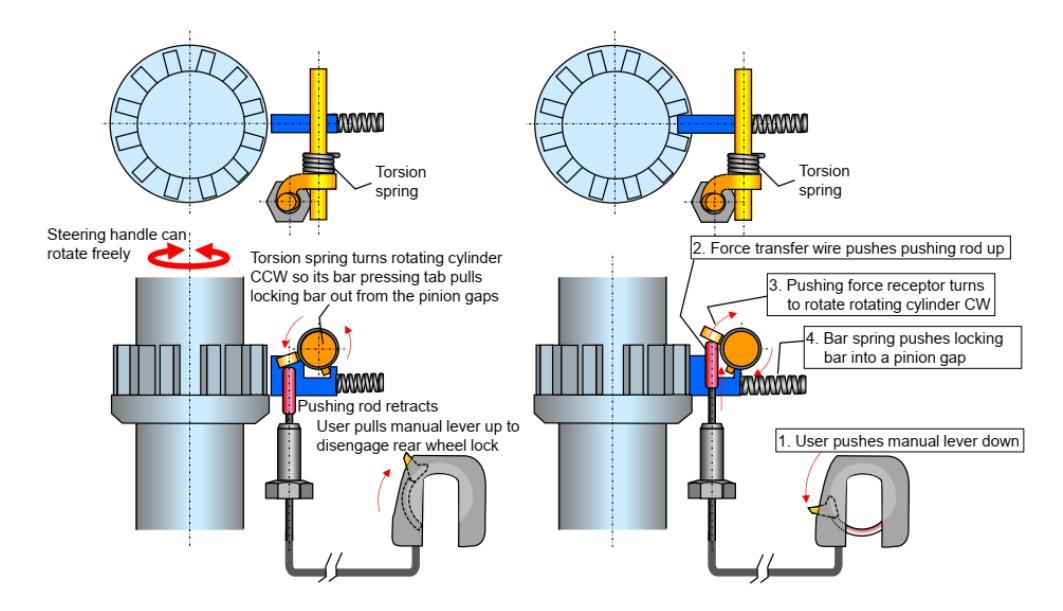
Figure 4. Mechanism of the single action double lock ([6] based on [7]).

Figure 4 shows the mechanism of the single action double lock. The left figure is when the shaft is unlocked, and the right figure is when it is locked. The movements 1 through 4 take place simultaneously; these numbers are for easier visualization of the mechanism.

The locking bar for engagement and retraction from a steering shaft pinion gap is made by the balance among the torsion spring, lock bar spring, and the pushing rod force. When the steering shaft is free, the pushing rod retracts (stays down in Figure 4), and the torsion spring applies counterclockwise (CCW) torque to the rotating cylinder. The CCW bar pressing tab force applied to the locking bar here overcomes the lock bar spring force, and the locking bar is pulled out from the steering shaft pinion gap, allowing free rotation of the steering shaft.

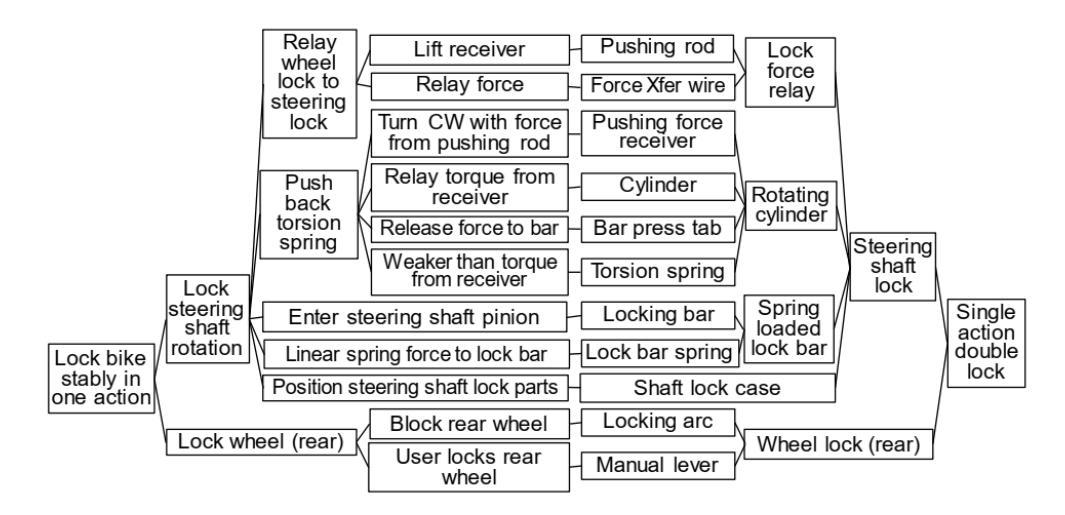
Figure 5. DRG of the "single action double lock" when the bicycle is parked (modified from [6]).

Figure 5 shows the DRG for this locking system. The arcs from FEs connect to the PEs all in a one-to-one manner. Thus, the design is uncoupled in AD. Equation (3) shows the AD design equation.

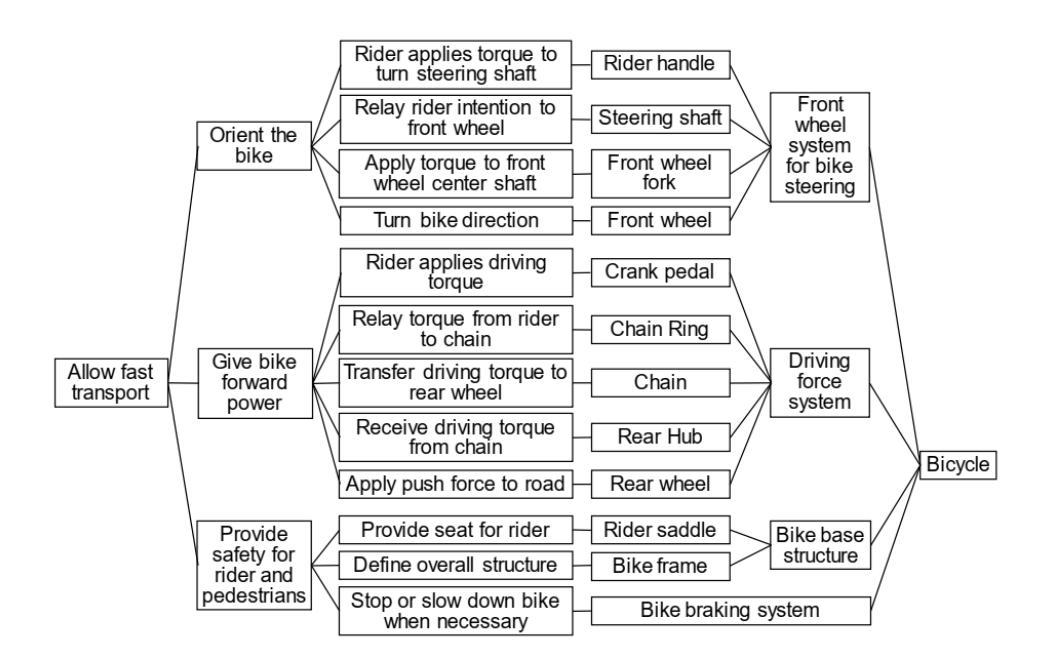
Figure 6. DRG of the bicycle in riding mode [6].

The above discussion is about how the "single action double lock" activates when parking. A rather more important function of a bike, however, is to ride it. Figure 6 is the DRG for the function of riding a bike. The figure does not have the detail of the braking system that has a number of parts, nor the detail of the locking system.

The locking system is not shown in Figure 6. To show it, one can add the function of "keep double lock engaged when parked" with the mechanism of the "single action double lock", or combining Figures 6 and 7 will give a complete picture.

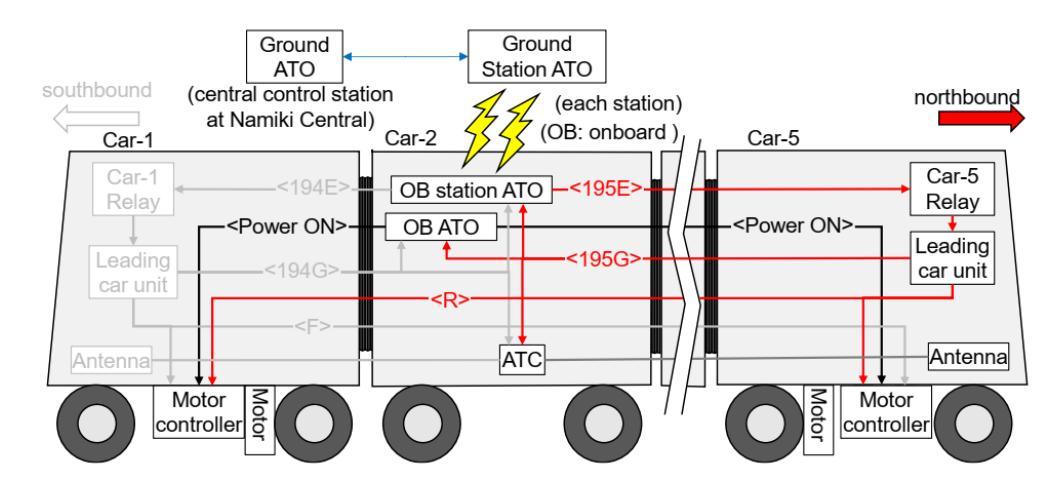
Figure 10. Automatic systems in Cars 1 to 5, northbound before reaching Shin Sugita station.

Figure 10 shows the five-car train except, Cars 3 and 4 are cut out from the illustration. The figure shows the controllers in the state of moving the train northbound, i.e., the proper travel just before the train reached Shin Sugita station. The single-line red arrows in the figure are control lines and, for this northbound travel, lines 195E and 195G and Control Line R were energized.

When the line failed during the train's southbound travel, nothing unusual happened because the motor controllers were designed to hold direction commands in memory. When the train reversed its direction at the south end of Kanazawa Hakkei station, the failure again went unnoticed because, there, the Control Line R turned ON and the train successfully reversed its direction to head north (Figure 10).

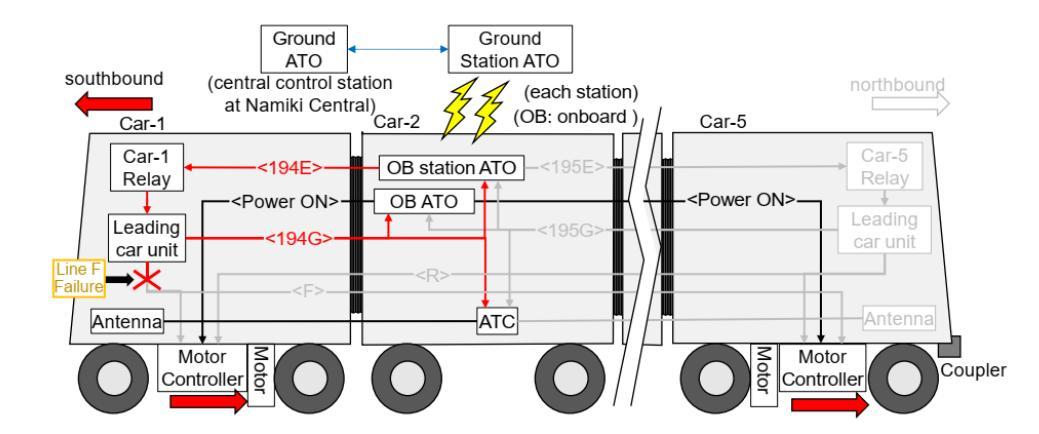
Figure 11. High level train control and motor controllers registered with opposite directions.

The leading car unit in Car-1 also had the function of sending the southbound signal to the three motor controllers in cars 1, 3, and 5 by energizing Control Line F that branched out to the three motor controllers. Figure 11 shows the controller communication. The accident investigation found that Control Line F was cut when the train, in its previous travel, was heading south at around the mid-point of the entire Kanazawa Seaside Line.

The motors accelerated, heading north. Figure 11 shows the train high level control system with registered direction of southbound, contrary to the direction memorized in the motor controllers.

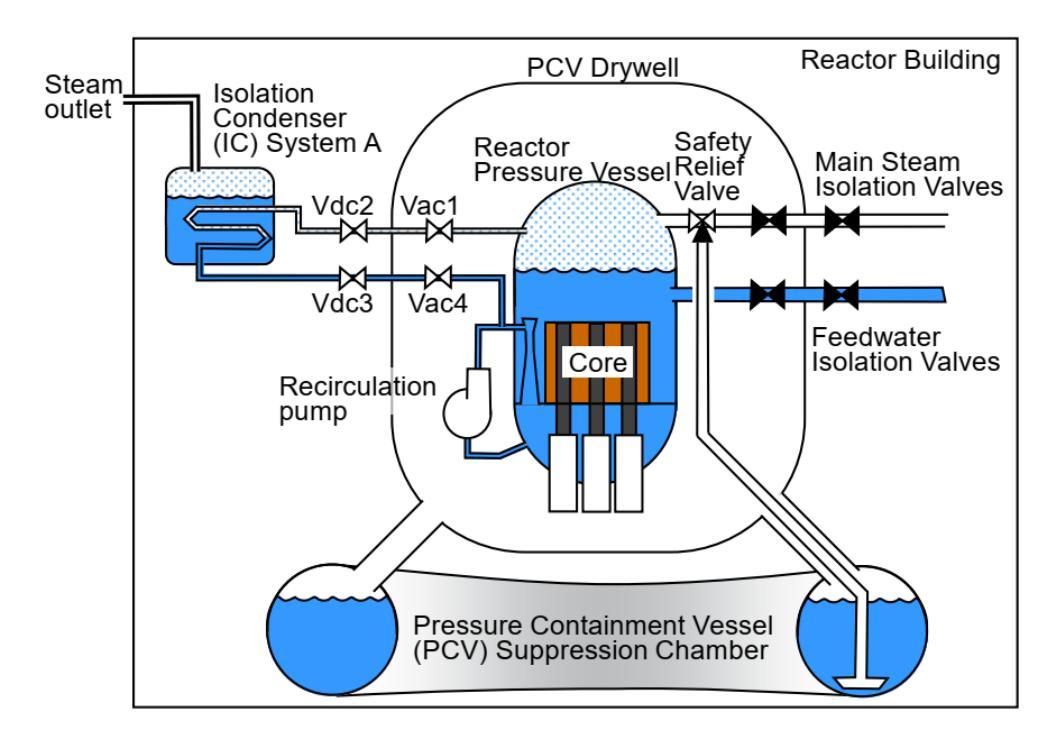
Figure 15. Fukushima-1 NPP Unit-1, IC system in core isolation mode [6].

The oldest of all units, Unit 1, started operation in March of 1971. It had two identical and independent isolation condenser (IC) systems, System A and System B, designed to remove decay heat at times of core isolations. Figure 15 shows System A at core isolation.

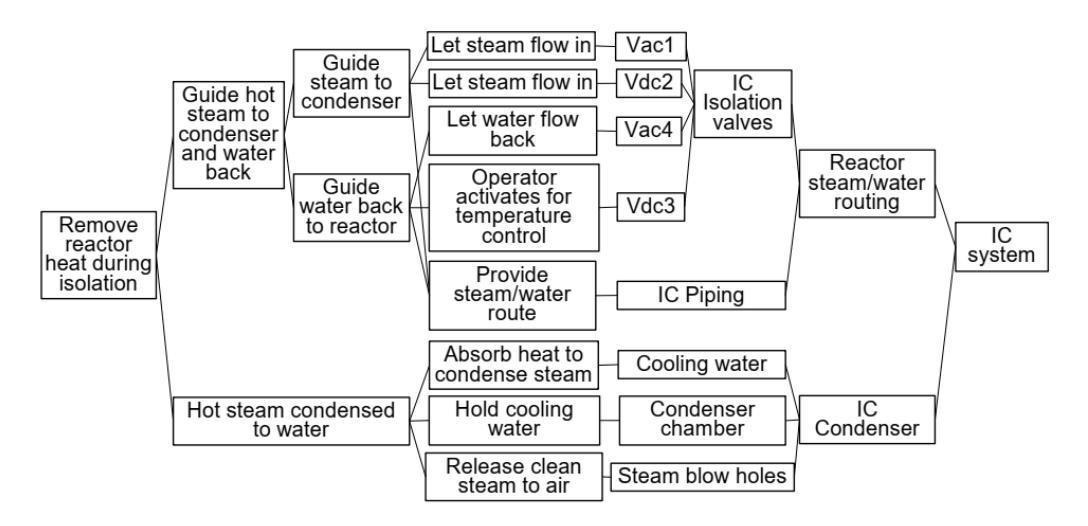
Figure 16. DRG of Fukushima-1 NPP Unit-1 IC System in operation [6].

IC is a simple condenser with a cooling water filled condensing chamber. Its piping connects to the reactor pressure vessel at a high elevation filled with steam. The IC piping routes the reactor steam to the IC chamber where the steam condenses to water inside the IC piping. The piping then exits the IC chamber and connects to the recirculation piping, and the condensed water eventually returns to the reactor pressure vessel at a low elevation filled with water. This IC piping has four isolation valves: Vac1 and Vac4 in Figure 15 are two AC valves inside the pressure containment vessel and Vdc2 and Vdc3 are two DC valves outside. When in core isolation mode, Vac1, Vac4, and Vdc2 are fully open, and the operator operates Vdc3 on and off to keep the pressure vessel drop moderate to avoid damage to the pressure vessel and its components from a sudden temperature drop. Figure 16 is the DRG for the IC system in core isolation.
