# Online Diagnostics as a First Step in the Safe Use of Damaged Photovoltaic Modules

## Abstract

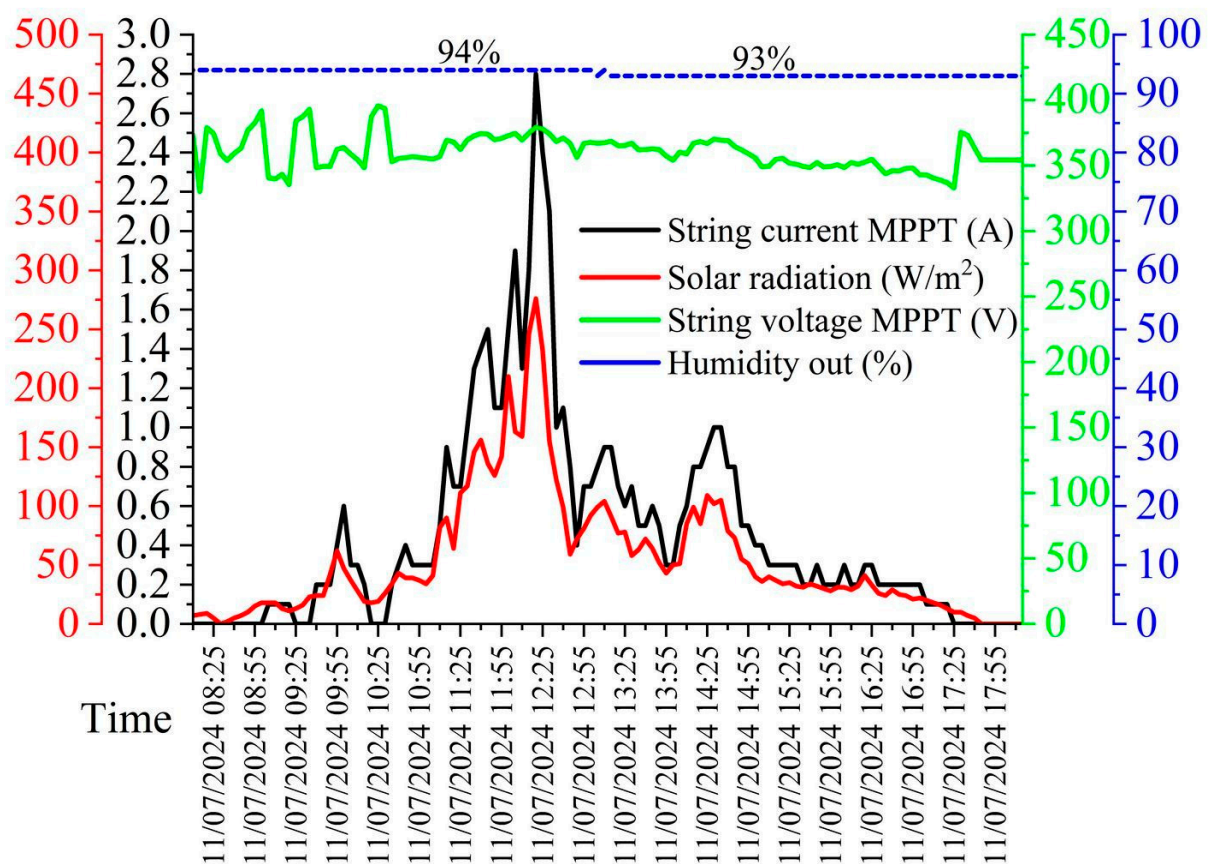
Figure 11 represents the dynamic behavior of solar irradiation and humidity on 11 July 2024. The data were obtained from the Davis Vantage Pro2 weather station, which was installed 30 m from the carport. The day was characterized by precipitation and high humidity, with a humidity level of 94% recorded between 8 a.m. and 6 p.m. Despite low solar irradiation, with a peak of only 276 W/m<sup>2</sup>, it is evident that the dynamic behavior of the DC voltage and current generated energy. The data were obtained using the iSolarCloud software and a Sungrow SG3.0RS-S inverter.

**Figure 11.** The following investigation considers the dynamic behavior of solar irradiation and humidity on 11 July 2024. Furthermore, the dynamic behavior of the direct current (DC) voltage and current on the same day is presented. The software used was iSolarCloud, and the inverter was the Sungrow SG3.0RS-S.

The grid-related faults recorded in July 2024 were two in number: one on the 14 July 2024 at 09:43:35 and one on the 28 July 2024 at 08:09:44. In both cases, the inverter fault code was 10 (mains failure). No fault code 39 (low system insulation resistance) was recorded during the monitoring period. No abnormal behavior in the conductive carport structure

was observed during the routine inspection. This included the inspection on the 11 July 2024 under high humidity.

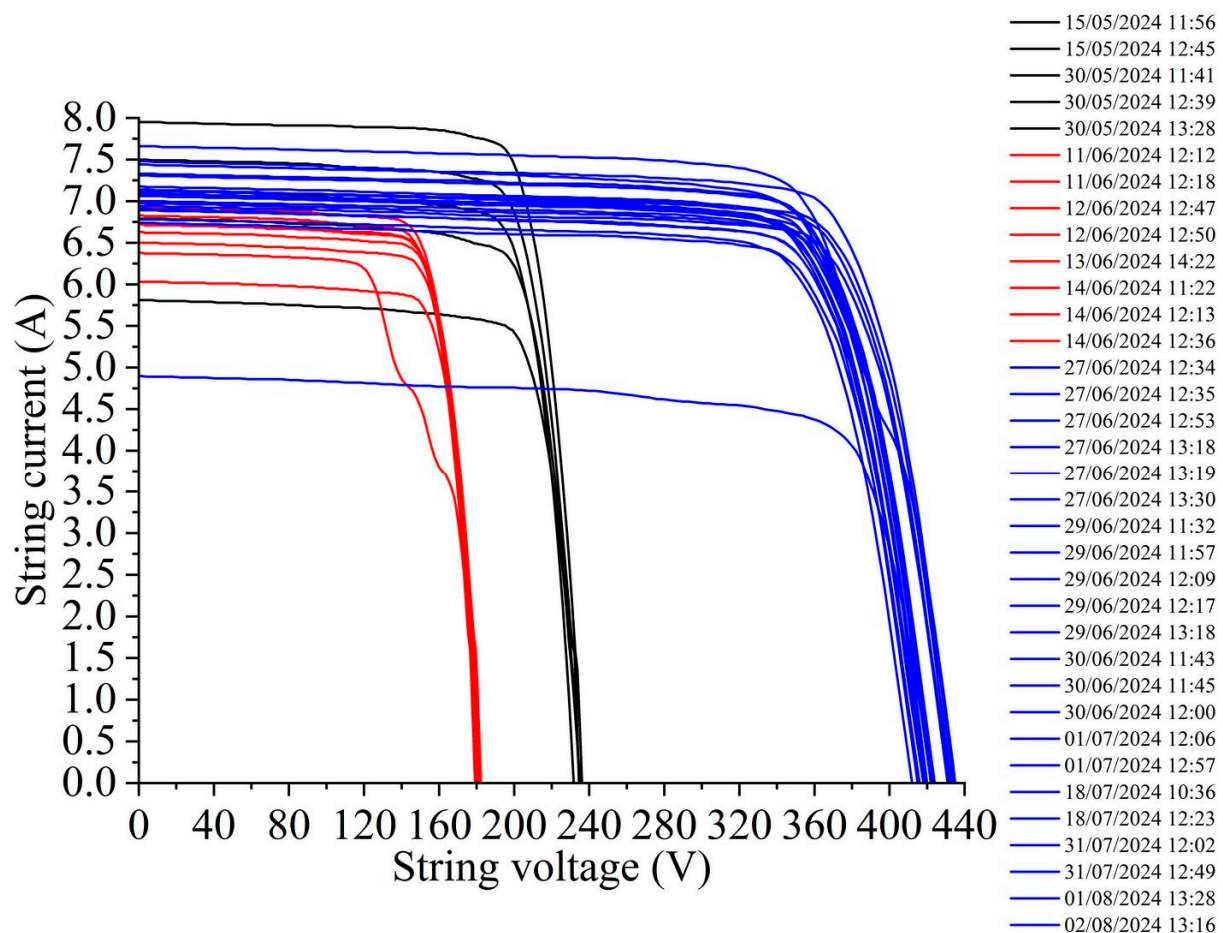
Figure 12 illustrates the dynamic behavior of the thirty-six I-V curves generated over the fourteen test days. The nine modules installed in the carport were originally divided into two strings due to the utilization of the SG5K-D inverter. During the tests, which were from 5 January 2024 to 4 June 2024, the SG3.0RS-S inverter remained connected to string 1, which consisted of five modules in series. This configuration is equivalent to the open-circuit voltage value in STC (the standard test conditions (CS3U-380MB-AG) yielded an open-circuit voltage value of  $V_{oc} = 239V_{dc}$ , with an  $I_{sc}$  range of 10.01 Adc to 13.01 Adc). From 4 June 2024 to 19 June 2024, the SG3.0RS-S inverter remained connected to string 2, comprising four modules in series. In standard test conditions (STC), this configuration yielded an open-circuit voltage value of  $V_{oc} = 191.2V_{dc}$ . From 19 June 2024 to 15 August 2024, the SG3.0RS-S inverter remained connected to the string comprising nine modules, which is equivalent to an open-circuit voltage of 430.2 Vdc in the STC. There was a strong correlation between the estimated open-circuit voltage ( $V_{oc}$ ) values and those provided by the manufacturer under STC. In this case, the purpose of the comparison was merely to provide a qualitative consistency check, as the values of the STC were model-corrected estimates and not direct measurements of the STC. This is also consistent with the documentation of the diagnostic tool, as well as the commissioning procedures described in [37]. Figure 5 illustrates the variation in ambient temperature from +26.1 °C to −0.8 °C on test days.

**Figure 12.** Dynamic behavior of the thirty-six I-V curves generated over the fourteen test days. Black: 1 May 2024 to 4 June 2024: the SG3.0RS-S inverter remained connected to the string comprising five modules. Red: 4 June 2024 to 19 June 2024: the SG3.0RS-S inverter remained connected to the string comprising four modules. Blue: 19 June 2024 to 15 August 2024: the SG3.0RS-S inverter remained connected to the string comprising nine modules. Note: The 36 I-V curves shown correspond to scans generated with the SG3.0RS-S inverter using iSolarCloud; commissioning operation with SG5K-D is not included in this I-V scan dataset.

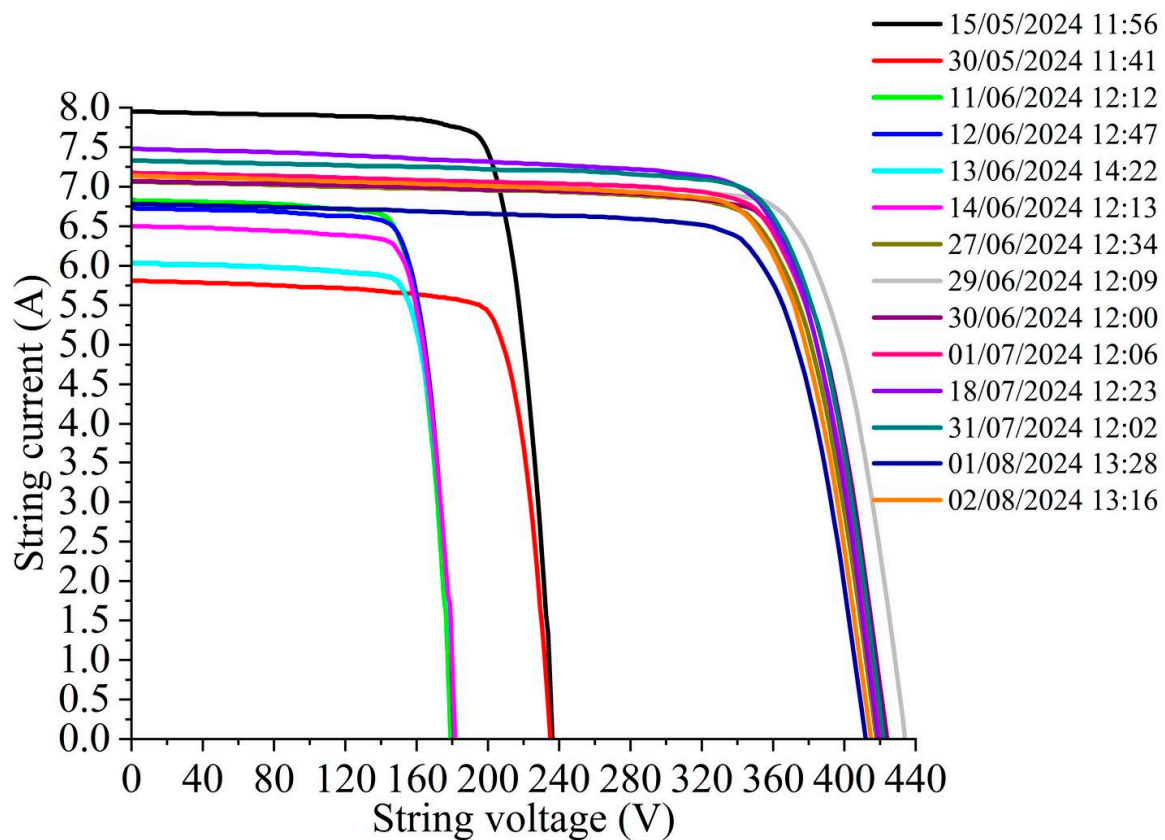
served when the approximate  $I_{sc}$  (under 600–800 W/m<sup>2</sup>) provided by the manufacturer is compared with the estimated values from the I-V characteristics in Figure 13.

**Figure 13.** Dynamic behavior of the I-V curves that were generated at a time close to 12 noon on the test days.
