# Research on Failure Modes and Causes of 100-m-High Core Wall Rockfill Dams

**Keywords:** core wall rockfill dam; failure modes; dam crest cracking; seepage; long-term deformation; wetting properties

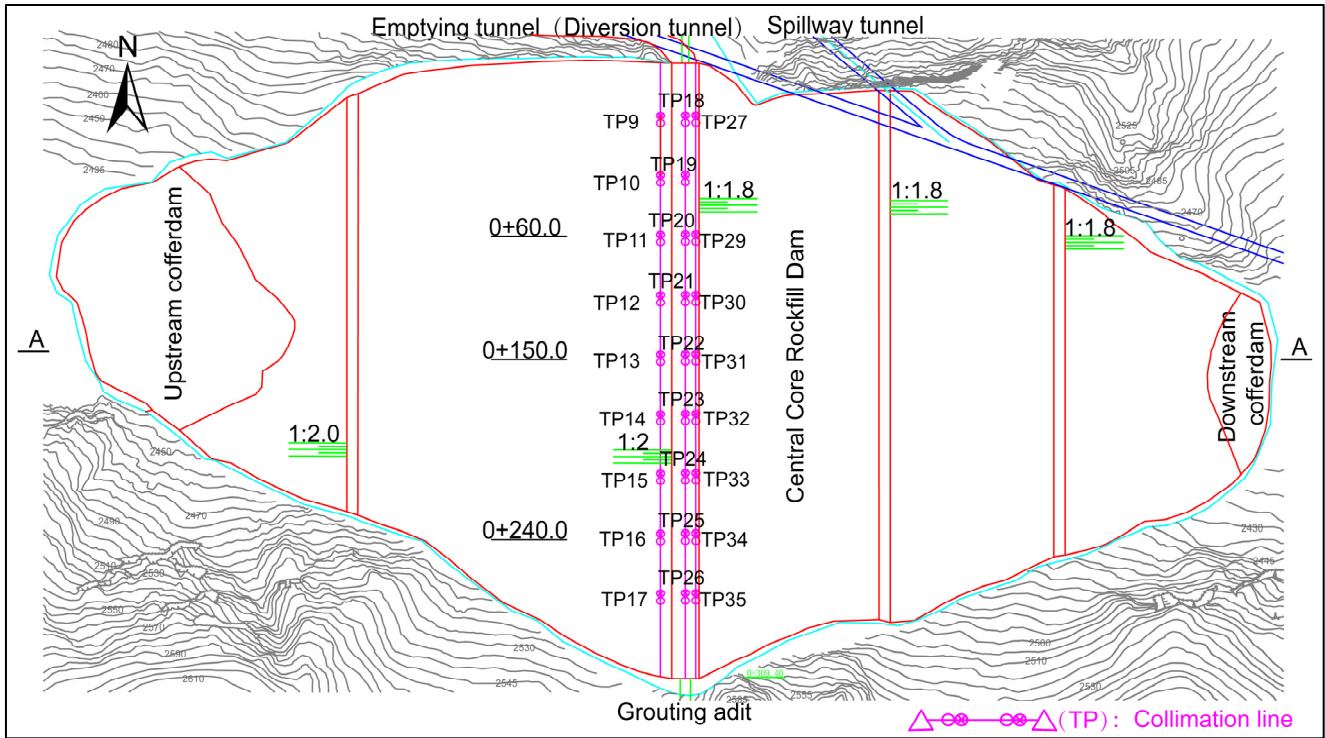
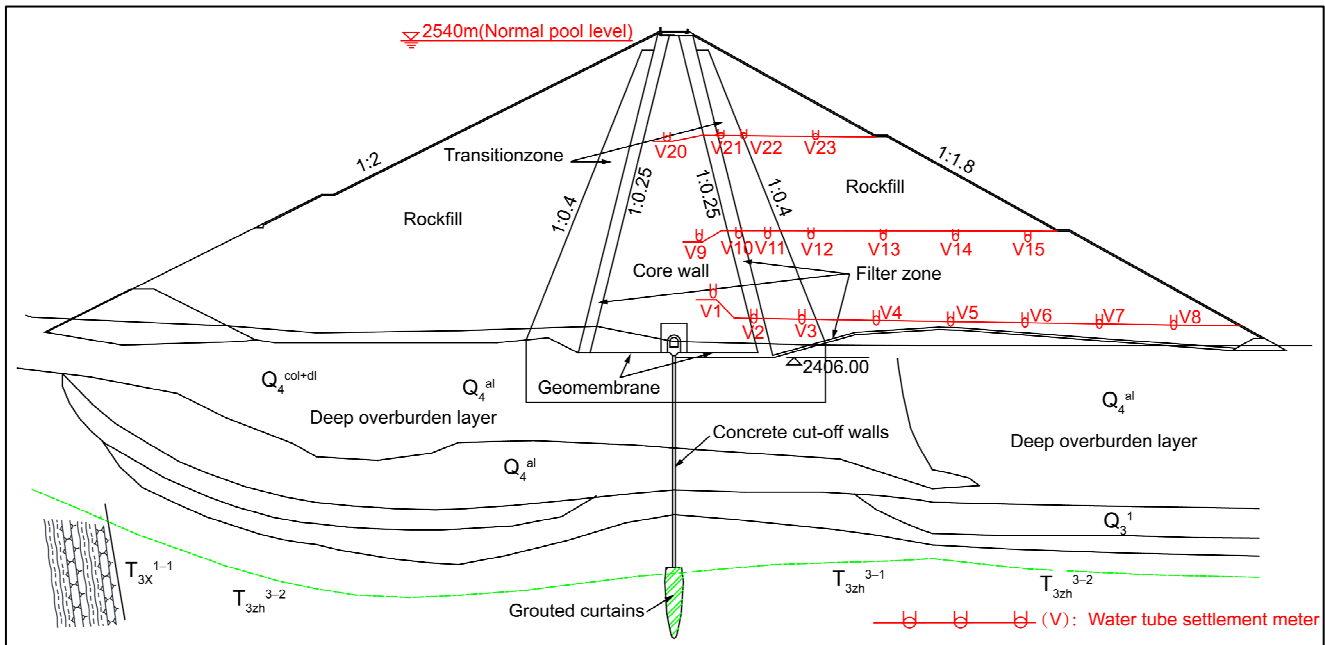
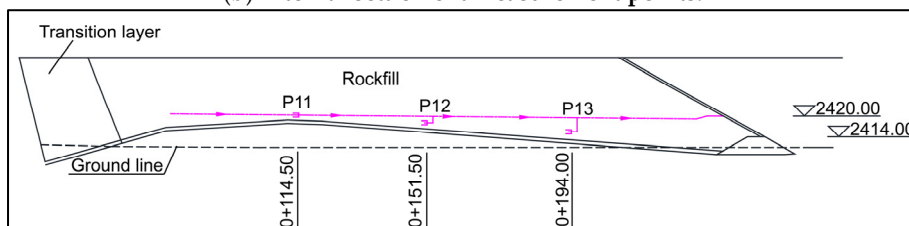
**Figure 7.** Layout of the monitoring points.

To monitor the external deformation of the dam crest, nine displacement markers were installed at the dam surface elevation of 2542 m upstream of the dam, along the dam crest axis, and downstream of the dam crest, parallel to the dam axis. The layout is shown in Figure 7a. The internal deformation of the dam was monitored using water pipe settlement meters installed at typical profile elevations of 2420 m, 2460 m, and 2505 m (Figure 7b). The inclination index is primarily used to analyze deformations, and the calculation formula for inclination is

To monitor seepage from the dam slope, three piezometers were installed in the downstream rockfill area to monitor the seepage pressure at the dam base (Figure 7c). Additionally, the seepage volume of the dam was automatically measured using the

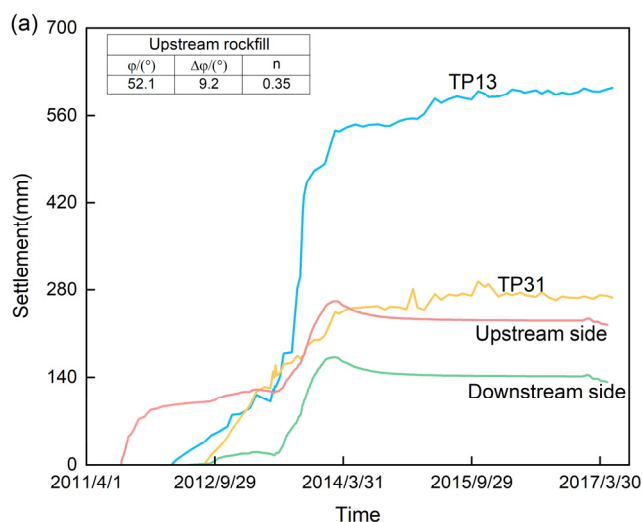
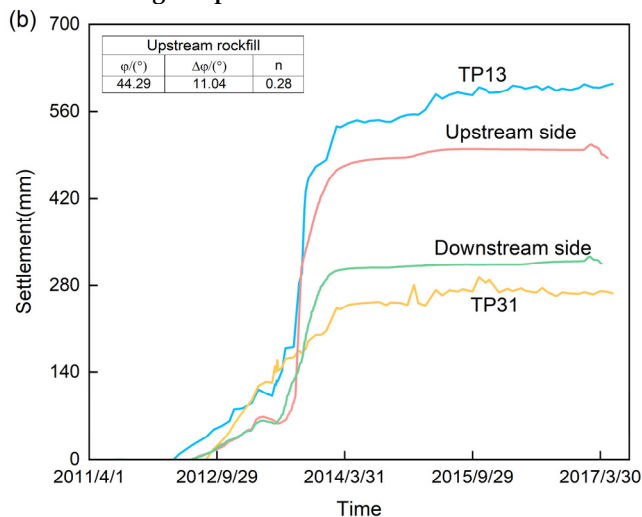
**Figure 13.** Comparison of the calculated and measured results.

Figure 13 compares the settlement differences between measured values at the dam crest and calculated results using both the original and back analysis parameters. The calculated settlement based on the original parameters is about 147.35–370.65 mm lower than

the actual measured values. This significant discrepancy fails to accurately reflect the actual deformation process of the dam. In contrast, the back analysis calculation produced results that closely matched the trends observed in the measured values. The average relative error for deformation at the TP13 and TP31 measuring points is 14.06% and 7.00%, respectively, which are within acceptable limits. Compared to the calculated results using the original parameters, the error between the results of the back analysis parameters and the measured values is reduced by 44% to 47.6%. This difference mainly originates from the weakening of the strength of the upstream rockfill, which is weakened by 15% by the finite element simulation for the internal friction angle of the upstream rockfill. According to the construction situation analysis, due to a lack of quarry sites for dam filling, different material sources are used to mix and fill in a ratio of at least 1:1, with some sites requiring only mixed materials. As a result, the quality of the mixed materials is difficult to control, and the properties of the dam material are uneven, resulting in a decrease in the mechanical properties of the rockfill material.

To address uneven deformation, the design will incorporate strict design criteria and improve dam construction materials, such as core wall soil mixed with gravel to enhance compressive strength. However, in practice, it is crucial to strictly control construction quality, optimize the quarry mining program, and rigorously manage the grading of rockfill materials and dam filling construction quality to prevent uneven settlement caused by inconsistent filling.
