Operationalisation of Building Inspections and Repair: Systematisation-Based Approach

Featured Application: This article applies to building maintenance and the life-cycle assessment of repair operations.

Keywords: building maintenance; building pathology; diagnosis methods; repair techniques; life-cycle assessment

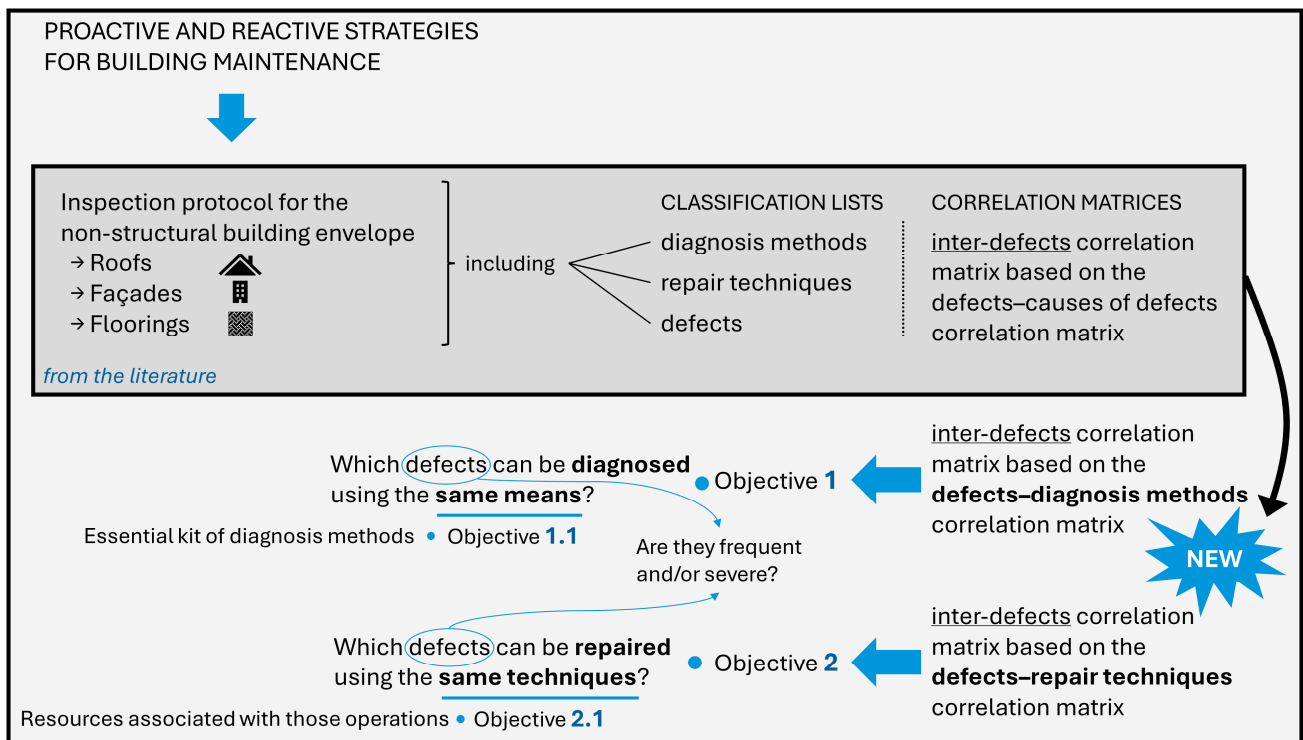
Figure 1. Diagram of the scope and objectives of the present research.

The presented study is included within the scope of inspection of the envelope of current buildings as a support task to proactive and reactive maintenance strategies. Considering the categories roofs, façades and floorings, the research objectives are as follows (Figure 1):

- understanding if and which defects can be diagnosed using the same means, considering visual observation as the base procedure and the use of tools and equipment as specific diagnosis methods;
- understanding if and which defects can be repaired using the same techniques and the number of resources associated with those practices.

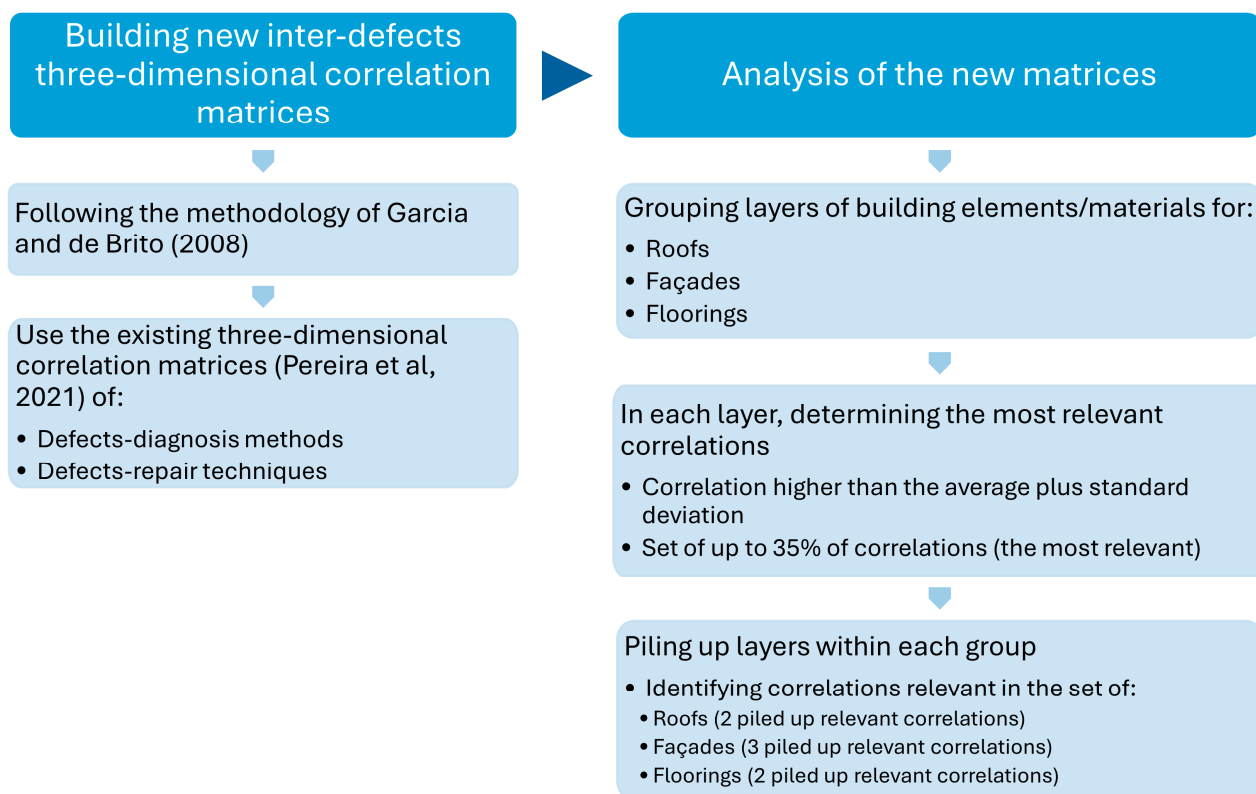
Figure 2. Methodology followed to build and analyse correlation matrices to reach the proposed goals (considering the information of Garcia and de Brito [35] and Pereira et al. [13]).

The materials and methods described in Sections 2.1 and 2.2 are outlined in Figure 2.

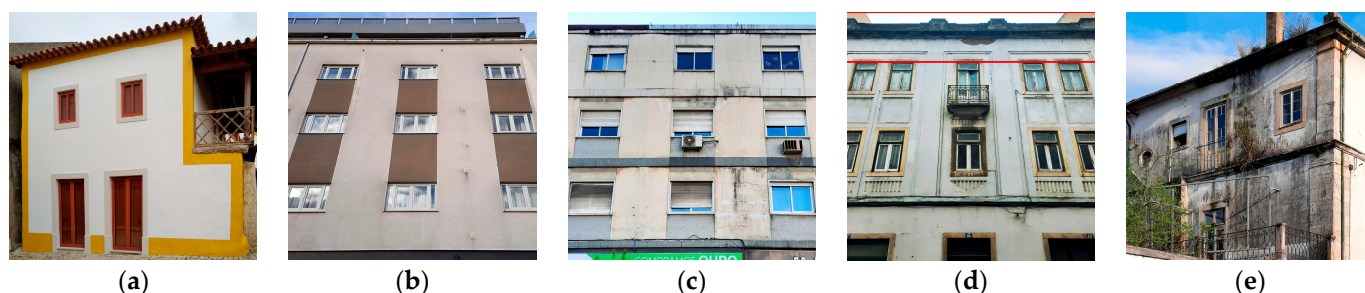
Figure 3. Levels of severity of stains/colour changes in painted façades: (a) Level 0; (b) Level 1; (c) Level 2; (d) Level 3; (e) Level 4.

As for painted façades, the severity implicitly associated with the degradation levels for defects by Chai et al. [54] may be used. Of the mentioned set of defects, these authors take into account “A-A2 Surface moisture”, “A-A3 Dirt and accumulation of debris”, and “A-B1 Biodeterioration/biological growth”, which are considered within the scope of “stains/colour change”. “A-C1 Mapped cracking” is also taken into account as “cracking”. Both for stains/colour changes and cracking, in Level 0, there should be no visible degradation. Stains/colour changes are classified from Level 0 to Level 4, considering the intensity of change and the type of visible signs of defects (Figure 3). So, in Level 1 (Good condition), only slight or little perceptible uniform surface dirt should be observed. In Level 2 (Slight degradation), moderate or quite perceptible uniform surface dirt may be observed. In Level 3 (Moderate degradation), moderate or quite perceptible humidity stains, biological growth, and localised surface dirt may be observed, or high or very perceptible uniform surface dirt may be observed. In Level 4 (Generalised degradation), high or very perceptible biological growth may be observed. Cracking is classified according to a visual scale of the density of cracks, from a small number of cracks (in Level 1) to a high number or density of cracks (in Level 4). Considering these data, biological growth and cracking may be the most severe defects in this set of defects in painted façades. Chai et al. [54] use a five-level scale from Level 0 (No visible degradation) to Level 4 (Generalised degradation).
