# Failure Mechanism of Sandy Soil Slopes Under High-Angle Normal Bedrock-Fault Dislocation: Physical Model Tests

**Abstract:** Bedrock fault dislocation is a crucial structural factor influencing landslide movement. Accurately predicting the location and scale of rupture zones within a slope body is essential for effective slope construction design and risk mitigation. Based on an analysis of seismic damage in slope cross-bedrock faults, this article creatively realizes the physical model test of the slope and its covering layer site with soil rupture zones at the top and toe of the slope caused by the dislocation of the bedrock normal fault. Through the model test, macroscopic phenomena were observed, and microscopic analysis was obtained by deploying sensors. The main results were as follows: (i) The evolutionary process of the instability mechanism could be divided into three stages: crack damage stage (Stage I), crack expansion and penetration stage (Stage II), and slope instability stage (Stage III). (ii) Two rupture modes of the soil body in the slope under bedrock dislocation were identified, with the rupture mode at the slope crest having a greater impact on the soil slope

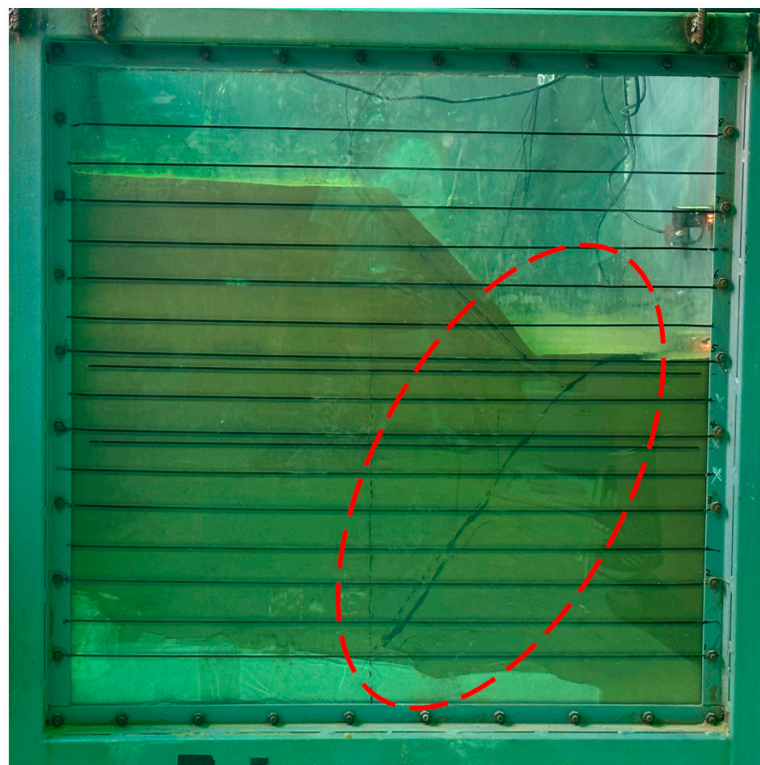
Figure 4. Pre-test site image of a sand slope.
