# Evaluation of Mechanical Properties of Horticultural Galvanized Steel Pipes Based on Service Life

Mechanical properties of agricultural galvanized steel pipes with service life provide fundamental data for evaluating the structural performance and stability of aging greenhouse structures. Tensile tests (tensile strength, yield strength, elongation) were conducted in accordance with ASTM E8/E8M-16a. Soil pH and EC, in which the pipes were buried, were analyzed. Results were compared with the strength standards requirements for vinyl-house steel pipes specified in the Industrial Standard (KS D 3760). Yield strength met the standard for the 6- and 7-year samples, whereas tensile strength met the standard for the 6-, 7-, 11-, and 13-year samples. Elongation satisfied the requirements for the 7- and 21-year samples. Significant differences in the tensile strength and yield strength were observed with increasing service life, with noticeable reductions occurring after 11 years with an average reduction of about 20%. Elongation showed significant differences in all service years except the 7- and 21-year samples. The average soil pH was 5.8, indicating acidic conditions, and the EC ran

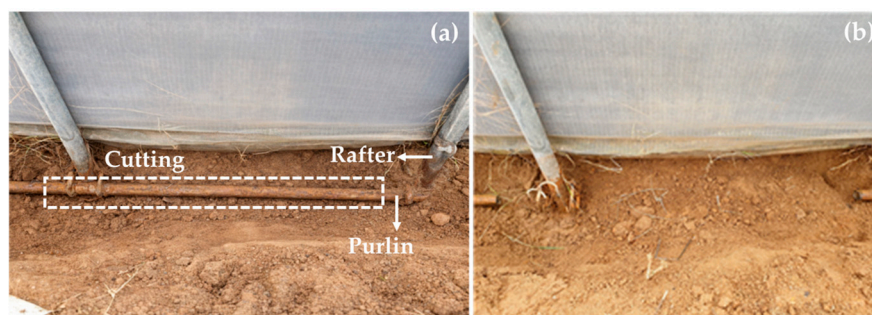
**Figure 1.** Example of collecting buried rafters or purlins in a greenhouse: (a) rafter and purlin before cutting; (b) section of a purlin after cutting and harvesting from the buried installation.

The material used for the test was galvanized steel pipe installed in the cultivation area of an old facility horticultural test site located in Gangseo-gu (Busan Metropolitan City, Republic of Korea; 35°13'16" N, 128°56'27" E). The method for extracting steel pipes from buried sections of a greenhouse is depicted in Figure 1. Galvanized steel pipes were

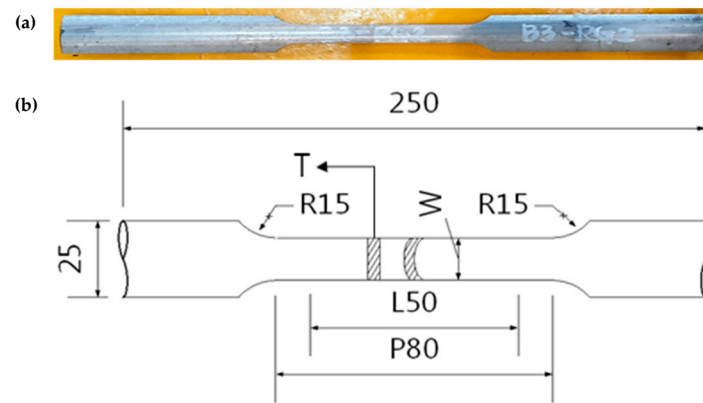
**Figure 2.** Specimen for tensile test used in this study. (a) Specimen; (b) specimen size (W: width, T: thickness, L: gauge length, P: length of the parallel section, R: radius).

Tensile specimens were prepared in accordance with KS B 0801. For specimen fabrication, galvanized steel pipes (300 mm in length) were cut and machined into KS B 0801 No. 14 standard tensile specimens using a laser cutting machine (Figure 2) [19]. The total length of the specimen was 250 mm, with a width (W) of 12.5 mm. The thickness (T) ranged from 1.1 to 1.6 mm depending on the pipes. The gauge length (L) was 50 mm, the length of the parallel section (P) was 80 mm, and the radius (R) was 15 mm.

The L was used as the reference for elongation measurements and the P represented the load-bearing region during tensile testing. A total of 54 specimens were used for testing and analysis, consisting of 6 specimens for pipes with different service lives.

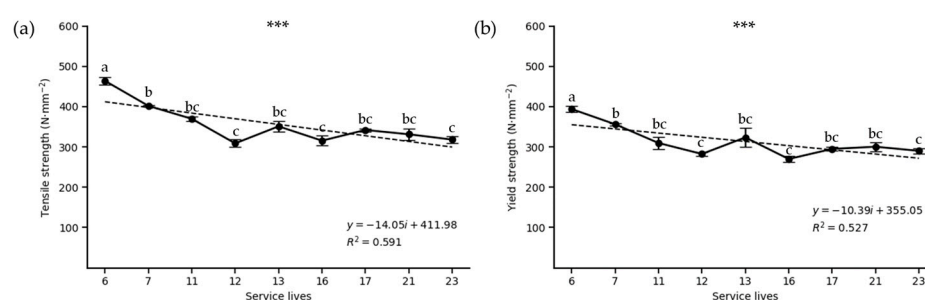
**Figure 3.** Tensile strength (a) and yield strength (b) of buried specimens by pipe service life. Vertical bars represent the standard errors. Different letters indicate significant differences among groups (one-way ANOVA followed by LSD test;  $n = 6$ ). Significance level: \*\*\*  $p < 0.001$ .

Tensile strength, yield strength, and elongation were evaluated across service-life groups using tensile tests (Figures 3 and 4). Both tensile and yield strength decreased with increasing service life (Figure 3). Notably, the 6-year specimens exhibited the highest values at 464 and 393  $\text{N}\cdot\text{mm}^{-2}$ , respectively. In contrast, the 12-, 16-, and 23-year specimens showed significantly lower tensile and yield strength than the 6- and 7-year specimens. The oldest (23-year) specimens recorded tensile and yield strength of 318 and 290  $\text{N}\cdot\text{mm}^{-2}$ , corresponding to reductions of approximately 31% and 26% relative to the 6-year specimens. This strength decline is likely attributable to accumulated corrosion and material aging due to increased service life. However, the pH and EC of the soil from the buried pipe were measured in this study did not show significant differences according to service life, so it is difficult to explain the strength decline solely by changes in soil chemical conditions (Table 3). Therefore, it is possible that the strength decline was caused by a combination of various environmental factors such as rainwater, groundwater, nutrient solution exposure, moisture content, and microorganisms in addition to the aging of the material due to service life, which accelerated corrosion and aging [12,31,32].

As a result of evaluating the KS standard for SPVHS, the tensile strength satisfied the standard of 6- and 7-year specimens, whereas yield strength satisfied the standard of 6-, 7-, 11-, 13-, and 21-year specimens. Nam [14] proposed a standard service life of 7–8 years for small greenhouses. Consistent with this, specimens with a shorter service life (6–7 years) in this study generally satisfied the KS standard.

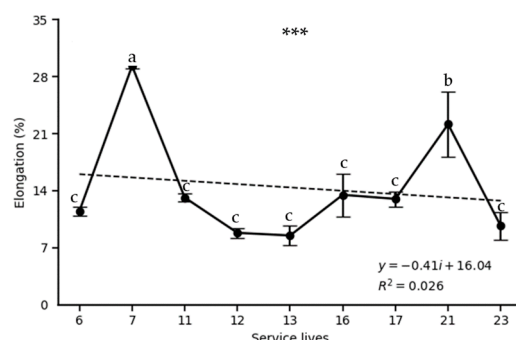
**Figure 4.** Elongation of buried specimens by pipe service life. Vertical bars represent the standard errors. Different letters indicate significant differences among groups (one-way ANOVA followed by LSD test;  $n = 6$ ). Significance level: \*\*\*  $p < 0.001$ .

Although significant differences in elongation was observed across service-life groups, the pattern did not show similar trend with the tensile strength and yield strength (Figures 3 and 4). Elongation satisfied the SPVHS standard only for the 7- and 21 years specimens, whereas other groups (6, 11, 12, 13, 16, 17, and 23 years) did not (Figure 4 and Table 2). Elongation is an indicator related to the ductility of a material, and it has been confirmed that it generally tends to decrease as a material ages. However, in this study, elongation values were relatively high for the 7- and 21 years specimens, resulting in a statistically significant difference among service-life groups. The 21 years specimens showed a mean elongation of 22.2% with a relatively large standard deviation of 9.8%, indicating substantial variability in elongation among specimens. Meanwhile, the 7 years specimens showed the highest elongation. However, the average diameter and thickness of the 7 years specimens did not differ significantly from those of the groups, and no notable abnormalities were observed in their visual characteristics that could explain the increased elongation.
