# Self-Healing Efficiency of a Multidirectional CFRP Laminate After Low-Velocity Impact

The widespread use of carbon fiber-reinforced polymers (CFRPs) in unmanned aerial vehicle (UAV) structures increases the importance of understanding low-velocity impact damage, which is often barely visible yet can significantly reduce residual strength and lead to structural failure during service. This study investigates the impact behavior and healing capability of a multidirectional CFRP laminate with a thermally activated self-healing matrix (CompPair HealTech®). Laminates with a thickness of 1.45 mm were subjected to drop-weight impacts at 5 J and 10 J. After impact, specimens were thermally activated at 150 °C for 30 min and re-impacted under identical conditions. Impact response was evaluated from force, energy, and displacement histories, while residual properties were assessed by compression after impact (CAI) testing and X-ray phase-contrast imaging (XPCI). At 5 J, the re-impact response was nearly identical to the initial impact, with a peak force of approximately 2.1 kN, indicating largely reversible damage. At 10 J, the peak force decreased from ~3.0 kN to ~2.6 kN and displacement

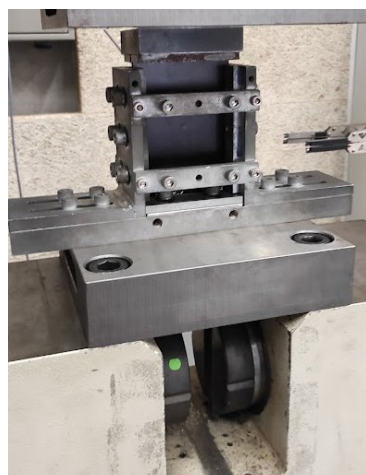
**Figure 2.** Experimental setup for compression after impact testing, showing the anti-buckling fixture and specimen positioning in the testing machine.

Residual mechanical properties were evaluated using compression after impact (CAI) testing in accordance with ASTM D7137/D7137M [6] on a Schenck Trebel RME 600 (SCHENCK RoTec GmbH, Darmstadt, Germany) testing machine (Figure 2).
