Research on Material Removal Mechanism of C/SiC Composites in Ultrasound Vibration-Assisted Grinding

Abstract: C/SiC composites are the preferred materials for hot-end structures and other important components of aerospace vehicles. It is important to reveal the material removal mechanism of ultrasound vibration-assisted grinding for realizing low damage and high efficiency processing of C/SiC composites. In this paper, a single abrasive particle ultrasound vibration cutting test was carried out. The failure modes of SiC matrix and carbon fiber under ordinary cutting and ultrasound cutting conditions were observed and analyzed. With the help of ultrasonic energy, compared with ordinary cutting, under the conditions of ultrasonic vibration-assisted grinding, the grinding force is reduced to varying degrees, and the maximum reduction ratio reaches about 60%, which means that ultrasonic vibration is beneficial to reduce the grinding force. With the observation of cutting debris, it is found that the size of debris is not much affected by the a_p with ultrasound vibration. Thus, the ultrasound vibration-assisted grinding method is an effective method to achieve low damage and high eff

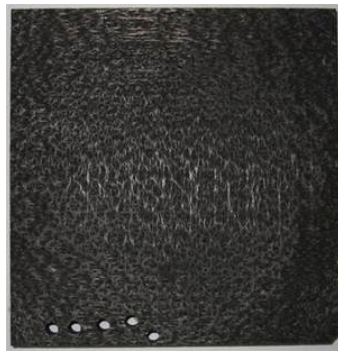
Material Properties	Numerical Value
density $\rho/\text{g/cm}^3$	2.37
elastic modulus E/GPa	136
Poisson's ratio μ	0.07

Figure 1. C/SiC test piece and its material properties.

The C/SiC composite material used in the cutting experiments adopts a structure iterating in the order as follows: single-layer 0° carbon fiber non-woven cloth, SiC matrix layer, 90° carbon fiber non-woven cloth, and SiC matrix layer. The carbon fiber layer is unidirectional, and short fibers are distributed in the layer due to existence of the mesh inside the SiC matrix layer. To make the whole structure, the relay acupuncture technique is used to vertically pierce the short fibers inside the mesh layer into the non-woven cloth [31]. The needling structure can increase the interlayer strength of C/SiC composites, but the ratio of needling area is relatively small and can be ignored during the cutting process. Figure 1 shows the C/SiC test piece and its material properties. The C/SiC composite was divided into samples with a size of 35 mm × 8 mm × 5 mm, and then the upper surface was polished into a mirror surface to observe the scratches of the single diamond abrasive particle.

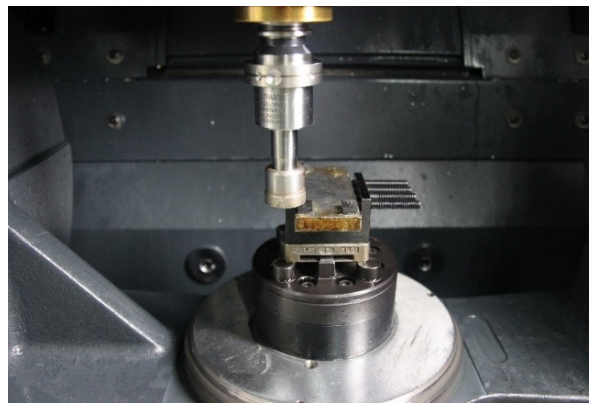
Figure 2. Test devices for ultrasound-assisted cutting with a single abrasive particle.

As shown in Figure 2, the test was performed on a vertical high-speed machining center (DMG Ultrasonic 20 Linear, DMG MORI, Bielefeld, Germany). As shown in Figure 3, a single diamond abrasive particle is brazed on the end face of a cup-shaped diamond grinding wheel base, which is made of low carbon steel (Type 45 steel), its diameter is $\varnothing 24$ mm, the wall thickness is 2 mm, the diameter of the diamond abrasive 91 μm , as a cutting tool with a single abrasive particle. The particle size of the diamond abrasive particle is 40/50 mesh. During ultrasound-assisted cutting, the resonant frequency of the tool is 21.2 kHz and the end amplitude is approximately 4 μm . After selecting multiple sets of experimental parameters for the experiment, a set of experimental parameters was selected based on the experimental results and experience, under which the cutting force and temperature values were lower. The cutting parameters are as follows: the spindle speed n is 1000 rpm, the grinding depth a_p is 10 μm , and the workpiece speed v_w is 100 mm/min.

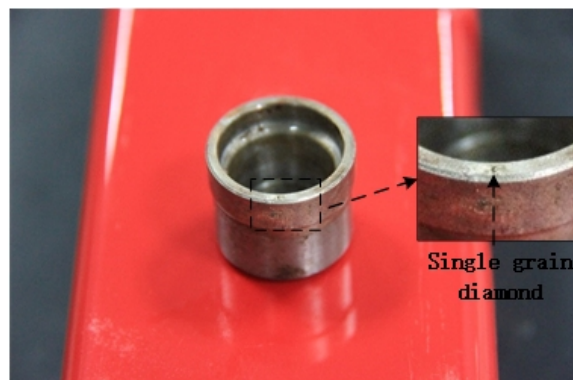
Figure 3. Ultrasound-assisted cutting tool with a single abrasive particle.

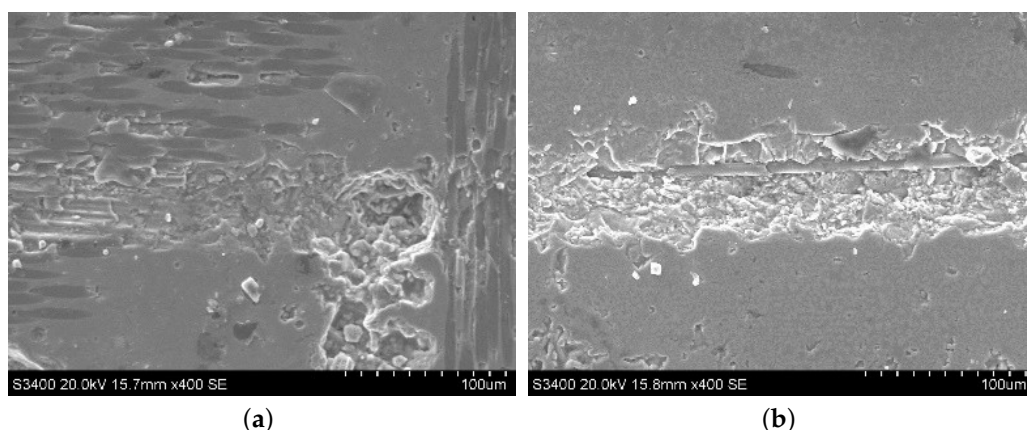
Figure 4. Typical surface morphologies of the SiC region in C/SiC composite after ordinary cutting and ultrasound-assisted grinding. (a) is ordinary grinding and (b) is ultrasound-assisted grinding.

Typical machined surface morphologies of the SiC region in C/SiC composite after ordinary cutting and ultrasound-assisted cutting are observed by SEM as shown in Figure 4. Due to ultrasound vibration, the diamond abrasive particle hammered the SiC surface periodically, and the hammering pits generated accordingly, resulting in the fact that the SiC surface has brittle spalling, which will also make the generation and propagation of cracks in the workpiece material easier, and the grinding force during the grinding process decreases. At the same time, compared with ordinary grinding, intensive hammering also makes the SiC region peel off more easily in ultrasound-assisted grinding. Therefore, it can be seen that the abrasive particle vibrates up and down under ultrasound vibration, which changes the motion form of the abrasive particle and weakens the cutting effect of the tool on the surface during processing.

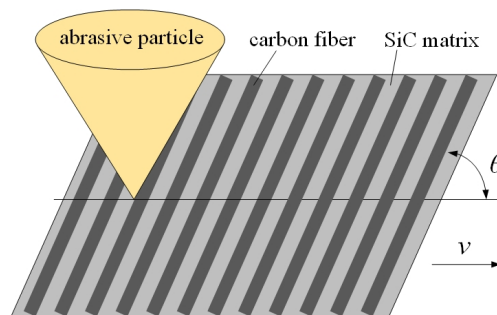
Figure 5. Diagram of a fiber orientation angle.

The definition of fiber orientation angle is shown in Figure 5, and the angle θ between the velocity orientation of the abrasive particle and the fiber orientation is defined as the fiber orientation angle.

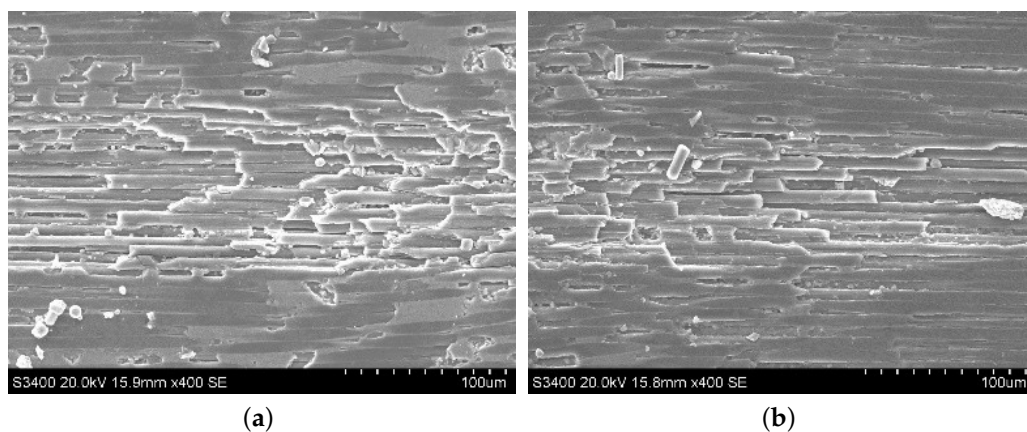
Figure 6. Typical morphologies after cutting C/SiC composites at 0° . (a) is ordinary cutting and (b) is ultrasound-assisted grinding.

The surface morphologies of ordinary cutting and ultrasound cutting when the fiber orientation angle is 0° are shown in Figure 6. It can be seen that carbon fibers break along the cutting direction, and the fiber fractures are more intensive under the ultrasound condition. When the fiber orientation angle is 0° , the forces applied on the fibers are shown in Figure 7. In addition, Figure 8 shows the analysis of a single fiber cutting force when the fiber orientation angle is 0° . The main cutting force F generates a cutting force F_1 perpendicular to the fiber direction and a cutting force F_2 parallel to the fiber direction. F_1 is perpendicular to the direction of the fiber layer and points to the surface of the material. F_2 subjects the fiber to compressive stress. When the fiber orientation angle $\theta = 0^\circ$, the single-particle cutter peels the carbon fiber from the silicon carbide matrix in the cutting area. The stripping process is smooth, the material in the cutting area is completely removed, and the cross-section is clear and tidy. This is because the tool moves in the same direction as the fiber. The tool can easily cut into the material and separate the carbon fiber from the silicon carbide matrix. Because the bonding strength between the carbon fiber and the silicon carbide matrix is much less than the shear strength of the carbon fiber, the carbon fiber is more easily peeled along the direction of the cutter movement. This form of cutting deformation can be called an interlayer peeling type. Under ordinary cutting condition, as shown in Figure 7, the main cutting force F can be divided into a cutting force F_2 parallel to the fiber orientation and a cutting force F_1 perpendicular to the fiber orientation. When applied the cutting force, the carbon fibers bend under pressure. As the abrasive particle moves forward, the fibers undergo strong deformation and eventually break in front of the abrasive particle at a certain distance. While under the condition of ultrasound cutting, as shown in Figure 7b, under the high-frequency strike of abrasive particle, the carbon fibers are cut into small pieces by the shear stress, and fracture is located under the abrasive particle.

It can be seen from Figures 6, 9, and 12 that, after ordinary cutting and ultrasound-assisted cutting, the fiber regions of the material both have stepwise breaks. Fibers under ordinary cutting are pulled out totally and break, while fibers under ultrasound-assisted cutting process are broken into pieces, and the affected area and damage degree are slightly lower than those of ordinary cutting. This fracture characteristic is similar to that of the SiC region, and both are related to the up-and-down vibration of the abrasive particle under ultrasound vibration, which is the main reason that the cutting force of ultrasound-assisted grinding is smaller than that of ordinary grinding. Under ordinary cutting condition, cutting quality with the fiber orientation angle of 0° is better than that of 90° , and even

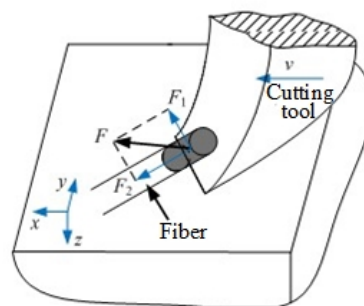
Figure 8. Analysis of a single fiber cutting force when fiber orientation angle is 0° .

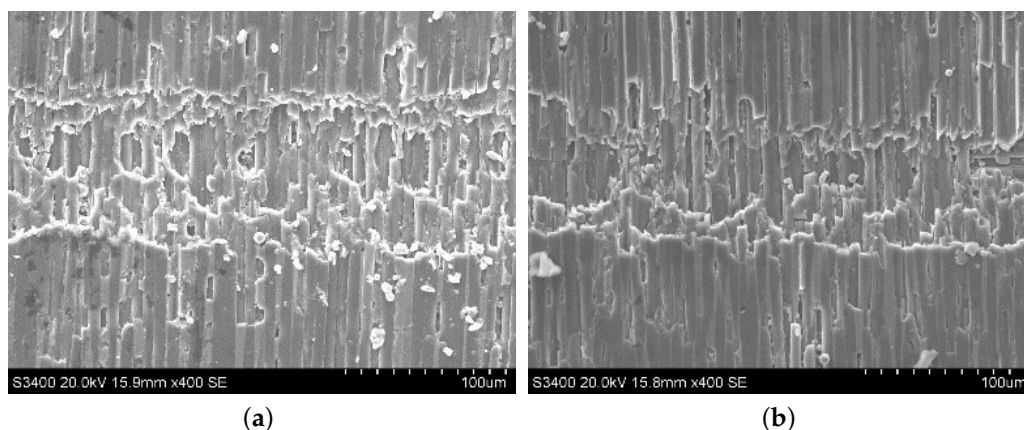
Figure 9. Typical morphologies after cutting C/SiC composites at 90° . (a) is ordinary cutting and (b) is ultrasound-assisted grinding.

Surface morphologies of ordinary cutting and ultrasound cutting when the fiber orientation angle is 90° are shown in Figure 9. It can be seen that, under ordinary cutting conditions, the scratch width is larger than that of ultrasound cutting, which illustrates that, under ordinary cutting conditions, the fiber breaks are farther away from the abrasive particle than that of ultrasound cutting. When the fiber orientation angle is 90° , forces applied on the fibers are shown in Figure 10 and the force analysis of a single fiber during cutting is shown in Figure 11. Under ordinary cutting condition, the main cutting force F is perpendicular to the fiber axis, and can be divided into a cutting force F_3 on the plane of the fiber layer and a cutting force F_4 perpendicular to the plane of the fiber layer. The forces and deformations of the fibers on both sides of the tool are the same. The fibers may crack at the contact position and both sides of the tool. As the abrasive particle moves forward, the fibers bend and break, as shown in Figure 10a. Under the condition of ultrasound cutting, due to the high-frequency strike of the abrasive particle, the fibers are cut at the position where they contact the abrasive particle, as shown in Figure 10b.

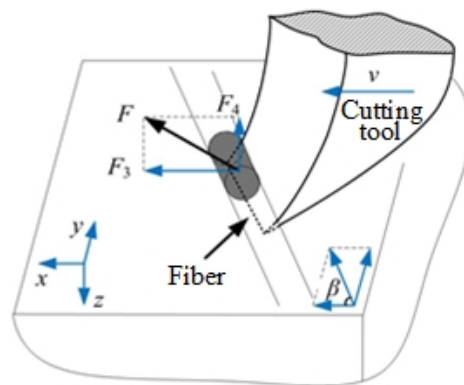
Figure 11. Force analysis of a single fiber during the cutting process when the fiber orientation angle is 90° .

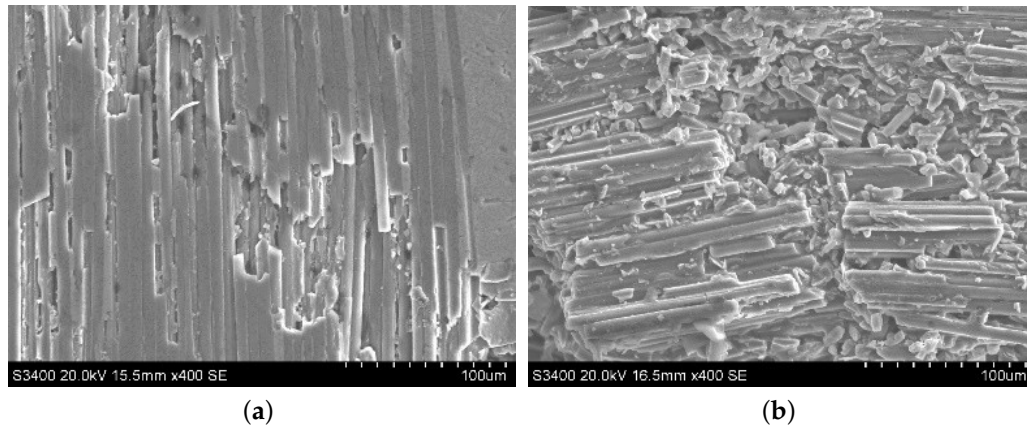
Figure 12. Typical morphologies after cutting C/SiC composites at 45° . (a) is ordinary cutting and (b) is ultrasound-assisted grinding.

When the fiber orientation angle is 45° , surface morphologies of ordinary cutting and ultrasound cutting are shown in Figure 12. It can be seen that, under ordinary cutting conditions, the carbon fibers at the scratch position peel off from the matrix, and the fracture region concentrates on both sides of the scratch, with a lot of uncut carbon fibers in the middle of the scratch. Under ultrasound conditions, the carbon fibers at the scratch position are cut into small pieces, forming a large amount of debris. When the fiber orientation angle is 45° , forces applied on the fibers are shown in Figure 13 and the force analysis of a single fiber during cutting is shown in Figure 14. The fibers can be divided into two parts, namely I and II. It can be seen that the cutting force F_2 parallel to the fiber direction makes the force applied to the I part of the fiber be compressive stress, while the force applied to the II part of the fiber is tensile stress. At the same time, the cutting force F_1 perpendicular to the fiber direction can be decomposed into a force F_{11} in the plane of the fiber direction layer and a force F_{12} perpendicular to the fiber direction layer. As the abrasive particle moves forward, the fibers in front of the abrasive particle undergo bending deformation. Since carbon fibers are brittle material, minor deformation can cause cracks. The cracks on the tensile stress side tend to expand, and it is more difficult for the cracks on the compressive stress side to expand. Therefore, the failure of carbon fibers with the fiber orientation angle of 45° is mainly caused by cracks and expansion on the tensile stress side of the fibers during the bending deformation, which then leads to fracture.

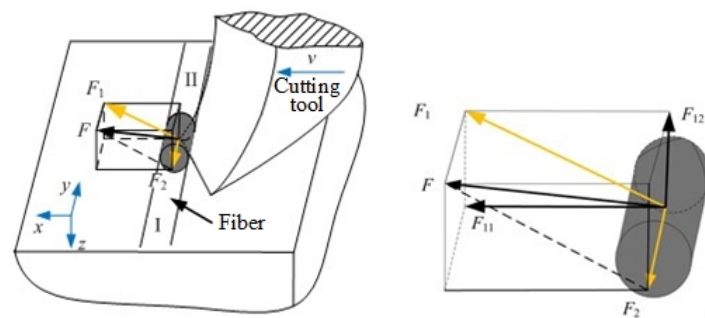
Figure 14. Force analysis of a single fiber during the cutting process when the fiber orientation angle is 45° .

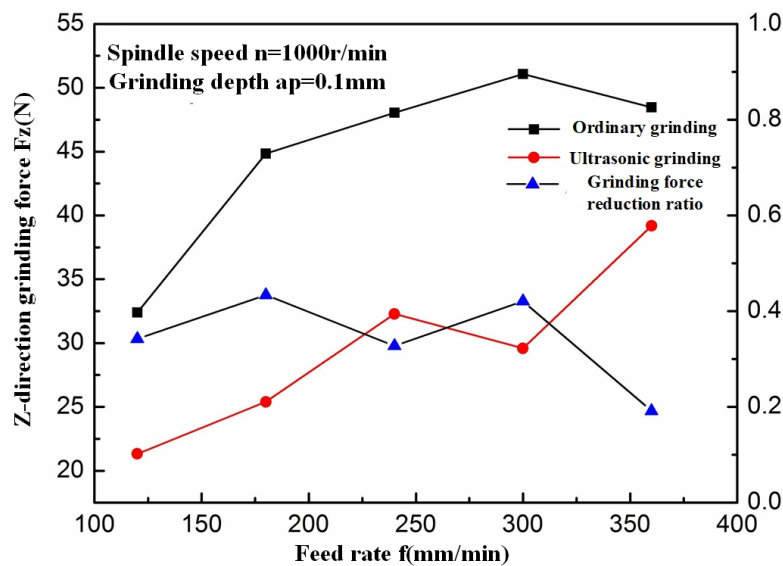
Figure 15. Comparison of ultrasonic grinding and ordinary grinding force at different feed speeds.

At the same time, we compared the grinding force under different feed speeds of ordinary grinding and ultrasonic vibration-assisted grinding. It can be seen from Figure 15 that, under the condition of ultrasonic vibration-assisted grinding, the component forces in all three directions are smaller than the grinding forces in the ordinary grinding condition. The grinding forces are reduced to varying degrees, and the maximum reduction ratio is about 60%.

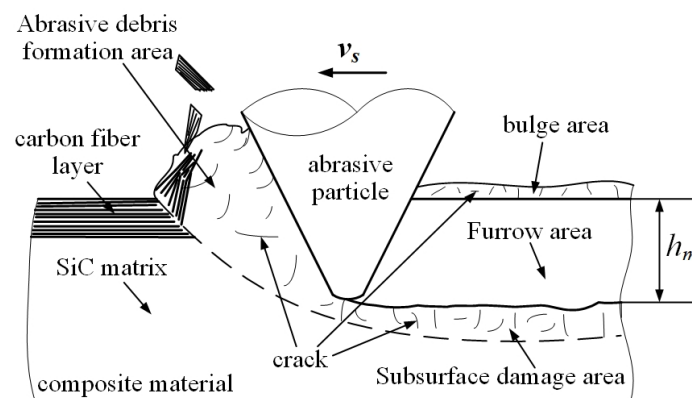
Figure 16. Two-dimensional cutting model of single abrasive particle for C/SiC composites.

In order to reveal the removal mechanism of C/SiC composites, a two-dimensional cutting model was established based on the cutting effect of single abrasive particle on C/SiC composites, as shown in Figure 16.

Combining the material preparation process with the actual machining process, it is assumed in the model that the carbon fiber layer is always on the surface of the cutting area. It can be known from the simplified process of the above model that the cutting depth of the abrasive particle in Figure 16 is the maximum undeformed abrasive debris thickness h_m of vertical-axis plane grinding, and the cutting speed of the abrasive particles is v_s . The cutting area can be divided into four deformation areas, namely abrasive debris formation area, subsurface damage area, furrow area, and bulge area.

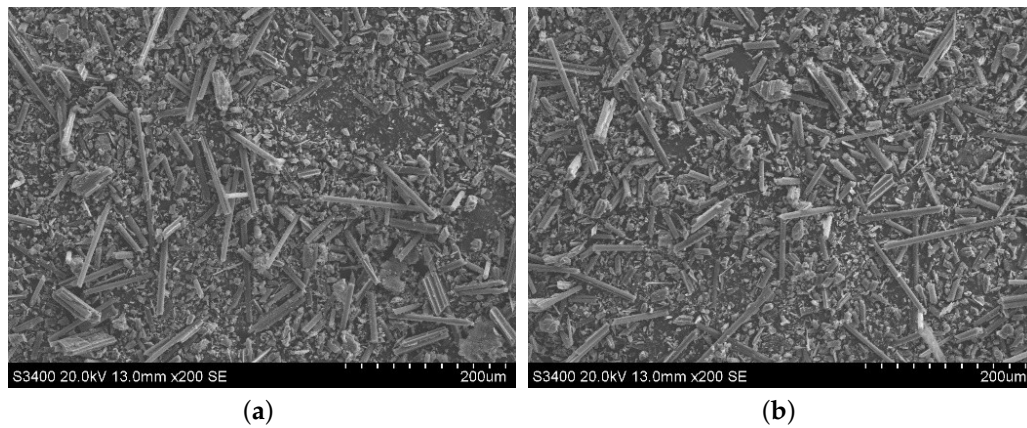
Figure 17. Morphologies comparison when a_p is 0.1 mm. (a) is ordinary cutting and (b) is ultrasound-assisted cutting.

The abrasive debris of ordinary cutting and ultrasound cutting under different cutting depth conditions was collected, and the scanning electron microscopy was used to observe the morphologies of the abrasive debris under different conditions, as shown in Figures 17–20. It can be seen that the abrasive debris generated by grinding on C/SiC composites can be roughly divided into two types: abrasive debris formed by the SiC matrix and abrasive debris formed by the carbon fibers. Under ordinary cutting conditions, the abrasive debris formed by the SiC matrix changes from powder to piece with the increase of cutting depth. While under the condition of ultrasound cutting, the abrasive debris formed by the SiC matrix basically remains powdery, which was not affected much by the change of a_p . Under ordinary cutting condition, as the cutting depth of the abrasive particle increases, the abrasive debris formed by the carbon fibers changes from short strips to long strips. While under ultrasound cutting conditions, morphology of the abrasive debris formed by the carbon fibers roughly remains short bar.

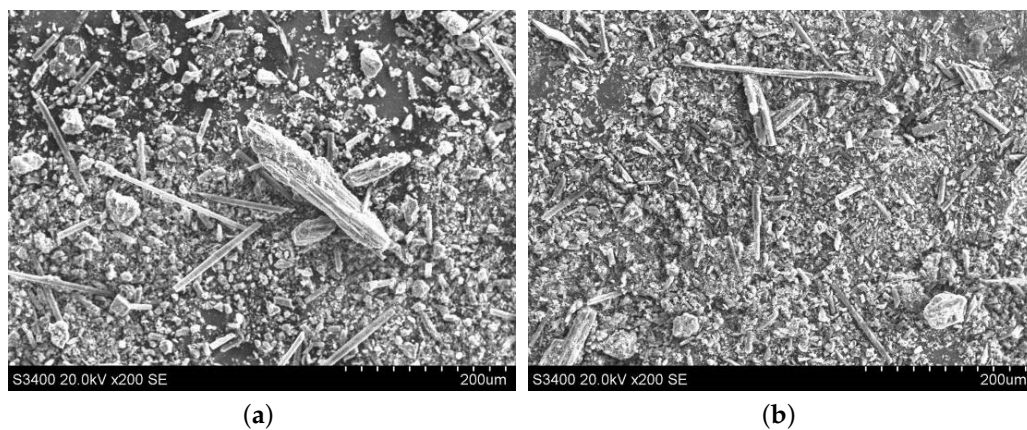
Figure 18. Morphologies comparison when a_p is 0.2 mm. (a) is ordinary cutting and (b) is ultrasound-assisted cutting.

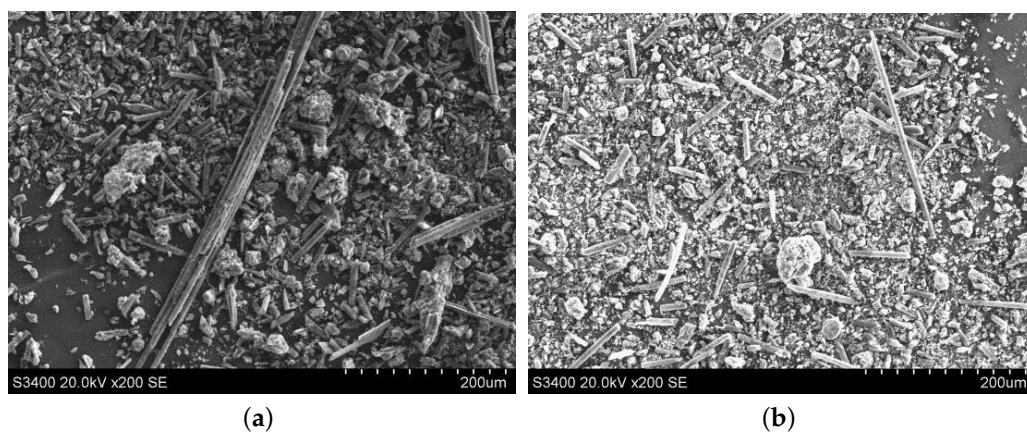
Figure 19. Morphologies comparison when a_p is 0.3 mm. (a) is ordinary cutting and (b) is ultrasound-assisted cutting.

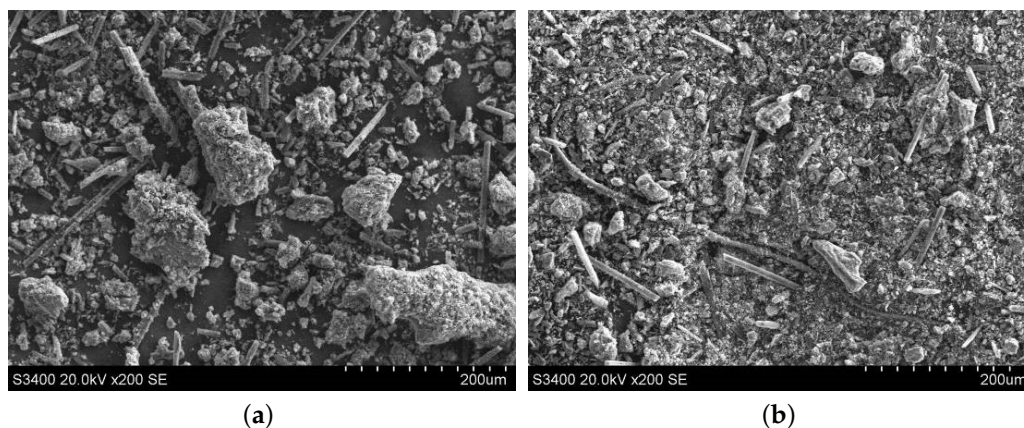
Figure 20. Morphologies comparison when a_p is 0.5 mm. (a) is ordinary cutting and (b) is ultrasound-assisted cutting.
