Permanent Deformation and Stiffness Degradation of Open Hole Glass/PA6 UD Thermoplastic Composite in Tension and Compression

Abstract: UD glass/PA6 coupons with an open hole are subjected to tensile and compressive loading. Three layups: $[0/90]_{5s}$, $[+45/-45]_{5s}$ and $[+45/0/-45/90]_{3s}$ with a shape based on ASTM D5766 were tested. Both monotonic loading as well as loading–unloading–reloading tests were executed. The strain field on the sample surface was measured with digital image correlation. This allowed identifying the distribution of the strain field during loading, permanent deformation and the evolution of the sample elastic modulus. This information is not frequently measured. Yet, it is vital for the development and validation of advanced failure models. The results indicate that the thermoplastic matrix allows large plastic deformation under tensile loading for the specimens with layup $[+45/-45]_{5s}$. In addition, the specimen elastic modulus reduces by about 70%. The other layups show minor permanent deformation, while the elastic modulus reduces by up to 15%. Furthermore, the quasi-isotropic laminate shows a significant post-failure load-bearing capacity und

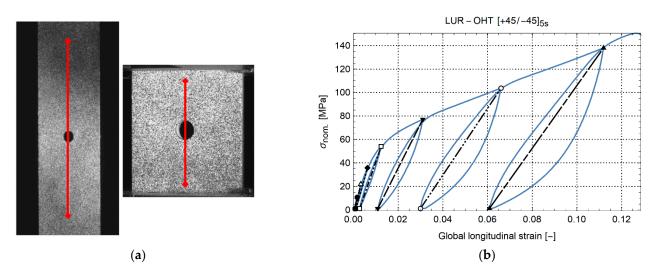
Figure 2. (a) Global sample strain gauge for tension (left) and compression (right) specimen, (b) nominal stress–global strain of an open-hole sample with layup $[+45/-45]_{5s}$ under tension load.

In Equation (1), F is the force from the load cell, w is the sample width, t is the sample thickness, and d is the hole diameter. The global sample strain is defined as the engineering strain between two points located close to the clamps, as indicated in Figure 2a. This definition indicates the global state of the specimen and allows a representative comparison between the samples. As a result, the forthcoming "stress–strain" curves of these experiments indicate specimen behavior and not material behavior.

The specimen elastic modulus is defined as the slope between consecutive maximum and minimum loads in the unloading–reloading cycle. This is illustrated by the straight black lines in Figure 2b. In the figure, one can also see the development of permanent strain after each loading cycle. After mechanical testing, the specimen sides were polished to identify the fracture mechanisms occurring on the side. Additionally, several specimens were inspected through transmission ultrasound to identify the extent of internal delaminations across the gauge length. The ultrasonic C scans were recorded with an automated scanner system on a rectangular grid. The scan axis measured points with steps of 0.1 mm, while the index axis was moved in steps of 0.5 mm. A through-transmission setup was used with two shockwave transducers with 5 MHz nominal frequency (GE Measurement & Control H5, Rotterdam, The Netherlands) spaced 130 mm apart. For the waveform generation, a UTPR-CC-50 ultrasonic pulser/receiver (Tecscan, Quebec, Canada) with negative spike pulse excitation was used, while data acquisition was handled by a NI-PXIe-5172 card (National Instruments Corporation, Austin, TX, USA). Signals were recorded with a sampling frequency of 125 MS/s. Instrument control was done in LabVIEW (version 2020) [19]. The lateral resolution of the ultrasound is 3.33 mm.

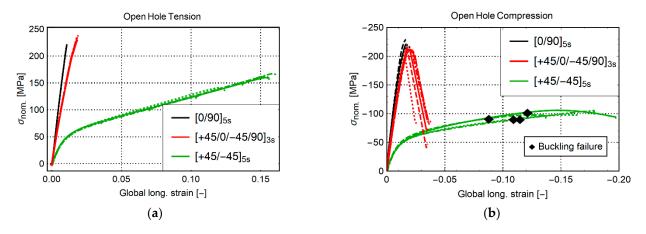
Figure 3. Nominal stress vs. global strain of samples subjected to monotonic loading until failure. (a) OHT, (b) OHC.

The nominal stress–global strain of the experiments is shown in Figure 3. A different color represents the result for each layup. For the results of samples with the same layup, different dashing is used.

The cases for OHT are shown in Figure 3a. The coupons with layup $[0/90]_{5s}$ and $[+45/0/-45/90]_{3s}$ show quasilinear behavior up to sudden failure at about 220 MPa. The coupon with layup $[+45/-45]_{5s}$ initially shows linear behavior. This, however, turns nonlinear at 1% strain. A failure strain of about 12–15% is observed with a failure load of about 150 MPa. These failure strains are significantly higher than for the other specimens because the +45/-45 plies are primarily loaded in shear. This loading type is matrix-dominated and illustrates the large deformation capability of the PA6 matrix. Remarkable is that the OHT strength of the QI laminate is higher than the OHT strength of the coupon with layup $[0/90]_{5s}$. This is caused by the high OHT strength of the +45/-45 plies, which contribute significantly to the strength of the QI laminate.

The curves for OHC are shown in Figure 3b. Similar to tension, layups $[0/90]_{5s}$ and $[+45/0/-45/90]_{3s}$ show quasilinear behavior up to failure. A small nonlinear region is present close to the final failure. After kinking at maximum load, the QI samples still carried about 35% of the maximum strength at -75 MPa. The curves for layup $[+45/-45]_{5s}$ are nonlinear. A notable difference is that buckling occurs at about -90 MPa, as indicated by the black diamonds. Recall that the end of the curves for $[+45/0/-45/90]_{3s}$ and $[+45/-45]_{5s}$ does not indicate specimen failure. The specimens were removed after, respectively, kinking and buckling to protect the load cell of the machine and preserve the crosshead alignment. Yet, the specimens could still have been compressed more. This was illustrated with the last QI specimen. The result is shown in Figure 4a. After kinking failure, the load-carrying capacity of the material steadily reduces, while the global strain reaches more than 15% global compressive strain. Figure 4b shows the final state of the

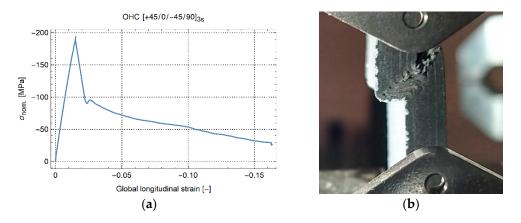
Figure 4. Compression of a specimen with layup $[+45/0/-45/90]_{3s}$. (a) Nominal stress–global strain (b) side view at -0.16 [-] strain.

specimen in the test machine before stopping the test. Both specimen halves were still intact with significant plastic deformation and failure.

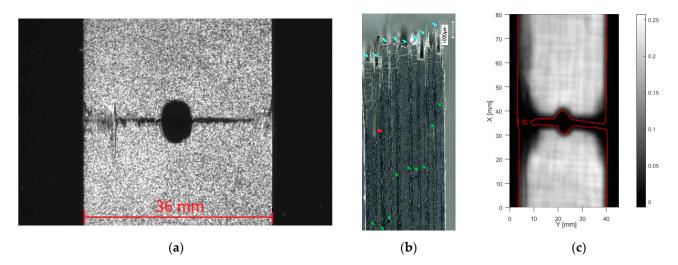
Figure 5. Tensile failure of $[0/90]_{5s}$. (a) front view, (b) side microscopy, (c) through transmission ultrasound (for high resolution, please refer to the online version of this article).

For the samples with layup $[0/90]_{5s}$, both tensile and compressive loading showed a quasilinear stress–strain behavior with brittle material failure. Figures 5 and 6 show typical failure under, respectively, tensile and compressive load. The videos of the DIC images during loading were analyzed. It is observed that OHT failure of the samples with layup $[0/90]_{5s}$ shows no indication of growing cracks just before sudden failure. In an instant, symmetrical cracks appear from the edge of the holes to quickly span the entire width of the sample. Remarkable for this failure is that several fibers still bridged over the crack at the sides of the specimen. This connection was quite weak yet indicates that next to fiber breakage, fiber pull-out is a damaging phenomenon for this composite material. Microscopic observation of the side of the samples, Figure 5b, shows this. It can be seen that the "pulled-out" fibers (cyan arrows in the figure) continue as ply delaminations as far as 3 mm away from the crack face (red arrow in the figure). Matrix cracking is observed in the [90] degree plies. This is observed at a distance of up to 10 mm from the crack face. The green arrows on the figure indicate the ply cracks observed furthest away from the hole. High-resolution images can be consulted in the online version of the article. Ultrasound inspection, Figure 5c, shows that a limited amount of delamination develops in the hole's vicinity. The red lines on the figure indicate the edges of the specimen. At the edges of the sample, delaminations are present up to 2 cm away from the crack face.

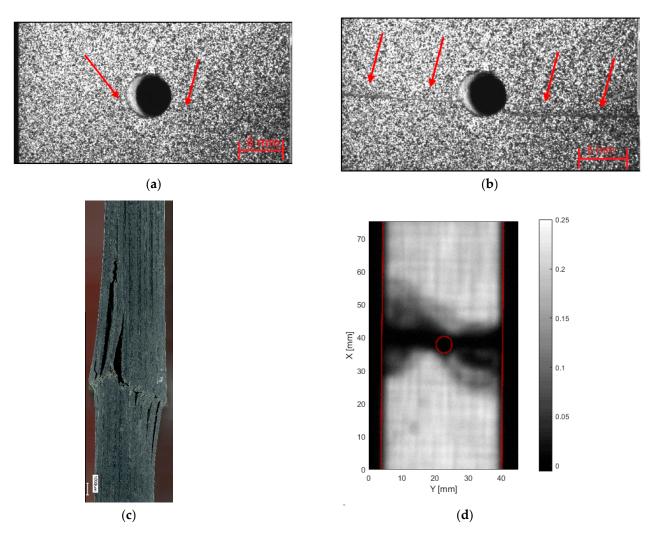
Figure 6. Compressive failure of $[0/90]_{5s}$. (a) front view just before failure, (b) front view after kinking failure, (c) side microscopy, (d) through transmission ultrasound (for high resolution, please refer to the online version of this article).

OHC failure of the samples with layup $[0/90]_{5s}$ shows kinking failure. The samples do not buckle before losing load-bearing capacity. Just before failure, localized kinking

can be observed originating from the hole edge. This is indicated by arrows in Figure 6a. Next to that, microscopic observation shows that few matrix cracks developed. Yet, large delaminations occur where plies were pushed apart after kinking failure, Figure 6c. The extent of the internal delamination is illustrated in Figure 6d with ultrasound inspection.

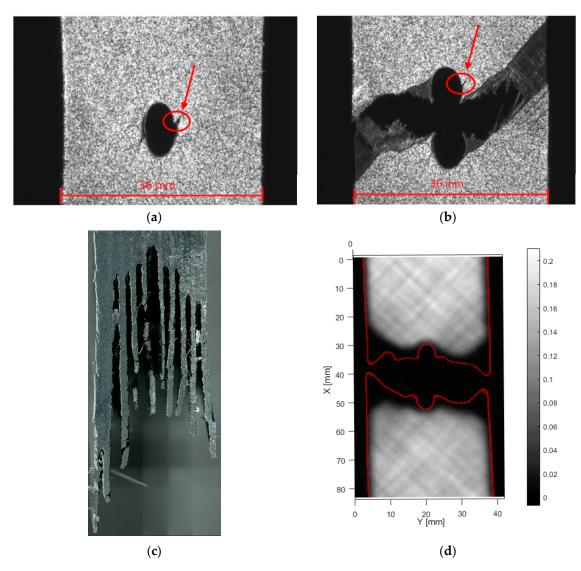
Figure 7. Tensile failure of $[+45/-45]_{5s}$, (a) front view just before failure, (b) front view after failure, (c) side microscopy, (d) through transmission ultrasound (for high resolution, please refer to the online version of this article).

The samples with layup $[+45/-45]_{5s}$ showed large nonlinear behavior before failure for both tensile and compressive loading. Figure 7 shows typical observations under tensile loading, while Figure 8 shows typical observations under compressive loading. OHT failure for the samples with layup $[+45/-45]_{5s}$, Figure 7, shows a combination of crack growth and ductile failure. Before the failure, multiple cracks develop at the hole edge, as indicated in Figure 7a. However, these initial cracks do not necessarily grow to cause final failure. In Figure 7a,b, the same crack is indicated with a red circle. Since this crack appears to be the largest, one could expect this to cause a final fracture. Surprisingly, the crack causing load-bearing failure occurs from a different location. The main failure phenomenon is ply delamination. This is shown on the microscopic images. In Figure 7c the separation between the [-45] and [+45] plies, that each remained attached to one-half of the specimen. A limited amount of matrix cracks is observed. The extent of internal delaminations for this layup is shown in Figure 7d. It can be seen that the ply separations do not extend further than the center area.

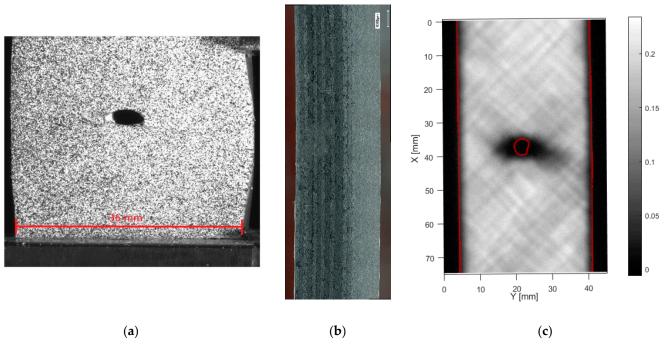
Figure 8. Compressive buckling of specimen with layup $[+45/-45]_{5s}$, (**a**) front view, (**b**) microscopy of side, (**c**) through transmission ultrasound (for high resolution, please refer to the online version of this article).

OHC failure for the samples with layup $[+45/-45]_{5s}$, Figure 8, could not be achieved. The samples buckled at about -100 MPa nominal stress. Figure 8a shows the sample deformation, which could be observed. To protect the test machine, and especially the clamp alignment, it was not attempted to fully break the samples. Therefore, the samples were unloaded and removed after the occurrence of buckling. Remarkably, side microscopy shows, apart from a permanent bend of the specimen, no signs of internal damage, Figure 8b. This is confirmed by ultrasound, Figure 8c, which only shows a limited amount of delamination around the hole edge. The absence of matrix cracking or delamination after such severe out-of-plane deformation is attributed to the ductility of the PA6 matrix combined with a strong fiber-matrix bond.

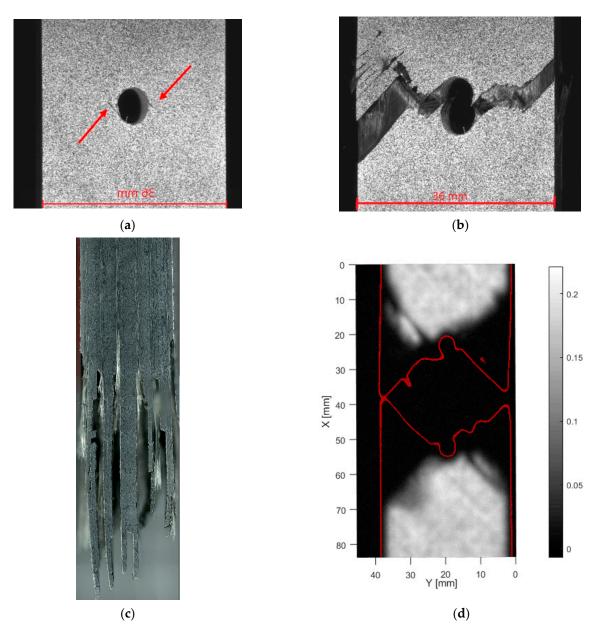
Figure 9. Tensile failure of $[+45/0/-45/90]_{3s}$, (a) front view just before failure, (b) front view after failure (c) side microscopy, (d) through transmission ultrasound (for high resolution, please refer to the online version of this article).

Figures 9 and 10 show the tensile and compressive failure for specimens with layup $[+45/0/-45/90]_{3s}$. For the tensile case, Figure 9a,b, cracks are seen to develop along the +45 fiber direction of the top ply. These grow from the hole edge towards the edges of the sample until final failure. The specimen fails in a brittle way due to the presence of the 0 degree plies. Side microscopy, Figure 9c, shows a combination of the fracture phenomena observed in the previous layups. The [0] plies show fiber pull-out with delamination, [90] plies show matrix cracking and the [±45] plies failed in the typical shear-out failure. Associated with the failure of the latter plies is the internal delamination, as in Figure 9d.

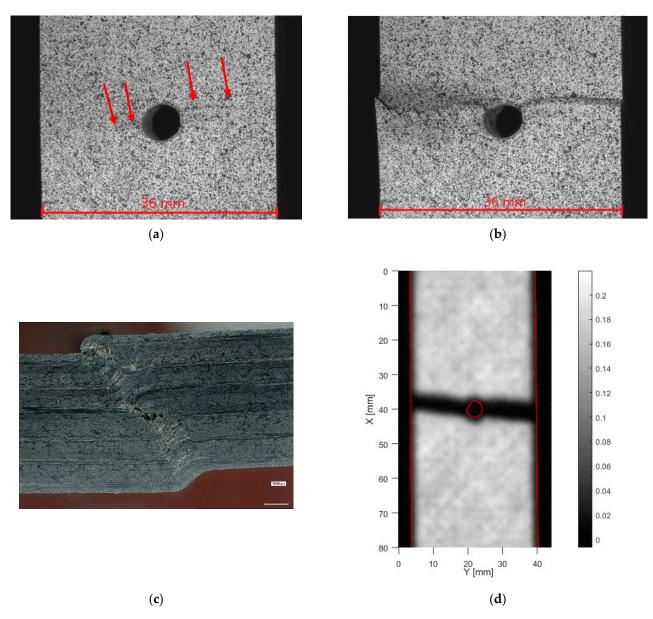
Figure 10. Compressive failure of $[+45/0/-45/90]_{3s}$, (**a**) front view just before failure, (**b**) front view after kinking failure, (**c**) side microscopy, (**d**) through transmission ultrasound (for high resolution, please refer to the online version of this article).

Similar to $[0/90]_{5s}$, the compressive failure of $[+45/0/-45/90]_{3s}$ occurs in the form of kinking, Figure 10. Buckling was not observed during loading. However, it is noted that the specimens do not fracture in two pieces, as seen from the side view in Figure 10c. The kink band is also clearly visible in the ultrasound, Figure 10d. The delamination damage is contained within the kinking zone. Combining plies in all three primary directions can keep the plies from both sides of the specimen connected and attached, even after severe kink deformation. This allows the specimen to carry load after initial failure.

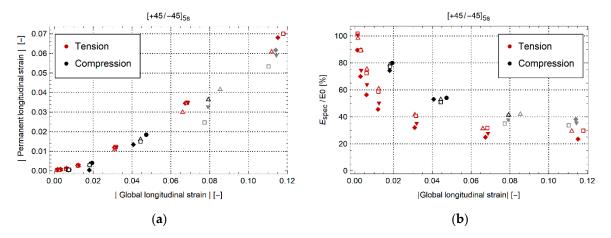
Figure 11. (a) Permanent strain and (b) evolution of normalized elastic modulus for $[+45/-45]_{5s}$. Datapoints in gray are measured after buckling.

Figure 11 shows the evolution of permanent strain and modulus of the specimen with layup $[+45/-45]_{5s}$. On the vertical axis, figures show the longitudinal specimen modulus (E_{spec}) normalized concerning the undamaged elastic modulus (E0) and longitudinal

specimen permanent strain. One can clearly see that a large amount of permanent strain develops. In addition, the elastic modulus reduces with each load cycle up to about 30% of the original modulus for tension and 40% (before buckling) for compression. In figures, the same symbols are used for the same test. The data points in gray occurred after buckling. Between tensile and compression loading, the evolution of permanent strain is similar. The evolution of specimen elastic modulus is less steep for compression.

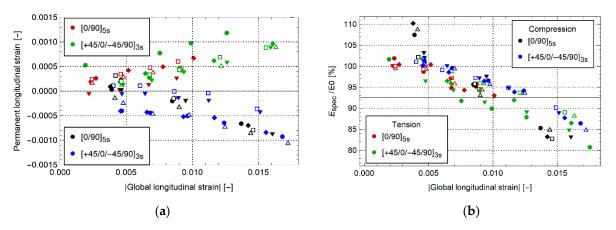
Figure 12. (a) Permanent strain and (b) normalized elastic modulus for $[0/90]_{5s}$ and $[+45/0/-45/90]_{3s}$.

Figure 12 shows the evolution of the permanent longitudinal strain and elastic modulus for $[0/90]_{5s}$ and $[+45/0/-45/90]_{3s}$. Though the nominal stress–global strain curve is quasilinear, both layups show a small evolution in the permanent global strain with a modulus reduction of about 20%. This suggests that, at least locally, some damage and plasticity occur in the specimen volume. Similar evolutions are shown between tension, compression, and per layup. Note the initially higher elastic modulus after the first unloading cycle in the compression data of Figure 12b. This is caused by variability in strain measurement at small strain magnitude. Despite this, both elastic modulus evolution and permanent strain evolution are similar between tension and compression.

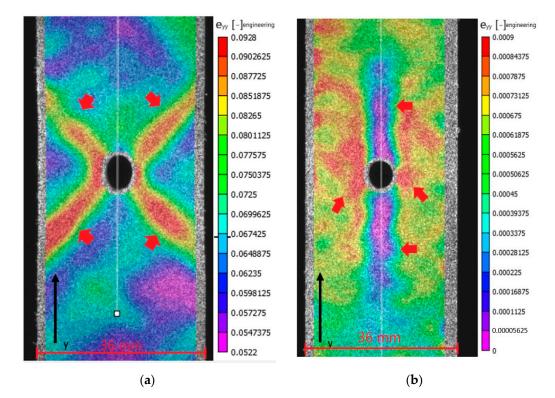
Figure 13. Permanent strain developed after unloading specimen (a) LUR-OHT with layup $[+45/-45]_{5s}$ and (b) $[0/90]_{5s}$ after the highest loading cycle before failure.

Although the global specimen behavior reveals the evolution of permanent strain and elastic modulus, it does not show where the permanent strain occurs. This can be identified from the surface strain fields obtained by DIC. Figures 13 and 14 show the longitudinal strain on the specimen surface at unloading after either the last load cycle or just before buckling. Note that the scales associated with individual figures are different. This was done to provide the clearest view of the variation in strain for each figure. For the samples

with layup $[+45/-45]_{5s}$ X-shaped shear bands with high permanent strain develop. These meet at the side of the hole. This is illustrated in Figure 13a for the tensile case where the longitudinal strain is positive. For compression, the longitudinal strain has the same shape yet with negative strain values. For the samples with layup $[0/90]_{5s}$, Figure 13b, a region of nearly zero longitudinal strain occurs above and below the hole center. To the left and right of the hole, a local region with permanent strain occurs. For the tensile case, the longitudinal strains are positive, while for the compressive case, these are negative. The region with larger permanent strain is limited to the immediate vicinity of the hole, which is in sharp contrast with layup $[+45/-45]_{5s}$, where the region of permanent strain extends fully to the specimen edges.

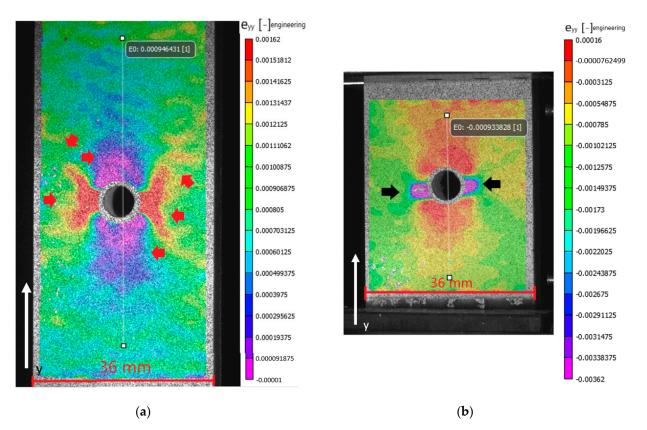
Figure 14. Permanent strain developed after unloading specimen (**a**) LUR-OHT and (**b**) LUR-OHC for the laminate with layup $[+45/0/-45/90]_{3s}$ after the highest loading cycle before failure.

The permanent strain pattern for the QI layup, Figure 14, shows a combination of the patterns from the $[0/90]_{5s}$ and $[+45/-45]_{5s}$ laminates. In the tensile case, Figure 14a, regions with nearly zero permanent strain are present above and below the hole, while left and right from the hole, a region with limited permanent strain develops. Further away from the hole, this region splits into two arms, extending similarly to the X-shaped pattern seen in the $[+45/-45]_{5s}$ laminate. In contrast to the other laminates, the QI laminate in compression, Figure 14b, does not seem to show an inverse pattern as the tensile case. In fact, this seems more similar to the compressive case of the $[0/90]_{5s}$ laminate. The authors attribute this difference to the different failure phenomena occurring for this laminate under tension and compression. In fact, in the compressive case, one can already see the initial growth of the kink band forming close to the hole, while it does not yet span the full specimen width.
