Review

Root Causes and Mechanisms of Failure of Wind Turbine Blades: Overview

Leon Mishnaevsky, Jr.

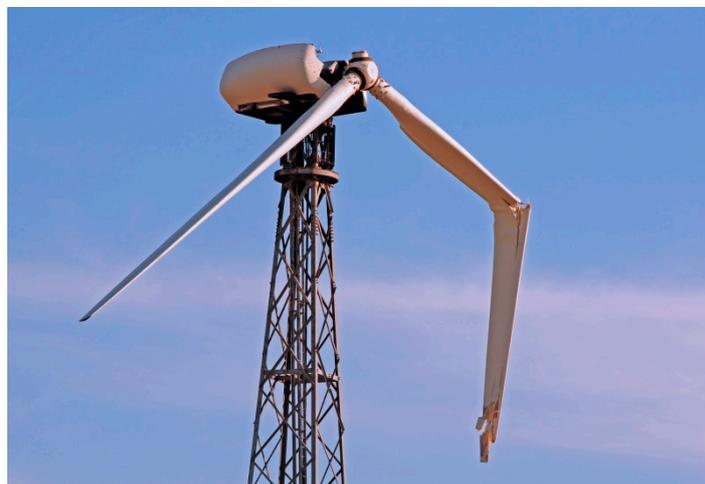
Figure 1. Wind turbine with broken blades. The photo from Bigstock© collection is reproduced according to the Bigstock content usage agreement.

However, the maintenance of wind turbines remains an important cost factor, influencing the energy price and competitiveness of renewable energy [4]. For instance, onshore wind farm operators spent around USD 15 billion on operations and maintenance services in 2019, 57% of which was on unplanned repairs [5]. Further, the number of wind turbines reaching 20 years of operation annually, for instance, in Spain and Germany will be of the order of 800 per year in the next decade [6]. An ageing fleet leads to increased repair requirements [7,8]. With an estimated 700,000 blades in operation globally, there are, on average, 3800 incidents of blade failure each year. The total repair budgets in Europe increased from 2019 to 2020 from USD 4.7 to 8.6 mil, and unplanned repairs also increased slightly in Europe (2%) and even by 10% in America [6]. Failure events of different degrees take place relatively often. Figure 1 shows a wind turbine with broken blades.

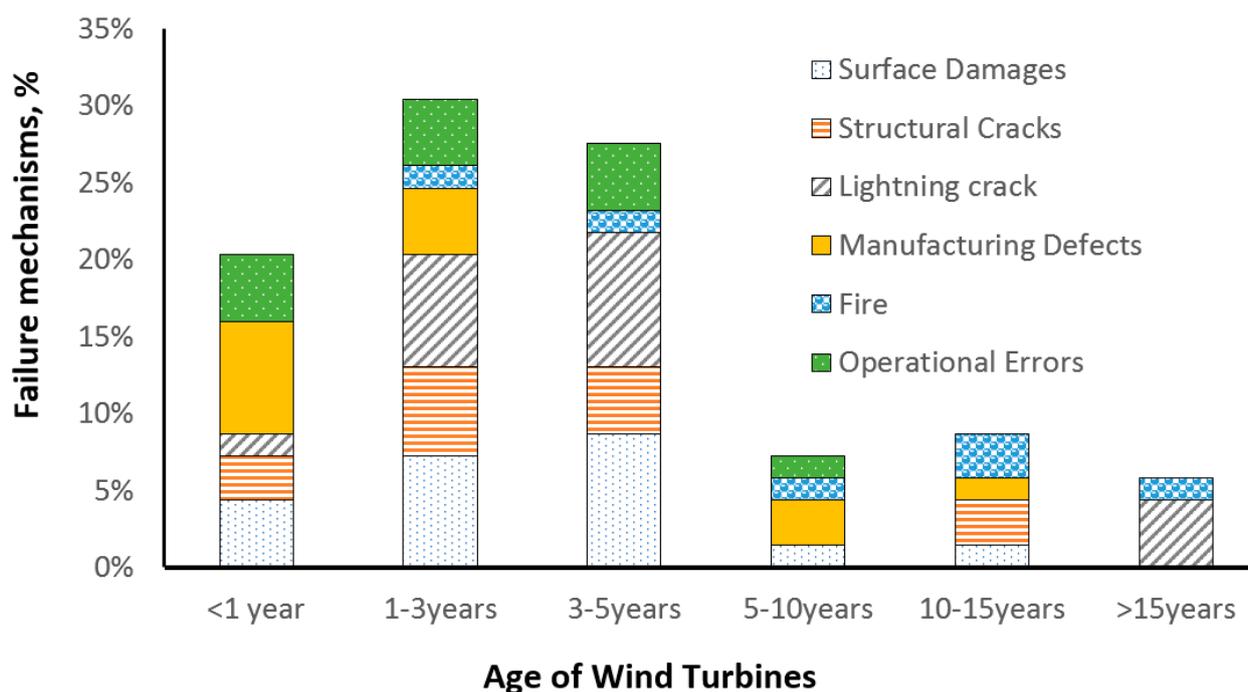
Figure 2. Results of the survey of blade service companies: Frequency of wind turbine blade failure mechanisms depending on the age of wind turbines. Reprinted from [19] with kind permission from John Wiley and Sons.

Boopathi, Sumatraa and colleagues [19] carried out a survey among the wind turbine service teams regarding the frequency of the observed damage mechanisms in different regions in Europe and India. Figure 2 shows the results of the survey of blade service companies, presenting the frequency of wind turbine blade failure mechanisms depending on the age of wind turbines based on data from [19]. They observed that leading edge erosion and lightning strikes are the two most often observed damage mechanisms. Leading edge erosion can occur from the first year after wind turbine installation. The lightning strike is observed especially often in monsoon areas. In Europe, fire and even operational errors determine the failure of wind turbines, reaching 5 . . . 10 years and more. In India, the wind energy industry is generally younger and less “crowded” than in Europe, and therefore, operational errors and manufacturing defects are among the main failure mechanisms of recently installed wind turbines, even after installation or 1–3 years old. That leads to structural failure even in young, recently installed wind turbines (1–5 years, which is not observed in Europe).

Figure 2 shows the frequency of observing different blade damage mechanisms over years, according to the survey of service companies [19]. It can be seen that surface erosion is the most often observed damage mechanism (for those turbines that survived the risks caused by initial manufacturing defects during the first years and were not subject to lightning strikes). In fact, it is above the structural failure risks, which combine spar buckling, trailing edge failure and adhesive joint failure (i.e., most other failure mechanisms). Surface erosion is also the damage mechanism which most often requires repair and is most expensive for wind turbine owners [4]. According to [4], the costs of minor repairs of wind turbine blades are more than 12 times higher than the costs of major repairs or replacements.

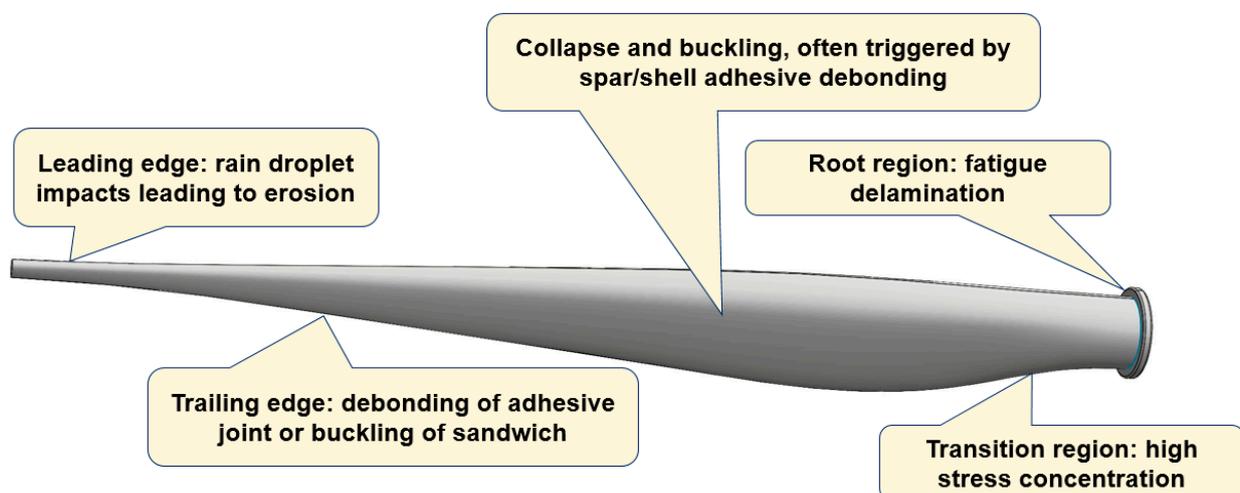
Figure 3. Schema of locations of often-observed damage mechanisms of a wind turbine blade [3,7].

Therefore, the most endangered regions of the blades include the outstanding and high velocity region (tip), the transitional and tapered areas and the interface regions. Figure 3 shows a schema of the locations of the often-observed damage mechanisms of a wind turbine blade.

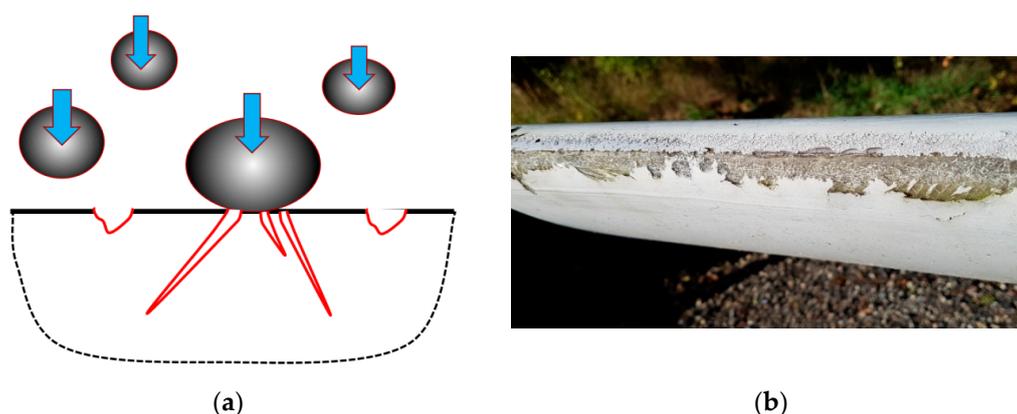
Figure 4. Schema of leading edge erosion of blades (a) and eroded blade (b).

Figure 4 shows a mechanism of the leading edge erosion of blades, and a micrograph of severely eroded blade. Due to the complexity and microscale and multiphysical mechanisms of erosion, the relationships between laboratory studies and field observations are not straightforward, and computational models are often required to interpret and link the test observations with the field results.

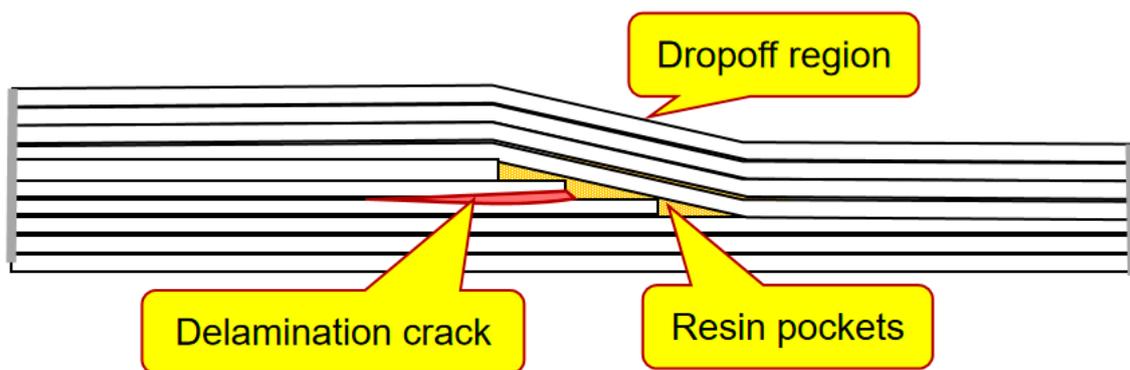
Figure 5. Schema of a delamination crack in the plydrop region.

Tapered areas and plydrops in the blades are necessary in the blades to ensure an optimal, aerodynamic shape. Plydrops are formed by terminating some of composite plies. The tapered structures create local stress concentrations, in particular, interlaminar stresses in the vicinity of the ply drop-off which can lead to the delamination of plies and the failure of these regions [50]. Figure 5 shows a schema of a delamination crack in the plydrop region, starting from a resin pocket.

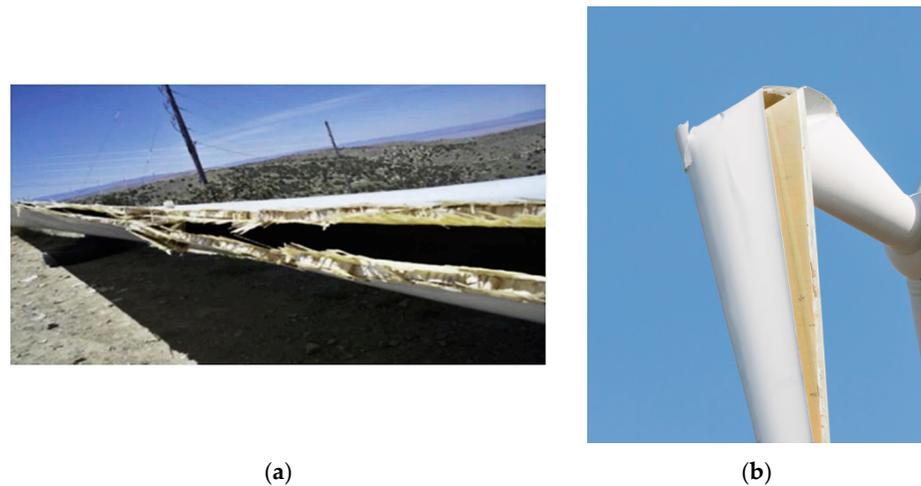
Figure 6. Blade failure: (a) Failure of edges in 24 m wind turbine blade. Reprinted from [27,84] with kind permission from Elsevier, and (b) Collapsed blade.

The trailing edge is another critically important structural part depending on the reliability of adhesive bond. Figure 6 shows the failed trailing edge of a 24 m wind-turbine blade.

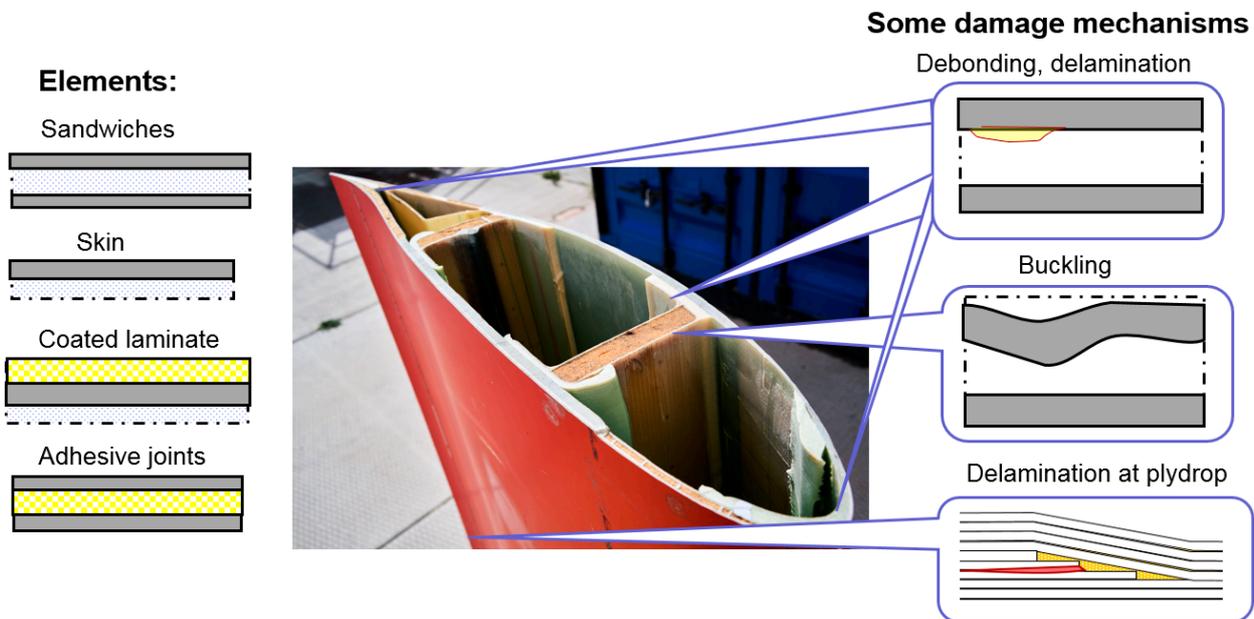
Figure 7. Elements of the blade structure (left), blade cross section (middle) and some common damage mechanisms (right). On the blade cross section, white adhesive layers and brown/white sandwiches can be seen. The photo from Bigstock© collection is reproduced according to Bigstock standard content usage agreement.

Wind turbine blades are structures built from fiber-reinforced composites, including various elements such as single skins, sandwich structures and adhesive layers [38]. Figure 7 (middle) shows a cross section of a wind turbine blade, with white adhesive layers and brown/white sandwiches in shear web and shell.

The complexity of the structure leads to a situation where the smallest deviations from the designed geometry of blades can drastically influence the blade life. In particular, internal defects in the elements of the blade can reduce the lifetime of wind turbine blades and trigger various failure mechanisms. Figure 7 shows the main elements of a blade (sandwiches, adhesive joins, skin) and some typical structural blade failure mechanisms (debonding, buckling, delamination, ply-drop delamination).

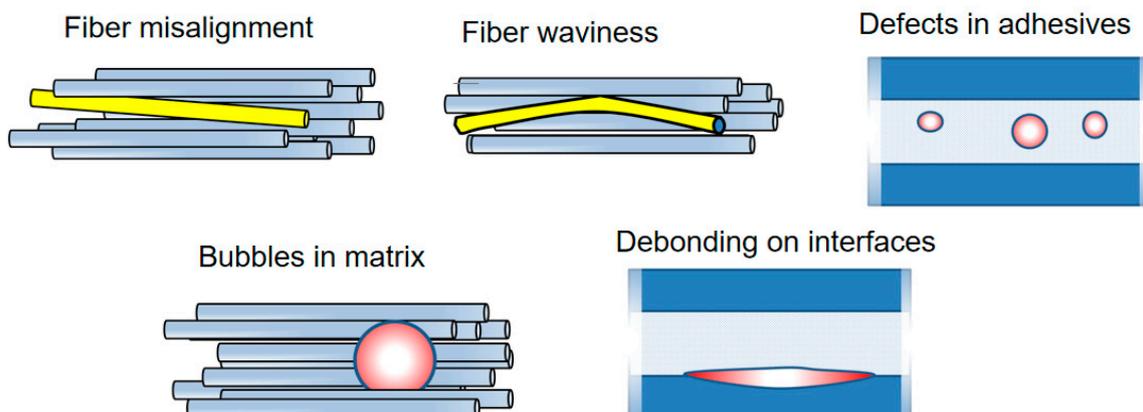
Figure 8. Schema of the typical manufacturing defects on wind turbine blade composites: fiber misalignment and waviness, voids in adhesives and in matrix, debonding on interfaces.

Figure 8 shows schematically the common defects observed in wind turbine blade composites: fiber misalignment and waviness, voids in adhesives and in matrix and debonding on interfaces.

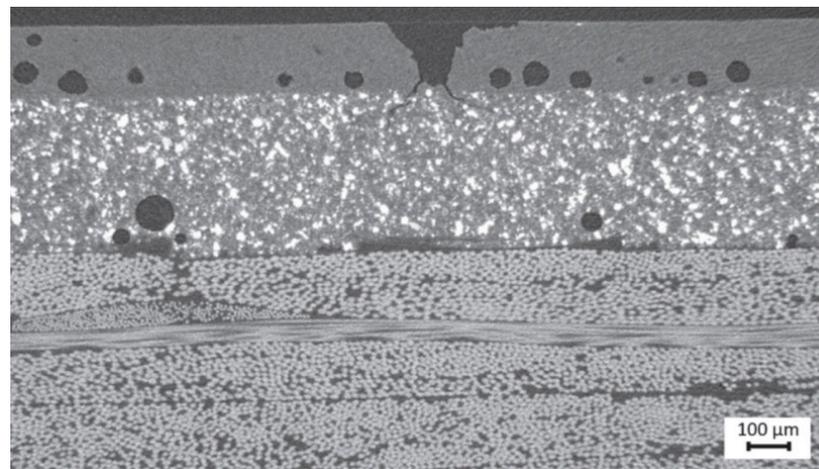
Figure 9. Voids in leading edge protection layers: Sites of damage initiation. Reprinted from [15] with kind permission from Wiley.

Leading edge erosion. The microscale mechanisms and factors controlling the leading-edge erosion have been studied in [15,16,48,49]. Wind turbine blades from old wind turbines from Vindeby wind farm, established in 1991 and decommissioned in 2015–2017, were cut and investigated using X-ray tomography [15,16]. The interesting observation was that the erosion damage starts in fact not from the contact surface (where a rain droplet hits the blade and the highest stresses are expected), but from voids and debonded particles inside the coating. Figure 9 shows the voids in the leading edge coatings and the start of the damage from the voids. Further, computational models of coatings have been developed, which include the real observed defects inside the coatings [15,16]. In the computational simulations, it was again observed that the erosion microcracks start from voids or debonded particles in the coatings, and not from the high stress regions of the contact area on the coating surface (as one could expect). In Refs. [48,49], the authors ran simulations of rain droplet impact on intact and voided coatings and observed that even small voids drastically increase local stresses, and reduce the lifetime of coatings.

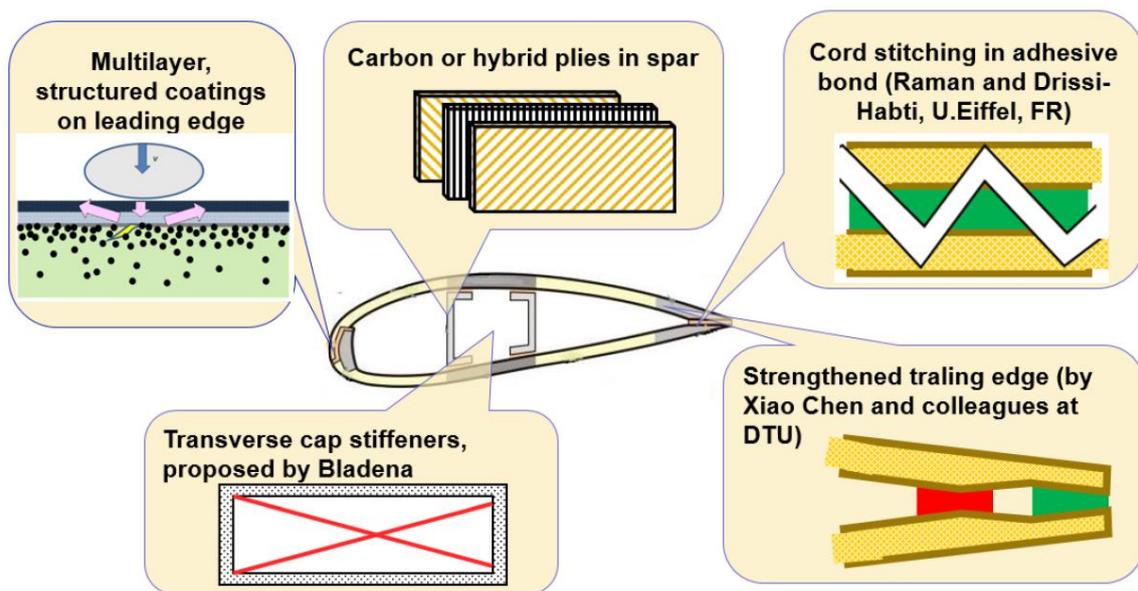
Figure 10. Schema: Some technical solutions for preventing or mitigation of different damage mechanisms of wind turbine blades, discussed in Section 5: (**upper left**) multilayered, architected coatings to mitigate leading edge erosion [39,117] (the figure shows the blade coated with multilayer leading edge protection, reinforced by black particles, with rose arrows showing the stress wave direction after rain droplet impact) (**upper middle**) carbon or hybrid plies in spar laminates, increasing the strength [121], (**lower left**) transverse stiffeners proposed by Bladena to prevent buckling [31,32], (**lower right and upper right**) strengthened trailing edge by Chen and colleagues [136] and cord stitching in adhesive layers, preventing the layer degradation [84].

Figure 10 shows schematically some technical solutions for the prevention or mitigation of different damage mechanisms of wind turbine blades, discussed in this section.
