Effect of Impact Position on Repaired Composite Laminates Subjected to Multi-Impacts

Keywords: composite structures; adhesively bonded repair; external patch; multi-impact response; mechanical testing

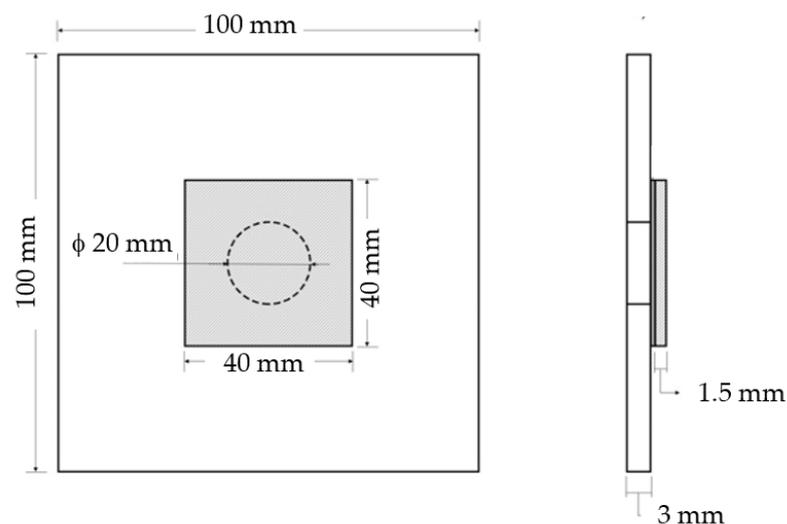
From the plates produced with dimensions of 330 × 330 × 3 [mm] and 330 × 330 × 1.5 [mm], square pieces with 100 mm and 40 mm sides were cut to produce the samples. Subsequently, in the 100 mm square pieces, holes of 20 mm in diameter were introduced to simulate the damage and, for this purpose, a special drill was used. Finally, as shown in Figure 1, the different parts were bonded with the adhesive “Araldite[®] 420 A/B” (supplied by Antala, Barcelona, Spain). To improve the adhesion between pieces, they were previously cleaned in an ultrasonic bath and, after drying, were degreased with methyl-ethyl-ketone. The bonding procedure was concluded with the specimens being placed in an oven at 40 °C for 4 h.

Figure 1. Geometry and dimensions (in mm) of the samples.

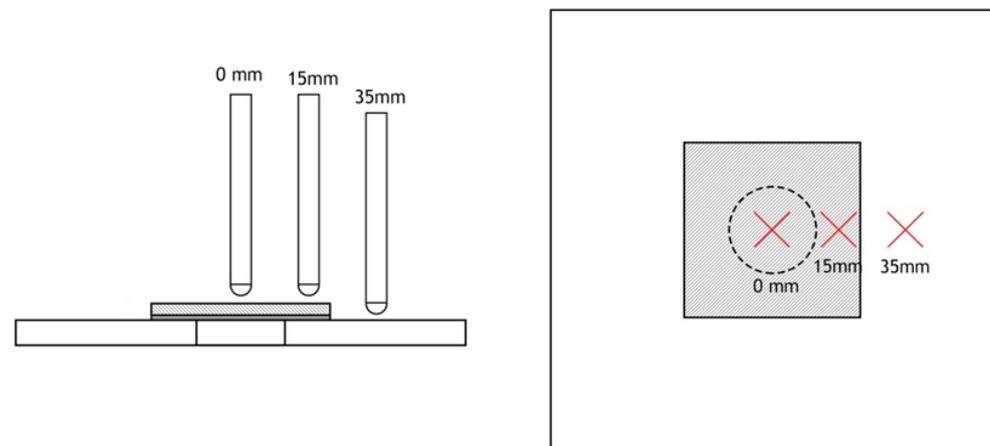
An IMATEK-IM10 drop weight-testing machine (conveniently described in [24]) was used to perform impact tests at room temperature and according to the procedure described in the EN ISO 6603-2 standard. The impactor used, with a diameter of 10 mm and a mass of 2.827 kg, impacts the samples that are simply supported, with dimensions of the useful section of 75 × 75 mm. An energy of 8 J was used, selected from the results published in [17], considering an adequate value to produce visible damage, but unable to penetrate the external patch due to its smaller thickness. Regarding the impact point, as shown in Figure 2, three positions were selected. The first is located at the centre of the external patch (denominated by 0 mm) and aims to assess its impact strength. Subsequently, the impact point is located 15 mm from the centre of the patch and aims to compare the impact strength between the parent and repaired laminate in the overlap region. In both cases, this point is very close to the hole and, consequently, subject to stress concentration due to its proximity. It is intended to evaluate the interaction of the repair with the stress concentration caused by the hole, and the respective impact response. Finally, the last point is located 35 mm from the centre of the repair and is close enough to the boundary conditions. In this case, the

effect of boundary conditions on the impact response of repaired and damaged laminates is analysed. The damage is simulated by a 20 mm diameter hole. To ensure the uniformity of the results, each condition used at least three specimens that were subjected to several impacts with the same energy until complete perforation occurred.

Figure 2. Location of the three impact points.

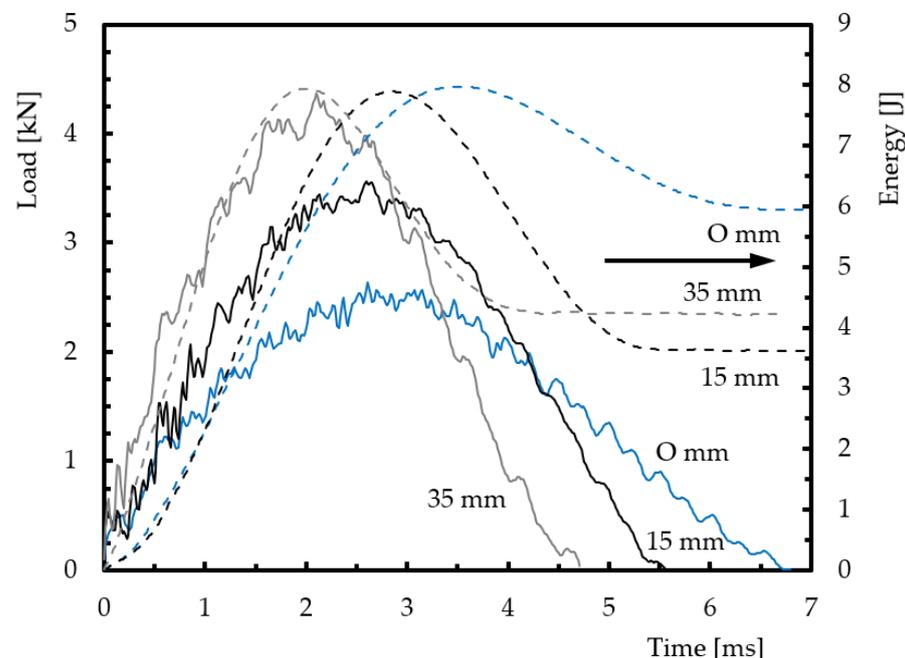
Figure 3 shows the effect of the impact point on load–time and energy–time curves for the first impact. They represent the typical behaviour observed for all specimens and agree with those reported in the literature [15,25–30]. The oscillations observed are caused by the vibrations of the specimen [27,31].

Figure 3. Effect of the impact point on load–time and energy–time curves obtained with an energy of 8 J and for repaired specimens.

It is possible to observe that the load increases up to a maximum value (P_{max}), which depends on the impact energy and determines the failure modes triggered in the composite [25–30]. From the energy–time curves, it is noted that the energy used was not enough to perforate the laminate, because the impactor contacts the sample and is returned by it. This evidence is replicated by the profile of the energy–time curve, where the peak value

represents the energy at maximum load and the beginning of the plateau at the loss of contact between impactor and sample and, consequently, represents the energy absorbed by the sample. The restored/elastic energy will be obtained by the difference between these energies [26,32], and when the collapse occurs, its value is zero, i.e., all the energy is absorbed in the form of damage.

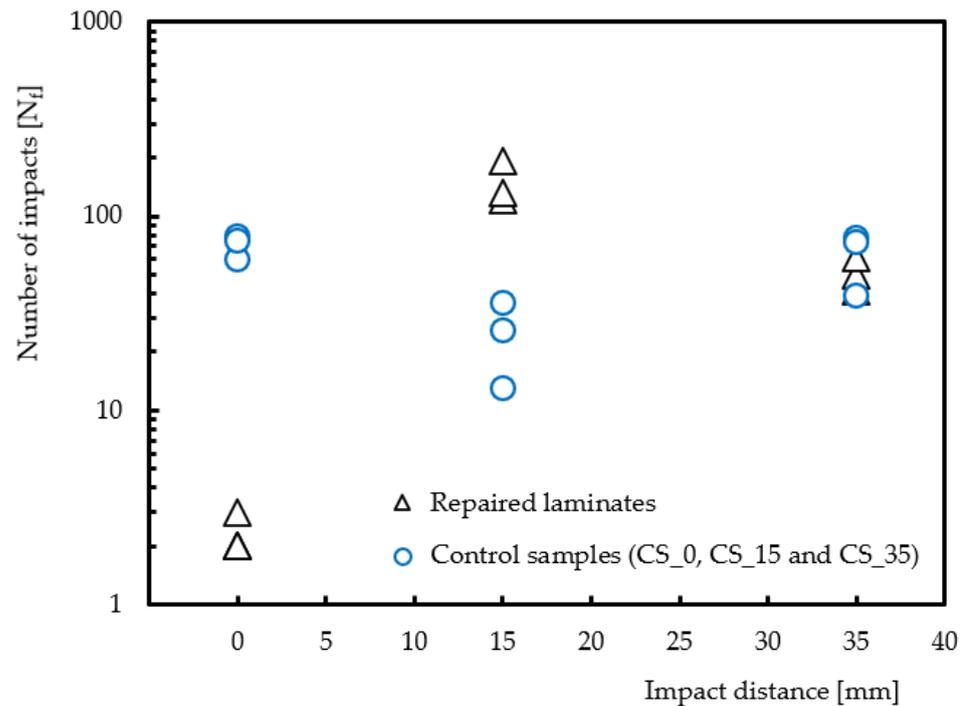
Figure 4 shows the number of impacts required to achieve full perforation as a function of the impact point. It is possible to observe that the patch region is the most sensitive, because, for the energy level used in this study, perforation occurs after two to three impacts. Compared to the parent laminates without holes, the impact fatigue life has an average decrease of about 96.8% due to the huge difference in stiffness [33]. In this context,

higher impact strength is only achieved with thicker patches, despite the aerodynamic problems that may occur. When the impact is located 15 mm from the centre of the patch, an increase in impact strength of about 494.7% is obtained over the same position in the damaged laminates. This large increase can be explained by the higher stiffness of the repaired laminate and, simultaneously, by the stress concentration due to the hole being significantly attenuated with the patch [33,36]. Finally, when the impact occurs 35 mm from the centre of the patch, it is possible to observe similar impact fatigue lives for both laminates, highlighting that the edge effect is much more significant than the presence of the hole.

Figure 4. Distance effect on the number of impacts to rupture.

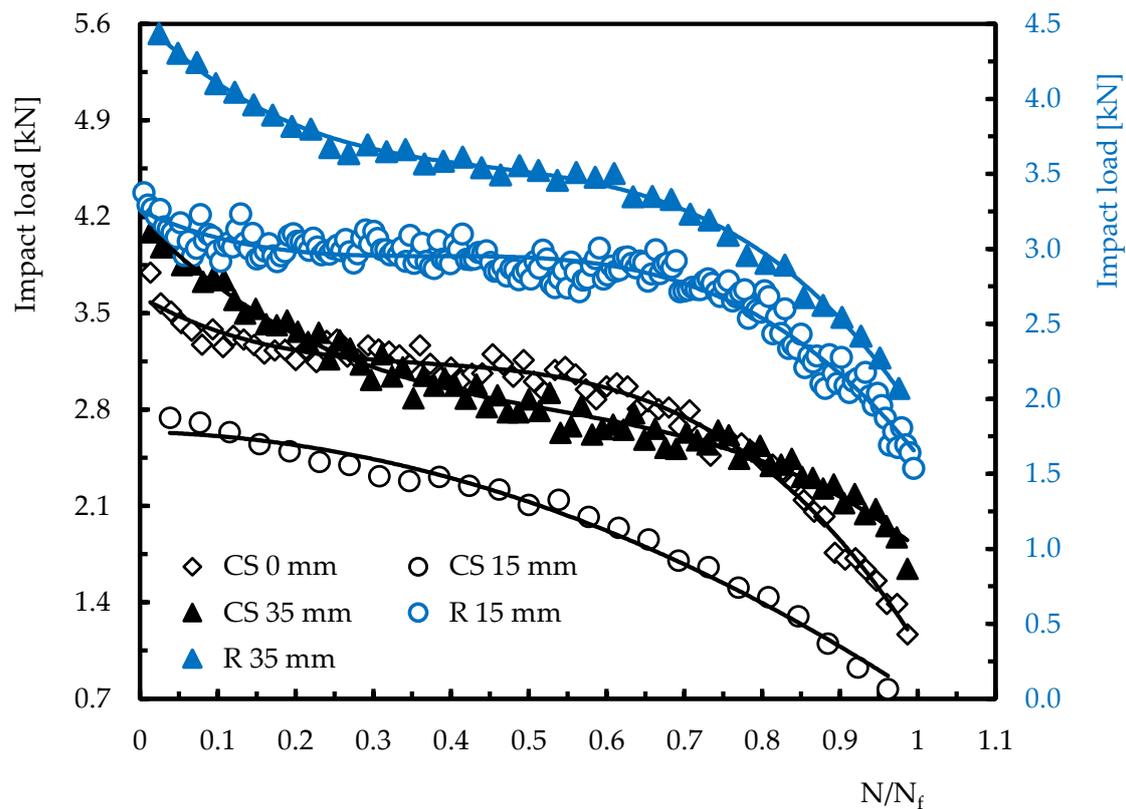
The impact properties will be the focus of a detailed analysis to better understand the distance effect on the number of impacts to failure (N_f). For example, Figure 5 shows how the maximum load evolves with the number of impacts for both the control laminates (in black) and those that were repaired (in blue). Only two distances were analysed for the repaired laminates, because, for the energy studied, the specimens impacted in the centre (0 mm distance) had full perforation after two to three impacts. In this figure, N/N_f represents the number of impacts at a given time over the total number of impacts. The impact load represents the responsiveness of a laminate and determines the type of damage introduced [25,37]. In this context, a gradual decrease in load with the number of impacts is clearly visible and, except for control specimens impacted at 15 mm from their centre (CS_15), all other configurations evolve according to a polynomial of degree three. Therefore, three stages can be well-defined, in which the first is characterised by an abrupt drop in the load, depending on the geometry and impact point, due to the severity of the first damages introduced. Afterwards, the damage slowly progresses along the second stage until it reaches saturation. Subsequently, the damage mechanisms change significantly and rapidly evolve to the final collapse, i.e., full perforation (third stage). It is also noted that control specimens without holes (CS_0) and repaired laminates impacted at 15 mm (R_15) are the ones that present a more stable second stage due to slower damage progression in these geometries.

Figure 5. Impact load versus number of impacts for different geometries and distances.

On the other hand, the impact load profile on specimens impacted at 15 mm can be described by a second-degree polynomial, because the damage progresses much faster due to stress concentration induced by the hole. In the case of repaired laminates, this effect is mitigated by the external patch and the respective increase in stiffness promoted by it [33,36]. This analysis was also reported by Coelho et al. [17], where the decrease in the impact load was explained by the damage accumulation and consequent lower stiffness, mainly at the impact point. Finally, at the level of specimens impacted at 35 mm, despite the repaired laminates presenting slightly higher loads, both curves evolve very similarly, because the stress concentration caused by the edge is decisive in the response of both laminates.

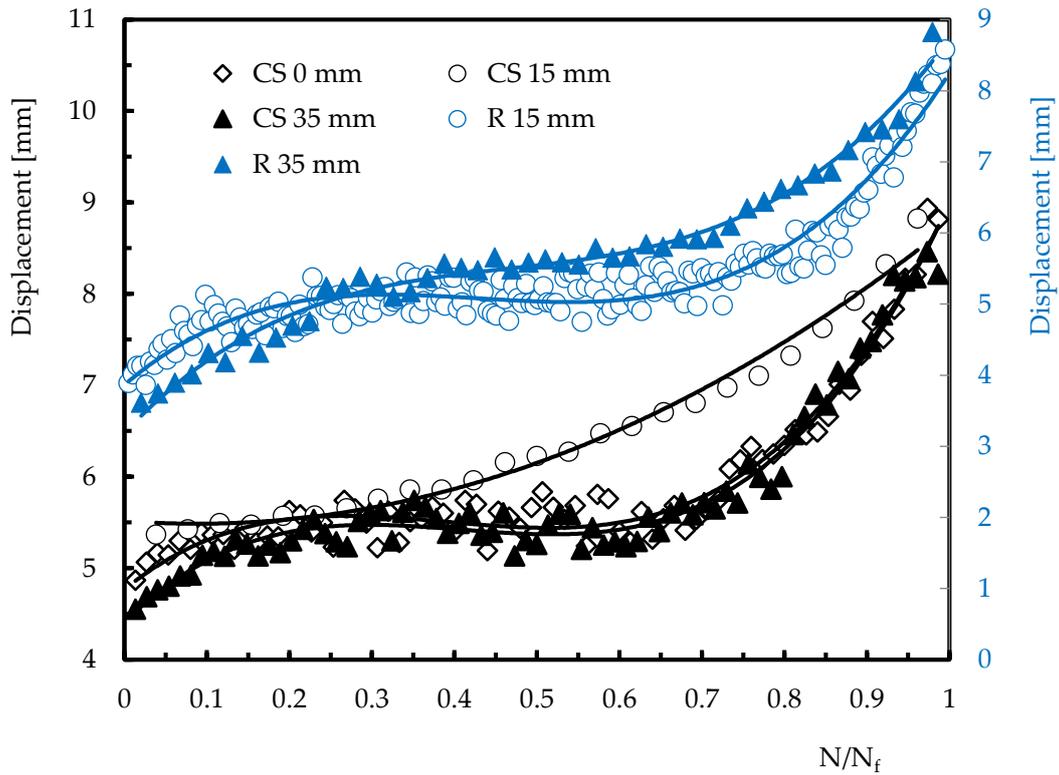
As shown in Figure 6, an opposite trend can be observed for displacement, which would be expected due to the accumulation of damage and consequent lower stiffness of the laminates. As observed in the previous curves (Figure 5) for the specimens impacted at 15 mm from their centre, the displacement versus number of impacts curves are also fitted by a second degree polynomial. This is a consequence of the higher severity of the damage introduced due to the proximity of the hole (stress concentration introduced by the hole). Therefore, the lower stiffness that occurred justifies the lower impact load and the higher displacement observed [38,39], and the very expressive dependence between these two parameters and the stiffness is very evident in Figure 7. The observed evolution of the impact bending stiffness (IBS) with the number of impacts presents very similar profiles to those obtained for the impact load and agrees with the literature [35,38]. In this case, as mentioned above, the stiffness loss is due to the higher damage severity introduced into the laminates. However, despite the profile observed for IBS being very similar to that obtained for the restored energy (and consequently inverse to the absorbed energy [34]), the damage is better evaluated through the IBS than through the restored energy.

Figure 6. Displacement versus number of impacts for different geometries and distances.

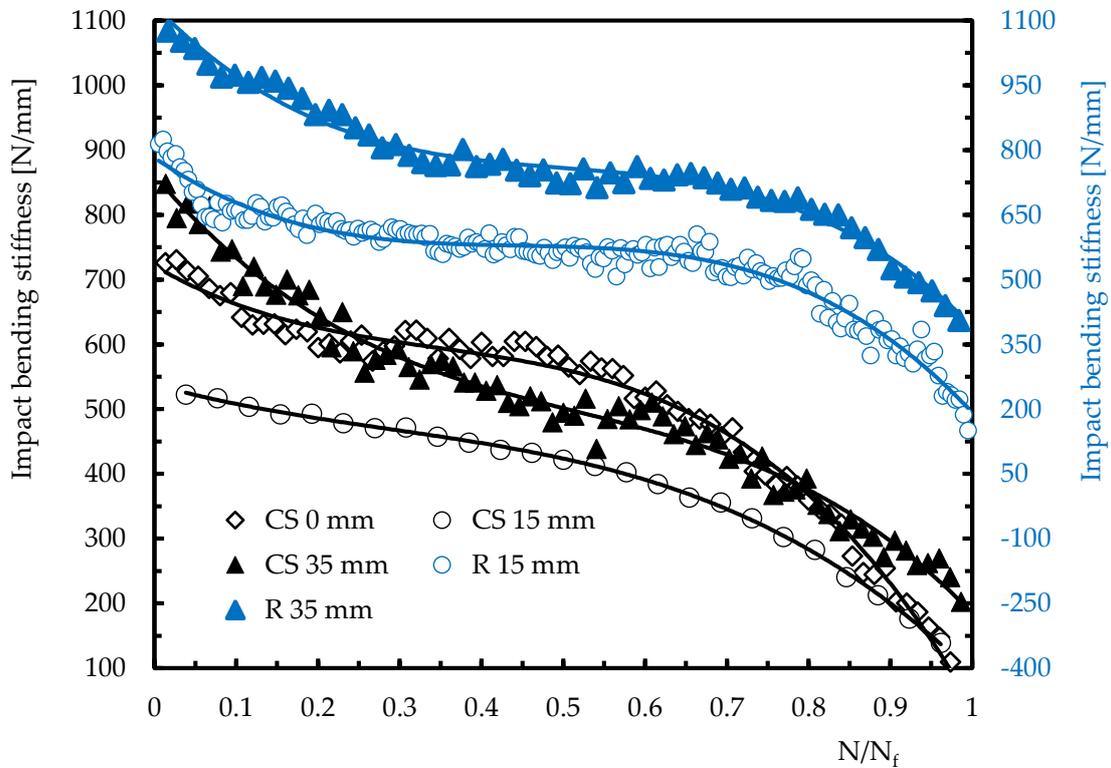
Figure 7. Impact bending stiffness versus number of impacts for different geometries and distances.

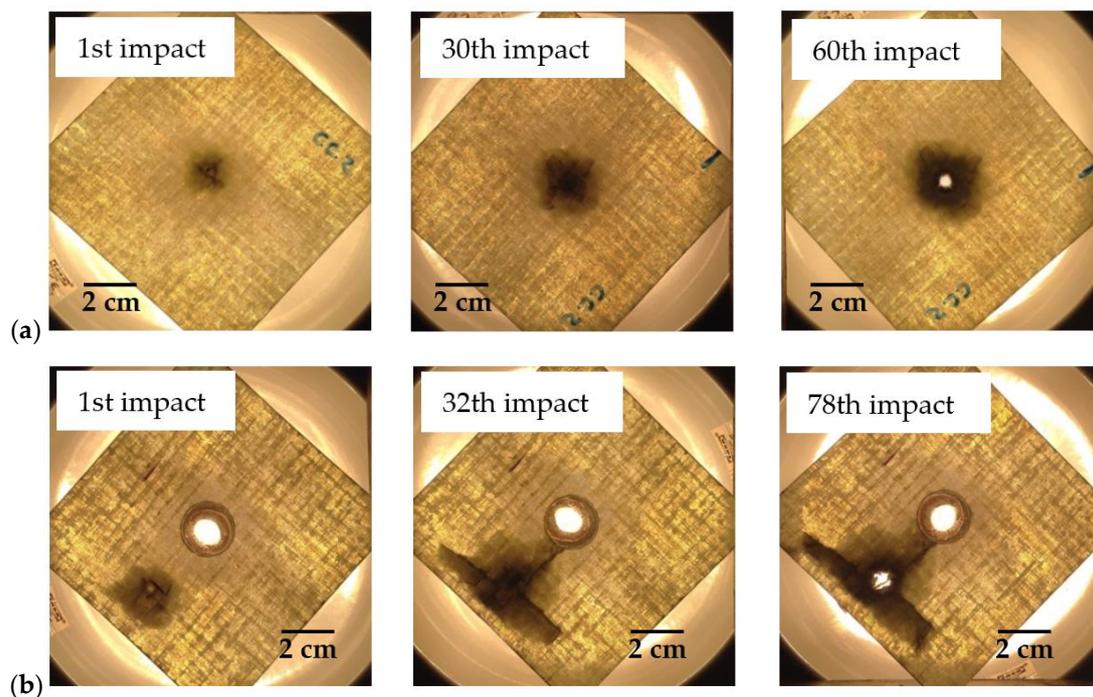
Based on this evidence reported by Coelho et al. [17], Figures 8 and 9 show some photos of the damage evolution related to the different laminates subject to multi-impacts. These figures clearly show that the damage severity is higher with increasing the number

of impacts and, consequently, the stiffness of the laminates is lower [40]. Although the literature indicates that the nature of damage in impacted thick laminates is quite complex, and usually involves multiple delaminations [41], there is a consensus that the first damage mode to appear is matrix cracking [42]. For this type of sample (stiff because they are short and thick), the impact loads are high and, consequently, induce transverse shear cracks under the impactor in the upper layers [42]. Subsequently, with increasing displacement, these cracks evolve into inter- and intra-yarn cracking and, finally, into inter- and intraply delaminations, evidencing, through all these interactions, a very complex damage mechanism [24,43]. At a later stage, the fibres begin to fail at the impact/indentation point, but on the opposite face due to high bending stresses, and the final failure culminates in perforation when the remaining fibres can no longer withstand the impact [42]. These figures also highlight that both repaired and unrepaired laminates have very similar damage when the impact point is close to the boundary condition, which reveals that the stress concentration resulting from this situation is determinant in the whole damage process [36].

Figure 8. Damage evolution for control samples: (a) Without hole; (b) Impacted at 35 mm from the centre of the hole.

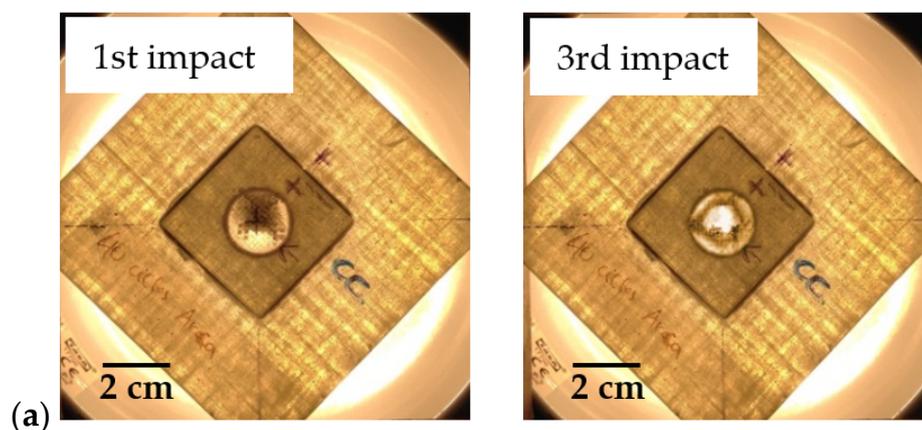
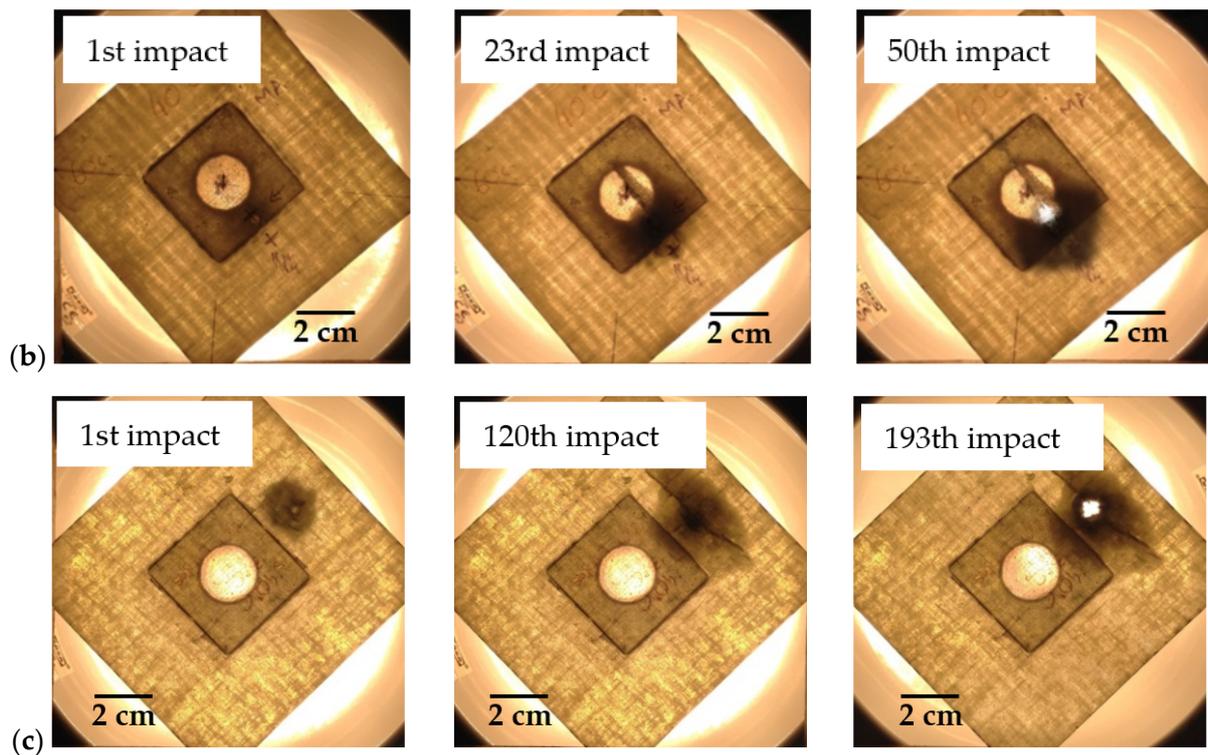
Figure 9. Cont.

Figure 9. Damage evolution for repaired laminates: (a) Impacted at the centre; (b) Impacted at 15 mm from the centre; (c) Impacted at 35 mm from the centre.
