Article

Seismic Performance of a Single-Story Timber-Framed Masonry Structure Strengthened with Fiber-Reinforced Cement Mortar

Keywords: timber-framed masonry structure; fiber-reinforced cement mortar; scaled model; seismic performance; shaking table test

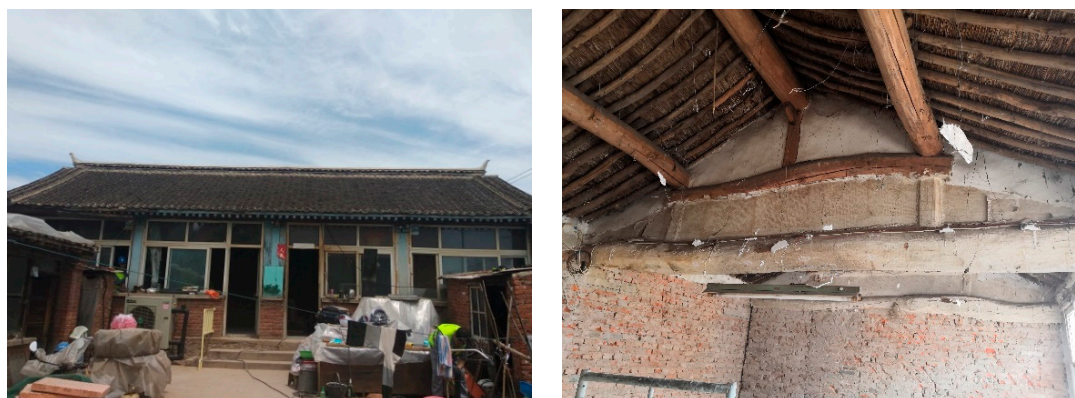
Figure 1. Timber-framed masonry structure.

At present, there are still many single-story timber-framed masonry structures in the area where the seismic fortification intensity is eight degrees, and most of the houses were built earlier. Most of them adopted the mixed bearing system of brick wall and roof woodwork. The main features were that the rear longitudinal wall and the pediment wall on both sides did not have open doors and windows, the front facade had no load-bearing wall, doors and windows were arranged longitudinally, and only the cantilevered wall was set [9–11], as shown in Figure 1. The masonry quality of the wall was poor, and there were no ring beams and structural columns, which were in the “unfortified” state, and there were serious safety hazards. Therefore, it was of great significance to adopt a reinforcement method with economical cost, convenient operation, and remarkable seismic effect [12,13].

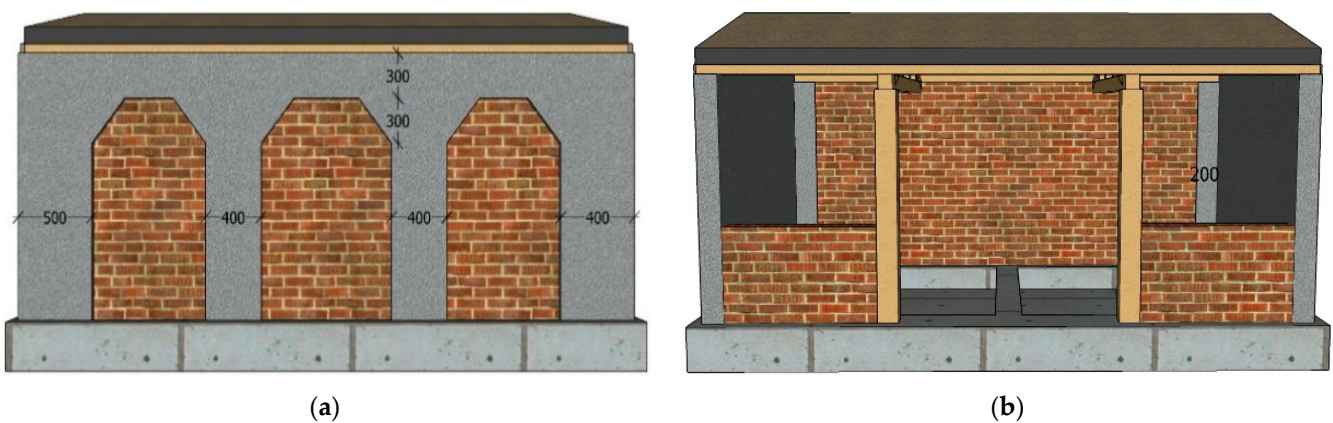
Figure 4. Model structure reinforced with FRCM layer (mm): (a) Reinforcement of the outside of the rear longitudinal wall; (b) reinforcement of the inside of the rear longitudinal wall and the gable.

Reinforcement with FRCM layer, the inside and outside of the gables was plastered to increase the stiffness and integrity. The rear longitudinal wall was reinforced with strips, the width of the vertical reinforcement strips on the outer side of the wall was 500 mm, the width of the vertical reinforcement strips in the middle was 400 mm, and the width of the horizontal reinforcement strips was 300 mm. The width of the vertical reinforcement strip set at the inner corner of the rear longitudinal wall was 200 mm. The thickness of FRCM layer was 10 mm, as shown in Figure 4. The reinforcement process and effect of the model are shown in Figure 5.

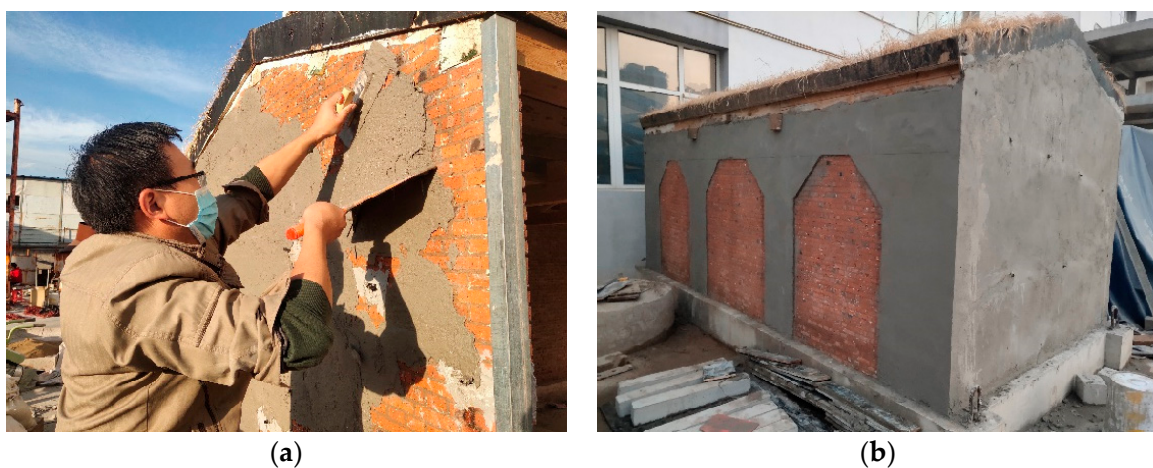
Figure 5. Model reinforcement process and effect: (a) Model reinforcement process; (b) model reinforcement effect.

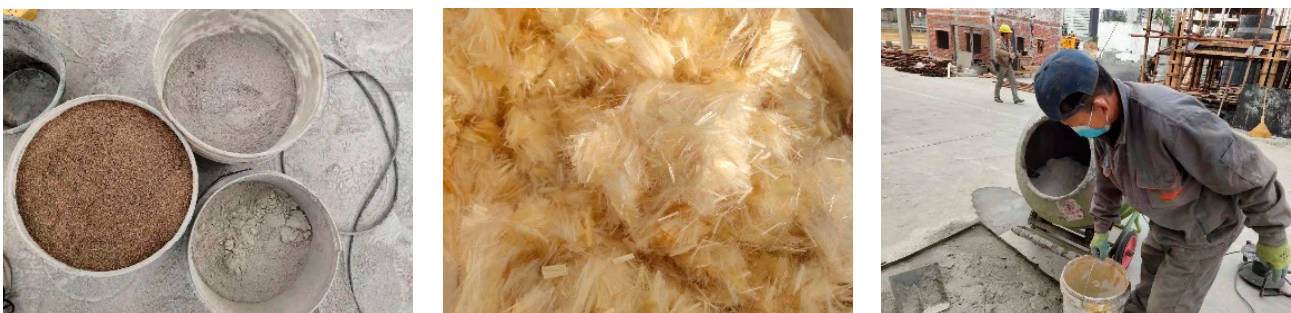
Figure 6. FRCM materials and mixing process.

The FRCM material used in this paper is made of cement, fly ash, slag, sand, water reducing agent and fiber. The materials are all from a chemical market and building materials market in Beijing. The mixing ratio is 1:0.5:0.5:4:0.02:0.006, and the water-binder ratio is 0.3. According to the relevant requirements of Literature [33], the powdered material is first mixed and stirred evenly and then the fiber is evenly mixed into the mixture several times, and then the mixture of water reducing agent and water is sprayed evenly one by one, stirring for 4 min to prepare fiber-reinforced cement mortar material, as shown in Figure 6. According to the requirements of the relevant technical standards [39,40], three test blocks with a size of 100 mm \times 100 mm \times 100 mm were created for the compressive strength test. The loading rate was 5 kN/s and the compressive strength of 28d was measured to be 40 MPa. The specimen size of the flexural test and the equivalent bending test is 40 mm \times 40 mm \times 160 mm, and the loading rate is 0.05 kN/s. The flexural strength at 28d age is 16.2 MPa, the ratio of flexural strength to compressive strength is 0.405, and the equivalent flexural strength at 28d age is 5.15 MPa. The loading equipment is WE-30 universal material testing machine.

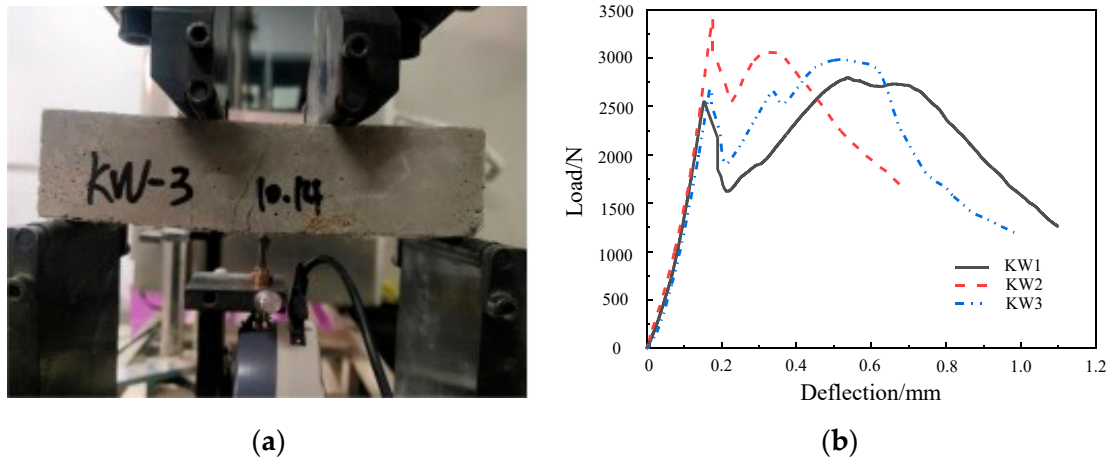
The failure phenomenon and load–deflection curve are shown in Figure 7. It can be seen from the curve that the equivalent bending test of the FRCM is divided into the elastic stage, plastic cracking stage, and failure stage. The deflection increases with the increase in the load. After the specimen cracks, the deflection continues to increase and the load decreases rapidly. At this time, the fibers randomly distributed inside the specimen begin to be pulled, and the load begins to increase slowly until it reaches the maximum load.

Figure 7. Equivalent bending test and load–deflection curve: (a) Failure phenomenon; (b) load–deflection curve.

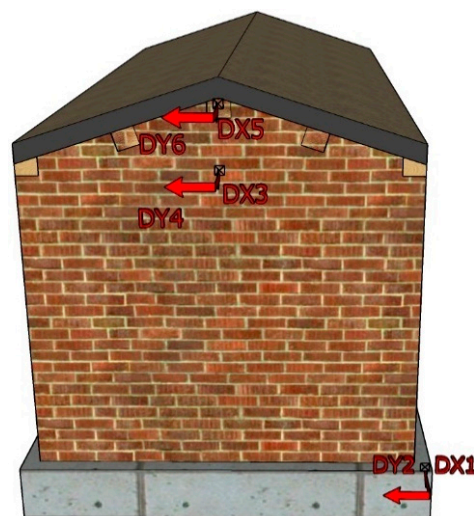
Figure 9. Layout of displacement meters.

A total of 6 displacement sensors were arranged along the X- and Y-direction at the southwest corner position of the foundation beam, the middle of the eaves of the western gable wall, and the top of the pediment of the western gable wall. The location and number are shown in Figure 9.

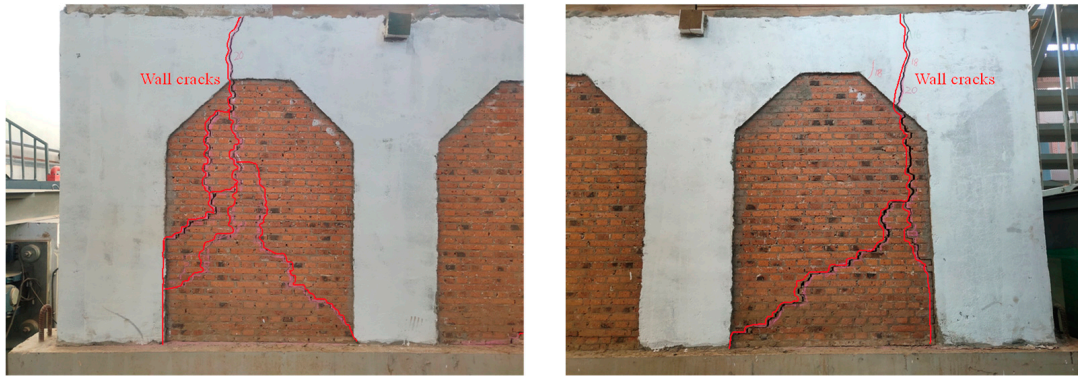
Figure 12. Failure mode of north elevation: (a) The east side; (b) the west side.

During the fourth stage of loading ($PGA = 1.15\text{ g}$, the 20th loading condition), the cracks in the rear longitudinal wall were obviously opened and closed, and the surrounding mortar dropped. The cracks continued to extend downward to form a through crack with a width of 5 mm. The rear longitudinal wall was divided into three parts by the cracks, as shown in Figure 8. There was a 45-degree oblique crack inside the gable on the east side, which continued to extend upward to the purlin to form a joint with a width of 5 mm. The outer drum phenomenon appeared on the outer eaves of the wall, as shown in Figure 12.

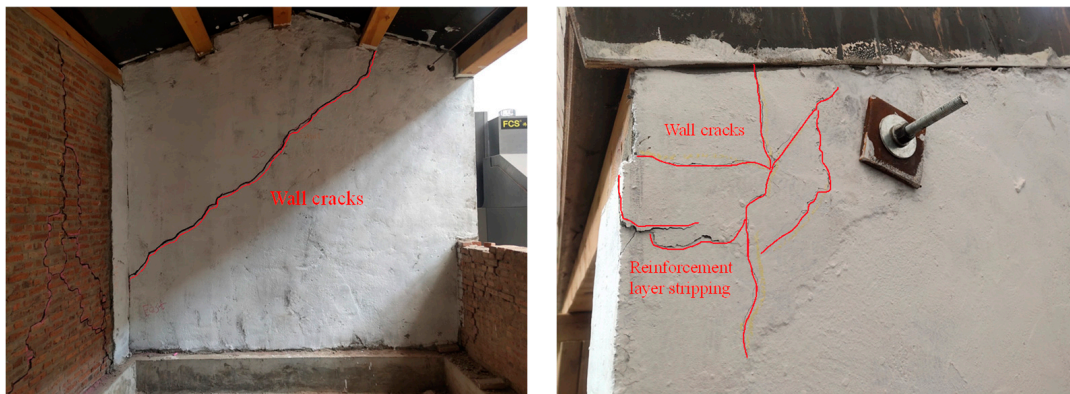
Figure 13. Failure mode of the east gable wall: (a) On the inside; (b) on the outside.

The bricks in the middle and lower parts of the wall were misplaced, and the bricks fell off the top and middle parts. The wood column was separated from the wall, and the bricks and mortar in the west corner were crushed and dropped. The FRCM layer peeled off and the corner position was seriously damaged, as shown in Figure 13. At this time, it was considered that the model structure had been destroyed and loading was stopped, but the structure and the main force components had not collapsed, as shown in Figure 14.

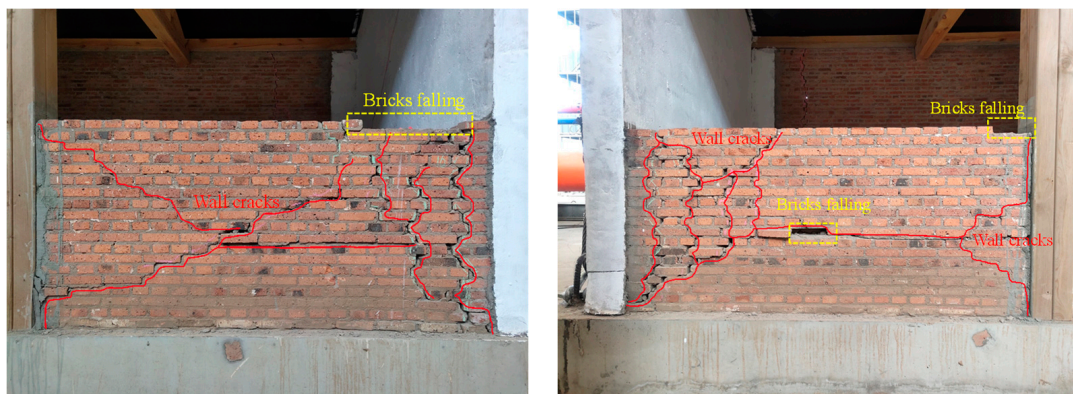
Figure 14. Failure mode of the cantilevered wall: (a) The east side; (b) the west side.

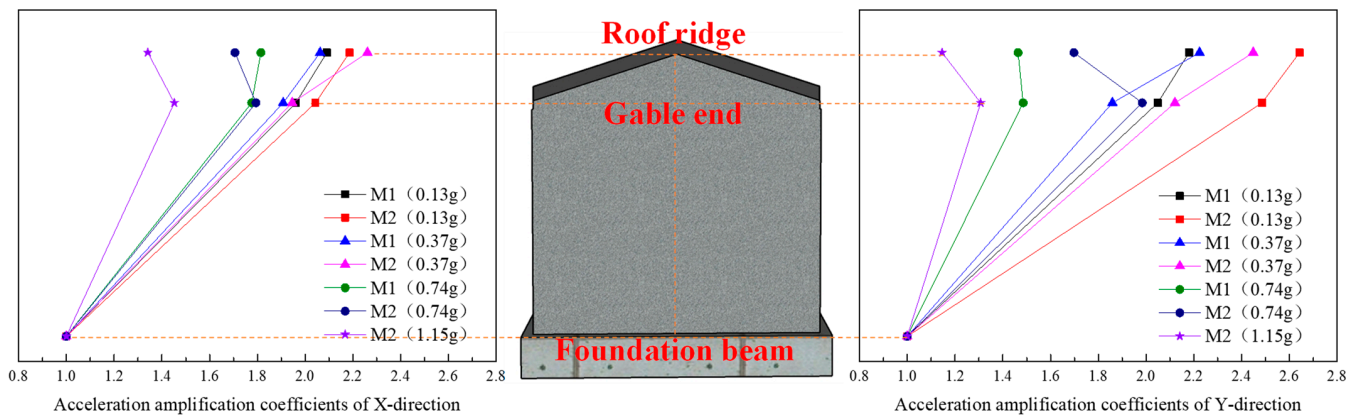
Figure 16. Acceleration amplification coefficients of the model under the action of El Mayor seismic waves.

with the increase in the input seismic action, the acceleration amplification factor shows a decreasing trend as a whole, as shown in Figures 16–18.

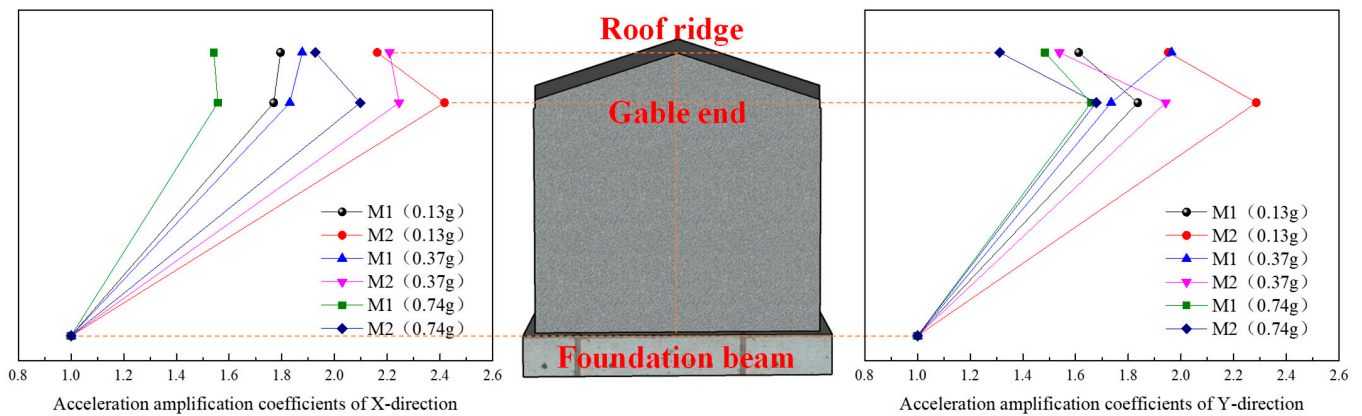
Figure 17. Acceleration amplification coefficients of the model under the action of Landers seismic waves.

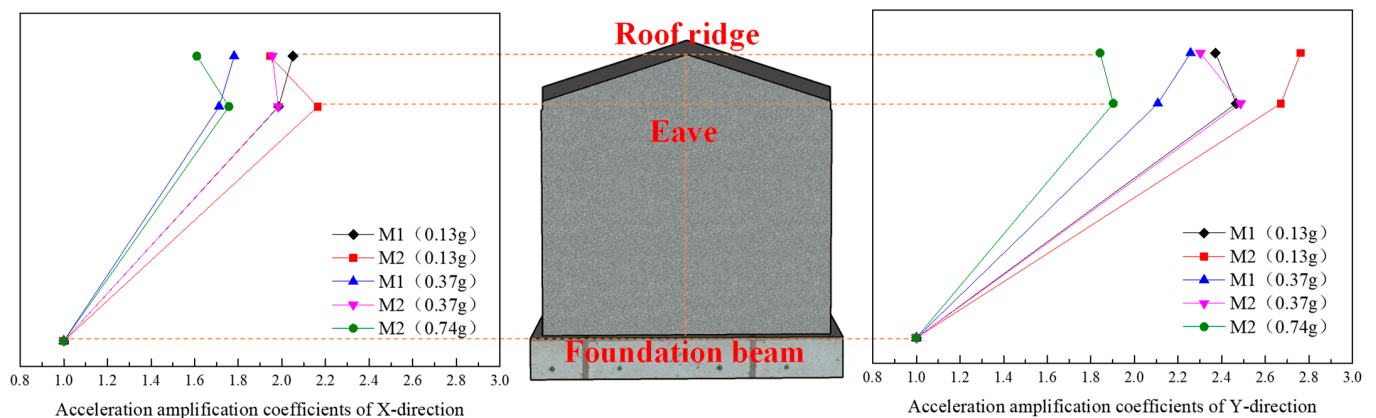
Figure 18. Acceleration amplification coefficients of the model under the action of artificial seismic waves.
