# Surface Damage Regeneration in Railway Wheels

This study examines the applicability of Plasma Transferred Arc (PTA) surface treatment as an advanced technique for the refurbishment of railway wheel treads. Conventional wheel reprofiling, typically performed on semi-automatic lathes, requires the removal of a minimum of 6 mm of material from the running surface, which accelerates rim thinning and ultimately necessitates wheel replacement. Moreover, the reprofiled surfaces are not subjected to any subsequent treatment aimed at enhancing their durability. To overcome these limitations, PTA cladding was selected due to its ability to generate surface layers with superior mechanical and tribological properties. In contrast to widely used diode laser technologies, PTA enables the deposition of alloying materials in powder form, ensuring a stable, controllable, and efficient cladding process. The resulting microstructure consists of a heat-affected zone, a transition zone, and a re-melted zone, each exhibiting significantly increased hardness relative to the untreated base material. The process facilitates the incorporation of metallic particles into the surface layer, promoting the fo

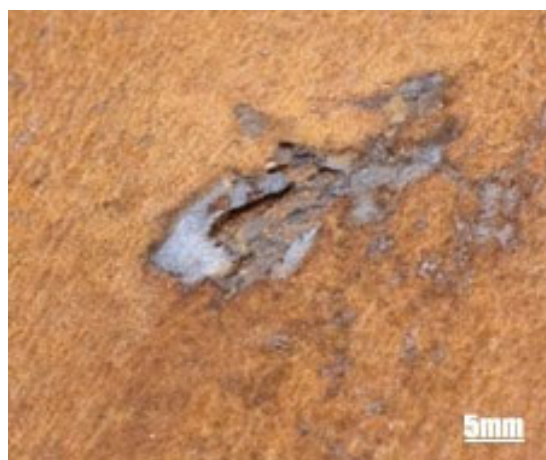
**Figure 1.** (a) Chipping—defects that occur on the running surface of the wheel (these are holes created by the detachment of the wheel’s native material); (b) testing machine used for investigations; and (c) samples using for testing.

Currently, carbon steel remains the primary material used for the production of railway wheels, valued for its favorable compromise between mechanical properties, availability, and cost. The manufacturing processes and quality requirements for railway wheels are detailed in the PN-EN 13262:2021-2 standard “Railway—Wheelsets and bogies—Wheels—Product requirements,” [19] which defines five steel grades approved for the production of monobloc railway wheels: ER6, ER7, ER8, ERS8, and ER9. The proper selection of steel grades is also crucial in the context of the environmental impact of rail transport, as processes such as the wear of wheels, rails, and braking components, as well as emissions associated with fuel combustion, contribute to soil and water degradation [20–22]. Among these grades, ER7 steel is widely used in industrial practice and frequently analyzed in scientific research due to its favorable set of mechanical properties and widespread use in railway networks [23–25]. Typical forms of damage observed during operation include surface wear, RCF cracks, chipping, surface layer detachment, and other fatigue defects. Examples of rolling surface damage are shown in Figure 1a, demonstrating the diversity and scale of wear phenomena. Figure 1b,c present the test rig and samples used in the analyses. The abrasion resistance tests were performed on the T-05 tester (Figure 1b) made by the company ITC.
