Feasibility Study on Application of Synchrotron Radiation μ CT Imaging to Alloy Steel for Non-Destructive Inspection of Inclusions

Abstract: In order to examine the feasibility of applying synchrotron radiation μ CT imaging to alloy steels for non-destructive inspection of inclusions for potential origins of internal fatigue damage in the very high cycle region, synchrotron radiation μ CT imaging was utilized for repeated non-destructive observation of Cr-Mo steel. An ultrasonic fatigue testing machine was used in aid of the repeated observation. As a result, it was found that the synchrotron radiation μ CT imaging with 70 keV was useful for non-destructive observation of inclusions of more than 10 μ m, one of which may be an internal fatigue origin. No identifiable damage was observed around every inclusion, and in the base metal, at least up to 70% of fatigue life was observed in the imaging volume.

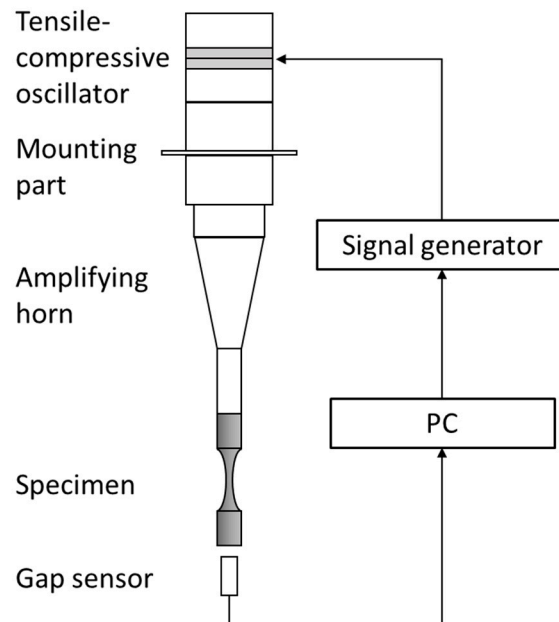
Figure 1. Configuration of an ultrasonic fatigue testing machine.

An ultrasonic axial fatigue testing machine is mainly composed of a piezoelectric oscillator, an amplifying horn, a specimen, and a controller, as shown in Figure 1 [8]. Sinusoidal electrical input from the signal generator vibrates the piezoelectric oscillator at about 20 kHz. The amplitude of the vibration is, however, only a few μ m and not enough to bring fatigue failure to a specimen. Thus, the cyclic vibration of the piezoelectric oscillator is amplified using an amplifying horn. The specimen had the first natural frequency at about 20 kHz of axial vibration mode and was resonated by the external input from the amplifying horn. In this study, an hourglass type specimen was designed by using theoretical formulas [11], and then the specimen shape was tuned by using finite element analysis to obtain exact resonance. The specimen shape and the profiles of axial stress amplitude are presented in

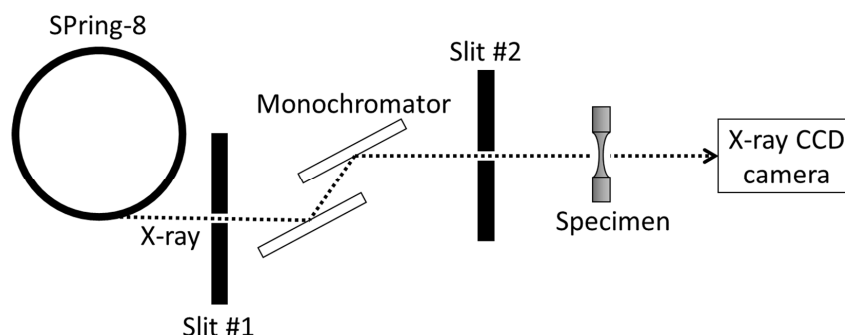
Figure 3. Set-up of the synchrotron radiation μ CT imaging.

Synchrotron radiation μ CT imaging was conducted at the beamline BL22XU at SPring-8. The maximum X-ray energy was about 70 keV. A specimen was placed on a rotating table so that the specimen axis was arranged on the rotating axis. The set-up of synchrotron radiation μ CT imaging is shown in Figure 3. Radiographs were taken at intervals of 0.2 degrees from 0 degrees to 180 degrees; the total number of radiographs was about 900 images. The area of radiographs was equal to the area of incident X-ray, which was H2.1 mm \times W4.0 mm, where the width was wider than the diameter of the necked portion of the specimen, i.e., 2.5 mm. The pixel size was 6.5 μ m. The stress amplitude at the top and bottom edge of the imaging volume was 95% of the maximum applied stress amplitude of the measured area. During μ CT imaging, a specimen was subjected to a static tensile load of 500 MPa, which was lower than the fatigue strength at 10^9 cycles, by using an in-house tensile loading apparatus in order to open if an internal crack(s) exists. The in-house tensile loading apparatus was mainly composed of an acrylic tube and a coil spring; a specimen was placed in the acrylic tube, fixed at the one end of the acrylic tube, and loaded with the coil spring by tightening a screw located in the other end. A preliminary μ CT imaging using a specimen with a fatigue crack from the surface was conducted to assess the feasibility of crack detection. The radiograph of the crack tip implied that it seemed to be possible to identify an internal fatigue crack if the size is on the order of 10 μ m.

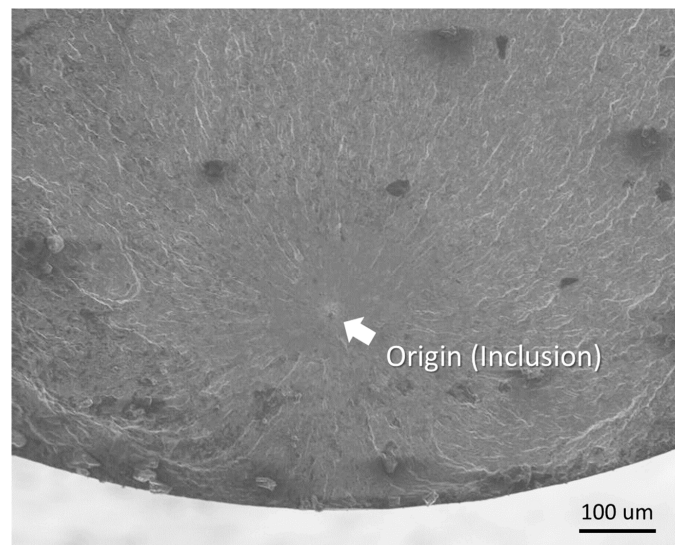
Figure 4. Fatigue origin of the specimen used for the repeated synchrotron radiation μCT imaging.

After the μ CT imaging experiment at SPring-8, the specimen was subjected to fatigue loading until fatigue failure in our laboratory by using the same fatigue testing machine and conditions mentioned above. The specimen failed when the cumulative number of cycles reached 1.4×10^8 cycles from an internal inclusion as shown in Figure 4. The result means that repeated μ CT imaging was conducted at 0%, 7.1%, 14.2%, and 70.9% of the fatigue life in the experiments. The chemical composition of the origin was characterized by using EPMA (JXA-8530F, JEOL, Tokyo, Japan) and was identified as an inclusion

of Al and Ca oxide with a 30 μm diameter. It should be noted that the cracked position was 3.1 mm far from the center of the imaging volume, which was, unfortunately, out of the imaging volume.

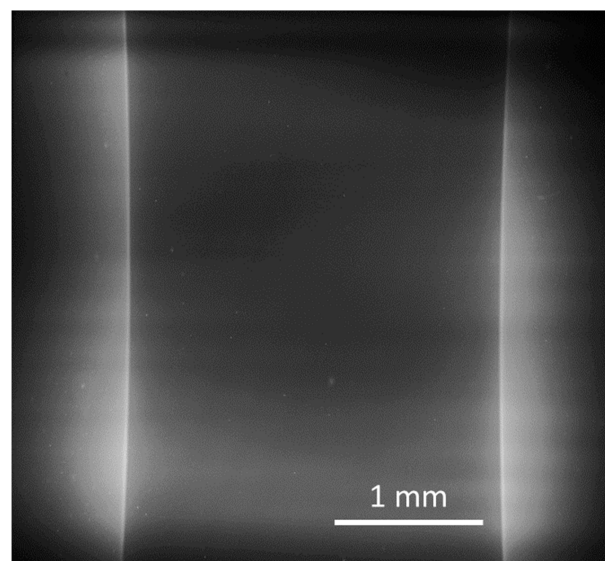
Figure 5. Example of a radiograph.

An example of a radiograph is shown in Figure 5, and an example of the reconstructed image of a cross section is shown in Figure 6. In the reconstructed image, a block of black pixels is observed. The block of black pixels was considered to be an inclusion [9]. At least 47 inclusions were identified within the imaging volume. Figure 7 shows the locations of the inclusions identified from the reconstructed images before fatigue loading. The projected positions in the vertical and horizontal sections are shown in the left and right figure, respectively. Most of the block size varied from 2 to 6 pixels, which corresponds to 12 μm to 36 μm in diameter. Since an inclusion size as a fatigue origin is, in general, 10 μm or more, the μCT imaging technique used can identify inclusions that may be fatigue origins. In other words, 47 potential fatigue crack origins were non-destructively monitored using the μCT imaging technique in the experiment, even though the repeated μCT imaging was conducted for only one specimen due to time limitation.

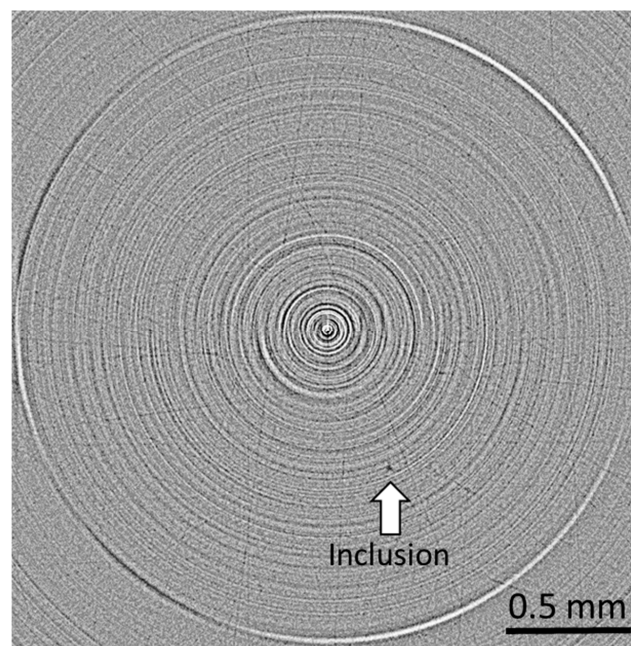
Figure 6. Example of the reconstructed image of a cross section.

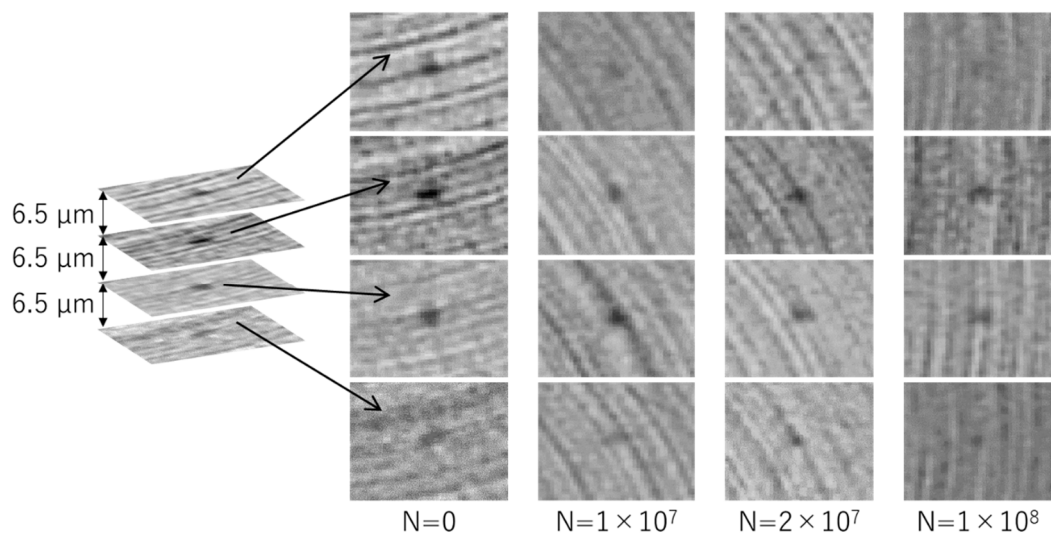
Figure 8. Reconstructed images of an inclusion #21 at every observation step.

Then, reconstructed images before and after fatigue loading were compared for investigating crack formation from inclusions. An example of reconstructed images of an inclusion subjected to almost the maximum stress amplitude, which is labeled “21” and thick circled in Figure 7, is shown in Figure 8. If a fatigue crack exits around an inclusion, crack opening occurs due to the applied load exerted by the in-house tensile loading apparatus during μ CT imaging. Thus, the contrast of a reconstructed image around the inclusion may change if there is a fatigue crack around the inclusion.

However, for every identified inclusion, no identifiable contrast change was observed before and after fatigue loading.
