# Study on Fracture Behavior and Toughening Mechanisms of Ultra-High-Strength Pipeline Steel

**Abstract:** In this paper, a series of low-temperature CVN (Charpy V-notch impact test) and DWTT (drop-weight tear test) experiments were carried out to deal with the intensifying contradiction of strength and toughness of ultra-high-strength pipeline steel. The fracture behavior and toughening mechanisms of ultra-high-strength pipeline steel were investigated using scanning electron microscopy, transmission electron microscopy and backscattered electron diffraction systems. The results show that DWTT fractures in ultra-high-strength pipeline steel had a variety of unconventional morphological features compared to CVN fractures, including ridge protrusion in ductile fracture conditions and a large-size fracture platform in brittle fracture conditions. Therefore, DWTT fractures contained more information about the material fracturing process, and could better reflect the actual process of material fracturing. In ultra-high-strength pipeline steel, fine-grained granular bainite caused cracks to undergo large deflections or frequent small transitions, which consumed additional energy and im

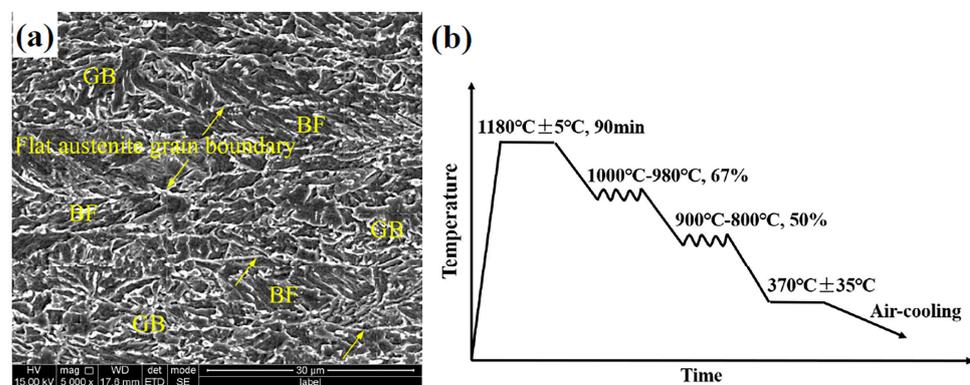
**Figure 1.** (a) Microstructure of ultra-high-strength pipeline steel; (b) Thermo-mechanical control process schedule.

In this work, the experimental steel was produced by industrially hot-rolled steel plates. As shown in Figure 1a, the microstructure of ultra-high-strength pipeline steel was mainly a mixture of granular bainite (GB) and bainitic ferrite (BF). Then, the thermo-mechanical control process schedule is displayed in Figure 1b.

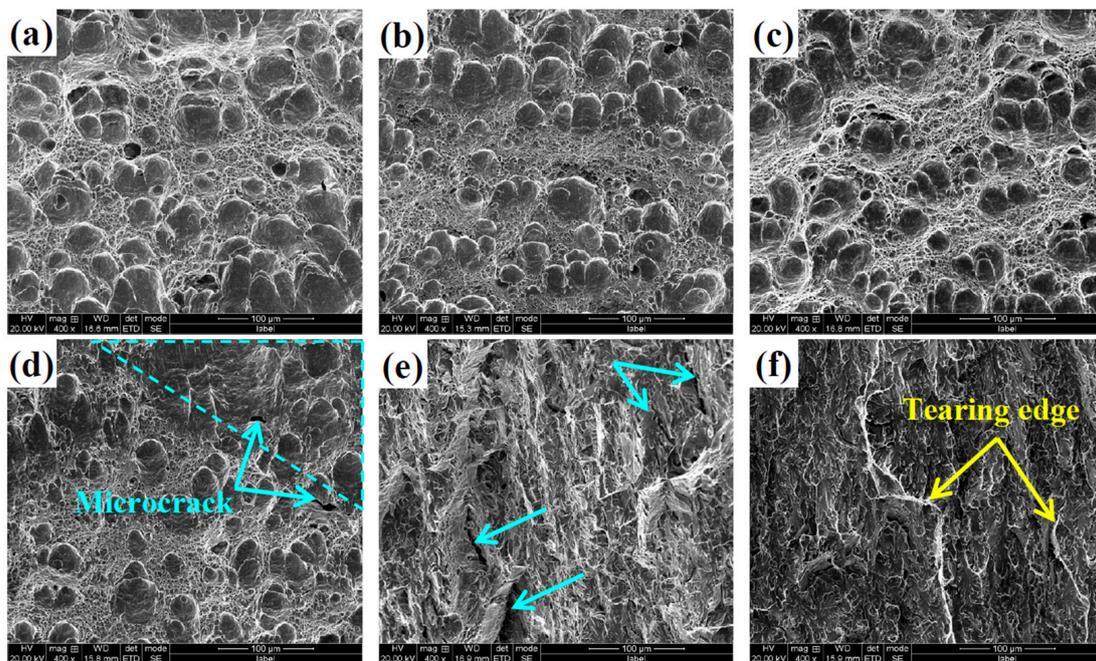
**Figure 2.** Low magnification SEM images of impact fracture morphology of ultra-high-strength pipeline steel: (a)  $0\text{ }^{\circ}\text{C}$ ; (b)  $-20\text{ }^{\circ}\text{C}$ ; (c)  $-40\text{ }^{\circ}\text{C}$ ; (d)  $-60\text{ }^{\circ}\text{C}$ ; (e)  $-80\text{ }^{\circ}\text{C}$ ; (f)  $-196\text{ }^{\circ}\text{C}$ .

Figure 2 shows the impact fracture morphology of ultra-high-strength pipeline steel at low magnification. The fracture morphology from room temperature to  $-60\text{ }^{\circ}\text{C}$  showed a large number of small deep dimples and large dimples interleaved. The size and distribution of the large dimples give rise to a distinct pattern. From the point of view of a microscopic mechanism, dimples are a fundamental feature of micropore aggregation and fracture as a result of micropore formation and growth. Larger and deeper micropores indicate that the material undergoes greater plastic deformation during fracture, consumes additional energy, and thus exhibits higher toughness [38]. Therefore, the morphology of the heterogenic dimple indicates a good toughness of the material. At  $-60\text{ }^{\circ}\text{C}$ , microcracks were observed on the fracture marked by sky blue arrows. In the upper-right triangular frame region, the small dimples disappeared and only a few large dimples could be distinguished, and there were no features of cleavage fracture. Such morphological features indicate the onset of toughness reduction. When the experimental temperature was reduced to  $-80\text{ }^{\circ}\text{C}$ , brittle fractures occurred in the experimental steel, and large cracks could be seen on the fracture marked by the sky-blue arrow. At  $-196\text{ }^{\circ}\text{C}$ , the fracture morphology is also brittle fracturing, and the obvious tearing edge (marked by the yellow arrow) on the fracture can be identified as a quasi-cleavage fracture.

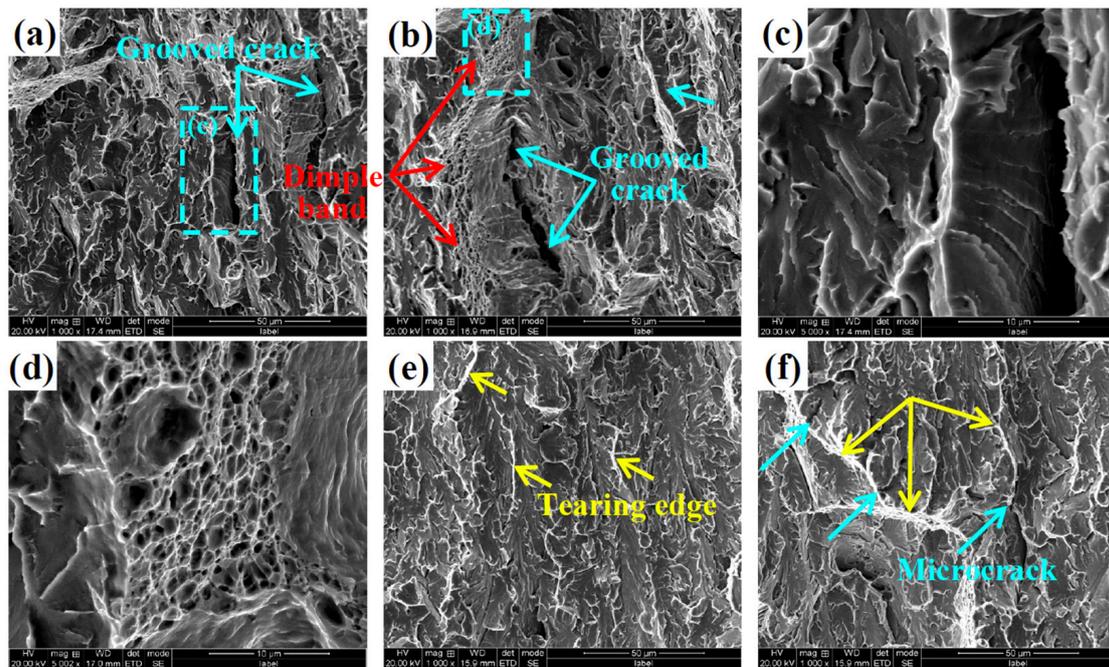
**Figure 3.** High-magnification SEM images of impact fracture morphology of ultra-high-strength pipeline steel: (a,b)  $-80\text{ }^{\circ}\text{C}$ ; (c) enlarged image of the sky-blue dotted box in (a); (d) enlarged image of the sky-blue dotted box in (b); (e,f)  $-196\text{ }^{\circ}\text{C}$ .

At high magnification, a grooved crack could be observed at  $-80\text{ }^{\circ}\text{C}$ , as shown by the sky-blue arrow in Figure 3a–d, which is usually caused by “delamination” during the fracture process [30–32]. A cleavage fracture occurs around the grooved crack in the plastic zone, and the red arrow in Figure 3b marks the dimple band distributed along the left edge of the grooved crack.

When the temperature was reduced to  $-196\text{ }^{\circ}\text{C}$ , as shown in Figure 3e,f, it could be seen that there were tear edges distributed in different directions on the section (marked by yellow arrows), and the crack stopped propagating when it met the tear edges perpendicular to it (marked by sky-blue arrows), but would expand along the direction parallel to it.

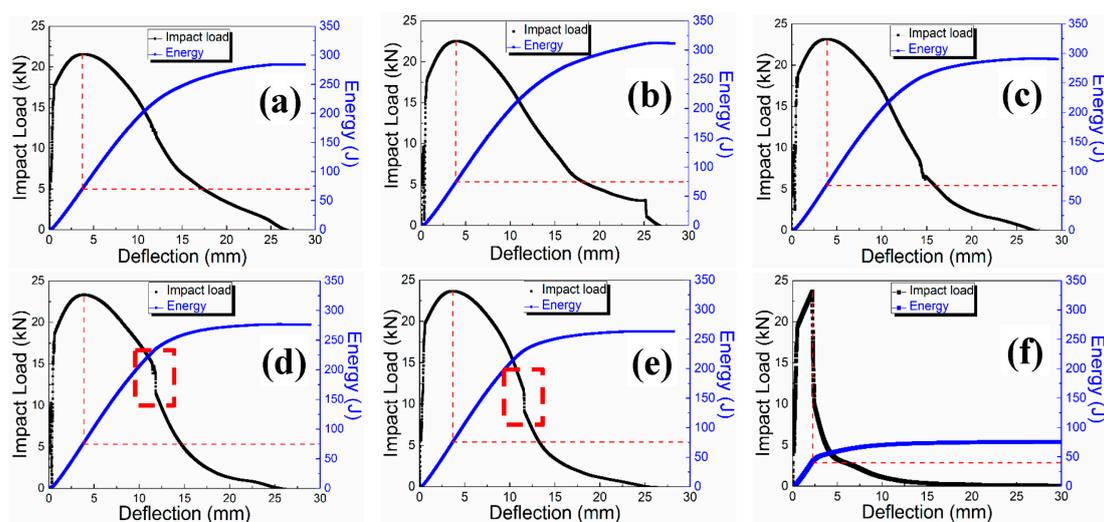
**Figure 4.** “Deflection–load–energy” curve of ultra-high-strength pipeline steel: (a) room temperature; (b)  $0\text{ }^{\circ}\text{C}$ ; (c)  $-20\text{ }^{\circ}\text{C}$ ; (d)  $-40\text{ }^{\circ}\text{C}$ ; (e)  $-60\text{ }^{\circ}\text{C}$ ; (f)  $-80\text{ }^{\circ}\text{C}$ .

Figure 4 shows the “displacement–load–energy” curve of ultra-high-strength pipeline steel at different temperatures. At the temperature of  $-60\text{ }^{\circ}\text{C}$  and above, the crack-initiation energy is the same, and the total energy leading to the final fracture of the material is also similar, and the temperature change mainly affects the crack-arresting energy. Brittle

fracture features appeared on the curve starting from  $-40\text{ }^{\circ}\text{C}$ , as shown in the dotted box in Figure 4d,e, but ductile fracturing was still dominant on the whole. When the temperature was reduced to  $-80\text{ }^{\circ}\text{C}$ , the curve changed significantly, as shown in Figure 4f, representing the disappearance of the plastic deformation region in the ductile fracture stage. This indicates that the fracture at this time transformed into a brittle fracture. In addition, the total energy consumed by the fracture also decreased sharply, indicating that the material failed rapidly and fractures occurred under brittle fracture conditions. This is consistent with the results observed for the fracture sections in Figures 2 and 3.

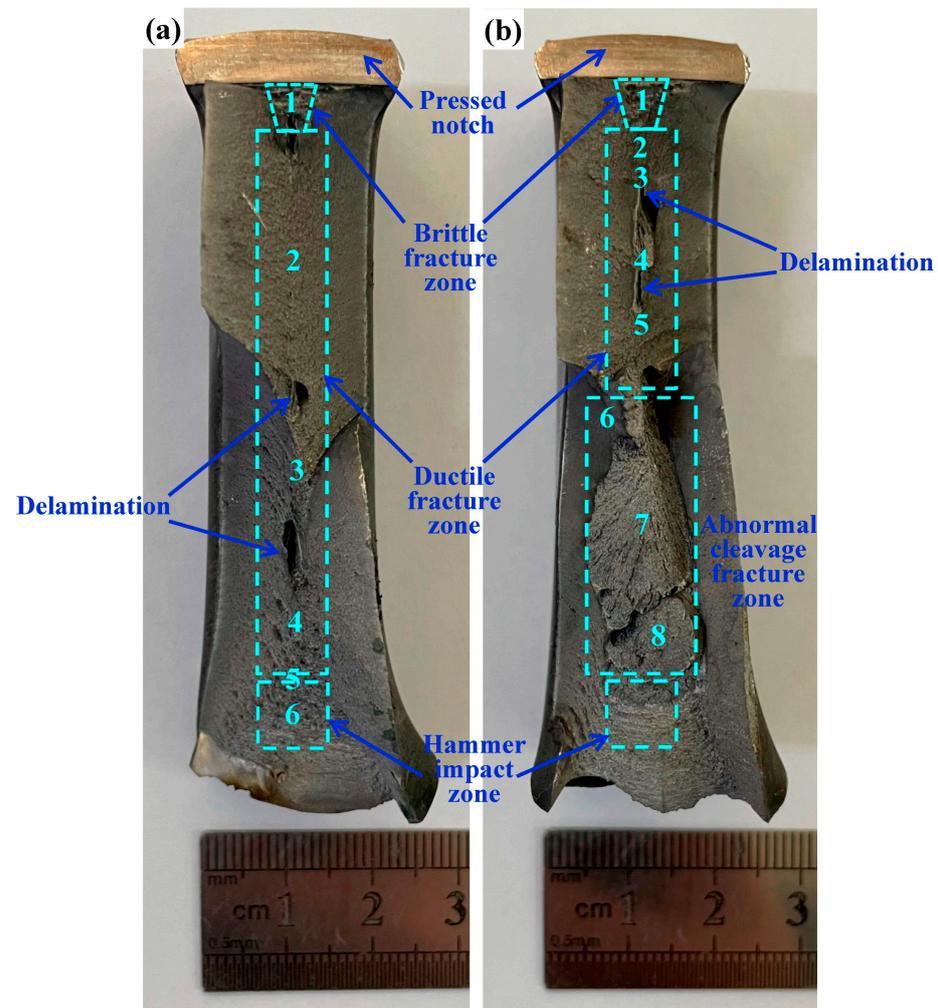
**Figure 5.** Macrograph of DWTT sample fracture of ultra-high-strength pipeline steel: (a) 0 °C; (b) −20 °C. Numbers 1–8 indicate the location of the observations.

Figure 5 shows a macroscopic picture of a DWTT fracture in ultra-high-strength pipe steel. At 0 °C and −20 °C, the shear area of the DWTT fracture is 99% and 71.6%, respectively. That is, 85% of the standard index requirements cannot be met when the temperature is reduced to −20 °C.

DWTT fractures can usually be divided into four regions: the pressing notch, brittle fracture zone, ductile fracture zone, and hammer fracture zone. Among them, the brittle and ductile fracture zones are key analysis areas that can give various information about the fracturing process.

In particular, there are delamination defects on the surface of the fracture at both temperatures, and the delamination defect is a typical morphology when the cleavage plane (100) is parallel to the rolled surface during the fracturing process.

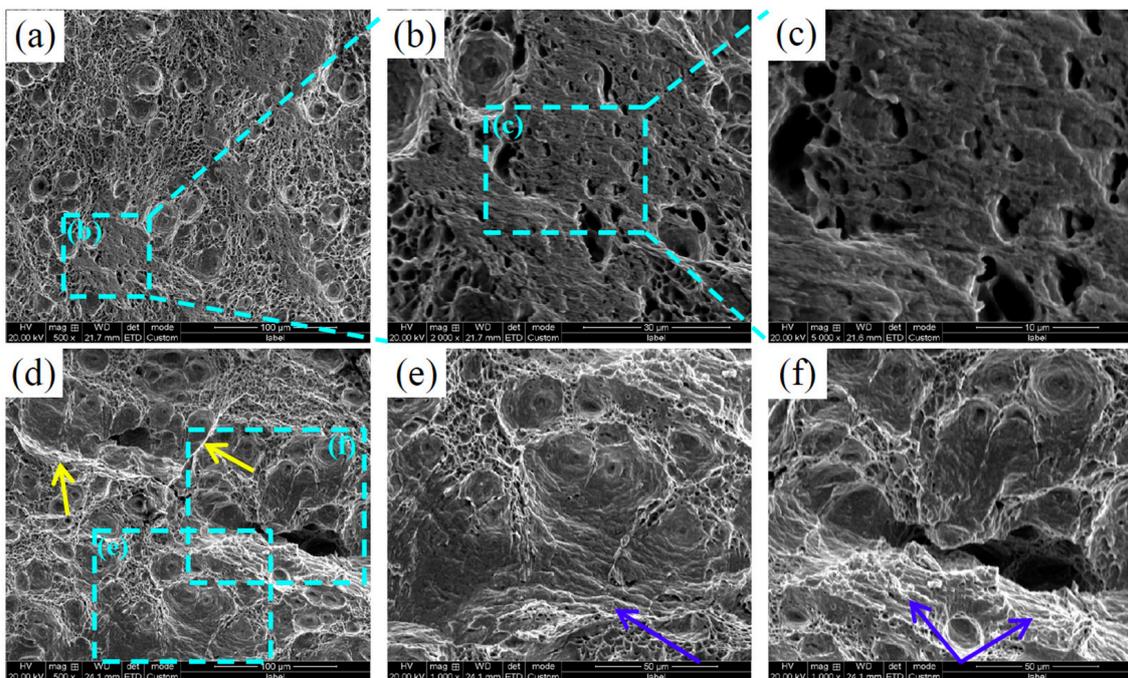
**Figure 6.** Micrograph of position 1 in DWTT fracture of ultra-high-strength pipeline steel at 0 °C. Figures (a–f) show different regions at position 1, respectively.

Figure 6 shows the microstructure morphology of position 1 in the brittle fracture zone of a DWTT fracture of ultra-high-strength pipeline steel at 0 °C. Although it had brittle-fracture characteristics in the macroscopic morphology, the SEM morphology at low magnification (Figure 6a) showed a large number of dimples with mixed sizes and some flat plane regions. When the planar region was enlarged (Figure 6b,c), it could be found that the dimples had totally disappeared, leaving only some irregular holes. The dimple disappears because a brittle fracture occurs at this location, that is, the fracture pattern of the material changes from ductile to quasi-cleavage. As a result, the dimple morphology typical of ductile fractures disappears at the fracture. Although it does not have the typical characteristics of a cleavage fracture, its contribution to toughness is extremely limited. Tear edges, which are common in quasi-cleavage fracture morphology, were observed as indicated by the yellow arrows in Figure 6d. In addition, a step-like morphological feature was also observed in some regions, as indicated by the blue arrows in Figure 6e,f, which is also one of the characteristics of quasi-cleavage fracture [40].

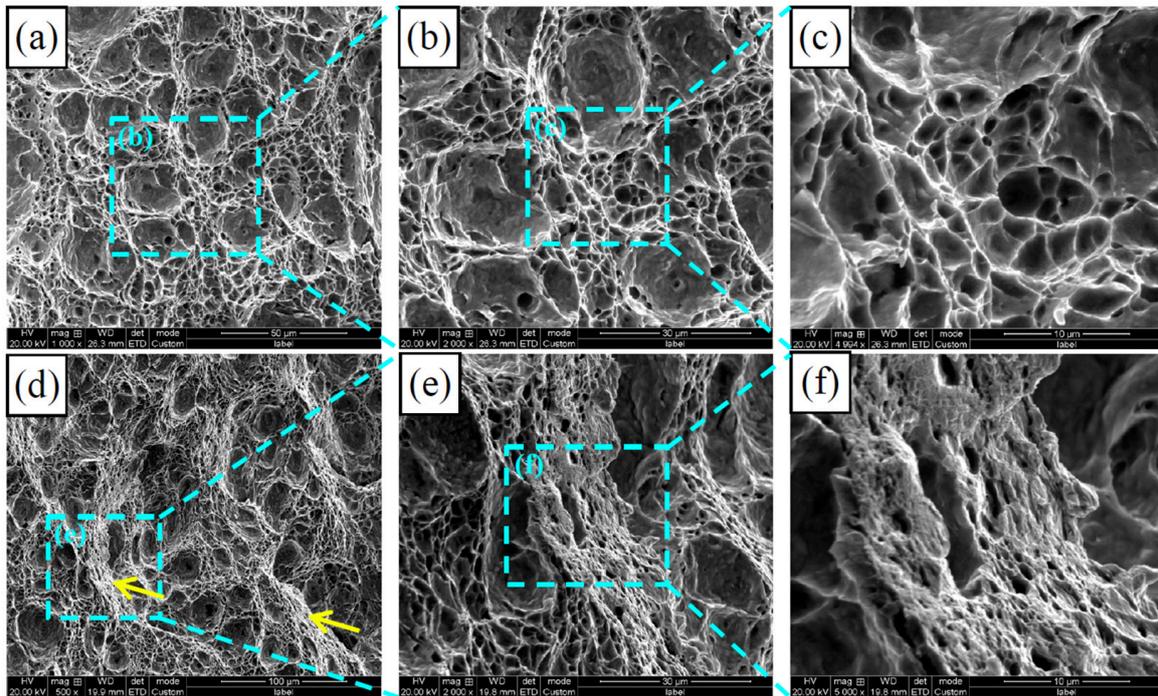
**Figure 7.** Micrograph of position 2 in DWTT fracture of ultra-high-strength pipeline steel at 0 °C. Figures (a–f) show different regions at position 2, respectively.

Figure 7 shows the microstructure morphology of position 2 in the ductile fracture zone of a DWTT fracture of ultra-high-strength pipeline steel at 0 °C. The fracture morphology was typical ductile fracture morphology with an alternating distribution of small and deep and large-size dimples, showing good toughness, as shown in Figure 7a–c. On the one hand, the formation of dimples is related to the size and distribution of the second-phase particles inside the microstructure, and on the other hand, it is also related to the grain size. The presence of fine granular bainite in ultra-high-strength steel favors the formation of small and deep dimples. In particular, ridge-like protrusion similar to the tear edge of quasi-cleavage features were observed at low magnification, as shown by the yellow arrows in Figure 7d. At high magnification (Figure 7e,f), it could be found that this special morphology was formed by severe plastic deformation of a large number of small dimples. In general, the formation of tear edges consumes a large amount of energy, which increases

the impact energy. Microstructures similar to tear edges formed in the ductile fracture zones are not observed in the fracture morphology of the impact specimens.

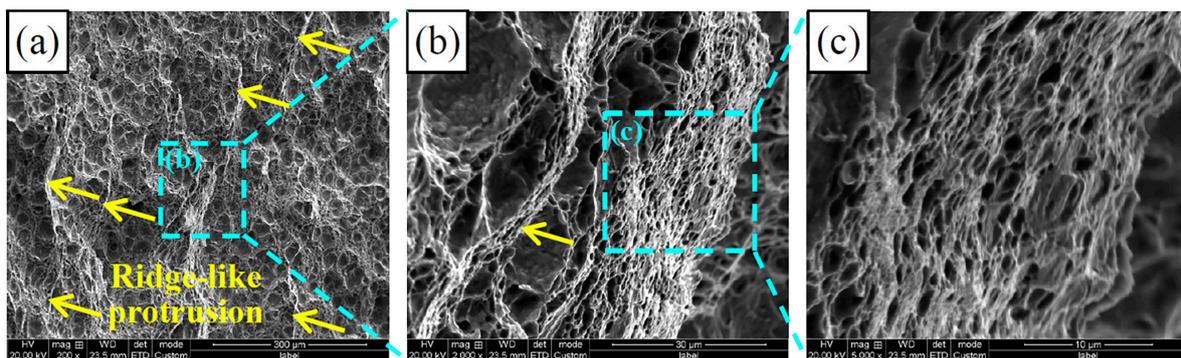
**Figure 8.** Micrograph of position 3 in DWTT fracture of ultra-high-strength pipeline steel at 0 °C. Figures (a–c) show different magnifications at position 3, respectively.

Figure 8 shows the microstructure morphology of position 3 in the ductile fracture zone of a DWTT fracture of ultra-high-strength pipeline steel at 0 °C. A ridge-like protrusion similar to that at position 2 is also observed at different magnifications, marked by the yellow arrow. Figure 9 shows the microstructural morphology of the ductile fracture zone at different magnifications of location 4. A sharper ridge-like protrusion is also observed, marked by a yellow arrow.

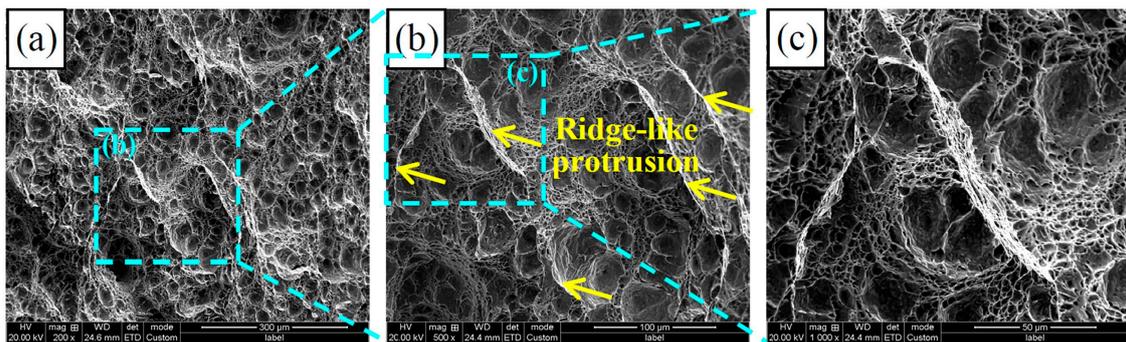
**Figure 9.** Micrograph of position 4 in DWTT fracture of ultra-high-strength pipeline steel at 0 °C. Figures (a–c) show different magnifications at position 4, respectively.

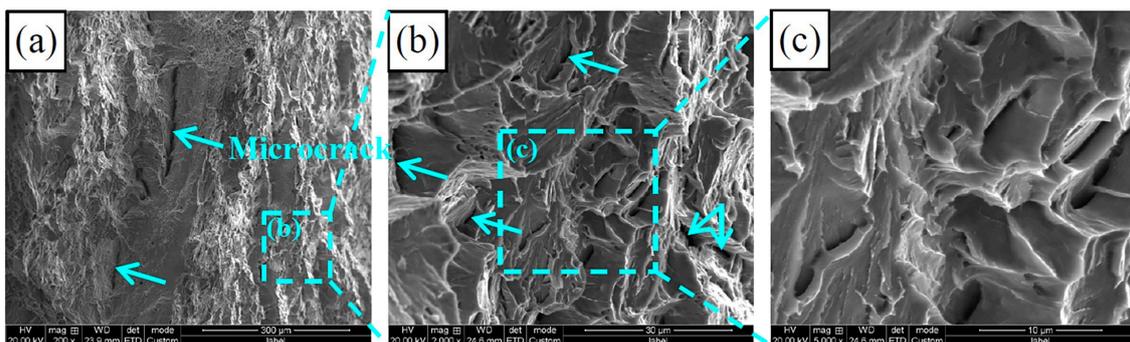
**Figure 10.** Micrograph of position 5 in DWTT fracture of ultra-high-strength pipeline steel at 0 °C. Figures (a–c) show different magnifications at position 5, respectively.

At position 5, the river pattern accompanied by micro-cracks (marked by sky-blue arrows) was observed, which is a typical brittle-fracture feature, as shown in Figure 10. However, position 5 has already reached the hammering zone and is therefore not included in the measurement range.

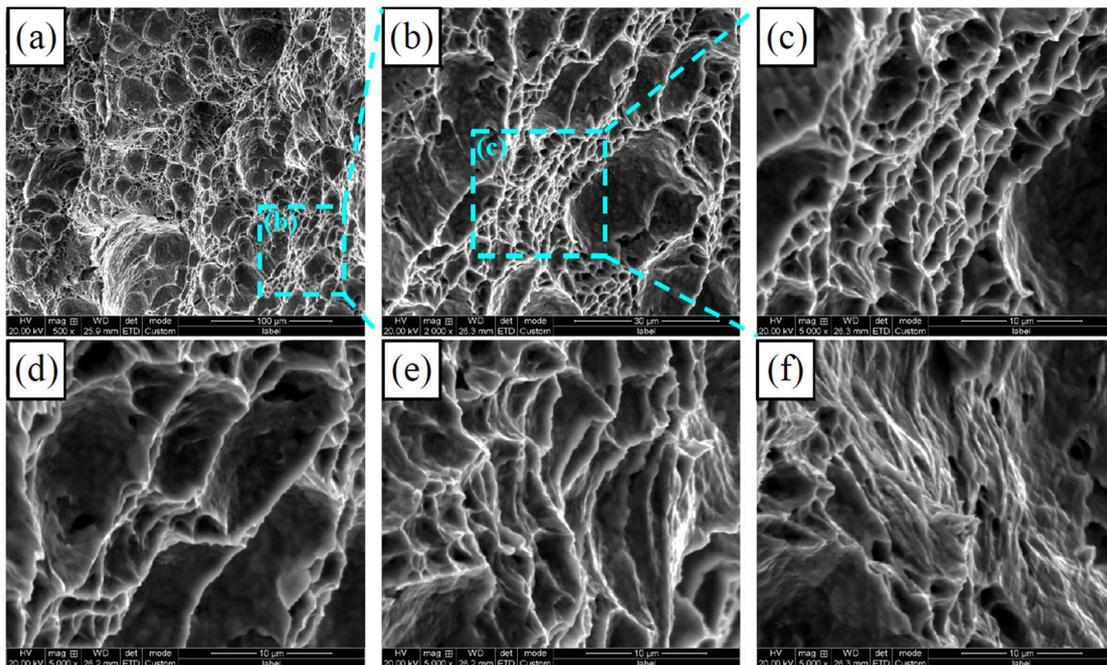
**Figure 11.** Micrograph of position 6 in DWTT fracture of ultra-high-strength pipeline steel at 0 °C. Figures (a–f) show different regions at position 6, respectively.

Figure 11 shows the microstructure morphology at position 6 of the hammering zone at different magnifications. Similarly to position 4, although the fracture morphology in Figure 8a is characterized by brittle fracturing at the macroscopic level, it still consists of ductile-fracture morphology at the microscopic level, as shown in Figure 11a–c. However, some of the dimples had significant plastic deformation (Figure 11d,e), or even had no dimple appearance at all (Figure 11f).

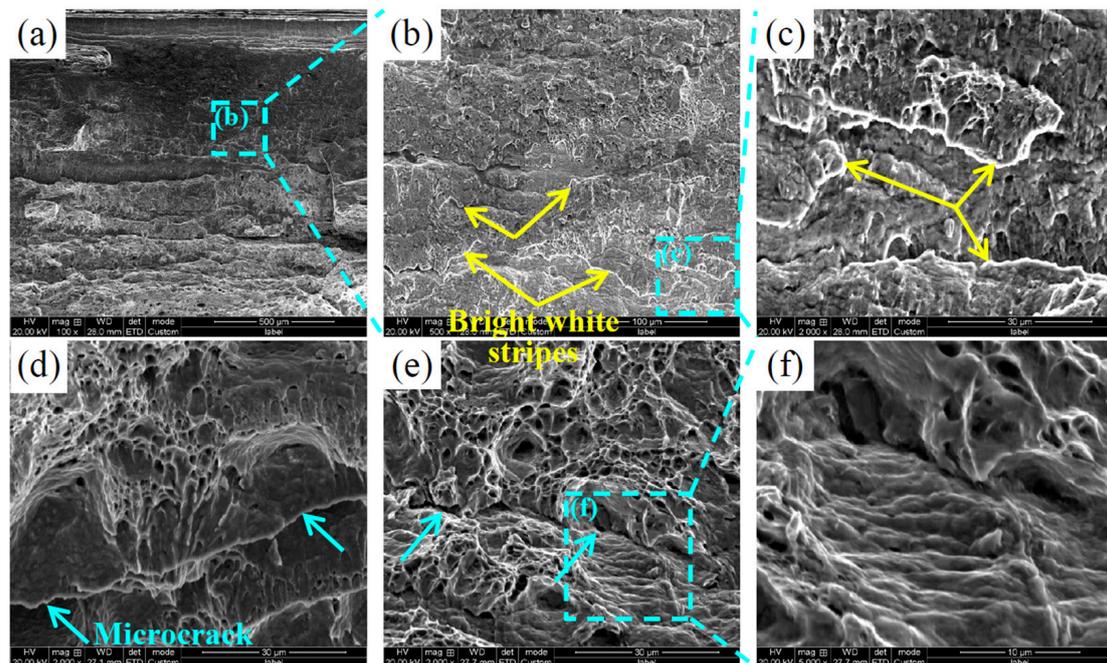
**Figure 12.** Micrograph of position 1 in DWTT fracture of ultra-high-strength pipeline steel at −20 °C. Figures (a–f) show different regions at position 1, respectively.

Figure 12 shows the microstructure morphology of position 1 in the brittle fracture zone of a DWTT fracture of ultra-high-strength pipeline steel at  $-20$  °C. At low magnification, the fracture was extremely flat (Figure 12a,b), with bright white stripes on the surface (marked by yellow arrows in Figure 12b,c), accompanied by numerous microcracks (marked by blue arrows in Figure 12d,e). The overall morphology was characterized by brittle fracturing, but it differed from the river pattern in a typical cleavage fracture. In addition, an irregularly arranged step shape was observed around the crack, as shown in Figure 12f.

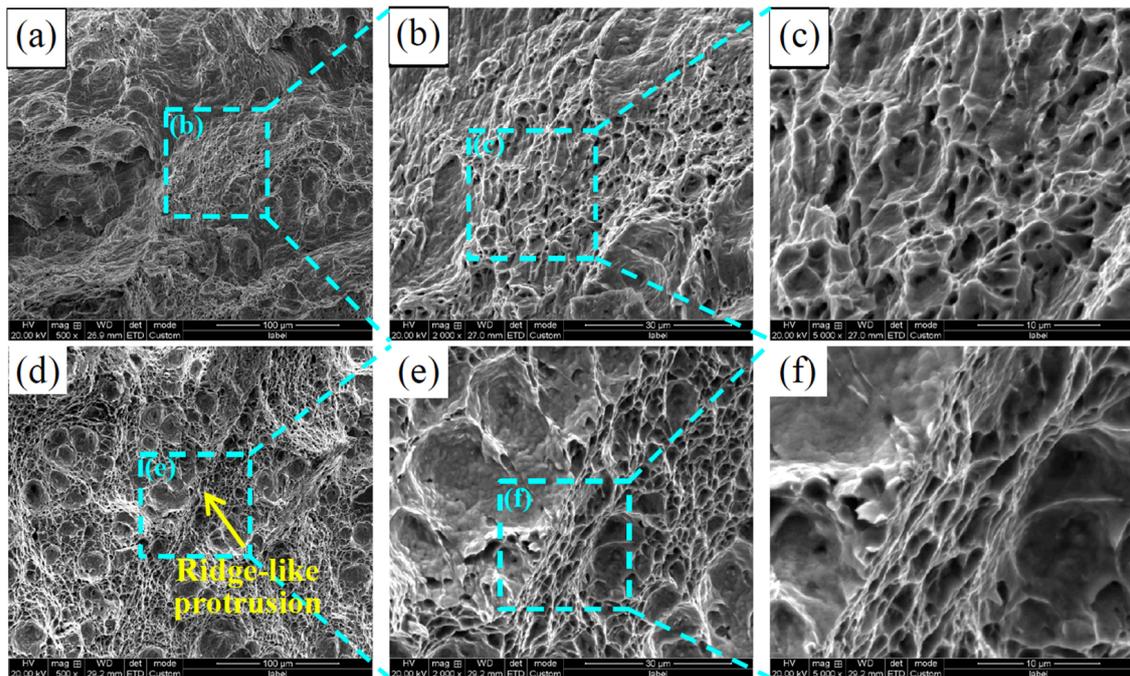
**Figure 13.** Micrograph of position 2 in DWTT fracture of ultra-high-strength pipeline steel at  $-20\text{ }^{\circ}\text{C}$ . Figures (a–f) show different regions and magnifications at position 2, respectively.

Figure 13 shows the microscopic morphology of position 2. At low magnification, the surface of the fracture is uneven (Figure 13a), and after local magnification, it shows a typical deformed dimple appearance (Figure 13b). Some of the dimples are shallow and small, with irregular morphology (Figure 13c). In some areas, a “ridge” shape consisting of a large number of distorted and elongated small dimples can also be observed (Figure 13e,f), which indicates that large plastic deformation and large energy consumption were experienced during the fracture process.

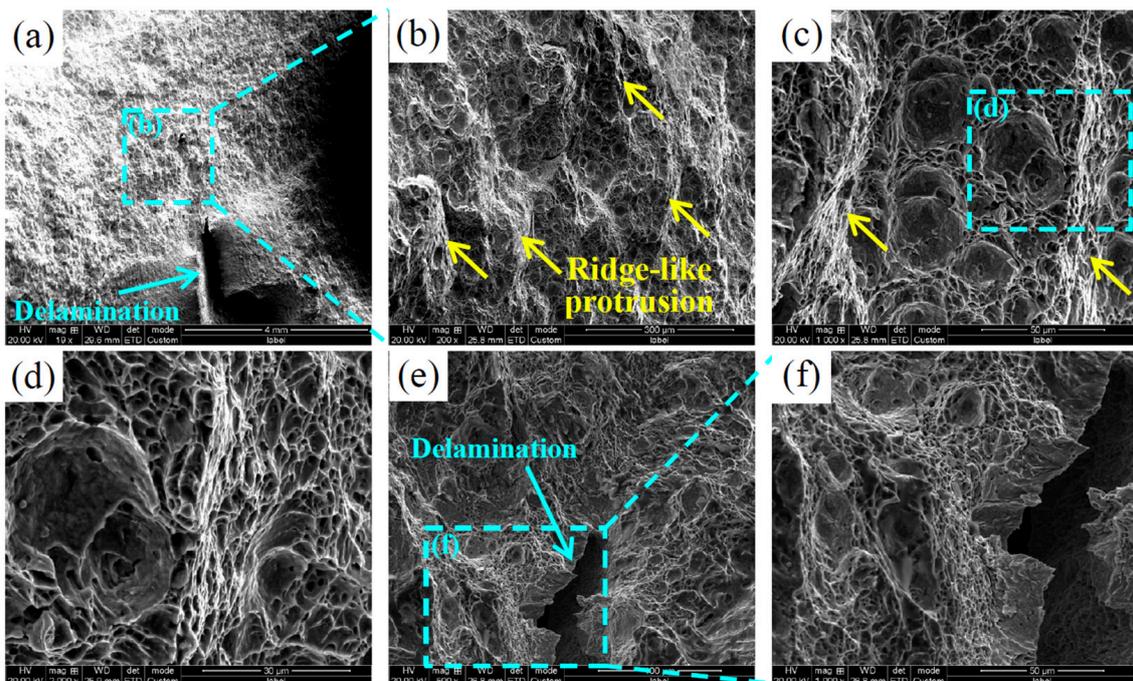
**Figure 14.** Micrograph of position 3 in DWTT fracture of ultra-high-strength pipeline steel at  $-20\text{ }^{\circ}\text{C}$ . Figures (a–f) show different regions at position 3, respectively.

Figure 14 shows the microscopic morphology of position 3 in the ductile fracture zone of a DWTT fracture at  $-20\text{ }^{\circ}\text{C}$ . As can be seen from the macroscopic morphology of Figure 5b, delamination defects appeared at this position. More “ridge”-like structures similar to those in Figure 13 could be observed above the delamination defects, as shown in Figure 14a–d. The cracks of the delamination defects are surrounded by a large number of small dimples, as can be seen from the sides of the delamination defects in Figure 14e,f.

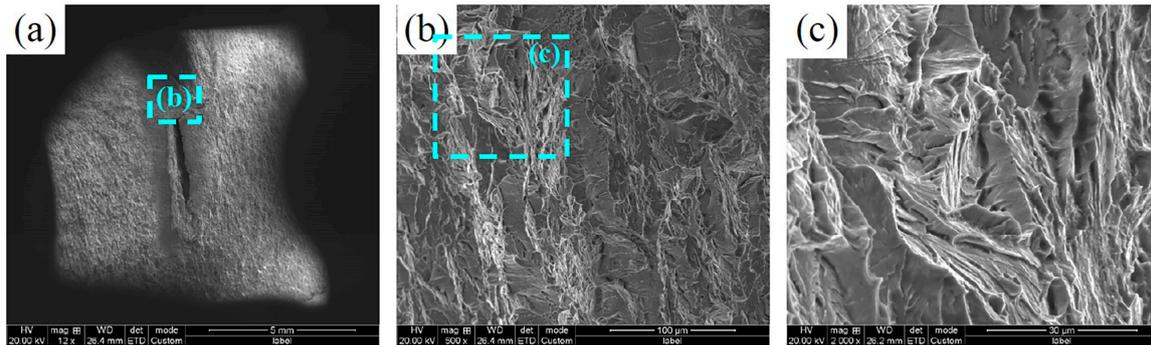
**Figure 15.** Micrograph of position 4 in DWTT fracture of ultra-high-strength pipeline steel at  $-20\text{ }^{\circ}\text{C}$ . Figures (a–c) show different magnifications at position 4, respectively.

Figures 15 and 16 show the microstructures of position 4 and 5 in the DWTT fracture ductile fracture zone of X100 ultra-high-strength pipeline steel at  $-20\text{ }^{\circ}\text{C}$ , respectively. As can be seen in Figure 15, the micromorphology at position 4 shows typical brittle cleavage-fracture features, including cleavage steps and river patterns. This indicates that local embrittlement occurred at the front end of the delamination defect. At position 5 under delamination defects, although a large number of edges parallel to the fracture direction can be observed at low magnification (Figure 16a), as at position 3, the entire section at high magnification shows deformed dimple morphology (Figure 16b,c), that is, it is still a ductile fracture. According to the results in Figures 14–16, the occurrence of delamination defects was independent of the fracture pattern.

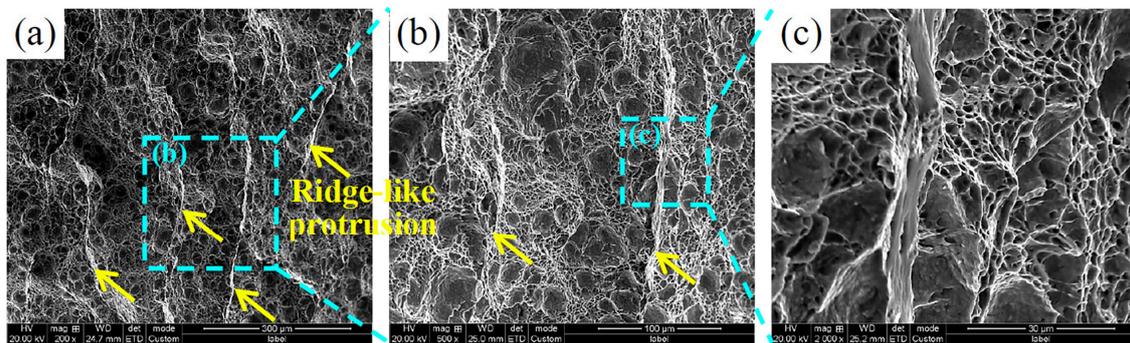
**Figure 16.** Micrograph of position 5 in DWTT fracture of ultra-high-strength pipeline steel at  $-20\text{ }^{\circ}\text{C}$ . Figures (a–c) show different magnifications at position 5, respectively.

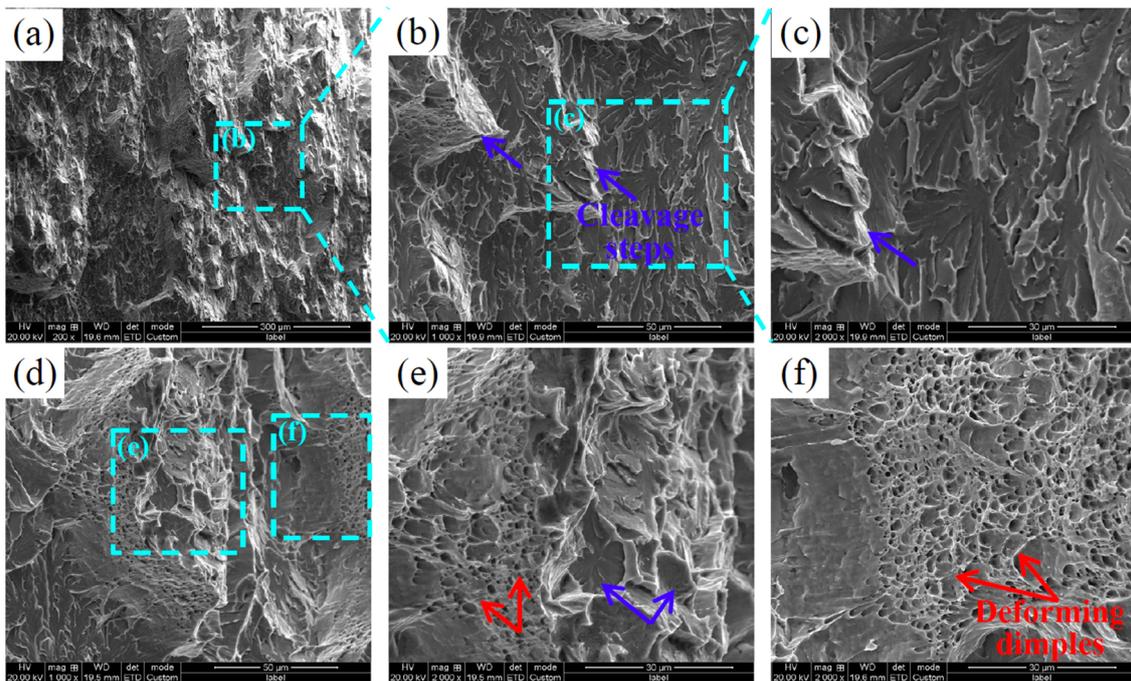
**Figure 17.** Micrograph of position 6 in DWTT fracture of ultra-high-strength pipeline steel at  $-20\text{ }^{\circ}\text{C}$ . Figures (a–f) show different regions at position 6, respectively.

The micromorphology of ultra-high-strength pipeline steel at positions 6 to 8 within the brittle fracture zone of a DWTT fracture at  $-20\text{ }^{\circ}\text{C}$  is shown in Figures 17–19, and the micromorphology at different positions in this region is all brittle fracturing. In general, cleavage fracturing is not carried out on a single cleavage plane, but along a set of parallel crystal faces, with cleavage planes at different heights connected by cleavage steps [41]. The blue arrows in Figure 17b,c mark the large cleavage steps, while the trend of the river pattern shows the direction of crack propagation. A large number of deforming dimples (marked by the red arrow) can be observed around the cleavage plane (marked by the blue arrow) in Figure 17e, indicating that the overall fracture pattern is a quasi-cleavage fracture. Position 7 is radial in the macroscopic morphology of Figure 5b and remains as a cleavage fracture in the microscopic morphology of Figure 18. There are a number of secondary microcracks marked by sky-blue arrows along the propagation direction of the crack. In particular, a large number of small dimples were observed on the side of a large cleavage step, as shown in Figure 18e,f, indicating that local plastic deformation also occurred during the brittle fracturing.

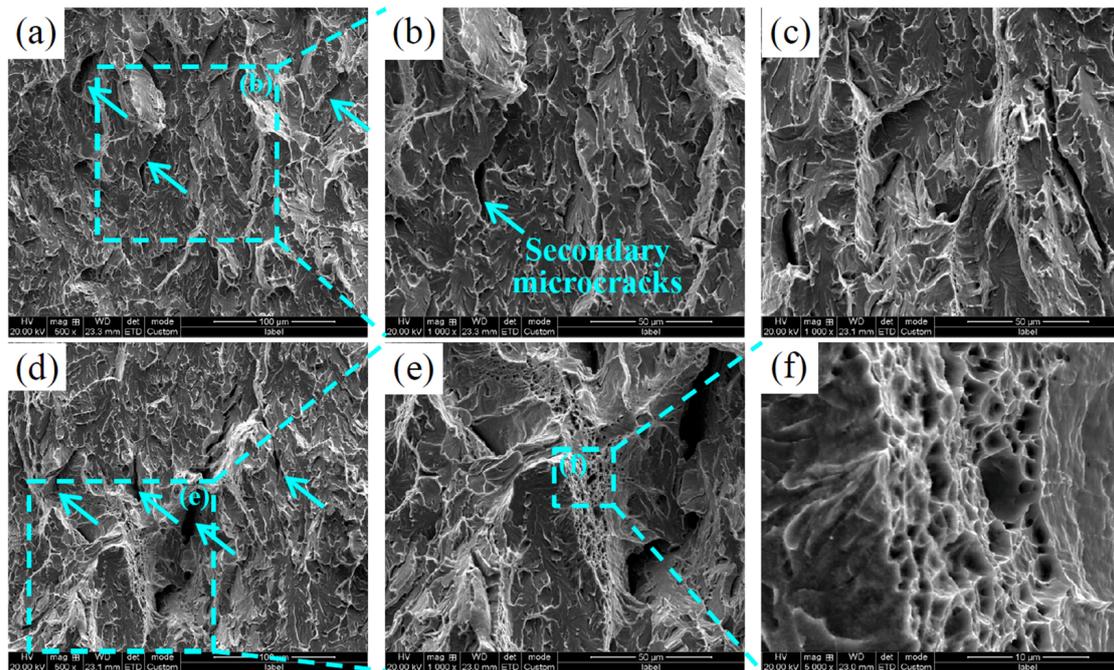
**Figure 18.** Micrograph of position 7 in DWTT fracture of ultra-high-strength pipeline steel at  $-20\text{ }^{\circ}\text{C}$ . Figures (a–f) show different regions at position 7, respectively.

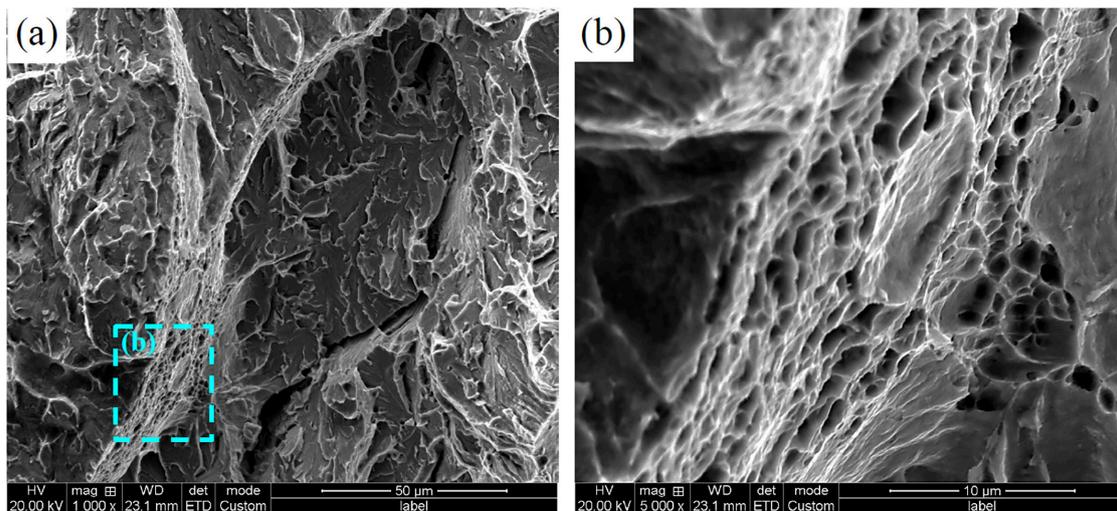
**Figure 19.** Micrograph of position 8 in DWTT fracture of ultra-high-strength pipeline steel at  $-20\text{ }^{\circ}\text{C}$ . Figures (a,b) show different magnifications at position 8, respectively.

At position 8, a large secondary crack forms along the junction of the cleavage steps, as shown in Figure 19. Similar to Figure 18f, one side of the large-size cleavage step has a large number of small dimples that are deformed and elongated. The study of L. Cho et al. [40] pointed out that the formation of ridge-like and large-size step-like microstructures is related to large-angle grain boundaries or lath boundaries, which has a significant hindering effect on the propagation of cracks.

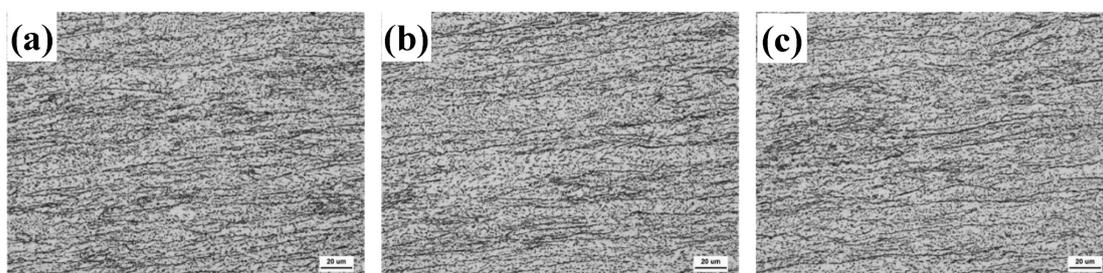
**Figure 20.** Metallograph of parent austenite grains of ultra-high-strength pipe steel in thickness direction: (a) side; (b) 1/4 position; (c) center.

Figure 20 shows the parent austenite grains of X100 ultra-high-strength pipe steel in the thickness direction, showing the flat austenite grain boundary morphology after TMCP. The average flat austenite height in the overall thickness direction is about  $9\text{ }\mu\text{m}$ . Relevant studies have pointed out that when the flattening height of austenite is less than  $9\text{ }\mu\text{m}$ , it can have excellent DWTT performance [9,41]. Thus, the complete flattening of the austenite during the controlled rolling process is one of the reasons for ensuring the toughness of the X100 ultra-high-strength pipe steel.

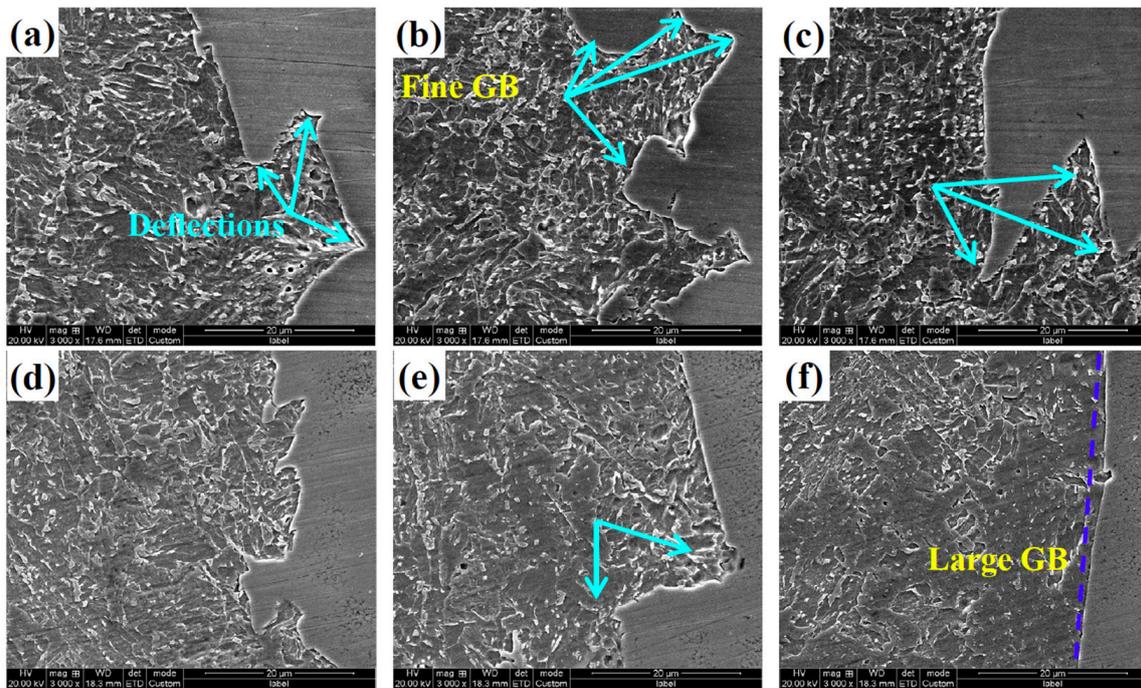
Figure 21 shows the CVN fracture section images of X100 ultra-high-strength pipeline steel at  $-80\text{ }^{\circ}\text{C}$  and  $-196\text{ }^{\circ}\text{C}$ . It can be seen that, when the crack propagation encounters

the fine-grained granular bainite, large deflections or frequent small turns will occur, which will consume more energy and improve the toughness. Clustered grains in a fine-grained granular bainite will disperse the high stress at the crack tip to the neighboring grains through coordinated deformation, so that the crack will deflect or even stop propagating. In contrast, when the crack propagation encounters a large-sized granular bainite, it will pass directly through it, that is, the large-sized granular bainite lacks an effective blocking effect on the crack and thus has a limited contribution to the toughness. Typical microstructure morphologies of the two granular bainites are shown in Figure 22.

**Figure 21.** Fracture section images of CVN specimen of ultra-high-strength pipeline steel: (a–c)  $-80\text{ }^{\circ}\text{C}$ ; (d–f)  $-196\text{ }^{\circ}\text{C}$ .

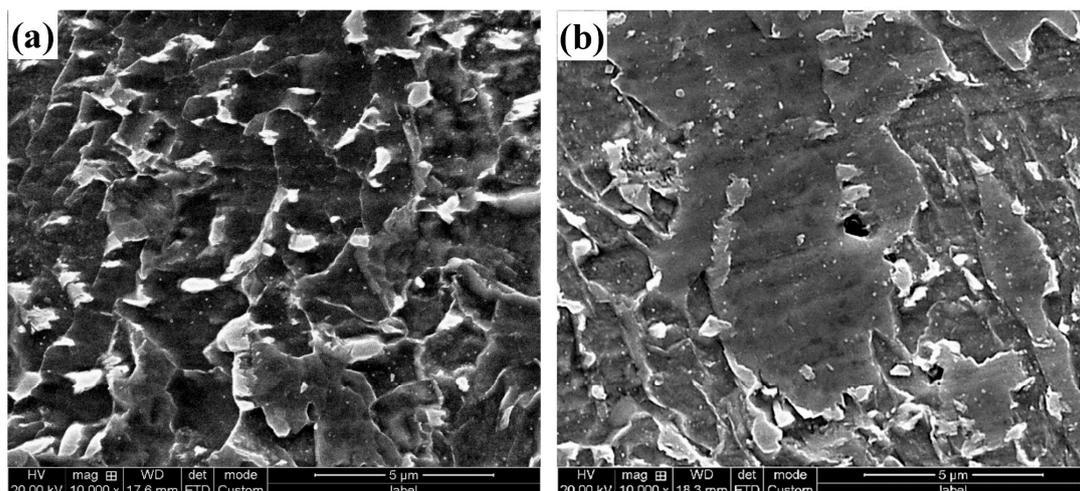
**Figure 22.** Fracture section microstructures of CVN specimen of ultra-high-strength pipeline steel: (a) fine-grained granular bainite; (b) large-sized granular bainite.

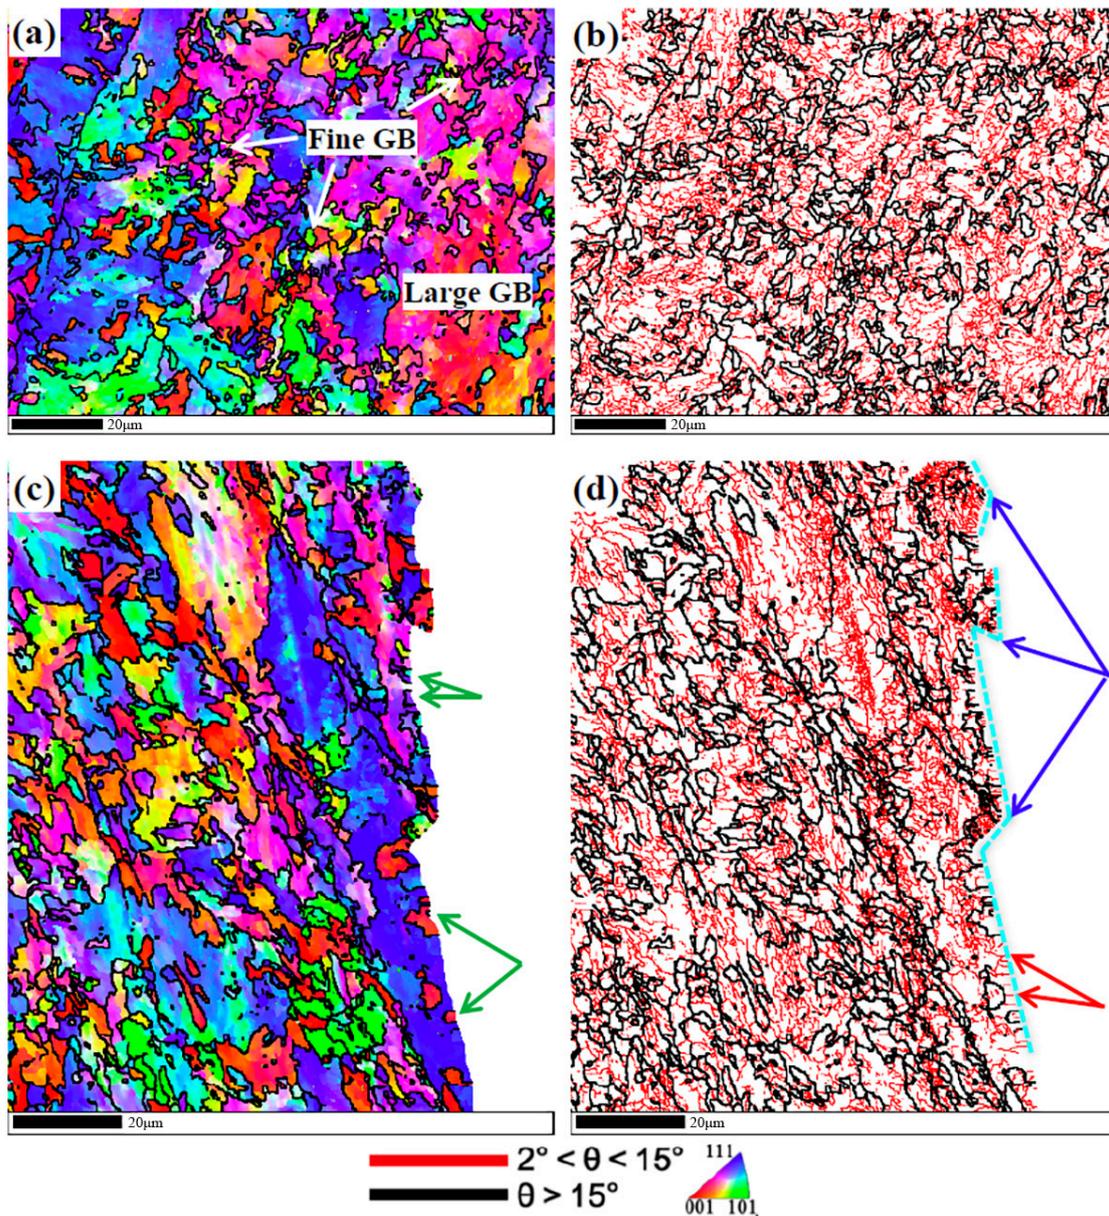
In order to further study the crack propagation process, EBSD pictures of the undeformed region of the fracture section (Figure 23a,b) and the cross-section of the crack propagation path (Figure 23c,d) are presented, respectively. It can be seen from Figure 23a,b

that the large-size granular bainite was composed of a large number of low-angle grain boundaries (LAGB, interfaces where the misorientation between adjacent grains is  $2^\circ$ – $15^\circ$ ). In contrast, the fine-grained bainite was surrounded by high angle grain boundaries (HAGB, the interface where the misorientation between adjacent grains is greater than  $15^\circ$ ), and the internal substructures were few and distributed in clusters. As can be seen from Figure 23c,d, when the crack encountered these small grains in the propagation process, it would have a large transition and change the direction of propagation (marked by dashed and broken lines in Figure 23d). However, when it encountered the large-sized granular bainite, it passed directly through, in agreement with SEM observations. Large-sized granular bainite, which is mainly composed of LAGBs, cannot effectively block crack propagation when it encounters a crack, which is not conducive to toughness enhancement, as indicated by the red arrows in Figure 23d.

**Figure 23.** EBSD images of fracture section at  $-196^\circ\text{C}$  conditions: (a,c) inverse pole figure; (b,d) grain boundary figure. Green arrows show that the HAGBs did not deflect the crack. Blue arrows show that high-density substructures proceeded large transitions. Red arrows show that LAGBs could not effectively block crack propagation.

It is commonly believed that HAGBs may inhibit crack propagation. However, it could also be found in Figure 23c that, although some of the small grains distributed separately were surrounded by HAGBs, they did not deflect the crack, as indicated by the green arrows. Relevant studies have shown that not all HAGBs have an obstruction effect on crack propagation, and only the interface with an angle of  $\geq 35^\circ$  between adjacent grain {100} cleavage planes in pipeline steel have an obvious obstruction effect on crack propagation [41]. In contrast, the clumping of fine grains will disperse the high stress at the crack tip to neighboring grains through coordinated deformation, thus deflecting or even preventing crack propagation.

In Figure 23d, high-density substructures can be observed to form inside some of the small grains at several locations where large transitions proceeded, marked by blue arrows, indicating that coordinated deformation occurred when the crack propagation encountered clusters of fine grains. Grain refinement can increase the density of boundaries with a higher special misorientation angle between {110}-planes, which is conducive to suppressing crack initiation [8]. The majority of the dislocations tend to pile along the {110} slip planes as dense dislocation walls to coordinate deformation. At low strains, grains are first divided into cell blocks that are nearly dislocation-free. At higher strains, dislocation tangled zones and lamellar boundaries develop [42]. The cell blocks, dislocation tangled zones and lamellar boundaries all belong to the substructures as marked by blue arrows in Figure 23d. Furthermore, combined with the morphological analysis of the brittle fracture, it can be seen that the large-size step morphology on the brittle zone of the fracture was most likely formed by the giant transition during the propagation of the crack.

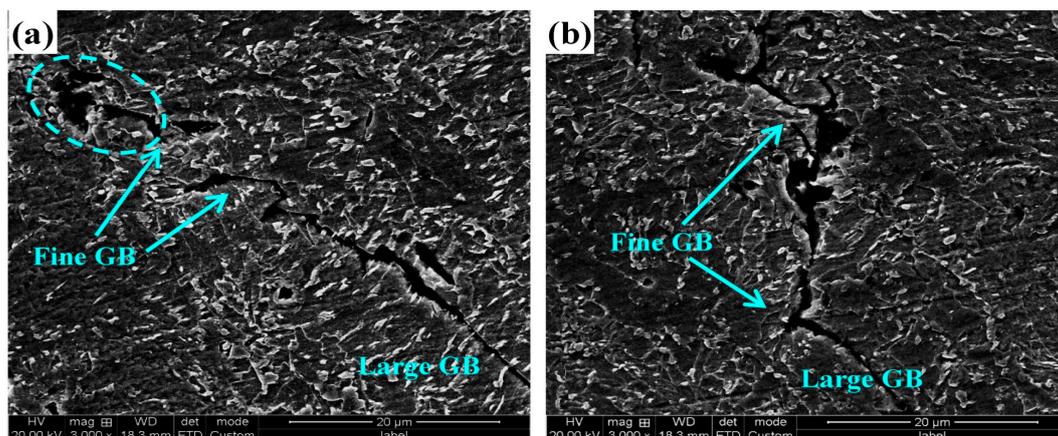
Figure 24 shows the morphology of secondary cracks in the brittle-fracture cross-section of X100 ultra-high-strength pipeline steel. It can be seen that the microstructure contained a large number of M/A constituents, which were mainly granular and striated. It could also be observed that some of the M/A constituents aggregated and led to crack formation, as shown by the dashed ellipse in Figure 24a. The M/A constituent belongs to the hard and brittle phase in the microstructure of pipeline steel and is generally surrounded by a stress field. If M/A constituents aggregate, the superposition of adjacent stress fields will produce stress concentration, and it is easy to crack and form micro-cracks in the process of deformation [43,44]. These cracks occur with a large deflection in the fine-grained granular bainite region, but pass directly through the large-sized granular bainite.

**Figure 24.** Microstructure of secondary cracks in fracture cross-section of CVN specimen at  $-196^\circ\text{C}$  conditions. Figures (a,b) show different regions at fracture cross-section.
