# Study on Fracture Behavior and Toughening Mechanisms of Ultra-High-Strength Pipeline Steel

**Abstract:** In this paper, a series of low-temperature CVN (Charpy V-notch impact test) and DWTT (drop-weight tear test) experiments were carried out to deal with the intensifying contradiction of strength and toughness of ultra-high-strength pipeline steel. The fracture behavior and toughening mechanisms of ultra-high-strength pipeline steel were investigated using scanning electron microscopy, transmission electron microscopy and backscattered electron diffraction systems. The results show that DWTT fractures in ultra-high-strength pipeline steel had a variety of unconventional morphological features compared to CVN fractures, including ridge protrusion in ductile fracture conditions and a large-size fracture platform in brittle fracture conditions. Therefore, DWTT fractures contained more information about the material fracturing process, and could better reflect the actual process of material fracturing. In ultra-high-strength pipeline steel, fine-grained granular bainite caused cracks to undergo large deflections or frequent small transitions, which consumed additional energy and im

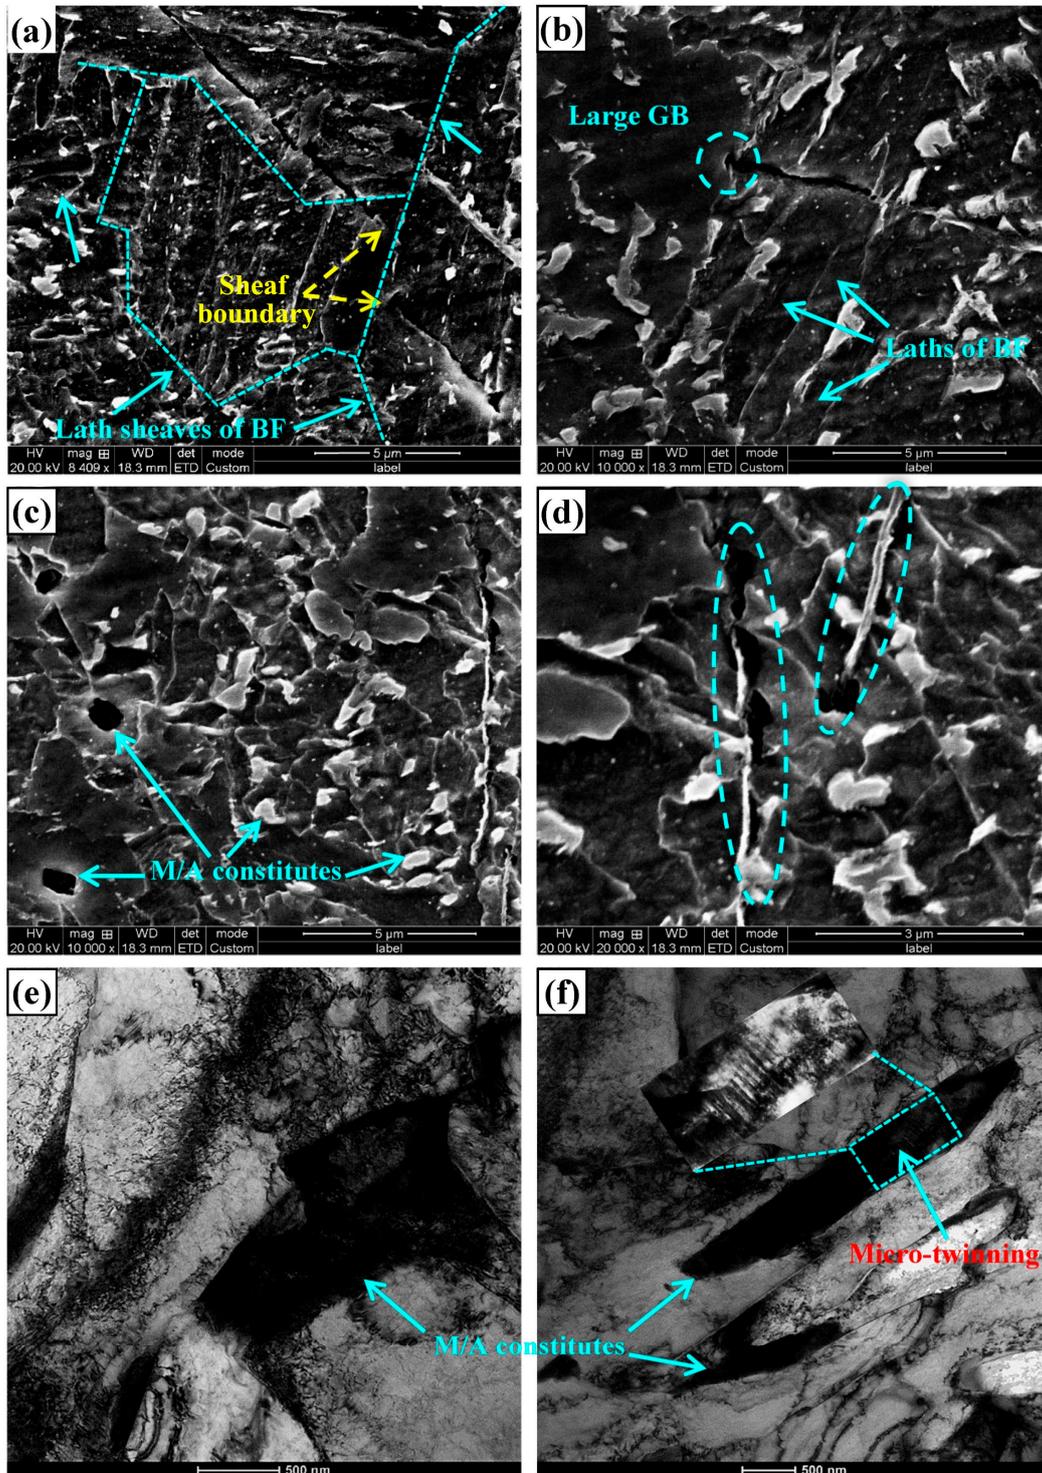
Figure 25 further shows a high-magnification picture of the secondary crack in the cross-section of the  $-196^\circ\text{C}$  impact fracture. When the crack propagation encountered bainite ferrite in ultra-high-strength steel, it could pass directly through the bainite lath,

but would deflect or stop at the sheaf boundary (indicated by the yellow dashed line in Figure 25a) or at the granular bainite grain boundary (indicated by the dashed ellipse in Figure 25b). In bainite ferrite, the interface of the lath is LAGB, so there is no blocking effect on the crack.

**Figure 25.** (a–d) High-magnification picture of secondary cracks in fracture cross-section of CVN specimen at  $-196\text{ }^{\circ}\text{C}$  conditions; (e,f) TEM image of typical M/A component in granular bainite.

As a hard and brittle phase in the microstructure, the M/A constituent would also fall off (marked by the sky-blue arrow in Figure 25c) or crack (marked by the dashed

ellipse in Figure 25d) during the deformation process, thus becoming the source of cracks. In particular, the strip M/A constituent is prone to micro-cracks and propagates cracks along itself. Figure 25e is a TEM image of a granular M/A constituent in granular bainite, which clearly shows the high density of dislocations inside and the entanglement of the dislocations caused by the surrounding stress field. The TEM image of the strip M/A constituent is then shown in Figure 25f, where micro-twins could be observed, which were twin martensitic transitions from the highly carbon-rich austenite, which had a higher hardness than the granular M/A in Figure 25e and was therefore more prone to micro-cracks.
