Article

Visual, Non-Destructive, and Destructive Investigations of Polyethylene Pipes with Inhomogeneous Carbon Black Distribution for Assessing Degradation of Structural Integrity

Citation: Kim, T.; Deveci, S.; Yang, I.; Stakenborghs, B.; Choi, S. Visual, Non-Destructive, and Destructive Investigations of Polyethylene Pipes with Inhomogeneous Carbon Black Distribution for Assessing Degradation of Structural Integrity. *Polymers* **2022**, *14*, 1067. <https://doi.org/10.3390/polym14051067>

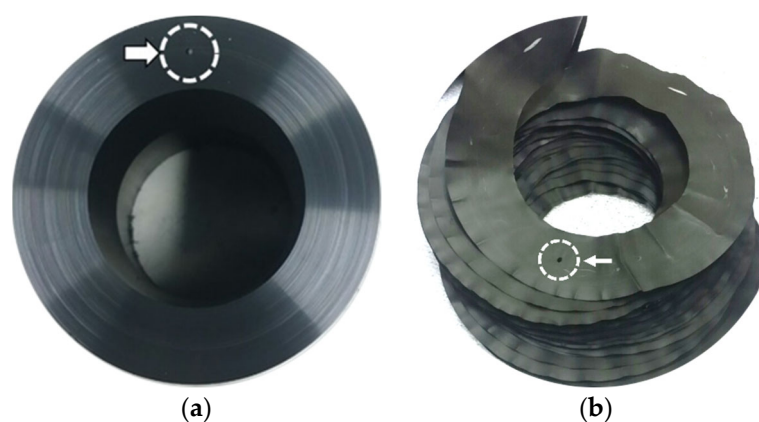
Figure 1. The 110 SDR 5 PE pipe, (a) 1 mm locator hole, (b) 50 µm thick whole pipe cross-section shavings.

Before cutting in the lathe, a 1 mm diameter hole was drilled into the pipe cross section as a locator hole (Figure 1a) for positioning the shavings in the proper orientation

(Figure 1b). In order to make the whole pipe cross-section shavings of various thicknesses, the pipe was turned in the lathe at a speed of 55 rpm with compressed air blowing at the cutting area. This condition minimized the twisting and coiling of the shavings being produced. The cutting speed in the pipe axial direction depended on the thickness of the shaving made.

For shavings greater than 50 μm , ironing at 120 $^{\circ}\text{C}$, removed twists and coils to flatten the whole pipe cross-section shavings (Figure 1b). It was noted that when the shaving thickness was less than 50 μm , the surface was no longer flat. Even after ironing, many local wrinkles appeared, which distorted the sample and made direct viewing of the windows difficult.

The visual observations of the windows were made by cutting enough shavings to reconstruct a whole pipe cross section (Figure 1b) and then placing the reconstruction under the transmitting white light, monochromatic light, and polarized lights for viewing. It was determined that a good resolution and contrast for viewing were offered by placing the shaving between two polarizer plates (ESM-647, Intech-optic, Goyangsi, Korea) in cross polarization. The monochromatic light was produced by a sodium vapor lamp (GEO-NH, GEOLighting, Anseong, Korea), and a white LED lamp (LED lamp, Cityo, Incheon, Korea) was used. A light diffuser plate was used for all observations.

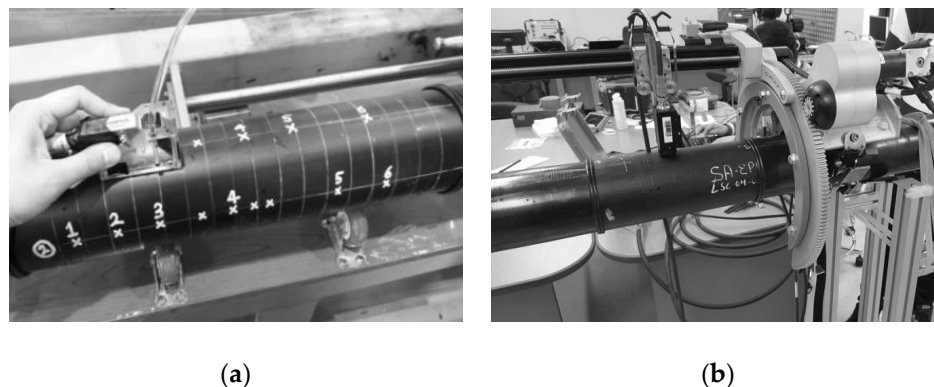
Figure 2. (a) PAUT and (b) MWI for non-destructive inspection of windows in pipes.

The inspection system for PAUT was an Olympus unit (OmniScan MX2, Tokyo, Japan), consisting of a detector, 2.25-MHz frequency, 32 active elements' transducer water wedge, encoder, and encoder jig, as shown in Figure 2a. Before the inspection, the pipes were marked with a white marker at regular 2 cm intervals along the inspection length considered. At first, the wedge and the transducer assembly were placed in close contact with the pipe surface, and the pipe was PAUT inspected along the circumferential direction by manually rotating the pipe. This procedure was repeated until the entire area of the pipe was examined. The beam was steered from 0° to $+85^{\circ}$ by sectorial scanning and focusing the beam at two-thirds of the pipe thickness. After

The microwave NDT apparatus used was a single frequency device that operates near 24 GHz (AMWI-SF24G-OW, Advanced Microwave Imaging, Baton Rouge, LA, USA). A microwave sensor consisted of a Gunn diode with a tuned cavity and two Schottky diodes placed in the exiting waveguide section. The microwave sensor was driven in an automated two-axis encoded device that ran axially and circumferentially around the pipe (Figure 2b). An open waveguide acted as the sensor antenna. The Schottky diodes generated a DC voltage in an alternating electric field that was roughly linear with the amplitude and phase of the alternating field. The voltages were recorded at locations along the pipe axial and circumferential scanning path. They were compiled into a viewing algorithm where the voltage variation was assigned a grayscale based on its magnitude, and a complete image of the pipe was created. Because of the very low losses in polyethylene material in the microwave frequency range, the sensor easily captured an image of the entire volume within the sensor aperture range. The open waveguide transmitted a signal that spread out from the aperture opening at a 45-degree angle from the aperture opening; so, the coverage area grew quickly as the beam penetrated the material depth. This ensured beam coverage to the entire pipe cross section; however, it hampered individual resolution of flaws deeper into the part.

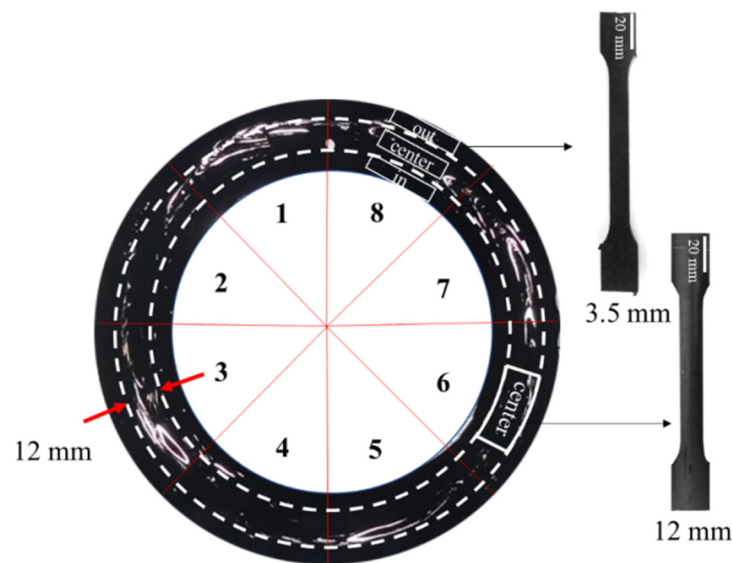
Figure 3. Eight sectors with known % windows where 12 mm thick tensile specimens were taken. The 3.5 mm thick specimen locations are also shown.

Tensile tests on windowed 110 SDR 5 PE pipes were performed using ISO 527-2 [36] Type 1A tensile specimens of 3.5 mm and 12 mm thickness, machined from each pipe sample. Since the windows were observed to reside approximately in the center of the 12 mm thickness portion of the pipe samples, 12 mm specimens were removed from the center of the pipe wall of every eight segmented pipe sectors, as shown in Figure 3. For these eight sectors selected, the % windows were all prior determined. On the other hand, 3.5 mm thick specimens were taken from the outer, central, and inner wall regions (Figure 3) and were used to estimate the change in properties through the pipe wall thickness.

The tensile specimens of 3.5 mm were made first by band-sawing the pipe into eight sectors. Then, a milling machine (Simplex-2, Hwacheon, Gwangju, Korea) was used to obtain the required thickness at their respective positions (Figure 3). The other dimensions were obtained using template machining with a cutter rotating at 3000 rpm. For the 12 mm specimens, the pipes were turned and bored in a lathe (Mecca Turn 400×750, Namsun, Gwangju, Korea) to remove the outer and inner layers until a 12 mm thickness was achieved. The same template machining was used for the final specimen dimensioning.

stress–strain behavior of all specimens from the inner and outer layers was not affected as these were from the pipe thickness free of windows (Figures 12a and 3). However, for specimens taken from the center pipe wall, fracture strains decreased in samples 3 and 4, and no decrease was observed in samples 1 and 2 (Figure 12b). The stress–strain behavior of 3.5 mm thick specimens confirmed the visual observations of the windows being positioned at the inner portion of the pipe wall for pipe samples 3 and 4. This was due to the higher shear stresses for CB mixing produced at the inner and outer walls of the pipe during pipe extrusion. On the other hand, the absence of fracture strain change for specimens from samples 1 and 2 indicated some minimum % windows are needed to cause a fracture strain decrease.

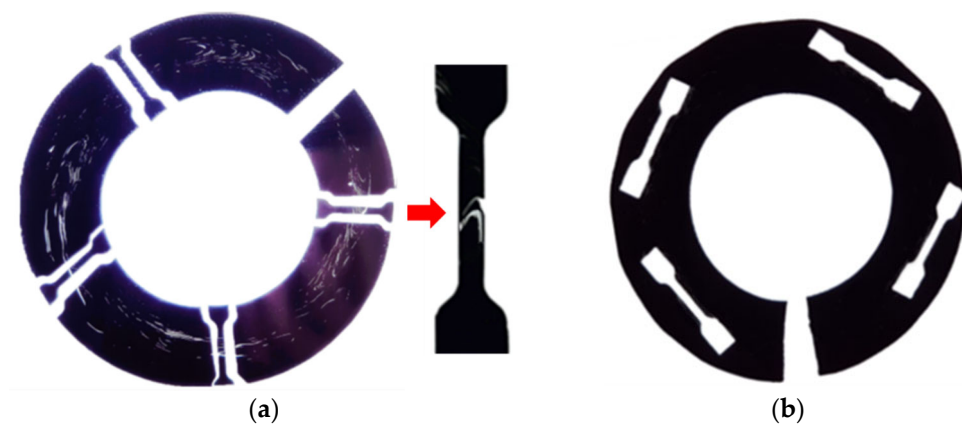
Figure 4. Sampling location of micro-tensile specimens. From (a) sample 4 and (b) sample 1.

Micro-tensile specimens of ISO 572-2 type 1A [36] on 100 µm thick shavings were made from pipe sample 4 and sample 1, and the photographs are shown in Figure 4. In sample 4, the specimens were punched out perpendicular to the pipe circumference at four high window swirl areas (Figure 4a) and in sample 1, from four positions, as shown in Figure 4b. The specimens were conditioned at 23 °C and 50% RH for at least 24 h prior to the tensile test. Tensile tests were carried out using pneumatic grips on a 500-N load cell at a 100 mm/min cross-head speed (AGS-5, Shimadzu, Kyoto, Japan). No extensometer was used.

To further understand how fractures initiate in a static tensile test with windows present, a tensile test was performed on micro-tensile specimens produced from the shavings of samples 1 (windows free) and 4 (high windows). The micro-tensile specimens from sample 4 were taken at four locations along the pipe circumference where intense window swirls were present, as shown in Figure 4. Tensile test results are exhibited in Figure 20. Distinct regions of initial displacement to tensile yield load (onset necking), neck formation, cold drawing, and orientation hardening prior to fracture for sample 1 can be observed. For sample 4, all tensile specimens failed during the early part of cold drawing and did not reach orientation hardening displacement. This is consistent with what was observed for the thicker tensile specimens made from samples 1 and 4 (Figure 13). The fracture mechanism can be inferred by observing the frame-by-frame photos of the tensile test, as given in Figure 21. The window swirl underwent uniform deformation up to yield (a); the neck formed and the cold drawing began (b); the cold drawing reached the window swirl (c); the cold drawing included windows and continued without any disturbance to the main window (d); further cold drawing caused a tear crack to initiate at the secondary window swirl below (e); the tear propagated (f) until a final failure occurred (g). The tear crack seemed to initiate at the boundary between the secondary window swirl and the black compound region between the main and secondary window swirls (e). Deveci and coworkers [23] also reported the boundary crack initiation in tensile testing of a 15 μm thick microtomed film containing windows. They attributed this to the higher CB concentration at the window–black compound boundary due to the interfacial free energy difference.

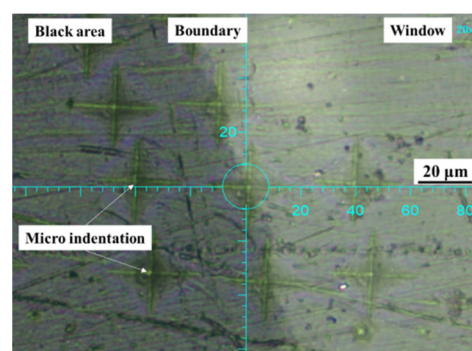
Figure 5. Micro-indentations on black compound, window, and along the boundary.

A micro-indentation test was carried out on a 100 μm shaving using a PICODENTOR HM500 (Helmut Fisher, Sindelfingen, Germany) with a 136° plane angle Vickers indenter that utilized the load-indentation depth method in accordance with ISO 14577-2 [40]. First, a shaving with windows was pressed against the glass slide using a rubber roller to obtain a good physical bond between the two. Once the indentation location was identified (Figure 5), a pre-selected load of 30 mN on a Vickers indenter was applied to the shaving for 6 s for the press-in followed by 5 s of indentation hold time. The load was then removed from the shaving at the same speed as the indenter press-in. A total cycle time of 17 s was used to obtain a load-depth profile from which various mechanical properties were computed using the methods in ISO 14577-1 [41]. Measurements included Martens hardness (HM), indentation hardness (HIT), and modulus of indentation (EIT). Figure 5 shows the micro-indentation positions on the window, the boundary, and the black compound.

To possibly confirm the effect of CB concentration on tear initiation, micro-indentations were made at various locations at specific distances away from the window–black compound boundary, as shown in Figure 5. The micro-indentation results are shown in Figure 22. The Martens hardness (HM) and indentation modulus (EIT) both increased, moving into the black compound area, reaching a maximum value at 100 μm from the boundary, and then began to slightly decrease to a lower value deeper in the black area (200 μm). On the other hand, the lower values were approximately maintained into the windows area. This confirmed that the presence of CB particles increased the hardness and modules of PE [31]. However, with only about a 7% higher indentation modulus of the black compound (1.5 GPa) compared to the window (1.4 GPa), the shear stress developed at the boundary was unlikely to be high enough to cause ductile tear initiation at the boundary. Further studies are needed to determine the mechanism of tear initiation at the window–black compound boundary.

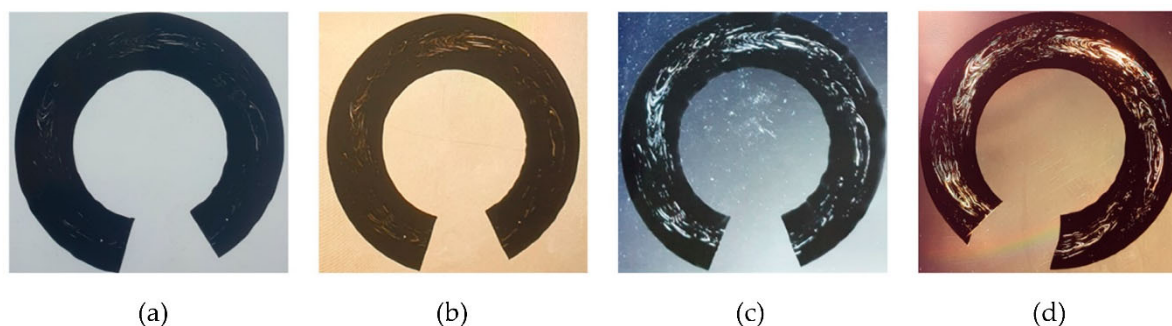
Figure 6. The 100- μm shaving viewed under: (a) white, (b) monochromatic, (c) cross-polarized white, and (d) cross-polarized monochromatic lights.

The characteristic in-flow patterns of windows in whole pipe cross-section shavings were observed under the transmitted white light (Figure 6a), monochromatic light (Figure 6b), cross-polarized white (Figure 6c), and monochromatic (Figure 6d) lights. The windows were best observed with a monochromatic cross-polarized light, followed by

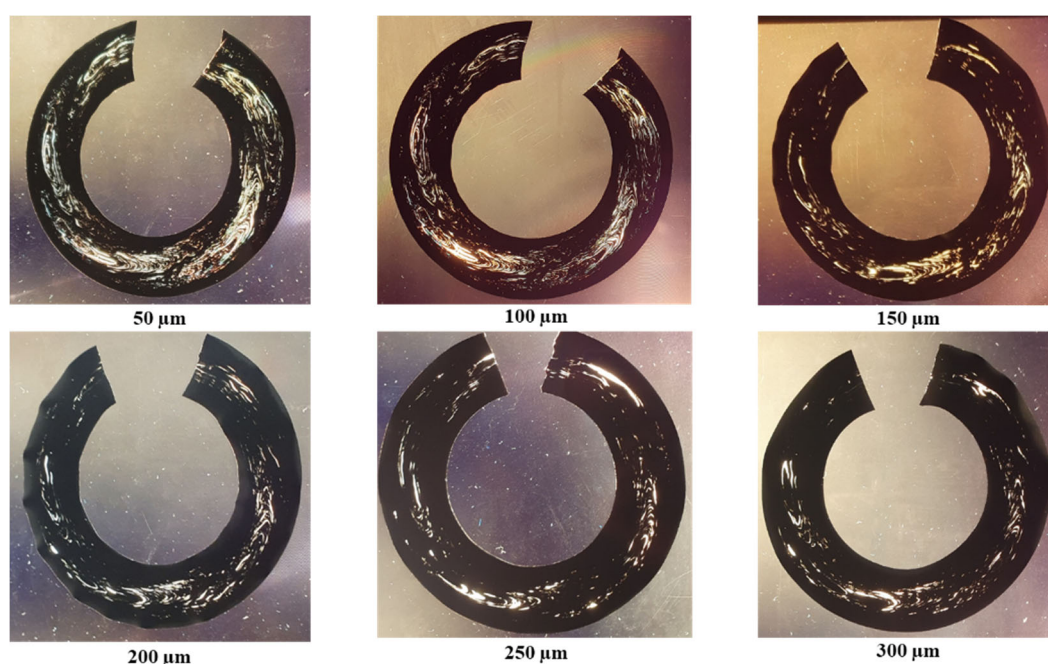
Figure 7. Windows' observation of the whole pipe cross sections in shavings of different thicknesses under cross-polarized monochromatic light.

cross-polarized white light. The shavings of sample 4 viewed under a cross-polarized monochromatic light are shown in Figure 7. The shaving thickness varied from 50 μm to 300 μm , and a higher area fraction of windows (% windows) appeared in the thinner shavings, as shown. Furthermore, at shaving thicknesses above 150 μm , some of the features of the original windows observed at thinner shaving thicknesses disappeared in polarized light. Therefore, in terms of making whole pipe shavings from the pipe, a good visual observation of the windows, ease of handling, and testing shavings, a 100 μm thickness was found to be the most suitable for use.

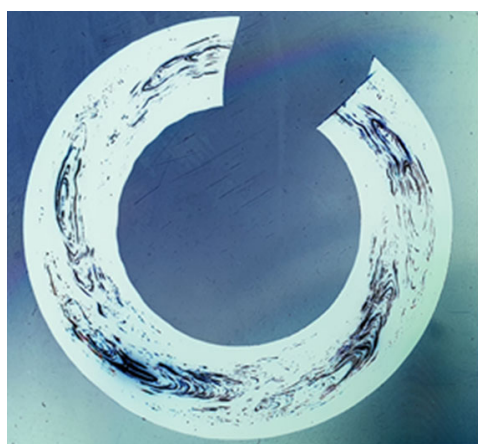
Figure 8. Color-inverted image of sample 4 (100- μ m shaving in Figure 7).

Figure 8 shows a color-inverted image of a shaving. Although the observed window details were similar, using both original and color-inverted images can complement each other to improve the viewing of the details of the windows' patterns.

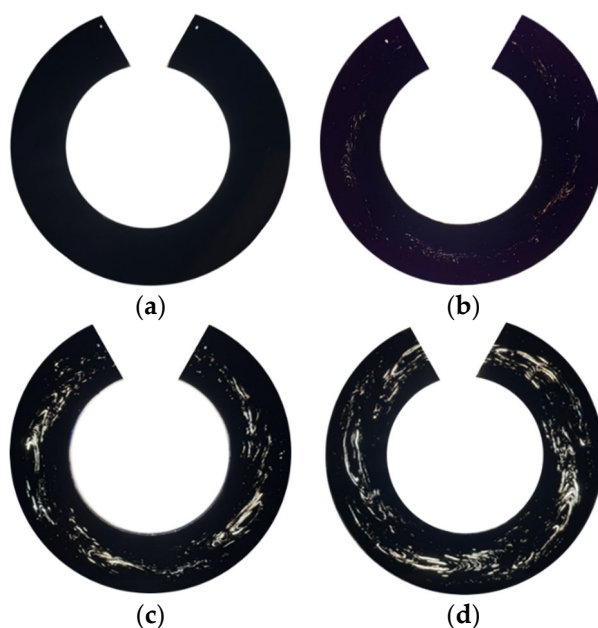
Figure 9. Whole pipe cross-section shavings under cross-polarized monochromatic light. (a) Sample 1, (b) sample 2, (c) sample 3, and (d) sample 4.

The 100 μ m thick shavings of the whole pipe cross section for all pipe samples are shown in Figure 9. In sample 1, no windows appeared as it was made windows-free, whereas highly directional window swirls in the in-flow direction were evident in the shavings from samples 2 to 4. The intensity of the window swirls diminished with decreasing levels of windows in the shavings; they all appeared to be grouped into four distinct swirls' patterns (Figure 9b–d). The formation of such characteristic swirls' patterns of windows was due to using a four-channel spiral die during pipe extrusion in a single screw extruder.

Figure 11 shows the resulting C-scan images from the PAUT inspection for sample 1 (Figure 11a), sample 2 (Figure 11c), sample 3 (Figure 11e), and sample 4 (Figure 11g) pipes. The horizontal axis of the C-scan image represents the full pipe circumference, and the vertical axis represents the inspection area in the axial direction of the sectorial scan. It can be seen that the amplitude of the reflected ultrasonic signals varied according to the level of windows present; thus, its distribution could be determined. What appeared to be columns of particulate indications in samples 2 to 4 was correlated to the window swirl clusters observed in the shavings, as shown in Figure 9. No PAUT indication of windows was found in sample 1 (windows free, Figures 9a and 11a).

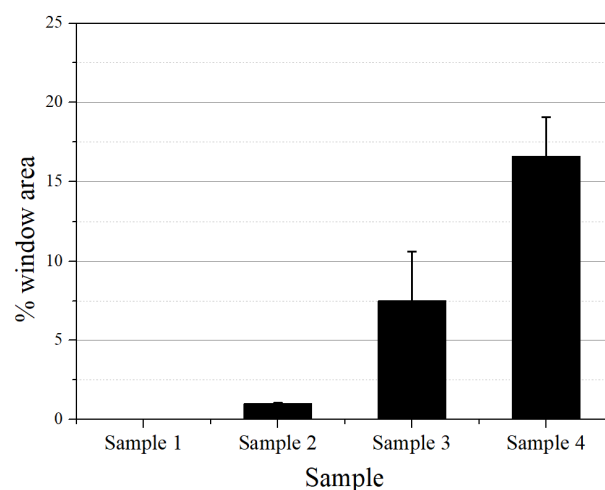
Figure 10. The % windows determined by the grayscale pixel count on 100 μm whole pipe cross-section shavings under monochromatic cross-polarized light.

The % windows of shavings determined using the monochromatic cross-polarized light are shown in Figure 10. The mean % windows were found to be 0%, 1.5%, 7.5%, and 16.5%, for samples 1, 2, 3, and 4, respectively.

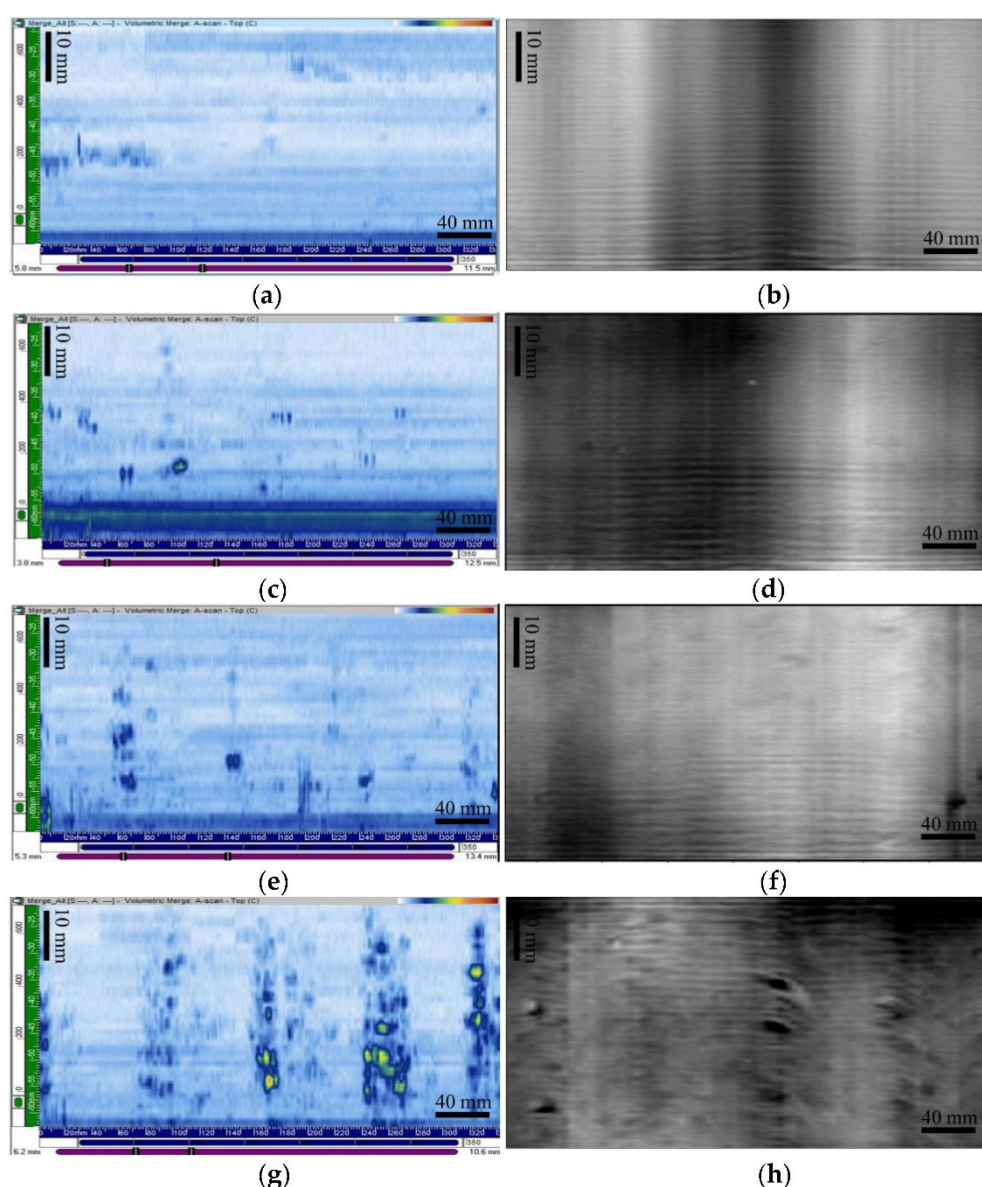
Figure 11. C-scan PAUT (left) and MW (right) images. (a,b) Sample 1, (c,d) sample 2, (e,f) sample 3, and (g,h) sample 4. In both the PAUT and MWI images, the horizontal axis is the pipe circumference from 0 to 360 degrees, and the vertical axis is an axial length of approximately 50 mm.

Similarly, window indications in the form of particulate column images were also displayed with MWI NDT (Figure 11b,d,f,h). The window indications increased going from samples 2 to 4. As with PAUT, no MWI indications of the window were found in sample 1 (Figure 11b). Both the PAUT and MWI indications showed windows clusters in the direction of the pipe axis. These NDT images can be further sectioned into known areas, and the number and size of windows present in the image can be counted and binned by their relative sizes. This would allow the level of windows to be quantitatively compared and the ranking determined by actual numbers rather than a simple visual comparison. Both approaches have merits and could be reviewed further in the future as the need arises. Therefore, PAUT and MWI are viable NDT methods for windows detection in polyethylene pipes.

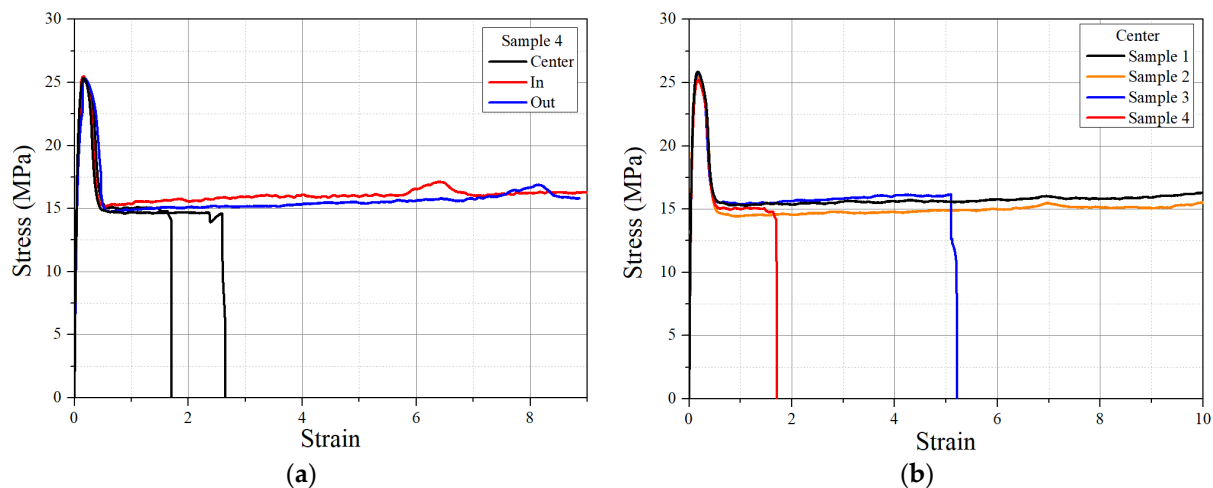
Figure 12. Stress–strain curves of (a) 3.5 mm-thick specimens taken from the inner, mid, and outer walls of sample 4 and (b) specimens from the center wall of all pipe samples.

Engineering tensile stress–strain curves from 3.5 mm thick specimens are illustrated in Figure 12. Tensile yield stress of about 25 MPa was indicated for all specimens independent of the position they were removed from. Additionally, as expected, the

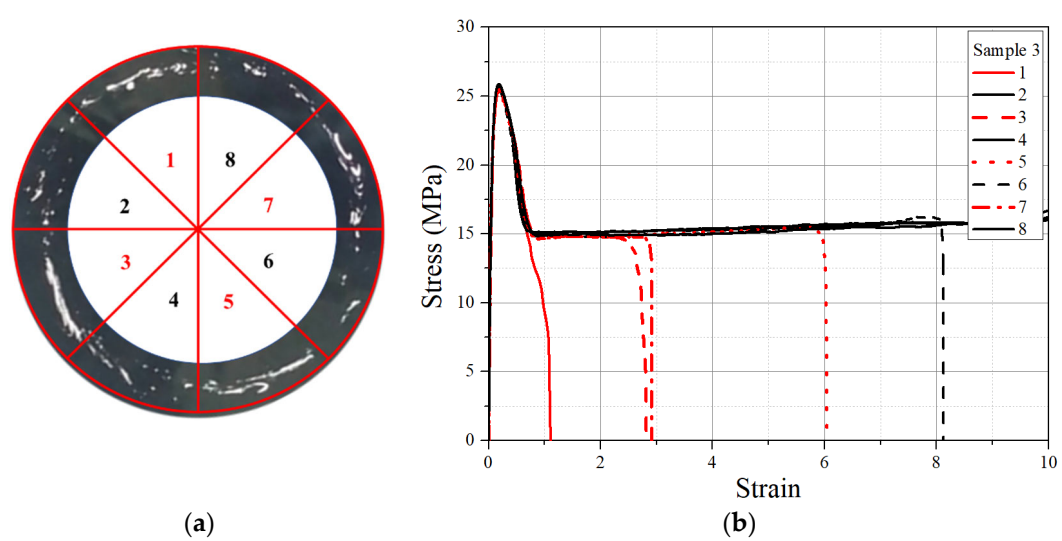
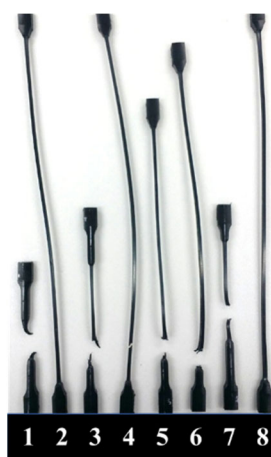
Figure 14. The 12 mm thick tensile specimens from pipe sample 3. (a) The eight sector locations, (b) tensile stress–strain curve of each specimen, and (c) tested specimen.

In order to see the effect of % windows on the stress–strain behavior of the pipe samples, the tensile results from the 12 mm thick specimens were considered. The stress–strain behaviors of 12 mm thick tensile specimens made at eight locations in the cross section with known % windows are shown in Figures 13, 14 and 15 for pipe samples 4, 3, and 2, respectively. In pipe sample 4, the fracture strain was drastically reduced for all specimens, as seen from the stress–strain graph and the actual failed samples. Tensile specimens 1, 3, 5, and 7 from pipe sample 4 were obtained from high-intensity window swirl locations (Figure 13a), and all showed higher fracture strain reduction (Figure 13b,c). Additionally, as expected, specimens 2, 4, 6, and 8 exhibited less reduction (Figure 13b,c), as they represented specimens from the lower % windows' portion of the pipe cross section (Figure 13a). A fracture strain reduction pattern was also observed in tensile specimens 1, 3, 5, and 7 and 2, 4, 6, and 8 from pipe sample 3, as shown in Figure 14. For specimens from pipe sample 2, as with pipe sample 1 (windows free), no position dependence of the fracture strain was found, as seen in Figure 15. A single specimen from pipe sample 2 had a premature failure before reaching the maximum strain value, and this was due to the presence of voids, as shown in Figure 15b.

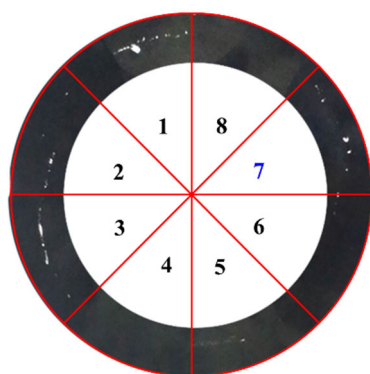
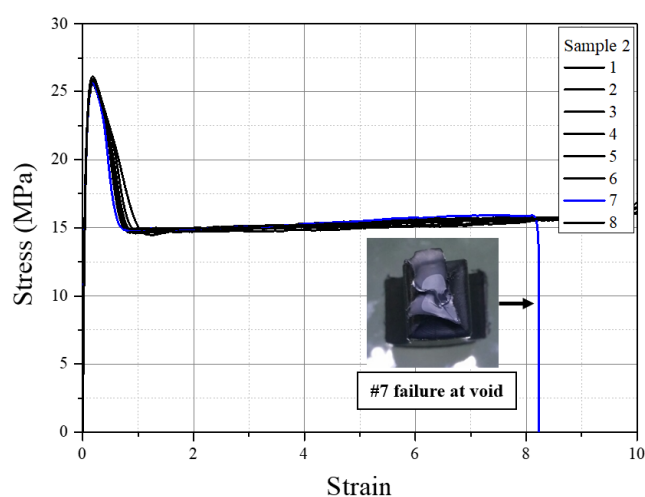
Figure 15. The 12 mm thick tensile specimens from pipe sample 2. (a) The eight sector locations, and (b) tensile stress–strain curve of each specimen.

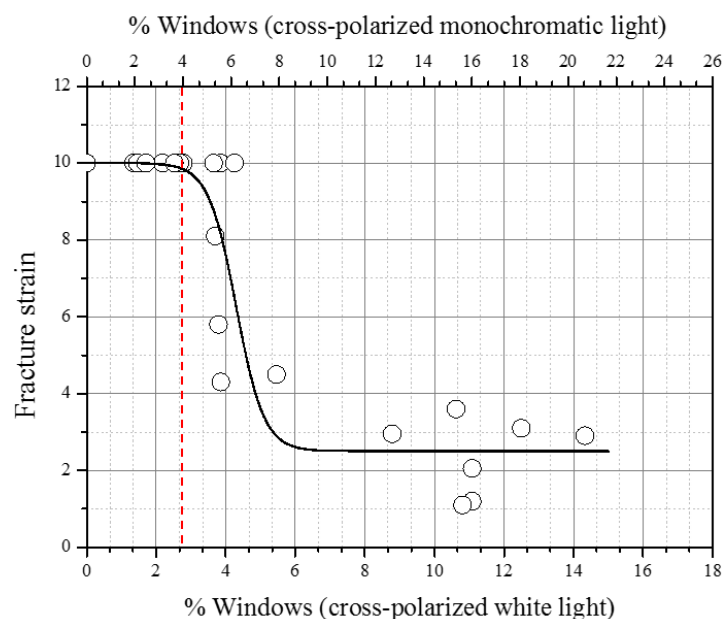
Figure 16. Fracture strain versus % windows of specimens from all sectors.

Figure 16 illustrates the correlation between the % windows determined at each of the eight sectors and the corresponding specimen fracture strains for all pipe samples. The fracture strain was seen to undergo no decrease until about 2.5% windows; then, a rapid decrease to about 250% limiting strain value occurred. From this behavior, one can estimate the limiting % windows at which the integrity of the tensile specimen can be maintained. It is noted that different lighting conditions used to determine the % windows can provide different results. For example, the limiting fracture strain of 2.5% determined with a white cross-polarized light became about 4.0% when a monochromatic cross-polarized light was used (Figure 16). Hence, the type of lighting and the shaving thickness used need to be mentioned when determining the % windows present.

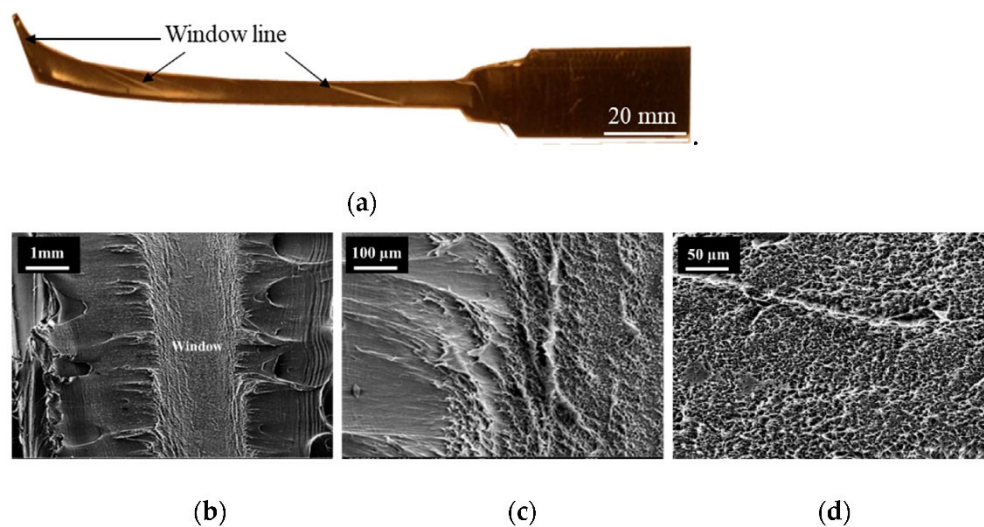
Figure 17. (a) Twisted window line along the cold drawn length of the tensile specimen and fracture surface morphology at (b) $\times 40$, (c) $\times 200$, and (d) $\times 500$.

Figure 17 shows the fracture surface of a tensile specimen taken from pipe sample 4. In the cold drawn region of the tensile tested specimen (Figure 17a), windows in the form of a twisted line can be observed along the length of the specimen up to the point of fracture (see the arrows). The fracture surface examined is shown in Figure 17b–d. At lower magnifications ($\times 40$ and $\times 200$), the fracture surface was seen to contain a region of flatter fracture sided by tearing from gross yielding. A further examination of the flat fracture at higher magnification ($\times 500$) showed a short, fibrillated surface, indicating micro-ductility in the windows. In contrast, the yielding tear adjacent to the fibrillated surface indicated shear yielding failure in the black compound area.

Therefore, it was clear that the windows' fracture produced a fibrillated fracture surface, whereas the black compound failed via a gross yielding tear. Hence, the cause for the reduction in the global fracture strain can be attributed to the presence of windows.

It is noted that the window fractures exhibited different fracture morphology comparing the tensile tested specimen (Figure 17) to the pipe specimen that underwent slow crack growth before the rapid crack propagation failure (Figure 18). The fracture morphology difference was likely due partly to the different loading and specimen geometries between the two cases. Nevertheless, these two examples clearly indicated that the presence of windows was a contributing factor leading to the premature failure of PE pipes.

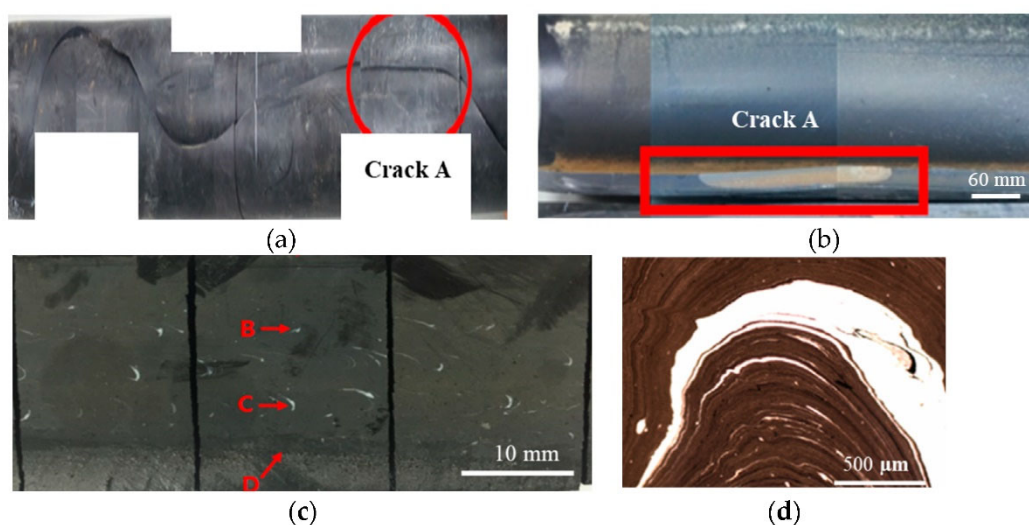
Figure 18. (a) Rapid crack propagation failure, (b) fracture surface at "crack A" indicating slow crack growth, (c) "crack A" fracture surface containing windows, and (d) windows swirls.

In support of this, Figure 18a shows a rapid crack propagation (RCP) failed 315 SDR 11 black HDPE water pipe and the slow crack growth preceding RCP failure (Figure 18b). The windows are clearly visible on the slow crack surface toward the mid-pipe wall (Figure 18c). They were further confirmed by the white swirls observed in the 15 μm thick film microtomed from the windowed area (Figure 18d). Figure 19 shows photomicrographs of the windowed area B (Figure 18c), seen under a scanning electron microscope (SEM). The windows exhibited a flat, brittle fracture surface. In contrast, the typical micro-ductility fibril morphology of the fracture surface was apparent in the black compound area, indicating that slow crack growth had occurred. Hence, the flat, brittle fracture of the local windows is thought to provide a path for premature failure.

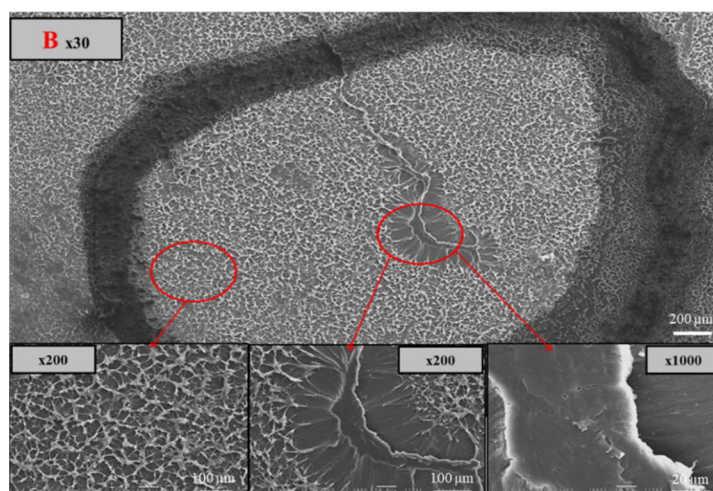
Figure 19. SEM photomicrographs of the fracture surface of the window and black compound regions (region B in Figure 18c).

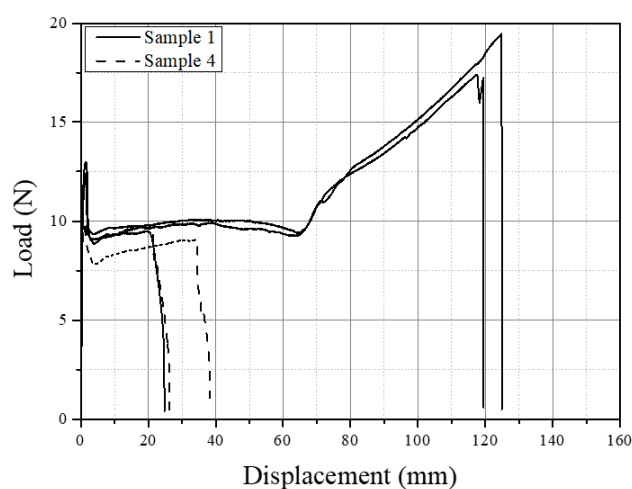
Figure 20. Load–displacement curves of tensile-tested 100 μm thick shaving from samples 1 and 4.

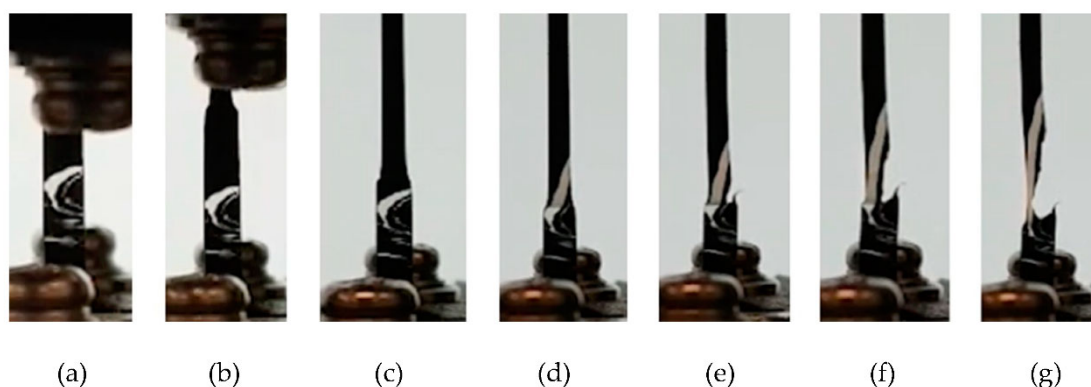
Figure 21. Frame-by-frame photographs showing the progression of windows' deformation to tear fracture.

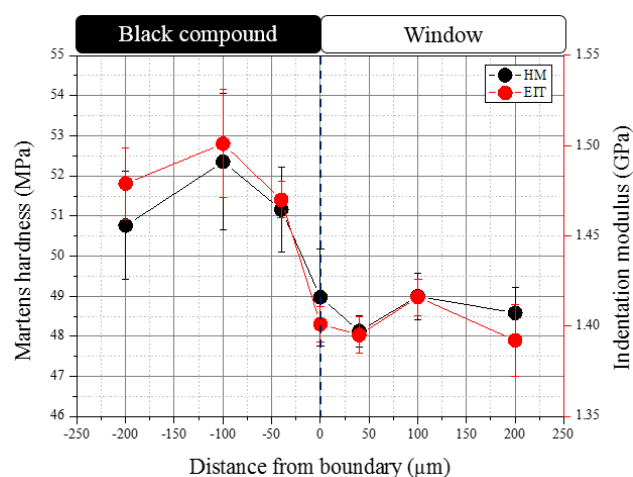
Figure 22. Variation of HM and EIT with distance from the windows–black compound boundary.
