Article

Precise Judgment of Reverse Fault-Induced Water Inrush Hazard under Influence of Roof Goaf Water

With that in mind, the 15,103 working face of Wenzhuang Coal Mine were taken as a typical example in this paper, the height of the FWCZ in overburden strata was judged in this paper through engineering analogy methods, e.g., drilling fluid leakage method and drilling television method, the method of numerical simulation analysis was then used to study overlying strata failure height after mining of 15,103 working face through F6 reverse fault from the hanging wall to the footwall, providing a theoretical support for the prevention of goaf water disaster and to protect the ecological environment around the Wenzhuang Coal Mine. The research results can provide reference for the safe mining of passing through reverse faults under the influence of roof goaf water.

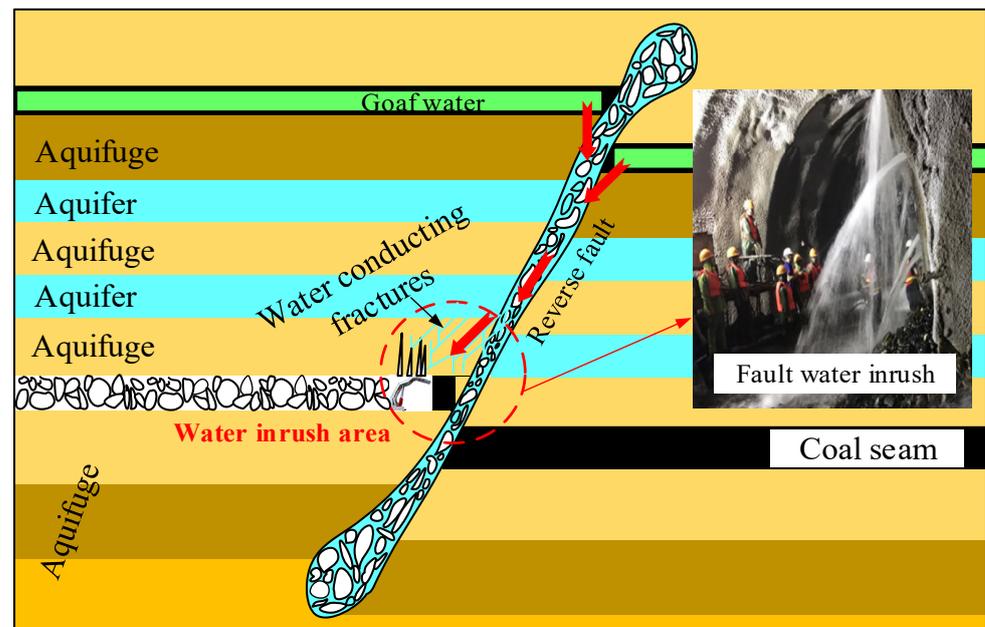
Figure 1. Description about fault water inrush in mining.

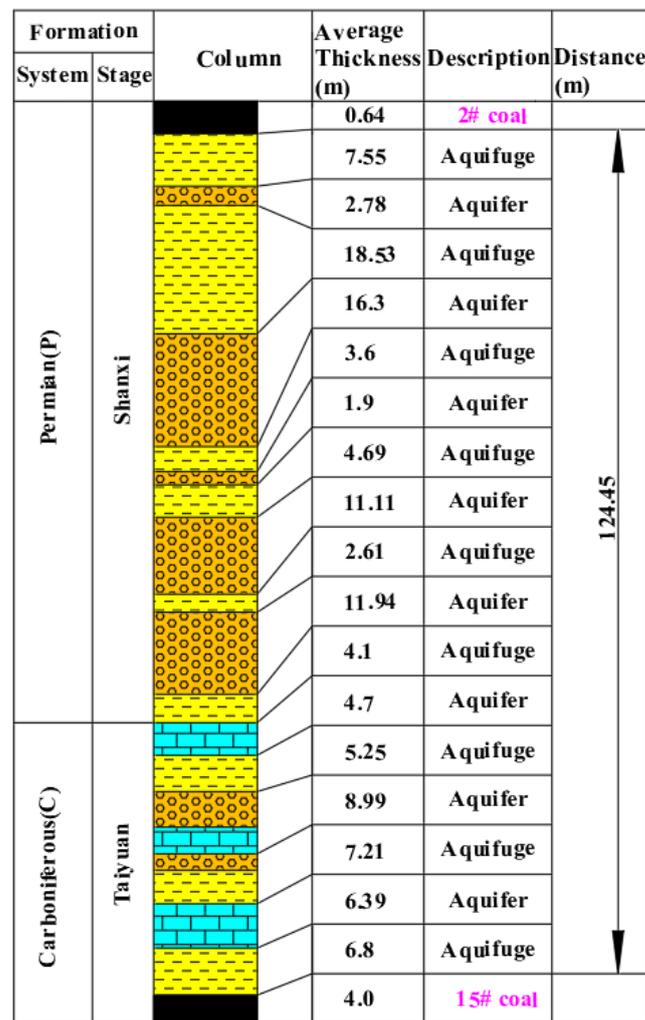
Figure 3. Composite column between No. 2 and 15 coal seams.

The Wenzhuang Coal Mine is situated in Wuxiang County, Shanxi Province, China, with a mining area of 9.94 km², which is subordinate to Shanxi Lu'an Mining Group Co., Ltd. (Figure 2). The method of strike longwall retreating full-mechanized mining was adopted. No. 2 Coal seam was located in the middle strata of Shanxi formation, the coal thickness was 0 to 1.59 m, with an average of 0.64 m, and the coal seam floor was mostly mudstone, sandy mudstone and fine sandstone. No. 15 Coal seam was located in the middle and upper part of the first section of Taiyuan formation, and the coal thickness was 3.08 to 4.91 m, with an average of 4.0 m, the coal seam roof was mainly composed of sandy mudstone, mudstone and siltstone. The aquifers between No. 2 and 15 coal seams were sandstone fractured aquifers of Shanxi formation with the characteristics of poor supply conditions and weak water yield, and limestone karst fractured aquifer of Taiyuan formation with the characteristic of weak water yield. There were stable aquifers dominated by argillaceous rocks between the aquifers, which can play a good role of interval water (Figure 3).

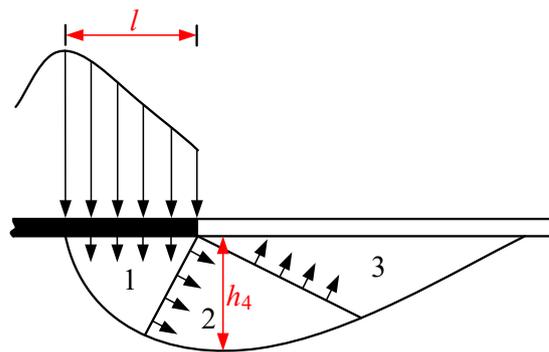
Figure 4. Area of floor failure zone due to support pressure [33].

The FFD caused by mining can generally be determined using the calculation method of foundation in soil mechanics. According to the plasticity theory, the limited equilibrium area in the foundation is divided into three zones, namely active stress zone, transition zone and passive stress zone (the numeric symbols, 1, 2 and 3 in Figure 4), respectively. The following calculation formula can be obtained [33]:

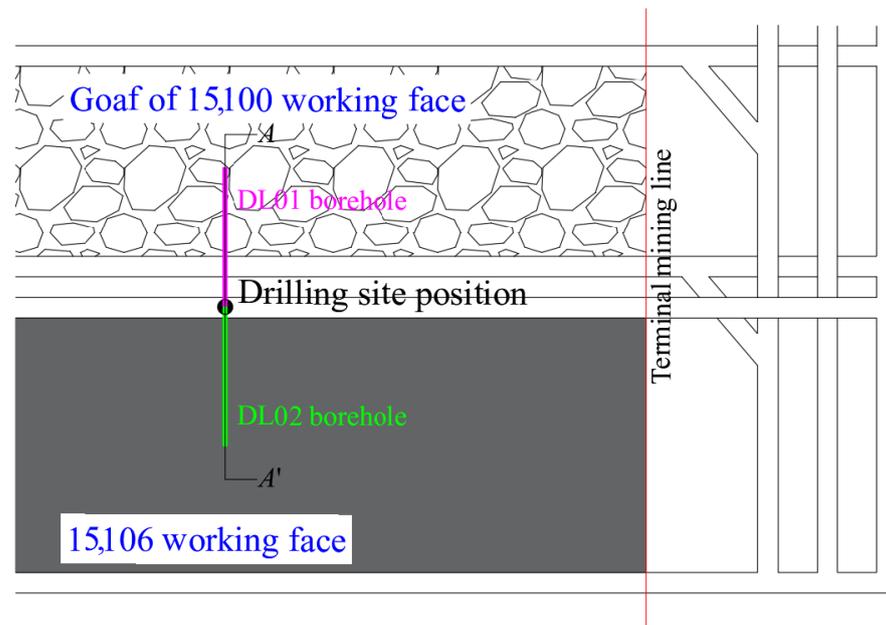
Figure 5. Plan of the drilling site position.

To increase the contrast between the boreholes, opening position of the two boreholes all arranged in ventilation roadway 770 m away from terminal mining line in working face 15,106. Among them, DL01 and DL02 boreholes were observation and comparison boreholes, respectively. The location of the drilling site and parameters is shown in Figure 5 and listed in Table 2, respectively. The lithology and hydrological conditions of each drill pipe passing through was recorded in detail in the process of drilling, and the whole drilling hole was sketched.

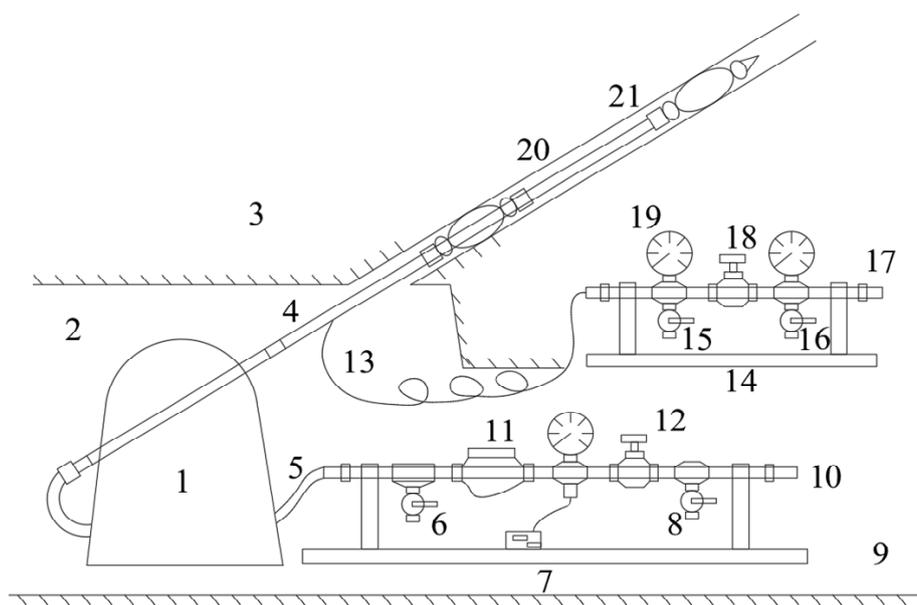
| 1 — Drilling rig | 8 — Pressure regulating valve | 14 — Console for plugging |

A self-designed double-head water-stopped machine was used to monitor the water injection leakage of boreholes before and after mining, and determined the distribution of fractures in each rock stratum after mining. The system was mainly composed of test probe, drilling rig, pressure hose, observation platform, etc. The simplified diagram of observation equipment is shown in Figure 6.

The observation process is described as follows: (1) All parts of the equipment were assembled before observation to ensure that all interfaces were well sealed, and the water-plugging device was then pushed to the observation position through the drilling rig. (2) During observation, injected water into the capsule to make the sealing pressure reached 1.8 MPa and completed the plugging of the drilling section, then water was injected into the drill pipe to keep the injection pressure at 1.2 MPa. If the water injection flow and leakage reached a dynamic balance, the water injection volume in unit minute was measured through the flow meter, that is, the leakage. (3) After observation, the drain valve of capsule was opened to unload the pressure, water in the hole section was then discharged with the contraction of the capsule. (4) The above steps were repeated until the observation was achieved.

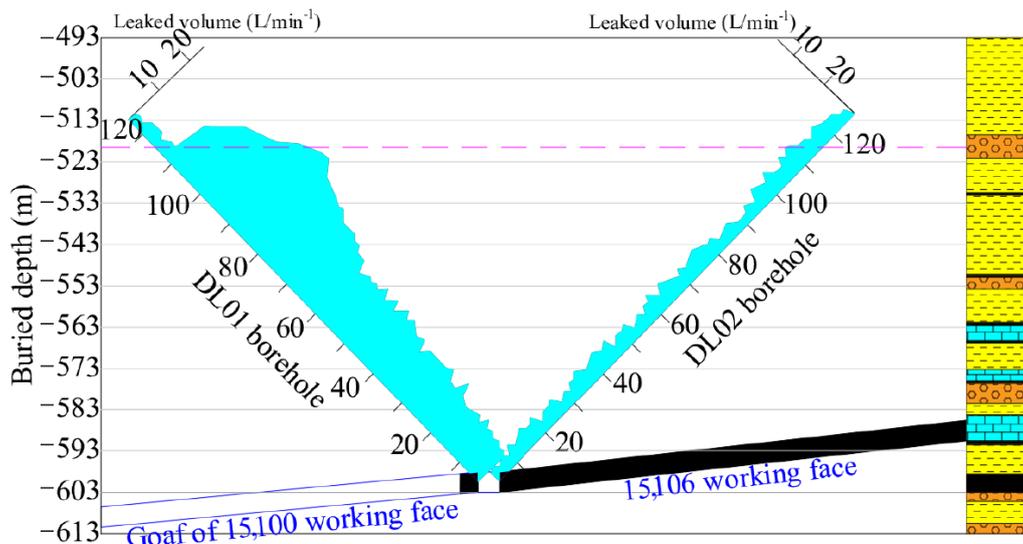
Figure 7. Distribution of water leakage in borehole.

According to the above observation scheme, DL01 and DL02 boreholes were observed on 14 January 2021. The water injection leakage data observed in each borehole and the column shape of nearby borehole were drawn into Figure 7 to analyze the change of water injection leakage in the borehole section and, finally, determine the height of water diversion fracture zone. Figure 7 is the distribution map of water injection leakage in DL01, DL02 boreholes. As we can see from Figure 7, the average change of water injection flow in DL02 borehole was 3.32 L/min, indicating that rock stratum has the characteristics of small permeability.

For DL01 borehole, the water injection leakage was in the range of 1.6–3.8 L/min within the drilling depth of 115–125 m (the vertical height was 82–90 m), which showed that the rock stratum in this section was not damaged compared with DL01 borehole. Nevertheless, the water injection leakage was in the range of 12.0–28.5 L/min within the drilling depth of 85–115 m (the vertical height was 61–82 m), indicating that the borehole penetrated the FWCZ at this time, for the water seepage of the rock stratum increased significantly. The rock stratum in this area was affected by mining to produce secondary fracture, and the water conductivity of rock stratum was relatively stronger. The rock stratum corresponding to the position of the FWCZ was medium sandstone, which were 85 m high from the coal seam.

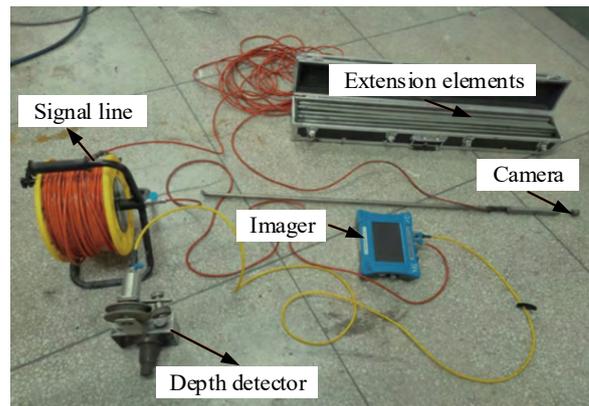
Figure 8. Detection equipment of borehole TV [41].

The downhole TV system is an observation system used for internal imaging of borehole, which includes a camera, an imager, extension elements, a signal line, etc. The geological structure in the borehole can be directly observed on the monitor by placing a waterproof camera with its own light source into the underground borehole. It can be used to identify lithology, fractures, cavities, weak interbeds and other conditions according to the shape, color, brightness and other information of the image. Figure 8 shows the borehole TV developed by Gude Technology Company (Wuhan, China).

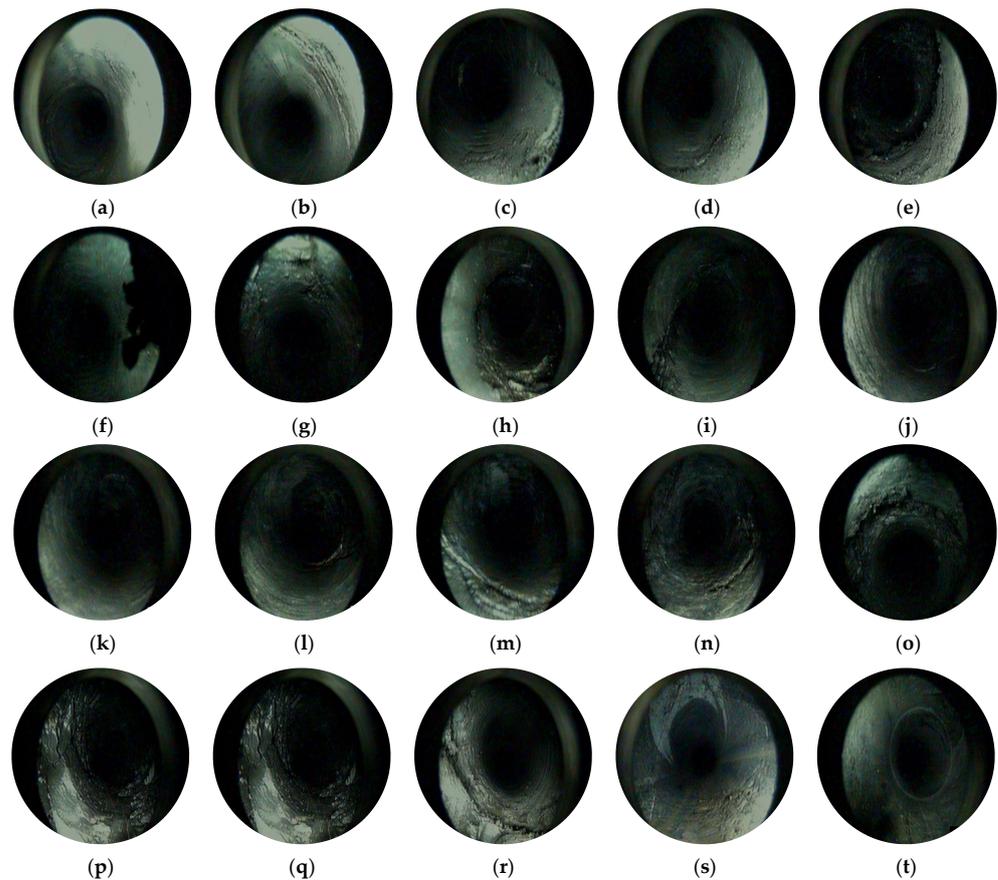
Figure 9. Photos of the overburden fractures after mining: (a) 3.21 m (b) 6.17 m (c) 12.27 m (d) 15.42 m (e) 18.29 m (f) 22.23 m (g) 25.39 m (h) 32.89 m (i) 35.14 m (j) 42.14 m (k) 50.14 m (l) 56.23 m (m) 62.38 m (n) 66.87 m (o) 72.21 m (p) 75.78 m (q) 82.48 m (r) 85.39 m (s) 88.16 m (t) 91.23 m.

On 14 January 2021, DL01 borehole was observed by builders with the borehole TV. The borehole depth of field observation was 125 m, of which the first 10 m included the borehole casing, and the actual effective observation depth was 115 m. Figure 9 shows 20 representative photos of the development of overlying rock fractures through the DL01 borehole. The numbers behind the figure number were the vertical distances between the coal seam roof and this location.

According to the on-site observation records, there were no obvious fractures in the overlying rock within the vertical depth range of 3.21–12.27 m from No. 15 coal seam (Figure 9a–c), indicating that the borehole section within this range did not yet enter the area of FWCZ. Obvious mining fractures began to appear in the overlying rock starting from the vertical depth of 15.42 m from No. 15 coal seam (Figure 9d–g), indicating that the rock strata within this range were significantly affected by mining, but the width and number of fractures were relatively small. At the vertical depth of 32.89 m from No. 15 coal seam (Figure 9h), the rock layer was severely damaged and the rock blocks were broken, which indicated that should be the overlying rock caving zone. As the vertical depth of No. 15 coal seam increased (Figure 9i), the degree of overlying rock failure significantly decreased and showed a certain regularity. Fractures intersect longitudinally or layer wise, indicating that the borehole passed through the overlying rock caving zone. Further increasing the drilling depth (Figure 9j–m), the identification of fracture direction and width increased, with oblique fractures being the main trend and showing obvious regularity. As the distance from No. 15 coal seam increased, the overlying rock fractures decreased, as shown in Figure 9n–q. At the vertical depth of 85.39 m from No. 15 coal seam (Figure 9r), the fractures completely disappeared (Figure 9s,t), indicating the height of the FWCZ was 85.39 m. The height of the caving zone and the FWCZ observed through borehole television were 32.89 m and 85.39 m, respectively, and the caving/mining ratio and fractures/mining ratio were 8.2 and 21.3, respectively. This was consistent with the height of the FWCZ determined by the borehole leakage method.

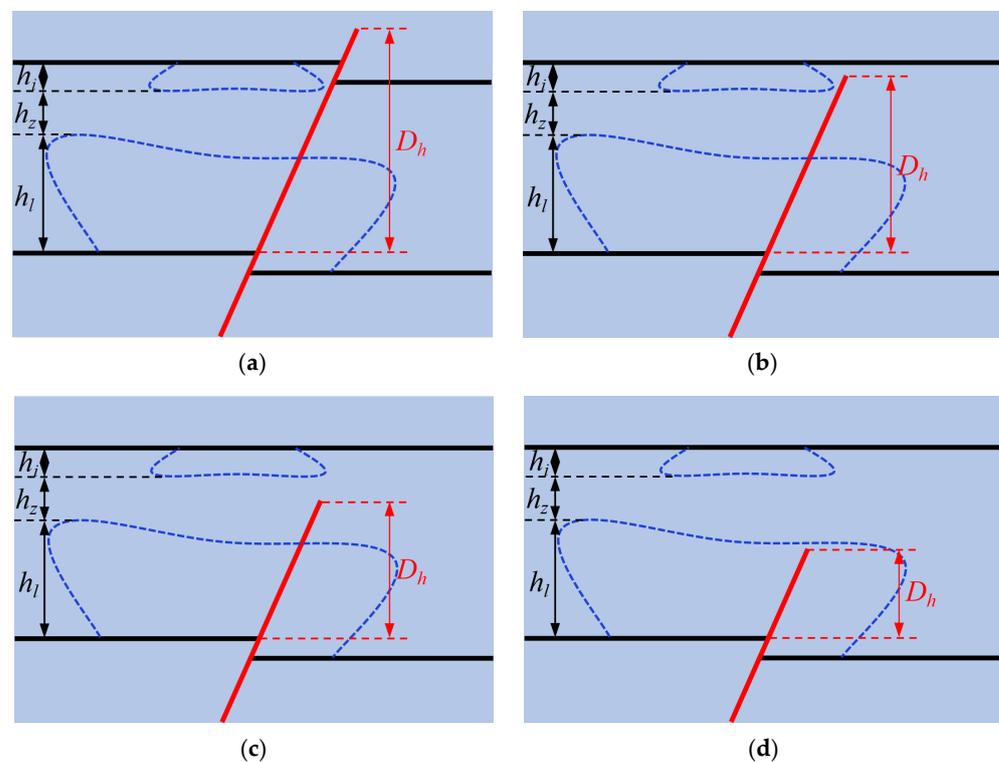
Figure 10. Four space relationships between F6 reverse fault and the mining-induced fractures: (a) $D_h \geq h_i + h_z + h_j$; (b) $h_z + h_i \leq D_h < h_i + h_z + h_j$; (c) $h_i < D_h < h_z + h_j$; (d) $D_h \leq h_i$.

Due to the lack of perfect geological data during the time that No. 2 coal seam was mining, the very existence of F6 reverse fault in No. 2 coal seam was uncertain. Figure 10 shows the four space relationships between F6 reverse fault and the mining-induced fractures, as follows:

(a) If $D_h \geq h_i + h_z + h_1$ (Figure 10a), it means that F6 reverse fault cuts through the rock strata between No. 2 and 15 coal seams completely, then the FFD of No. 2 coal seam will be deepened along the fault zone, and also the height of the FWCZ of working face 15,103 will be increased due to fault activation. As a result, the goaf water of working face 2071 flows downward along the fracture into the 15,103 working face.

(b) If $h_z + h_1 \leq D_h < h_i + h_z + h_1$ (Figure 10b), it means that the rock strata between No. 2 and 15 coal seams are not cut through completely by F6 reverse fault, the goaf water of 2071 working face may then flow slowly downward along the fractures and F6 reverse fault, and then enter the 15,103 working face in the form of dripping and drenching.

(c) If $h_1 < D_h < h_z + h_1$ (Figure 10c), the goaf water of 2071 working face cannot enter the 15,103 working face, according to the prediction results of the height of the FWCZ in the 15,103 working face.

(d) If $D_h \leq h_1$ (Figure 10d), F6 reverse fault has no effect on the FWCZ of the 15,103 working face, that is, the height of FWCZ is the same as that without fault. Intact curved rock strata between the FWCZ of the 15,103 working face and the floor failure area of 2071 working face had enough thickness to play the role of water-resistance.

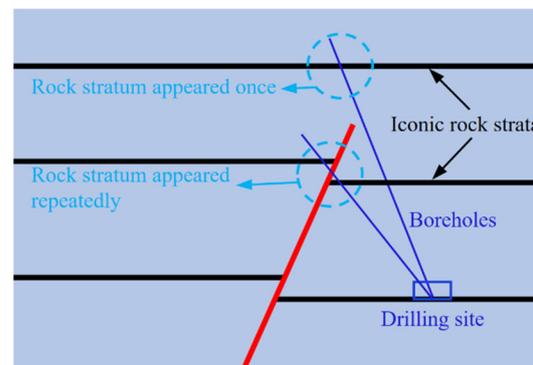
Figure 11. Layout of exploratory boreholes.

The drilling method was adopted to explore the cut through degree of F6 reverse fault in the overburden strata of the 15,103 working face, which can provide a basis for the prevention of goaf water disaster. The designed boreholes were constructed from the footwall to the hanging wall of F6 reverse fault. If the iconic rock stratum was cut through by the fault, its exposure will appear repeatedly in the borehole; otherwise, it will not (Figure 11). No. 8 coal seam was 70 m above the 15,103 working face, the distance was less than the height of the FWCZ (85.39 m). If No. 8 coal seam was cut through by F6 reverse fault, it will appear repeatedly in the borehole. Therefore, No. 8 coal seam can be used as the iconic rock stratum for analyzing the cut through degree of F6 reverse fault.

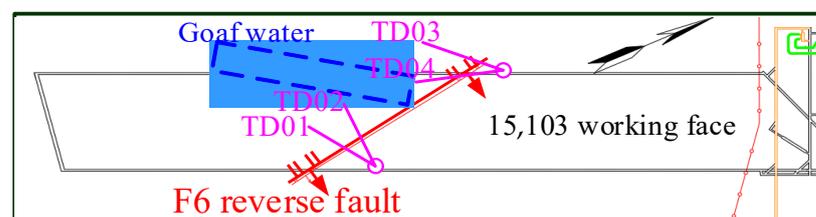
Figure 12. Location map of exploratory boreholes.

Four boreholes were constructed from the footwall to the hanging wall of F6 fault in return-air roadway and haulage roadway of the 15,103 working face. Figures 12 and 13 show the boreholes position and the photo of rock core specimens near No. 8 coal seam exposed by TD01 borehole, respectively. It can be seen that the No. 8 coal seam and its roof and floor rock-layers exposed were not repeated, nor were there fault planes and broken rock masses. Therefore, the No. 8 coal seam was not cut through by F6 reverse fault.

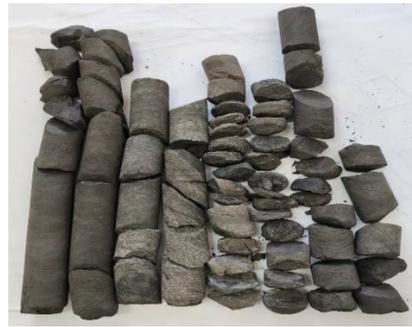
Figure 13. Photo of rock core specimens exposed by TD01 borehole.

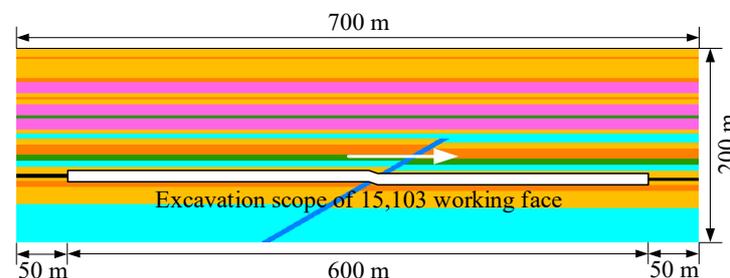
Figure 14. FLAC^{3D} numerical calculation model.

The overburden failure law during mining of the 15,103 working face was simulated through FLAC^{3D} numerical simulation software. The established model is shown in Figure 14 and the size was 700 m × 1 m × 200 m (length × width × height). The two sides and bottom of the model were fixed boundaries, and the top was free boundary. Mohr–Coulomb yielding criterion was adopted in the excavation simulation [35]. The length of the working face in advancing direction was 600 m in Figure 14. To reduce the boundary effect, coal pillars 50 m wide were intentionally left on both sides of the working face.

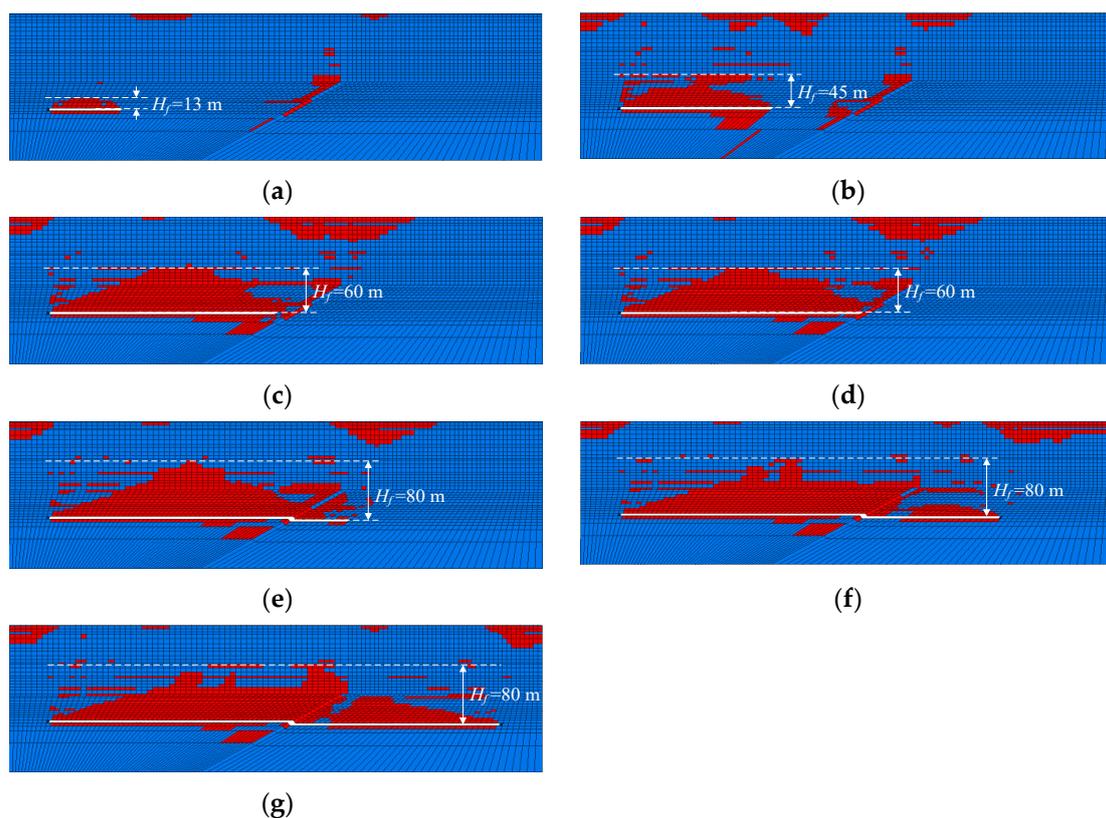
Figure 15. Sectional view of plastic zone when the panel 15,103 advanced (a) 100 m; (b) 200 m; (c) 300 m; (d) 320 m; (e) 400 m; (f) 500 m; (g) 600 m.

The study showed that the roof rock easily formed a plastic zone in shear or tensile state, because it was damaged after the coal mining operation was completed. Therefore, the numerical simulation in this paper mainly analyzed the distribution of the plastic zone of the roof rock after coal mining. Figure 15 is a sectional view of the plastic zones when the longwall face advanced 100 m, 200 m, 300 m, 320 m, 400 m, 500 m, and 600 m.

The results showed that the plastic and destressed zone distribution in the surrounding rock was $H_f = 13$ m when the working face advanced 100 m, a plastic zone appeared near the F6 fault but the overburden failure of working face 15,103 was not affected by the fault (Figure 15a). Periodic roof weighting in coal mine face appeared and the plastic zone developed to the basic roof with $H_f = 45$ m, when the working face advanced 200 m. At this

time, the range of the plastic zone near the fault increased (Figure 15b). With the progress of coal mining, the working face gradually approached the F6 fault. When the working face advanced 300 m (the distance from the F6 fault was 20 m), the plastic zone of the roof was locally connected with the plastic zone near the fault (Figure 15c, $H_f = 60$ m). When the working face advanced 320 m to the fault (Figure 15d), the plastic zone of the roof was completely connected with the plastic zone near the fault, the height of the plastic zone remained the same ($H_f = 60$ m). When the working face advanced 400 m (distance across the F6 fault was 80 m), the height of the FWCZ was increased to 80 m (Figure 15e). Figure 15f,g show the simulated vertical cross-sections as the 15,103 working face's advanced distances were 500 m and 600 m. The distributions of plastic zone in the vertical direction were almost the same, indicating that the plastic zone was fully developed, and the working face reached the super-critical mining stage and the FWCZ was fully developed and stabilized.
