Article Characterizing the Tensile Behaviour of Woven and Composite Fabrics under UV Exposure

Soon Yuan Jie¹, Leow Zhi Hoe¹, Suvash Chandra Paul² and Vivi Anggraini^{1,*}

- ¹ Civil Engineering Discipline, School of Engineering, Monash University Malaysia, Jalan Lagoon Selatan, Bandar Sunway 47500, Selangor Darul Ehsan, Malaysia
- ² Department of Civil Engineering, International University of Business Agriculture and Technology, Dhaka 1230, Bangladesh
- * Correspondence: vivi.anggraini@monash.edu

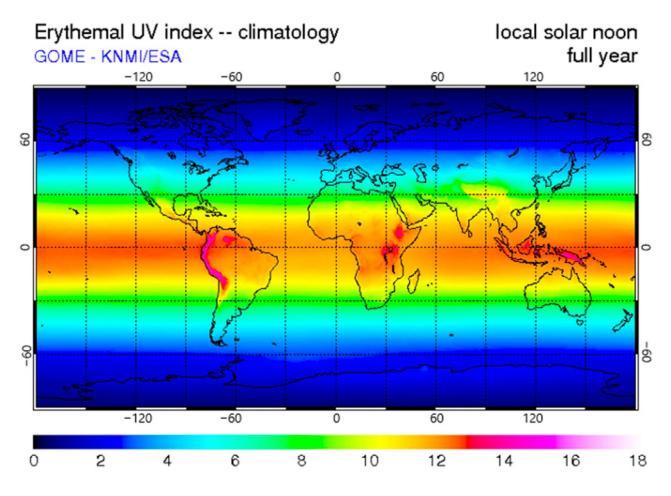
Figure 1. Global UV index map from 1996 to 2002.

Several factors have been identified that influence UV radiation. These include cloud cover, time of day, land cover, geographical latitude, earth's surface characteristics, seasons, altitude, and ozone concentration [11,15]. Malaysia is located close to the equator with minimal seasonal variation and is subjected to consistent UV radiation throughout the year. Therefore, it is important to assess the degradation of engineered fabrics based on the outdoor UV weathering test, which considers the geographical location and environmental factors as a basis for the holistic assessment. This proves the necessity and importance of field UV weathering in assessing the durability performance of engineered fabrics.

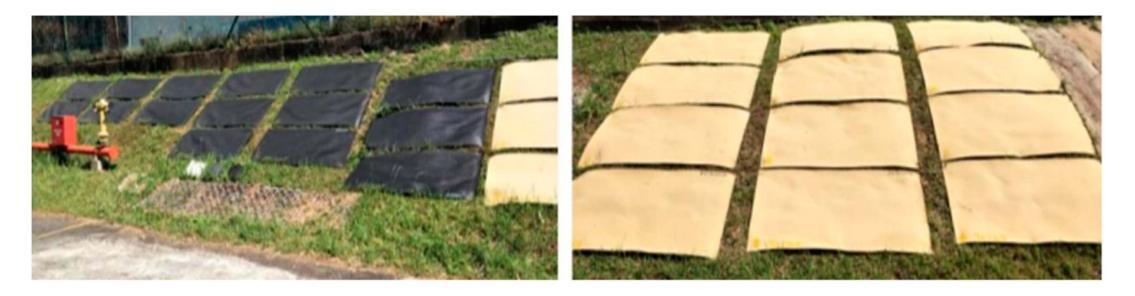
Figure 2. Outdoor UV weathering test for woven (black) and composite (yellow) (Courtesy: Tencate Geosynthetics Asia).

This research focused on the standard outdoor UV weathering of engineered fabrics. Engineered fabrics were first exposed to sunlight for a five-month duration. At the end of each month, these engineered fabrics were cut into specimens and subjected to a series of laboratory tests to monitor the extent of degradation. The engineered fabrics were placed in an open and uncovered area to maximise UV exposure (see Figure 2). The experimental setup was constructed at Petaling Jaya, Selangor, Malaysia. Environmental factors that could have potentially biased the test results were recorded. These included maximum (T_{max}) and minimum (T_{min}) air temperature, humidity (HUM), cloud cover (CC), UV index (UVI), precipitation (P), and air quality index (AQI). This meteorological data was useful in assessing the degradation of engineered fabrics. The correlation between the degradation of the engineered fabric (see later part to quantify the material degradation) and meteorological data was considered.

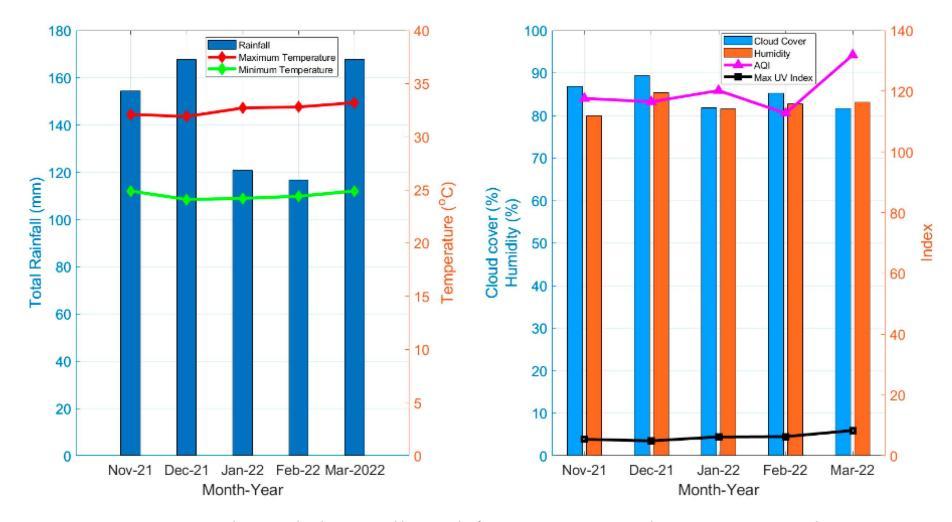
Figure 3. Meteorological data collected from 21 November to 22 March 2022 at Petaling Jaya, Selangor, Malaysia.

Figure 3 depicts the meteorological data collected during the outdoor weathering test from November 2021 to March 2022. This test was carried out in conjunction with the northeastern monsoon season, which typically occurs from early November to the end of March [27]. During this period, Malaysia is subjected to higher rainfall and an active cold surge. The statistical correlation matrix that was used to study the relationship between the meteorological data is shown in Figure 4. A strong positive correlation ($R \ge 0.8$) was identified between the T_{max} -UVI and UVI-AQI, and a negative correlation ($R \le -0.8$) was identified between the CC- T_{max} and UVI-CC.

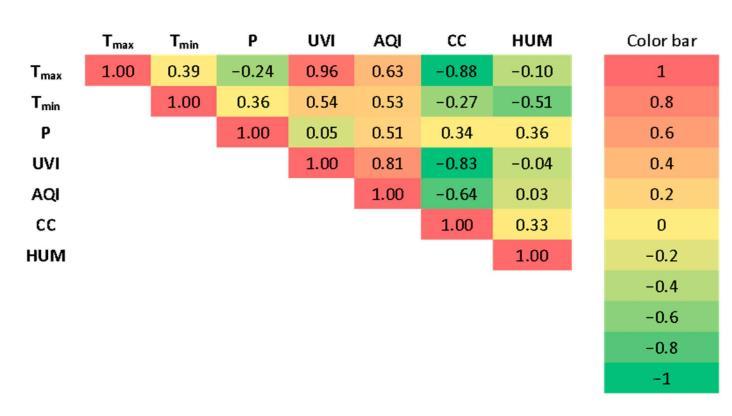
Figure 4. Statistical correlation matrix between the collected meteorological data from 21 November to 22 March 2022.

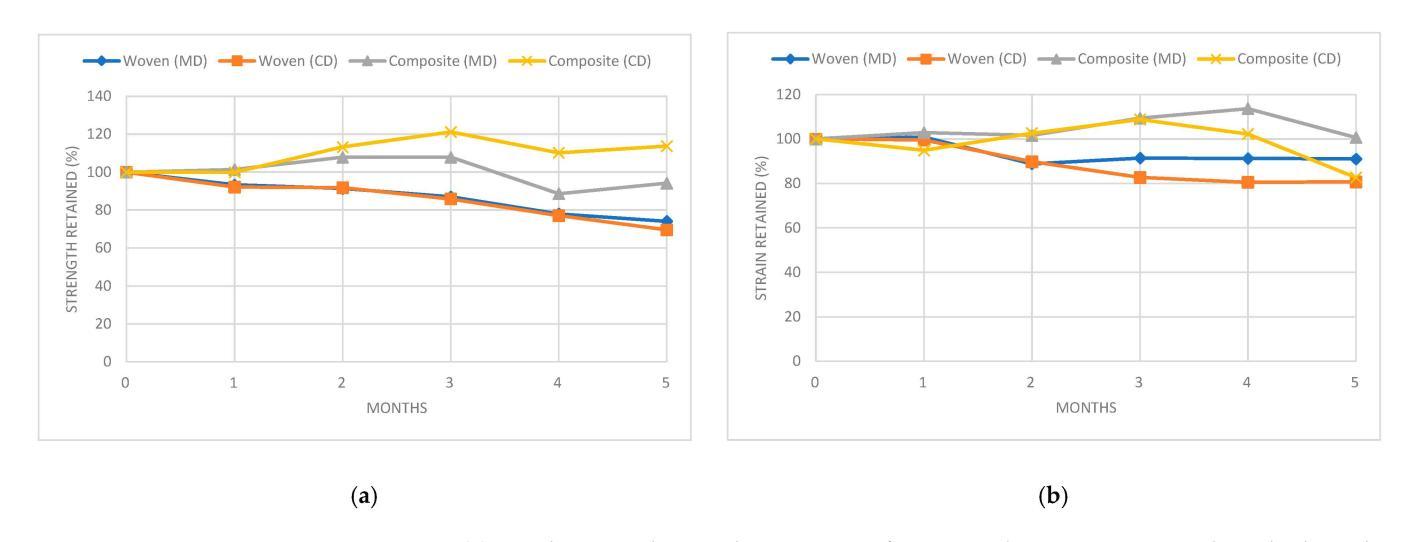
Figure 5. (a) Tensile retained strength percentage of woven and composite geotextiles in both machine (MD) and cross-machine directions (CD); (b) retained strain percentage of woven and composite geotextiles in both machine (MD) and cross-machine directions (CD).

Geotextiles, after each month of weathering tests, were studied for their respective tensile strength and retained strain percentages. Figure 5 shows the plot of maximum tensile strength and its corresponding retained strain percentage against various exposure levels for both geotextiles in MD and CD. The tensile properties retained were calculated based on the tensile properties of the exposed specimens divided by the unexposed specimens and multiplied by 100%. Figure 5a shows that the woven geotextile progressively lost its maximum tensile strength under prolonged UV exposure. Such degradation was associated with retained strength percentages of 74.06% and 69.55% in the final month of UV exposure in the MD and CD, respectively. The retained strength percentage for woven geotextiles after each month of outdoor exposure was relatively consistent and

well controlled in both directions, despite the anisotropic properties of geotextiles that indicated up to 8.66%. The tensile strength of the composite fabric was of particular importance, with an anisotropy of up to 15.58%. No strength losses were observed in the CD, while minimal strength losses in the MD began after the fourth month and were associated with a retained strength percentage of 94.19% following the last months of outdoor UV exposure. Overall, degradation was more pronounced in woven geotextiles, which had a lower retained strength percentage after five months of weathering testing than in composite geotextiles.

The corresponding retained strain percentage in Figure 5b reveals a higher degree of non-uniformity compared to the plot of maximum strength retained percentage. Woven fabrics started to show significant strain reduction only after the second month of outdoor exposure. Inconsistency of retained strain percentages began to emerge in the third month, when woven geotextiles showed a higher (lower) retained strain percentage in the MD (CD) than the preceding month. The strain reduction for the remaining months remained steady in both MD and CD, with 91.08% and 80.74% of the strain being retained in the final months, respectively. The anisotropy of the strain retained was determined to be up to 37.77%. For the composite fabric, no strain losses were observed in the MD after five months of outdoor exposure. However, initial strain reduction occurred in CD after the first month and disappeared for the following months until the final month of outdoor UV exposure, which depicted a retained strain percentage of 82.63%. Accordingly, the emerging difference contributed to an anisotropy of up to 45.46%. Overall, the composite fabric showed a greater retained strain percentage after the final month of outdoor exposure compared to the woven fabric.

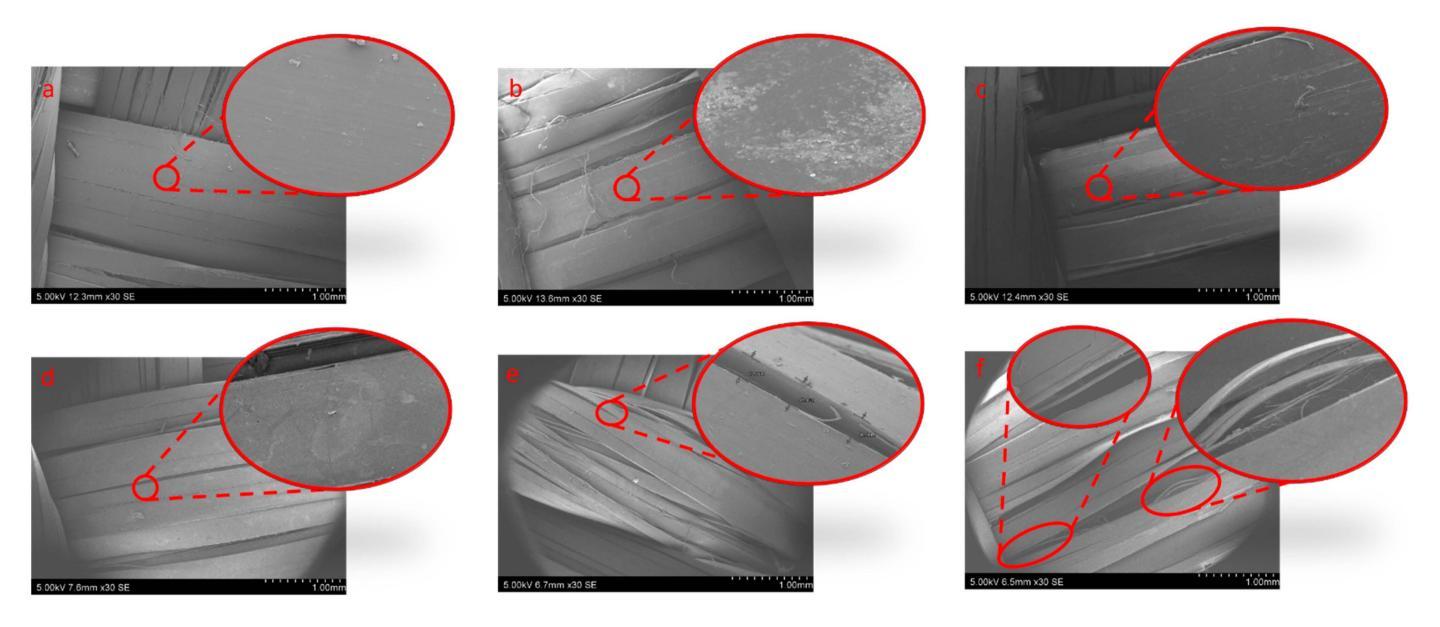
Figure 6. SEM micrographs of woven fabrics at (**a**) Month 1, (**b**) Month 2, (**c**) Month 3, (**d**) Month 4, (**e**) Month 5, and (**f**) Month 6 of exposure.

Figures 6 and 7 depict SEM micrographs of engineered fabrics at various exposure levels. Figure 6a indicates the SEM micrograph of an unexposed woven fabric with an even and smooth surface morphology. All fibres were positioned in a closely packed and well-aligned interlaced structure. The virgin sample showed no signs of degradation. After the first month of outdoor weathering tests, significant white spots with a rough surface texture were observed on the polymer surface under a magnification of $\times 3000$. Such white spots were also observed in the remaining months of the weathering test (not shown here). Additionally, SEM micrographs captured at $\times 30$ magnification indicated a minimum extent of degradation through the loosening of fibres at the edges after the first month, as shown in Figure 6b. For the remaining months of weathering tests, SEM micrographs captured at $\times 30$ magnification through significant changes in the polymer structure, specifically its fibre alignment. Where the fibres tended to spread apart from each other and become loose, this effect was more significant under prolonged UV exposure. In general, the fibres in UV-degraded woven fabrics showed a loose structural alignment after prolonged UV exposure.

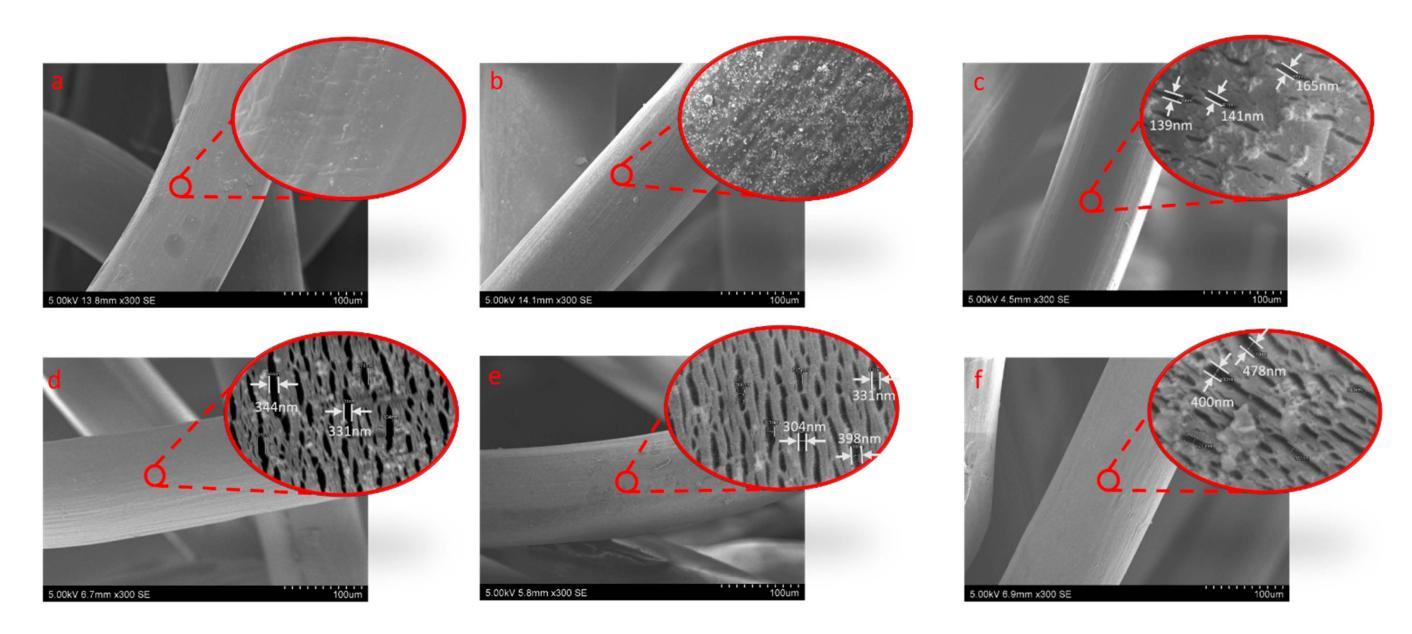
Figure 7. SEM micrograph of composite fabrics at (**a**) Month 1, (**b**) Month 2, (**c**) Month 3, (**d**) Month 4, (**e**) Month 5, and (**f**) Month 6 of exposure.

Figure 7a–f depicts the surface microstructure behaviour of composite samples. Similar to woven samples, the unexposed composite sample shown in Figure 7a indicates a smooth and even surface appearance with no degradation. The significant white spots were also present in the composite fabrics (see Figure 7b) after the first month, and subsequently decreased in the remaining months (see Figure 7c–f), which was associated with the formation of greater microcracks width. No degradation was observed at the end of the first month of UV exposure. Unlike woven fabric, the degradation mechanism was shown by the presence of microcracks (in the transverse fibre direction) that were observed after the second month of weathering testing. These microcracks continued to develop with a significant increase in width. At the end of the second month of exposure, microcracks with a maximum width of 165 nm were observed, and progressively increased to 478 nm after the final month.

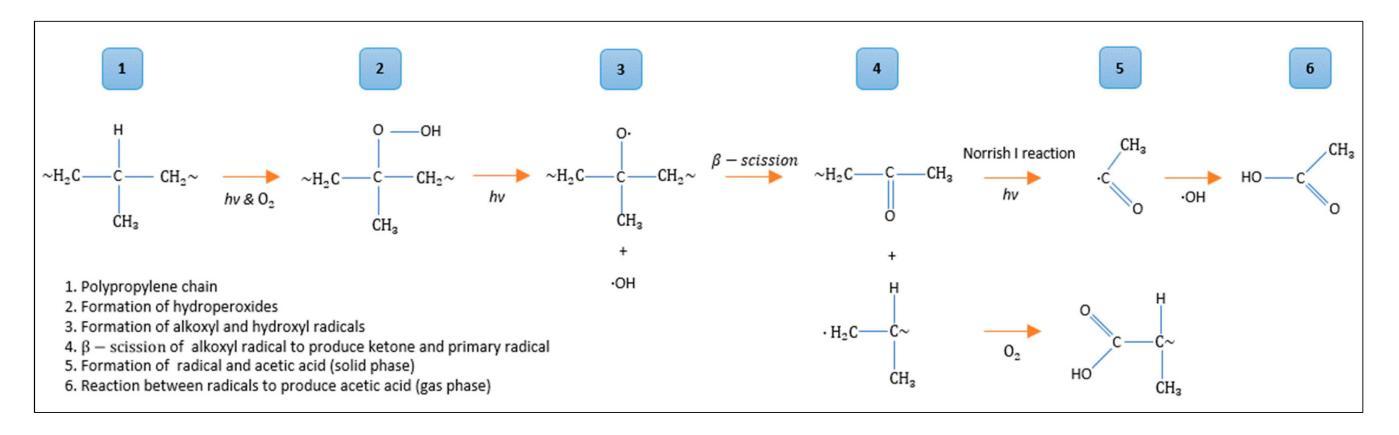
Scheme 1. Photo-oxidation degradation of polypropylene.

With reference to Figure 8, the FTIR spectra were sensitive towards the climatic elements that generally altered throughout the time of day or month under the outdoor environment. Accordingly, during the sunshine hours, the FTIR spectrum closely approached the upper limit of 1, which indicated a maximum absorption of solar radiation. Conversely, during the raining hours and night-time, the spectra intensity approached the lower limit of 0, which indicated a minimal absorbance of solar radiation. However, this behaviour of spectrum intensity was not clear evidence for the UV degradation of polypropylene under long-term exposure. Polypropylene subjected to UV radiation undergoes a series of chain scissions in its macromolecules through the multi-stage complex reactions. Scheme 1 illustrates the simplified photo-oxidation process of polypropylene. The preliminary stage of photo-oxidation involves the formation of hydroperoxides (2), after which it undergoes homolysis by the UV radiation under the conditions of oxygen availability to produce alkoxyl and hydroxyl radicals (3). Subsequently, reaction of alkoxyl radicals occurs through β -scission to produce ketones and primary radicals (4). These intermediate photoproducts, including free radicals, undergo further chain scissions which bring about deterioration towards the mechanical properties, such as tensile, shear, puncture resistance, etc. The final stage of degradation involves the photoproducts known as acetic acids in the form of solid and gas (i.e., volatile) phases. The formation of intermediate and final photoproducts from Scheme 1 can be tracked in the FTIR spectra (see Figure 8) through the corresponding absorption bands formed. In this research, the hydroxyl (O-H) and carbonyl (C=O) functional groups were used to monitor the extent of polypropylene degradation in conjunction with its chemical structural alteration, as shown in Scheme 1.

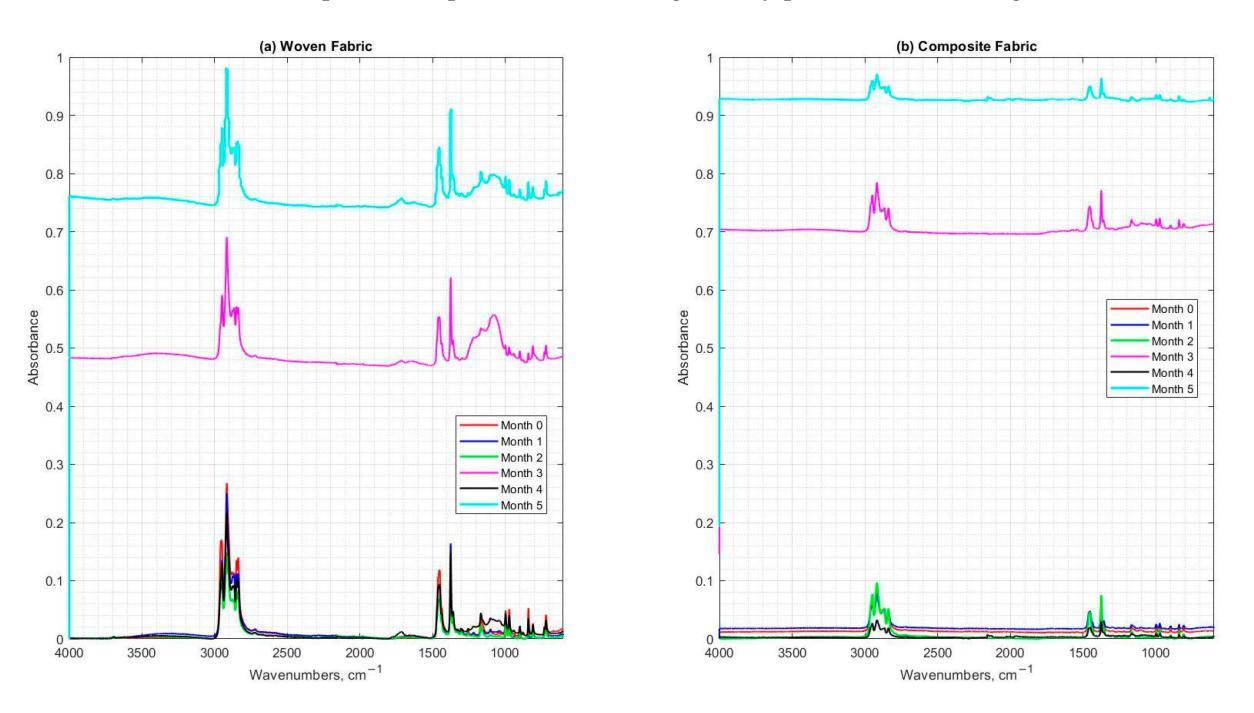
Figure 8. (a) FTIR spectra of PP120S fabric under various UV exposure levels; (b) FTIR spectra of TC120 fabric under various UV exposure levels.

The UV degradation suffered by engineered fabrics was further evidenced through FTIR spectrum dissolution. Figure 8 shows the FTIR spectra of the engineered fabrics under various UV exposure levels. The IR spectra are presented in the plot of absorbance against wavenumbers. The spectra of virgin samples were initially compared to reference spectra stored in the OMNIC software library databases to verify their polymer type. The spectral databases included a wide variety of reference spectral collections with detailed information which aimed to provide a more accurate comparison. Results indicated that the FTIR spectra of both samples closely resembled the characteristics of polypropylene atactic with a similarity of 87.84% (woven) and 86.81% (composite), in accordance with the Hummel polymer FTIR spectral library. The spectra similarity was characterized based on the reference absorption bands of polypropylene shown in Table 3 [26,29–32].

Figure 8a shows that the hydroxyl group ($3800-3000 \text{ cm}^{-1}$) formed a broad peak after the first month of outdoor exposure. The absorption peak in this region became notable under prolonged UV exposure. The development of a peak, indicating the presence of a hydroxyl group, served as evidence of the formation of hydroperoxides as the photoproduct in the early stage of photo-oxidation degradation (stage 2 in Scheme 1). Later, a significant peak was also observed due to the presence of a carbonyl group (1850–1650 cm^{-1}) after the third month. This absorption band, specifically located at a wavenumber of 1713 cm^{-1} , was identified in Scheme 1 as acetic acid [33,34]. This photoproduct appeared to be increasing under prolonged UV exposure, which was observed through its remarkable peak formed after the final month. The formation of acetic acids was further supported by the absorption peaks formed due to the presence of the CO bands $(1300-1000 \text{ cm}^{-1})$ which characterized the C-O stretching vibration of the acetic acids. Unlike woven fabrics, the hydroxyl and carbonyl groups belonged to the composite samples (see Figure 8b), which appeared to remain unchanged after several months of UV exposure. No peaks were observed after the final month of outdoor exposure. This result alone suggested that composite samples had not undergone any photo-oxidation degradation.
