Article Utilization of TiN and the Texture of Bionic Pangolin Scales to Improve the Wear Resistance of Cast Steel 20Mn Metal

Abstract: This research centers around cast steel 20Mn, which is the material utilized for the ear-picking roller of a corn harvester. The study delves into methods of enhancing its hydrophobicity and wear resistance. Fiber laser-processing technology was employed to fabricate pangolin bionic micro-textures on the material surface, and PVD technology was utilized to deposit a TiN coating. The wear resistance of the modified surface was investigated via the reciprocating dry sliding wear method, while its hydrophobicity was concurrently examined. The results demonstrate that the laser texturing technology and TiN coating managed to reduce the friction coefficient of the sample surface by 20% and 30.9%, respectively. This can be chiefly attributed to the significant effects of the modified surface in augmenting hardness, diminishing the contact area of the friction surface, lowering shear stress, and entrapping wear debris. When the pangolin texture and TiN coating work in concert, the abrasive and fatigue wear between the two surfaces is conspicuously mitigat

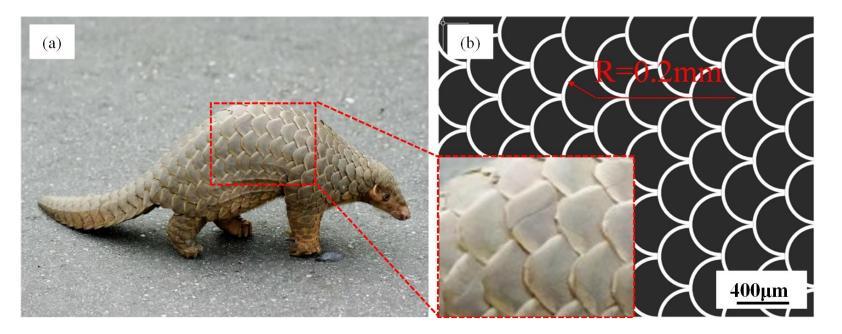
As depicted in Figure 1a, the body of a pangolin is enveloped by hard scales. Pangolins typically inhabit burrows in grassy foothill regions or damp areas with shrubs on hillsides. The texture present on the surface of pangolin scales potentially mitigates wear. Inspired by these pangolin scales, this research project devised a biomimetic texture that emulates the appearance of pangolin scales, as demonstrated in Figure 1b. The geometric parameters of the structure were set with a radius $R = 200 \mu m$ and texture width of 50 μm . A fiber laser marking machine (Zhongtian laser, Kunshan, China) was used to create a microtexture array, as shown in Figure 2a. The laser-processing parameters were as follows: scanning speed of 100 mm/s, average power of 15 W, pulse repetition frequency of 20 KHz, 5 scanning passes, and all laser ablation processes were conducted at 25 °C and 37% humidity. Then, the surface of textured samples was polished and cleaned in an ultrasonic bath to remove the oxide layer and debris. For clarity, the polished surface without texture was known as PS, while the surface with the processed pangolin scale biomimetic texture was known as TS.

Figure 1. (a) Pangolin Scale Structure, (b) Biomimetic Texture Design.

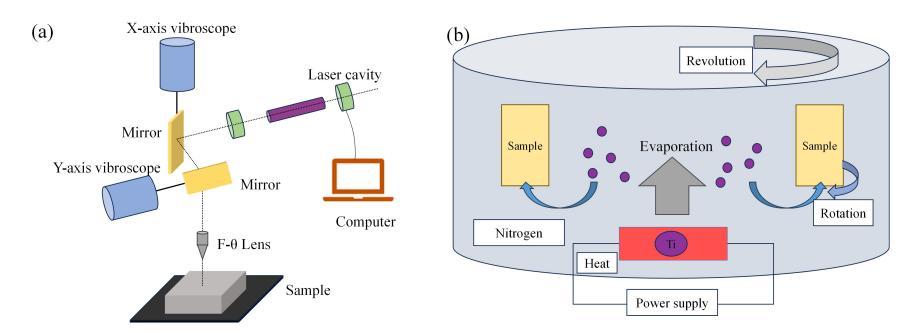
Figure 2. (a) Fiber laser. (b) TiN Coating Processing Schematic.

As shown in Figure 2b, the TiN coating was processed on the surface of the sample using the Physical Vapor Deposition (PVD) method. PVD was used (Huafu Metal Products Co., Ltd., Dongguan City, China) to deposit TiN coatings on the surfaces of PS and TS, respectively. Pure titanium targets (purity of 99.9%) were utilized for sputtering, with 99.99% pure nitrogen injected into the sputtering chamber as the sputtering gas. The deposition pressure was 2.0 Pa, the deposition temperature was 400 °C, and the deposition time was 7 h. For clarity, the material surface processed with TiN coating without biomimetic texture was labeled as TPS, while the material surface processed with TiN coating after the

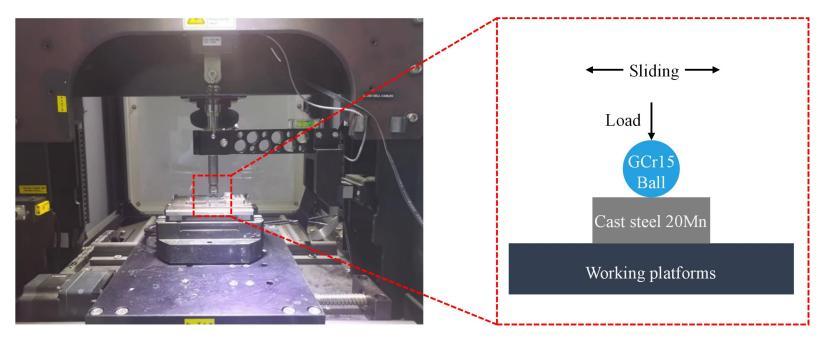
The sliding wear test was carried out in the Multifunctional Friction and Wear Testing Machine (MFT-5000, RTEC, San Jose, CA, USA) with the aim of investigating the impacts of biomimetic texture and Ti coating on the sliding wear behavior of the substrate. Figure 3 presents a schematic diagram of the sliding wear test. Given that the substrate material in this experiment was intended for use in the front-end ear picker roller of the corn harvester, which is a component that directly interacts with corn ears and demands a high level of wear resistance, a relatively harder GCr15 steel ball with a hardness of 55 ± 3 HRC was selected as the friction counterpart. In the actual operational context of the corn harvester ear roller, lubrication is absent. Therefore, dry friction was opted for as the experimental condition. All tests were performed without the use of lubricants at room temperature (25 °C) and 30% humidity. The experimental parameters are enumerated in Table 2. To minimize experimental errors, each test was replicated three times during the sliding wear tests.

Figure 3. Illustration of surface wear.

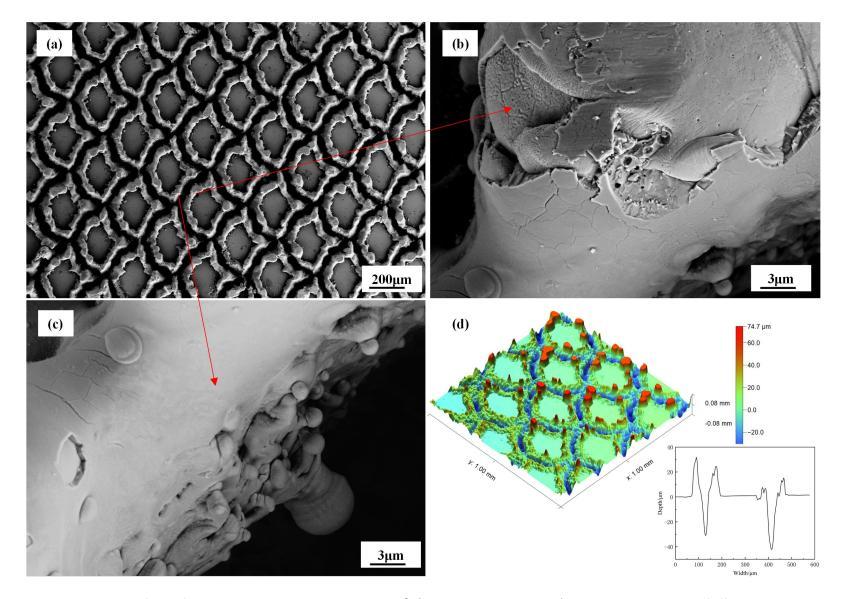
As illustrated in Figure 4d, the three-dimensional surface morphology of the pangolin biomimetic texture following laser processing was examined. It was discerned from the image that the depth of the biomimetic texture is approximately 25 to $45 \,\mu$ m, with a width spanning from 45 to $55 \,\mu$ m, a fan-shaped radius of 200 μ m, and a textured area ratio (texture area/total area) of around 30%.

Figure 4a–c display the SEM images of the modified surfaces. The image presented in Figure 4a represents the surface morphology of the biomimetic texture as observed at a magnification of 50 times. It can be observed from the image that the laser processing led to a distinct outline and a surface with a structurally regular pangolin scale-like appearance.

Figure 4. (**a**–**c**) are SEM images of laser-textured structures. (**d**) is a super depth of field threedimensional morphology image of laser-textured structures.

At the bottom of the laser irradiation trace, a layer composed of fine grains forming a remelted layer and a water-like structure is observed, while many micro-nano voids and cracks were distributed at the groove edges (Figure 4c,d), which may be related to the combined effects of laser ablation and melting [29]. During the lasering processing, surface vaporization, separation, and remelting usually occur as basic stages. The energy distribution of pulsed laser exhibits Gaussian characteristics, with a peak intensity at the center of irradiation that attenuates towards the periphery.

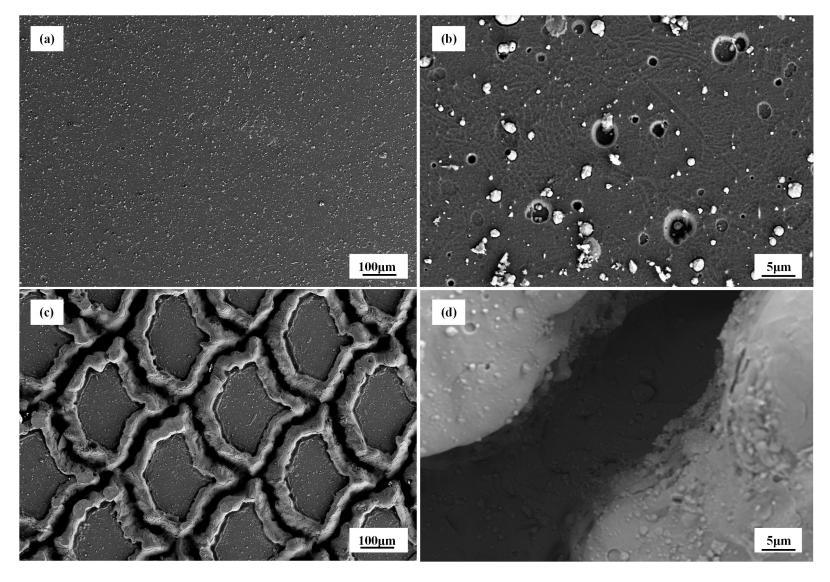
Figure 5 depicts the SEM surface morphologies of TiN-coated samples possessing diverse surface topographies. It is evident from the figure that the coating morphology on the substrate exhibits its porous surface structure. Apparently, there exist certain defects

on the surfaces of all coatings, such as cavities and surfaces with large particles. These are typical characteristics commonly found in coatings deposited by PVD on substrates that have been treated with gas abrasives [32,33]. There are pores of noticeably different sizes within the TiN coating. One potential cause for the non-uniform coating could be an unclean surface. The "large particles" formed during the deposition process are a result of the direct deposition of un-ionized film-forming particles onto the coating surface during the deposition procedure.

It is worthy of note that the two varieties of micro-textures formed on the substrate are not entirely concealed by the TiN coating, as shown in Figure 5c,d. The coating deposition procedure exerts no substantial influence on the morphology of the texture pattern. In Figure 5c, it was found that the coating quality of the laser protrusion was lower than that of the non-laser part, which was due to the increase in the surface roughness and porosity of the material after the laser.

Figure 5. (a,b) TPS surface SEM morphology. (c,d) TTS surface SEM morphology.

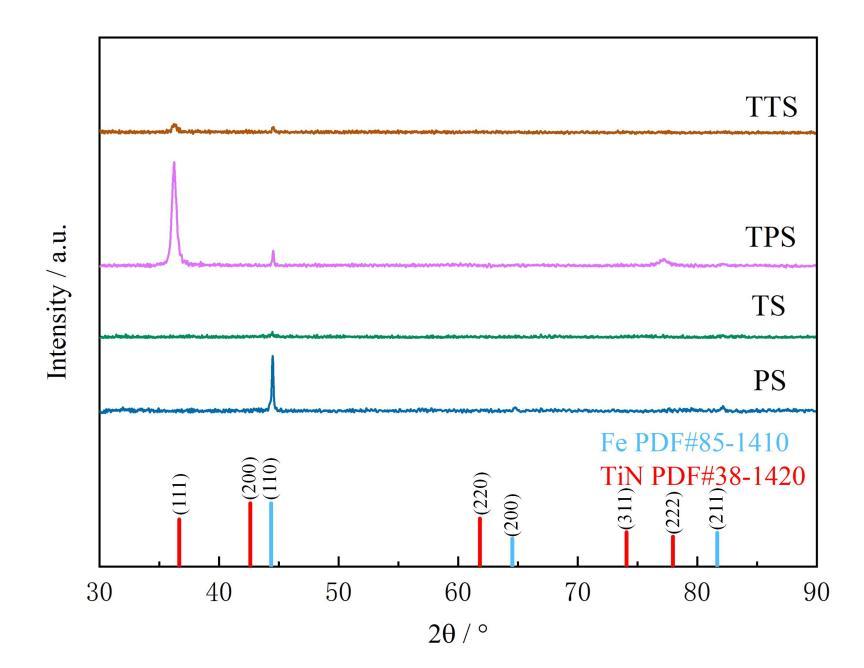
Figure 6 shows the XRD phase analysis map. The Fe phase peaks of the matrix appear at 44.352°, 64.526°, and 81.654° on the (110), (200), and (211) crystal planes, which fully conform to the standard card number 85-1410. After laser processing of microtexture, the intensity of diffraction peaks decreases. This phenomenon is caused by the increase in surface roughness and surface grain refinement after laser processing. In XRD testing, rough surfaces can complicate the scattering of X-rays. When X-rays hit an uneven surface, in addition to normal diffraction, more diffuse scattering occurs. These diffuse X-rays can interfere with the reception of normal diffraction signals, resulting in increased background noise and larger fluctuations in the diffraction pattern; the rapid heating and cooling process of laser processing can refine the grains on the test specimen. Generally speaking, the intensity of diffraction peaks will be reduced after grain refinement. As can be seen in the figure, the characteristic diffraction peaks of the TiN phase appear on the surface of the material after processing TiN coating, and the half-height width of the diffraction peak is very narrow, indicating that the crystal growth is good. The internal defects are few, and the coating quality is high. TiN has a face-centered cubic structure, and its main diffraction peaks usually appear near the 2-theta angles of about 36.7°, 42.6°, and 61.8°, which correspond to the (111), (200), and (220) crystal planes of TiN, respectively. It can be seen in the figure that there is a preferential orientation during the growth of TiN crystals, and the (111) crystal plane is preferentially grown in the XRD pattern, and other crystal planes are covered, which is a common phenomenon in PVD processing.

Figure 6. X-ray diffraction patterns of test samples.

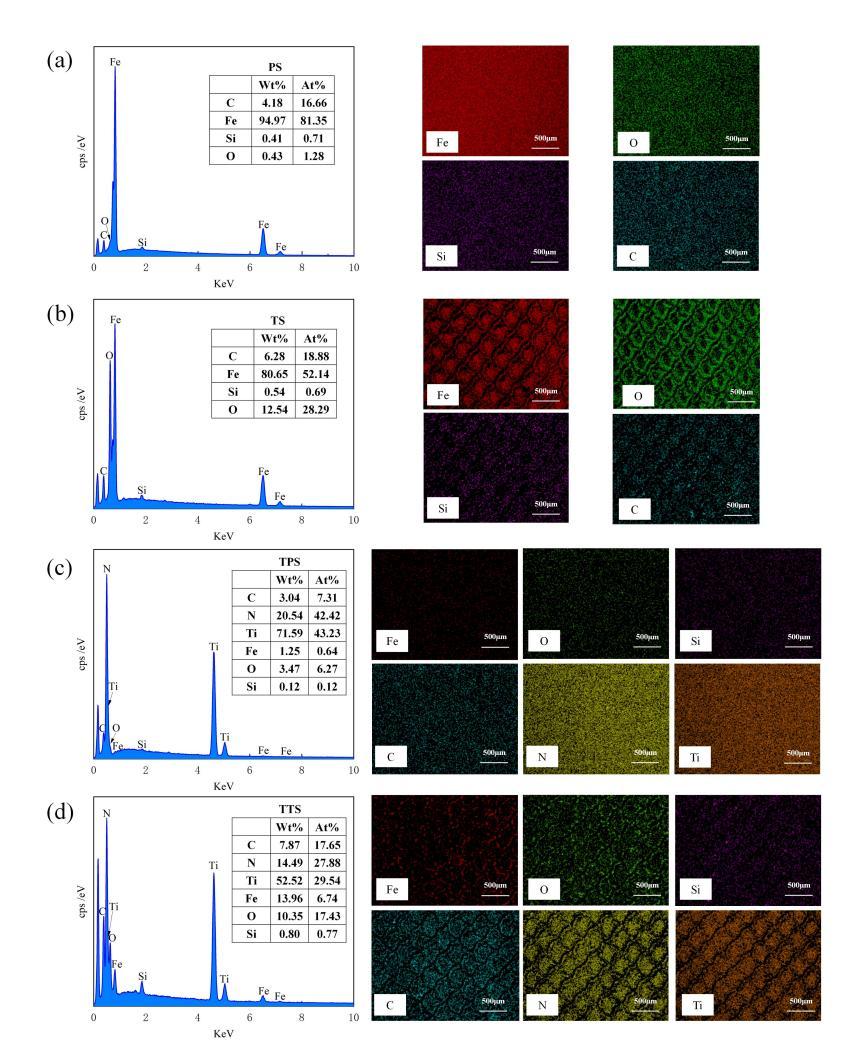
Figure 7 showcases the EDS results of the material surfaces. From Figure 7a, it is clearly observable that, in addition to Fe, Si, and C, O elements are detected on the surface of the test specimen. The origin of O is mainly ascribed to oxidation reactions when the material is exposed to air. As depicted in Figure 7b, following laser processing, there was a growth in the O content on the material surface, with the weight percentage (Wt) ascending from 0.43% to 12.54%, and O is distributed at the edges of the texture. By integrating Figure 7c,d, it can be noticed that not only is the O content substantial on the TS surface but it is also enhanced on the TTS surface, signifying that oxidation took place during the femtosecond laser processing. During the processing, the laser did not inflict obvious thermal damage to the interior of the material; thus, the oxidation traces were mainly dispersed within the texture. The existence of oxides frequently results in an augmentation of material hardness, and the material's wear resistance is also marginally improved. Cheng et al. [34] suggested that oxides may have beneficial or detrimental effects on the tribological behavior of materials. If the bond strength between oxides and the steel substrate is low, severe wear may occur due to fracturing or detachment from the steel substrate. In essence, under the action of frictional forces, adhesion points are sheared and slid, leading to oxide debris acting as free third bodies, causing wear on opposing surfaces. Ultimately, the wear process becomes a cycle of alternating adhesion and abrasion debris formation.

Figure 7. Elemental composition analysis using EDS (a) PS, (b) TS, (c) TPS, (d) TTS.

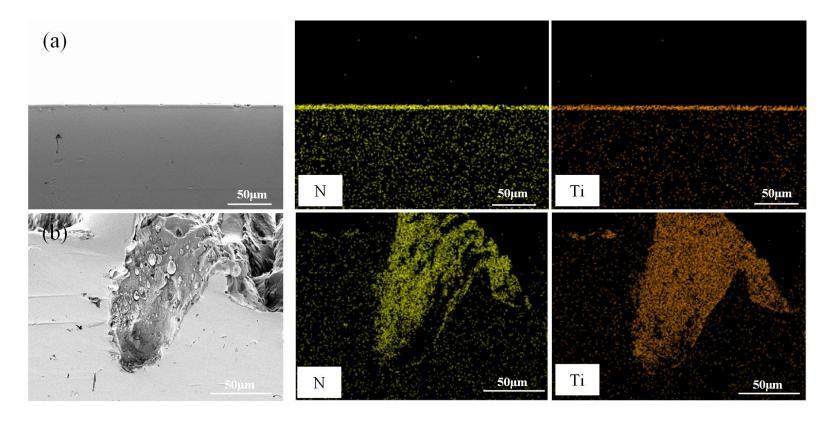
The coating samples were processed through wire cutting to obtain cross-sectional samples. Subsequently, they were polished with sandpaper until a mirror-like finish was attained. After that, ultrasonic cleaning was carried out using anhydrous ethanol, and then the samples were dried. The cross-sectional morphology was observed under a SEM for microscopic analysis. As illustrated in Figure 8, the cross-sectional morphology of all TiN coating samples exhibited dense microstructures without any voids. The TiN coating was effectively deposited at the bottom and edges of the microgrooves. There were no significant disparities in coating thickness among different samples, which implies a favorable adhesion interface between the coating and the substrate. Nevertheless, the interface bonding between the coating and the textured substrate is more compact. This might be attributed to the enhanced surface activity of the steel substrate resulting from surface deformation.

Figure 8. SEM micrographs and EDS mapping of the sample cross-sections (a) TPS, (b) TTS.

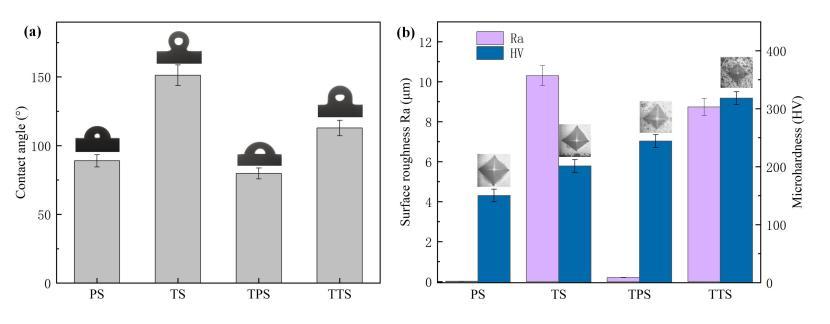
As shown in Figure 9b, the roughness of the PS surface $Ra = 0.02 \mu m$, the TS surface $Ra = 10.30 \mu m$, and the roughness of the TPS surface $Ra = 0.21 \mu m$ also increased, and the TTS surface $Ra = 8.74 \mu m$. The increase in roughness is mainly due to the presence of microstructure and the introduction of rough coating. The TS-treated surface exhibits the highest roughness value, which is caused by the significant height difference between the bottom of the surface and the raised part. These findings indicate that the modification process not only changes the microstructure of the metal surface but also has an important impact on its surface roughness.

Figure 9. After surface modification, (**a**) average contact angle measurement, (**b**) average surface hardness, and average surface roughness.

The TTS surface exhibited a contact angle (CA) of 112.82°. The experimental findings demonstrated that, in conjunction with the augmentation of the surface roughness of the TiN coating, the contact angle manifested a complex pattern of variation. Within a low roughness range, the contact angle may decrease with increasing roughness, aligning with predictions from the Wenzel model. As the roughness further increases, there may be a turning point in the contact angle, after which it increases with the roughness, in accordance with the Cassie–Baxter model.

Figure 9b shows the hardness change in the modified surface. During the hardness measurement, the loading force was set to 500 N, and the holding time was 15 s. The specific measurement method was to select four uniformly distributed points on the PS surface and the edge of the bionic texture, respectively, and then take the average value. The results showed that the hardness value for the PS surface was 150.26 HV, while the hardness value for the TS was 201.17 HV, representing a 33.88% increase compared to the PS. The hardness of the TPS reached 244.10 HV, showing a 62.45% increase compared to the PS. Furthermore, the hardness value for the TTS was 318.31 HV, indicating a substantial 111.84% increase in hardness compared to the PS. After processing biomimetic micro-textures, the hardness of the substrate had significantly increased, and the improvement in surface microhardness could be attributed to grain refinement [44]. During multiple erosion processes, inevitable oxidation phenomena, as shown in Figure 9b, could occur, which could enhance the surface hardness of the material [45].

The hardness values of the TS and the TTS were significantly higher than those of the PS and TPS. This is due to the high hardness of TiN coatings, which, when applied to the material surface, can significantly enhance overall hardness performance [46,47]. TiN typically exhibits good strength and hardness characteristics. During the coating process, there may be some interaction between TiN and the base material, such as the formation of chemical bonding or the generation of diffusion layers, therefore enhancing the surface hardness of the material. For example, research by Ke Chen et al. [48] involved processing TiN coatings on stainless steel. The study indicated that high-energy processing chambers promoted the rapid formation of chemical bonds in the TiN layer, revealing the corrosion-resistant mechanism of TiN at the atomic scale. This demonstrates a strong chemical bonding between TiN and the substrate, forming a dense protective layer.

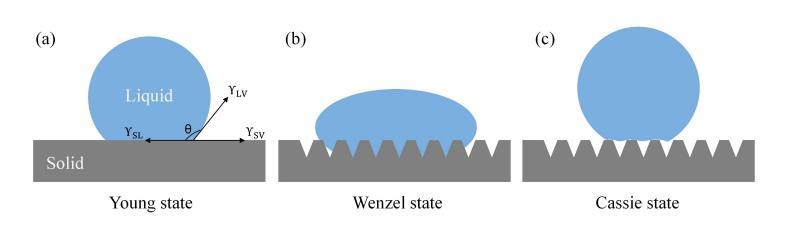
Figure 10. Wetting behavior of droplets on various solid surfaces. (**a**) Young's model, (**b**) Wenzel model, (**c**) Cassie.

Hydrophobicity is one of the important properties of solid surfaces. Metal materials with high hydrophobicity have more advantages in aspects such as corrosion prevention and self-cleaning. At present, a large number of researchers have tried to apply hydrophobic surfaces to the field of friction reduction and wear resistance to study the wear resistance of hydrophobic surfaces. Yilbas et al. [11] studied hydrophobic surfaces fabricated using lasers. The results showed that the coefficient of friction was reduced compared to untreated surfaces. Hao et al. [35] further confirmed the above conclusion. Typically, the contact angle (CA) is used to characterize the wettability of solid surfaces [36]. The classification of solid surface wettability is based on different CAs, where solid surfaces are considered hydrophilic (CA < 90°), hydrophobic (90° < CA < 150°), or superhydrophobic $(CA > 150^{\circ})$. In this study, we employed a contact angle measurement system to characterize the wettability of samples by precisely measuring the contact angle. The experimental results revealed the significant influence of surface morphology on wettability (Figure 10a). Specifically, PS surface CA = 88.89°, TS surface CA = 151.26°. Incredibly, laser microtexture makes the substrate surface change from a hydrophilic surface to a superhydrophobic surface. According to the Cassie–Baxter model [37]:

$$\cos\theta^* = f_1 \cos\theta - f_2 \tag{1}$$

where θ is the contact angle on a smooth surface, f_1 is the proportion of the actual liquidsolid contact area to the total apparent contact area, f_2 is the proportion of the liquid-air contact area to the total apparent contact area, and $f_1 + f_2 = 1$. For a smooth surface, assuming $f_1 = 1$, $f_2 = 0$ (no air involved), it adheres to the traditional Young's equation [38]:

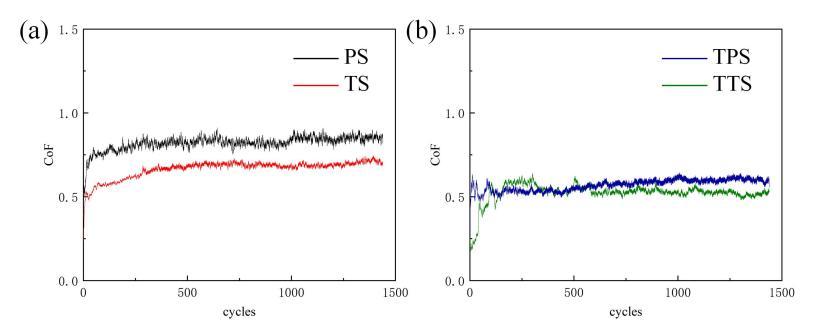
For the PS sample, as shown in Figure 11a, the friction coefficient exhibited a sharp increase in the initial stage. When the number of sliding cycles reached 132, the friction coefficient tended to stabilize, entering a stable operational phase, which could be considered a relatively short running-in period. Subsequently, the PS sample transitioned to a stable state, with an average friction coefficient of around 0.84. At the beginning of the curve, the friction coefficient was lower due to its high surface glossiness. Due to the effect of abrasion, the surface of the sample was rapidly damaged during the sliding wear process. The generated wear debris adhered to the friction surface, increasing the adhesion between sliding interfaces and resulting in an increase in the friction coefficient. Therefore, the transient increase in the friction coefficient of the PS sample could be attributed to the interaction between debris [49]. Compared to the PS sample, the TS sample had a longer running-in period, with the number of sliding cycles reaching 298, which can be considered a longer running-in phase. This was related to the reduced contact area caused by the protruding structures on the sample surface. In the stable friction stage, the TS had a friction coefficient of 0.67, lower than the stable friction coefficient of the PS (approximately 0.84). Compared to the polished substrate, the friction coefficient of TS had decreased by 20%. This was mainly due to the unique microstructure of pangolin scales, where the texture of pangolin scales typically had a certain direction and periodicity. From a materials mechanics perspective, this microstructure can alter the stress distribution on the material surface. When biomimetic textures are applied to metal or other material surfaces, it is like creating a microscopic "buffer zone" on the material surface. During friction, this texture can disperse stress, preventing stress concentration at a specific point, thus reducing instances of localized excessive wear. In the friction process, traditional smooth surfaces have large direct contact areas with the mating surface. Surfaces with biomimetic textures, however, reduce the actual contact area with the mating surface due to the presence of textures such as pits and ridges. According to the classical friction theory $F = \mu N$ (where F is friction force, μ is the friction coefficient, and N is the normal force), a decrease in the actual contact area leads to a decrease in friction force under constant normal pressure. For example, consider a smooth metal block rubbing against another flat surface with a large contact area. When the surface of this metal block is textured like a pangolin, creating many small "isolated zones" on the surface where only the tops of these zones contact the surface, the actual contact area decreases, leading to a natural reduction in friction. Additionally, the reduction in the friction coefficient due to the TS treatment could be attributed to the capture and storage behavior of wear debris in the microgrooves, alleviating third-body wear between the contact areas of the mating surfaces.

Finally, as analyzed earlier, the TS surface had a higher hardness than the PS surface, which was also a significant factor contributing to the reduction in the friction coefficient. Therefore, surface deformation pretreatment can effectively enhance the anti-friction performance of the substrate surface. Figure 9b depicts the variation in friction coefficients of samples after deposition of TiN. Similarly, all samples exhibited a running-in phase, with the TPS surface having a running-in cycle count of 82 cycles, followed by a stable friction coefficient phase. In the stable friction stage, the average friction coefficient of the TPS sample 0.58 decreased by 30.9% compared to the PS surface. This was mainly due to

the increased surface hardness after being processed with a TiN coating, making it less prone to being scratched by steel balls on the metal surface, reducing the contact area and, therefore, lowering the friction coefficient. The TTS surface had a running-in cycle count of 177 cycles. In the stable stage, the average friction coefficient of the TTS sample 0.52 in the stable sliding phase decreased by 38.1% compared to the PS sample. This result was a collaborative outcome of the TiN coating and pangolin biomimetic texture, indicating that surface texture pretreatment played a positive role in enhancing the tribological performance of TiN coatings.

Figure 11. Friction coefficient variations of different textured samples (**a**) without TiN coating, (**b**) with TiN coating.

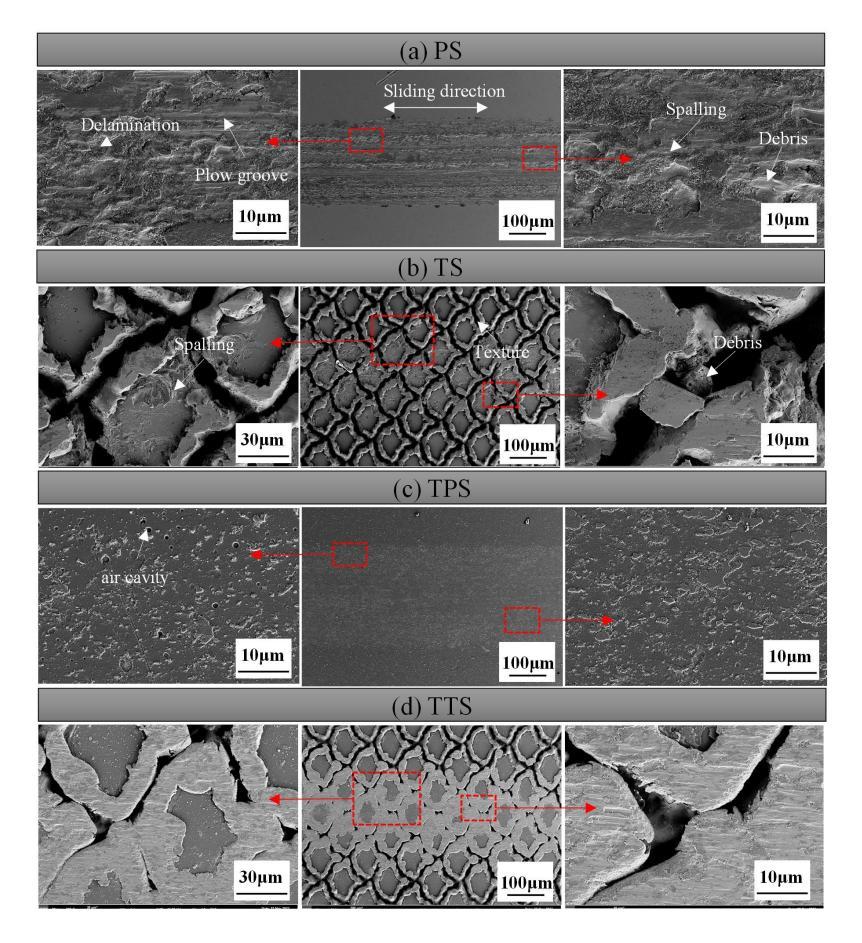
To better study the wear mechanism, the wear surface of the material after the first group of tests was analyzed by SEM. The morphology of the worn surface was observed in the middle of the wear track on each sample. In the PS sample (Figure 12a), many particles, such as wear debris and loose fragments, were distributed on both sides of the wear track. Additionally, a large amount of adhesion material, wear debris, delamination, and mechanical plowing phenomena were observed in the central part of the worn surface. This indicated severe adhesive wear on both surfaces, where adhesive points were formed due to plastic deformation in the contact area between the test specimen and the hard GCr15 steel. As the reciprocating sliding continued, these adhesive points underwent shear fracture due to significant frictional heat, leading to the formation of wear debris. Research indicated that in adhesive wear if the wear debris was hard and free, abrasive wear could occur [50]. (Figure 12a) Abrasive wear debris and particles were prominently distributed along the wear track, indicating the presence of significant abrasive wear in the contact area. As the GCr15 steel ball rubbed against the friction surface, it began to generate fragments and particles. With continued friction, due to increased frictional force and heat, adhesion occurred again. When a large number of abrasives come into play, material loss increased. Under the repeated action of abrasive particles, layer-by-layer wear mechanisms led to the formation of wear debris. This adhesion and hard abrasive wear debris increased the likelihood of stress concentration, reducing the surface strength. This wear behavior confirmed that the primary wear mechanisms of the steel matrix were abrasive wear and adhesive wear, accompanied by a small amount of fatigue wear.

Figure 12. SEM Micrographs of Material Surfaces after 1500 Sliding Cycles: (**a**) PS, (**b**) TS, (**c**) TPS, (**d**) TTS.

In comparison, the wear traces in the middle of the TS worn surface were significantly reduced (Figure 12b). Within the wear area, wear mainly occurred on the hardened layer at the edges of the laser texture, with only slight scratches and some laser protrusion peeling off onC the matrix surface. This indicated that biomimetic texturing reduced the abrasive wear of the material. At the beginning of reciprocating dry sliding, the strengthening layer (laser protrusions) predominantly affected the wear resistance of frictional wear. The strengthening layer underwent slight deformation during friction, and due to its high hardness, there was less wear debris and fewer grooves. With increased reciprocating sliding, the strengthening layer and micro-textures were worn, generating abrasive particles that aggregated to form a third body, leading to three-body wear. At this point, the microtexture pits captured wear debris, reducing the actual contact area

Figure 12c exhibited the SEM wear morphology of the TPS sample subsequent to 1500 sliding cycles after the application of a TiN coating. It was clearly discernible from the image that the sample surface remained intact, devoid of any indications of plowing, spalling, or the presence of wear debris within the wear tracks. However, a substantial amount of adherent material was observable on the surface. It is widely acknowledged that a prominent characteristic of GCr15 bearing steel is its intrinsic viscosity during sliding friction, which is manifested as a propensity for material transfer. The high-hardness TiN coating further expedited the wear of the steel ball with which it interacted. The EDS image of the abraded surface, as presented in Figure 14, disclosed the distribution of Fe elements, as depicted in Figure 14b. This further corroborated the adhesion of the wear ball within the wear track, providing compelling evidence for the analysis of the wear mechanism.

Figure 12d shows the SEM wear morphology of a TTS sample with a textured surface after applying a TiN coating after 1500 sliding cycles. It is clear that the wear of the TTS surface occurs at the position of the laser protrusion, and the protrusion will undergo plastic deformation during repeated extrusion. After 1500 repeated rubbing, the laser pits are nearly filled in the more severe positions, but it is undeniable that the smooth substrate surface without the laser is intact at this time, showing a complete appearance without any scratches or wear marks, which is the role of the laser protrusion. In the early stage of wear, due to the laser bumps, the smooth substrate surface does not participate in friction, and trace amounts of abrasive particles will occur in the bumps. At this time, trace abrasive particles will be captured by the laser pits. After a period of friction, the laser bumps will produce plastic deformation, and the pits will gradually be filled. The laser bumps that drop wear debris in the early stage become part of the substrate due to repeated extrusion in the laser pits, and since the pits are filled with laser bumps and coating materials, this will make the material in the pits higher than the original hardness of the substrate. The above results show that the most wear-resistant surface is obtained through the synergy of laser processing and TiN coating. The distribution of N and Ti elements in Figure 15c,d shows that the TiN coating on the surface of the sample remains intact after wear without observable loss. However, there is some loss of TiN coating on the edges of the textured bumps, indicating that these bumps are involved in the friction process. Figure 16 is a

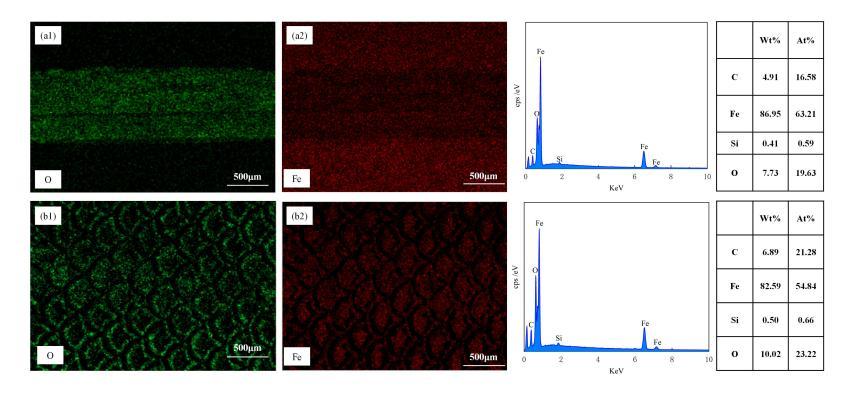
In Figure 13(a1), EDS elemental analysis showed a large number of oxygen elements detected in the middle of the wear track, confirming oxidation wear during dry air friction tests. In fact, under the action of continuous reciprocating sliding, the contact area was in a plastic flow state, and the generated oxides became the bonding material on the contact interface. Similarly, in this scenario, the generated oxides would act as bonding material aside from the lubricating material. Figure 11a, the PS sample with the most severe oxidation adhesion had the highest friction coefficient. Figure 13(a2) further confirmed the adhesion of iron elements in the wear track by the ball.

Figure 13. EDS Elemental Composition Analysis of Material Surfaces after 1500 Sliding Cycles: (**a1,a2**) PS, (**b1,b2**) TS.

In Figure 13(b1), EDS elemental analysis showed that the O elements generated during laser texturing decreased after a period of wear. The O elements on the unaltered matrix surface showed minimal variation, proving that the wear primarily occurred at the textured protrusions during the wear process. The distribution of Fe elements in Figure 13(b1) confirmed the reduction in adhesive material.

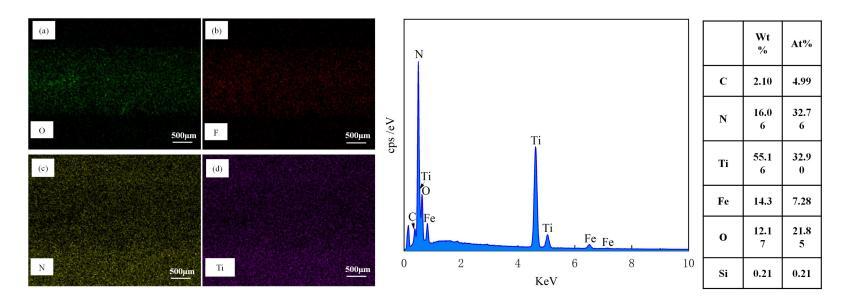
Figure 14. EDS Elemental Composition Analysis of TPS Material Surface after 1500 Sliding Cycles, (a) O, (b) F, (c) N, (d) Ti.

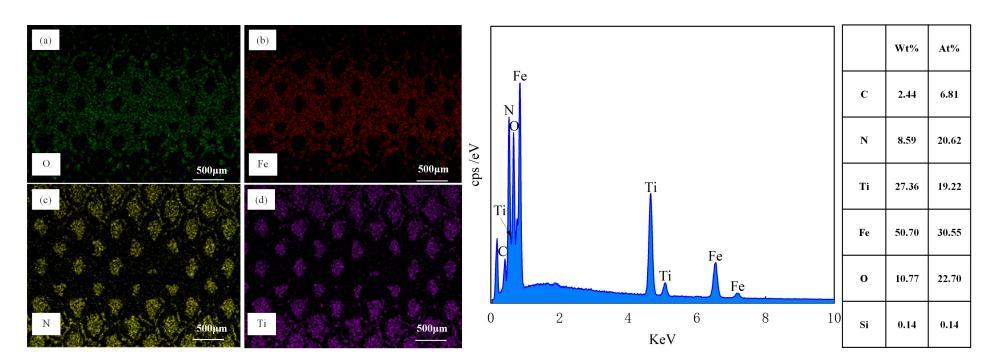
Figure 15. EDS Elemental Composition Analysis of TTS Material Surface after 1500 Cycles, (a) O, (b) F, (c) N, (d) Ti.

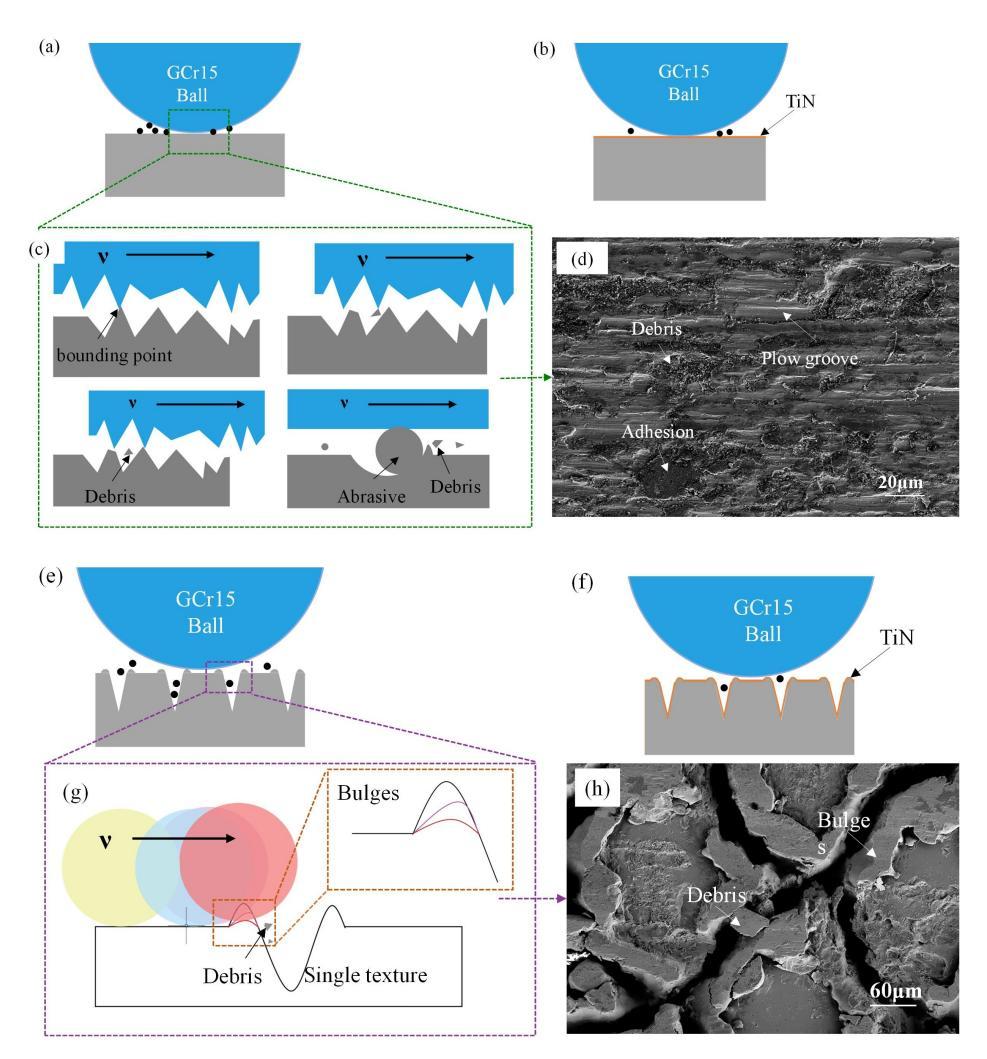
Figure 16. Cross-sectional schematic diagrams of the wear mechanism models of the samples under dry friction conditions: (**a**–**c**,**e**–**g**). SEM morphology images of the material surface after 1500 sliding cycles: (**d**) PS, (**h**) TS.

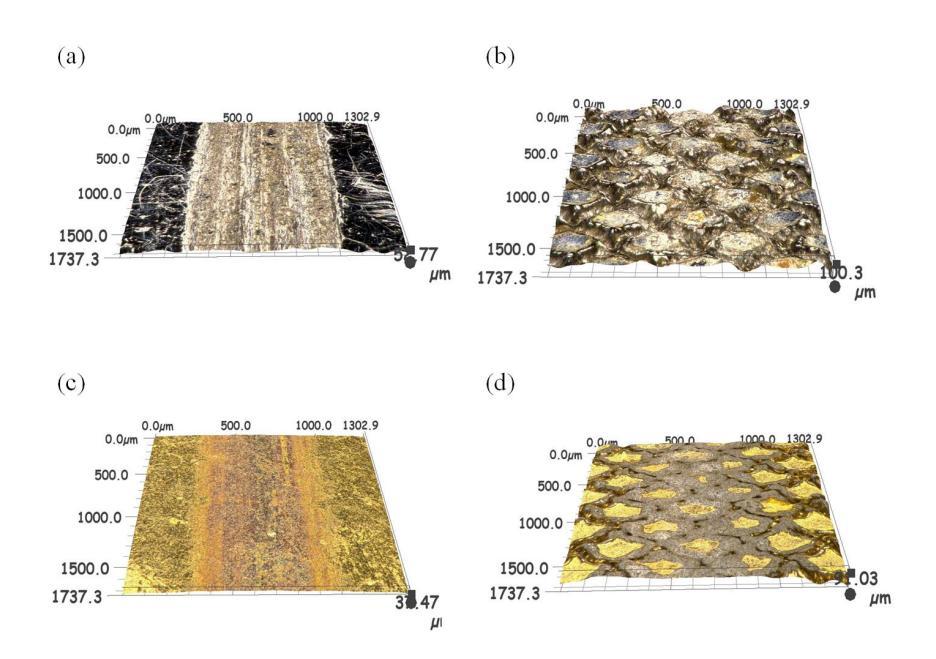
diagram of the wear mechanism, from which the wear process can be seen. Figure 17 is a three-dimensional map of different surface wear topographies, further confirming the previous analysis.

Figure 17. Three-dimensional morphology of wear marks: (a) PS, (b) TS, (c) TPS, (d) TTS.
