Article

Characterization of the Mechanical Performance in **Compression Perpendicular to the Grain of Insect-Deteriorated Timber**

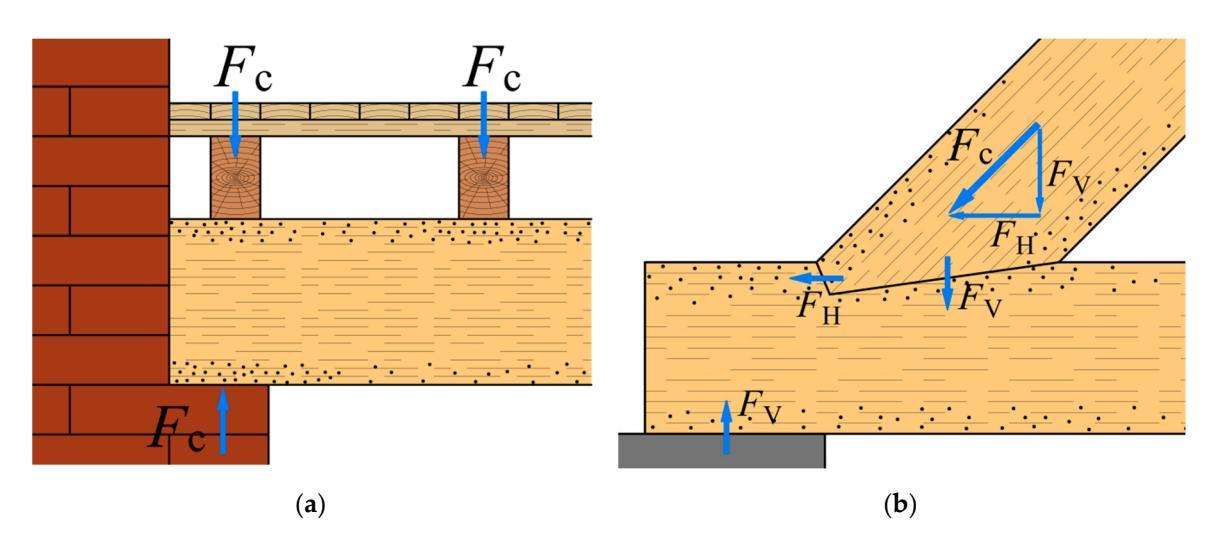
Figure 1. Insect-deteriorated timber members withstanding compressive loads (F_c), implying their vertical (F_V) and horizontal (F_H) components in connections: Main floor beam in contact with masonry support (**a**), single step joint within roof trusses (**b**). Black dots represent exit holes on the external surfaces of wood infested by insects.

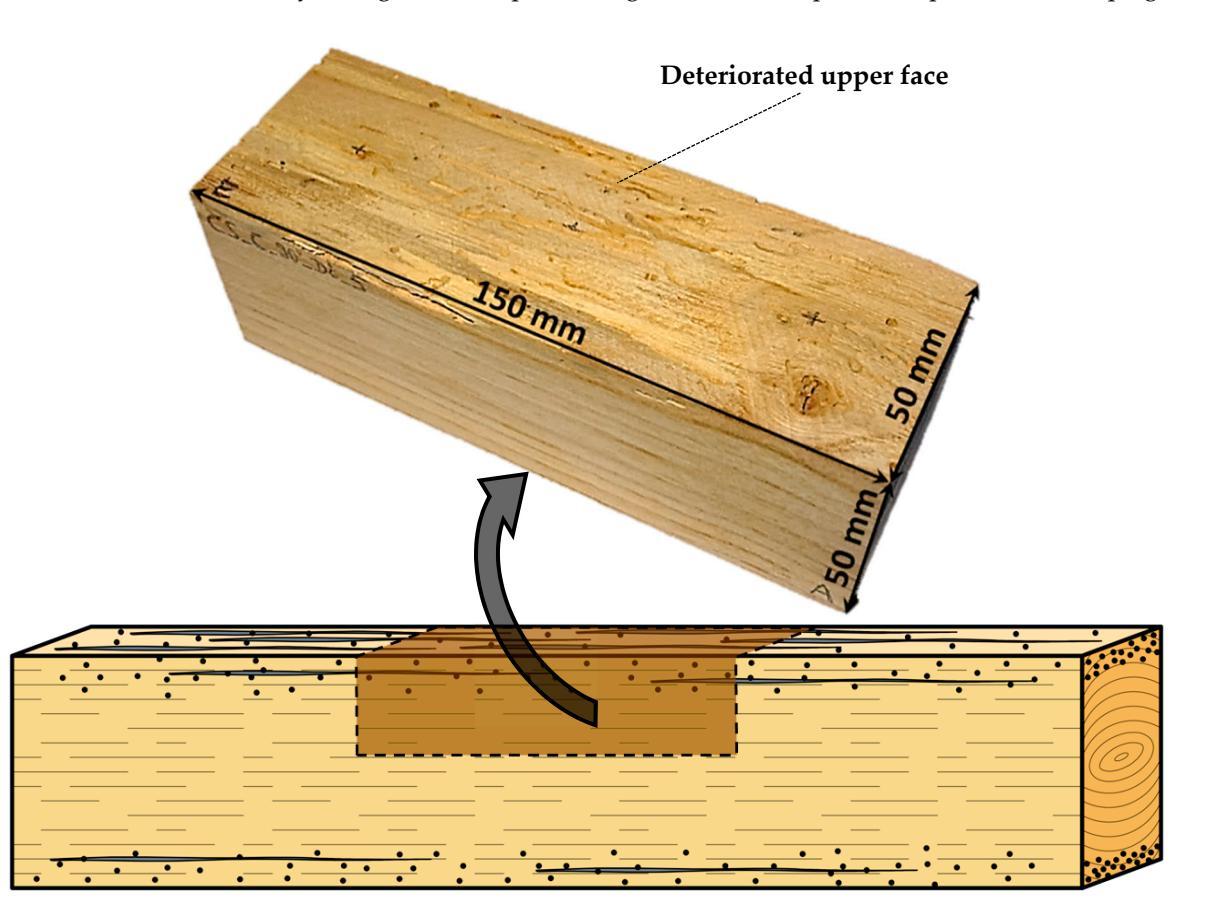
Figure 2. Geometry of the small timber samples extracted from existing beams infested by anobiids.

Several small samples were extracted from existing timber beams of chestnut wood (*C. sativa*), so that the upper face (Figure 2) was cut from the layer that visually appeared to present the higher level of deterioration. Regarding the mechanical characterization detailed further, the monotonic compression load was assumed on the upper face. The degradation found was restricted to sapwood and mainly due to insects identified as anobiids (Coleoptera Anobiidae). Due to the limited availability of infested timber beams, only 12 degraded samples were gathered for the present experimental campaign.

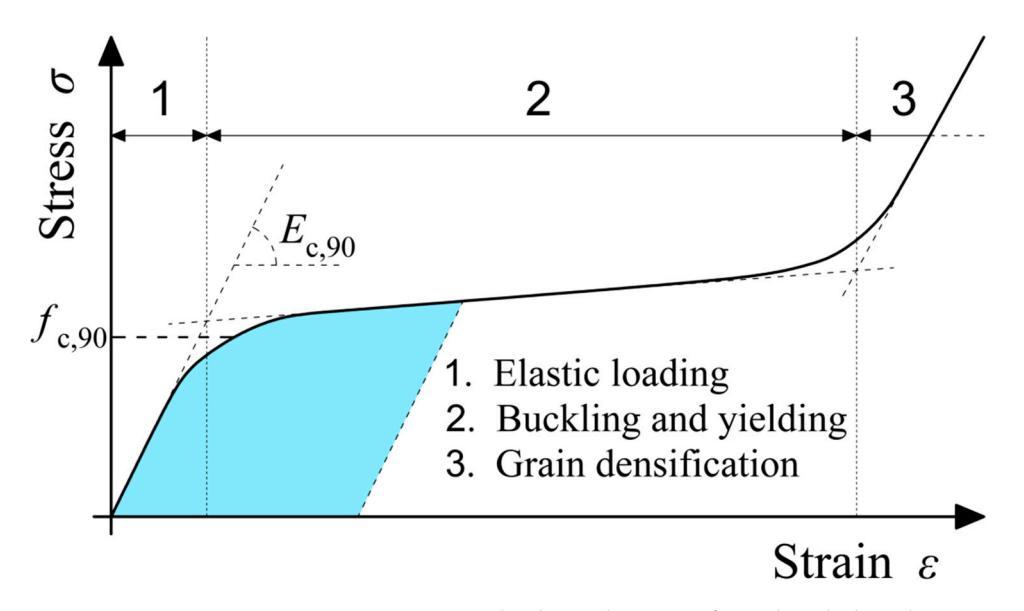
Figure 3. Compressive stress–strain curve perpendicular to the grain of wood, including the respective strength $f_{c,90}$ and elastic modulus $E_{c,90}$. Scheme inspired from [21,22].

The expected compressive stress–strain response of wood perpendicular to the grain (Figure 3) can be described in three steps [21,22]: (1) Elastic loading, (2) buckling and yielding, (3) grain densification. In the elastic part, compressive stress σ linearly increases with little strain ε perpendicular to the wood fibers, for which the related slope stands for the elastic modulus $E_{c,90}$. Once reaching the compressive strength $f_{c,90}$, buckling and yielding occur; they are characterized by intensified crushing of wood fibers and a very slow stress increase. With very high crushing, wood fibers start to densify, due to significant decrease of void volume inside the material, resulting in a sudden rising of compressive stress. In the present experimental program, only the first two steps of the compressive stress–strain response were tackled to achieve the objectives previously stated.

Regarding the 4 sound samples, the pattern of the compressive force-displacement responses (Figure 8) matches very well with the theoretical one (Figure 3), and with the experimental one (Figure 5b) obtained from sound samples made of *P. sylvestris* [10]. Indeed, the respective patterns related to both elastic and yielding steps can easily be simplified by drawing up two straight lines whose slopes represent the wood stiffness. It should be noted that the stiffness related to the fiber yielding is much lower than the elastic one, resulting in significant crushing perpendicular to the grain, while the compressive forces keep rising. The vertical crushing *w* was mainly concentrated under the loaded area over 10-mm depth on average (Figure 9a), although it might still spread with lower deformation up to 30-mm depth due to the significant stiffness of sound timber samples. After ending the tests, 1–2-mm depth of timber embedment was observed on the upper face of the specimens at the former location of the loading steel plates.

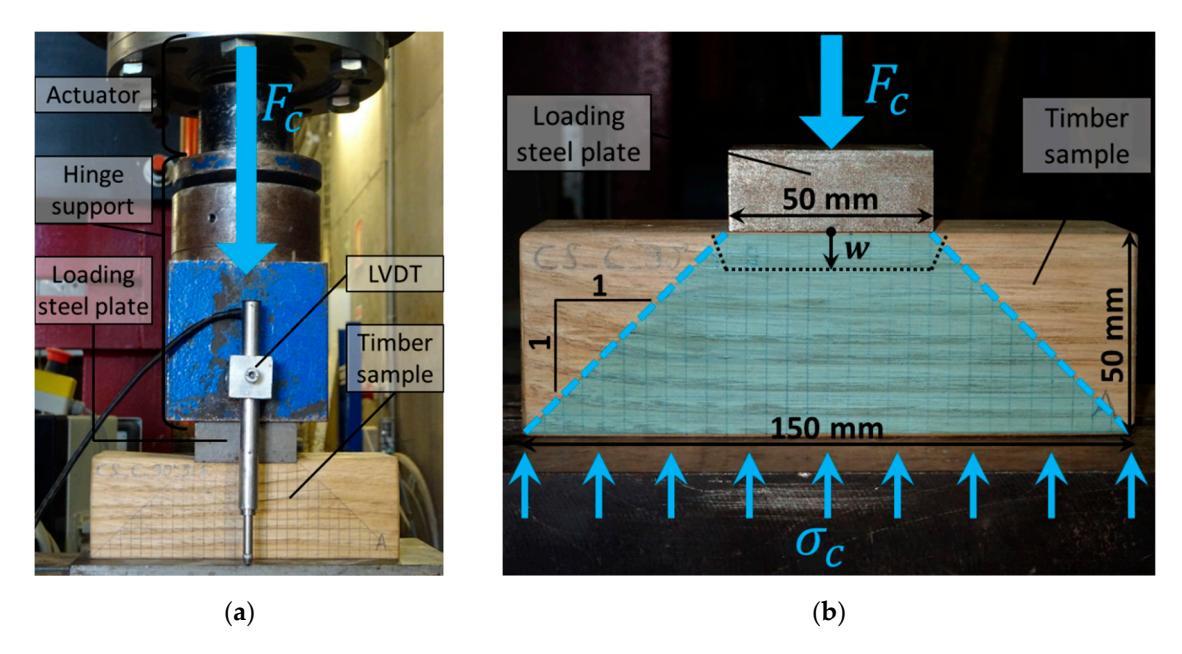
Figure 4. Setup required to apply the monotonic compression load F_c perpendicular to the grain (**a**). Compressive stress distribution σ_c and vertical crushing *w* assumed under the loaded area (**b**).

Conforming with ASTM D143-94 [11], the monotonic compression test consists of applying a vertical force F_c perpendicular to the grain in the radial direction, transferred from the actuator to the steel plate, in the middle of the insect-degraded upper face for small timber samples (Figure 4a). In this regard, the standardized loading velocity 0.01 mm/s was chosen. In order to minimize the distortion effects and out-of-plane displacements during the tests, a hinge support was settled beforehand between the actuator and the loading steel plate. Also, two Linear Variable Differential Transformers (LVDTs) aided by a sketched grid from either lateral faces of the sample were used to measure the vertical crushing *w* of the loaded area. The latter was delimited by the basis dimensions of the steel plate 50 × 50 mm² in order to ensure a standardized compressive stress distribution (Figure 4b) under an inclination angle of 45° (1:1). Small timber samples tested were simply supported from the bottom side to simulate the reaction of compressive stresses σ_c over the effective length of 150 mm, which is detailed further in the next section.

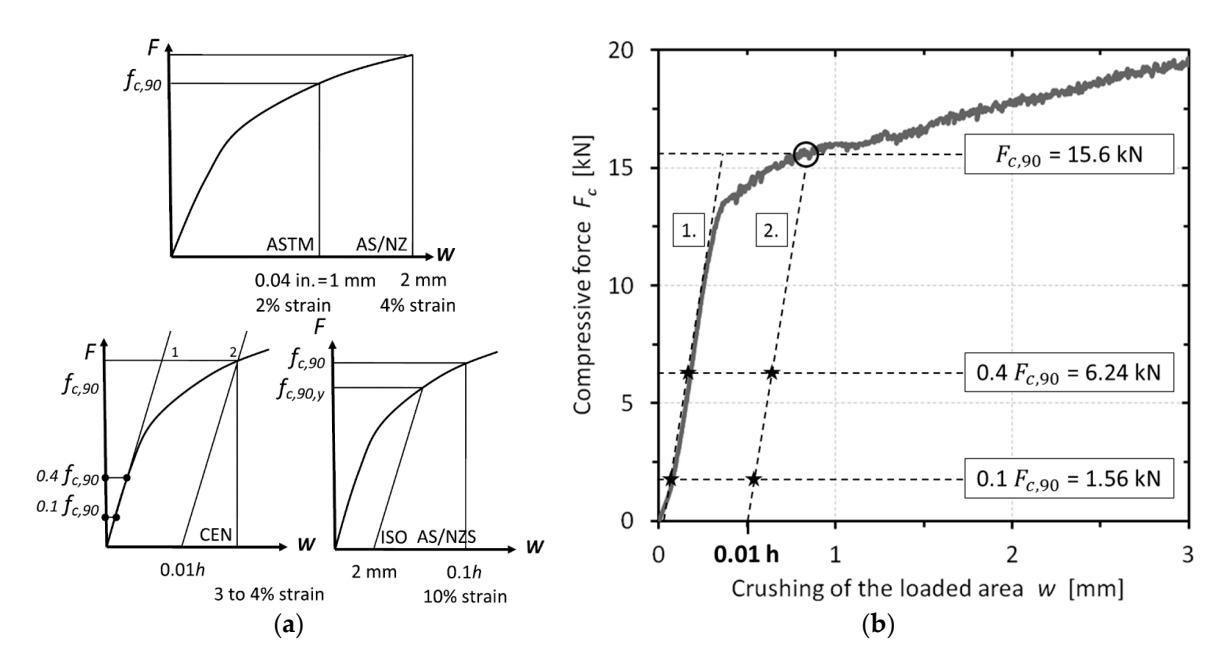
Figure 5. Standardized definitions (**a**) of the maximal elastic force $F_{c,90}$ in compression perpendicular to the grain, from [13]. Application of the European Standard EN 408 [12] on the mechanical characterization of scots pine (*Pinus sylvestris* L.) (**b**), from [10].

Conforming with the European standard EN 408 [12], the maximal compressive force (Figure 5b) is defined by the intersection between the force-displacement response and a line parallel to the elastic part of the curve with 0.01 *h* offset, where h = 50 mm is the timber sample height. The elastic part can be featured by a straight line including two displacements points, noted w_{10} and w_{40} , at 10% and 40% of the estimated maximal compressive force $F_{c,90}$. Furthermore, the elastic modulus $E_{c,90}$ is given by Equation (2) from the same standard [12], where b = 50 mm and l = 50 mm are, respectively, the width and length of the loaded area previously defined for the monotonic compression tests (Figure 4b). On the other hand, similar calculation methodology is introduced by the standard AS/NZS 3603 [24], but with 2-mm offset (Figure 5a), resulting in higher compressive strengths mostly used for assessing the serviceability limit of structural timber members working in compression [26]. Because the calculation method herein stated takes into account the likely variation of elastic stiffness as per

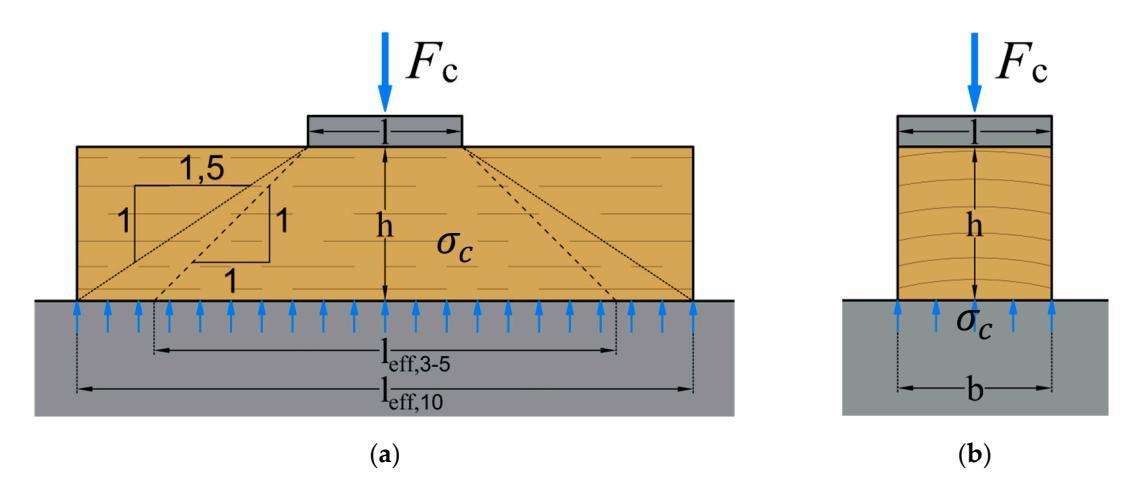
Figure 6. Theoretical compressive stress σ_c perpendicular to the grain in the radial direction spreading over the effective length l_{eff} on the lateral face (**a**), and over the width *b* on the transversal face (**b**), for a determined height *h* of the timber sample. Schemes inspired from [9].

In accordance with Eurocode 5 (EN 1995-1-1 [27]), the compressive strength $f_{c,90}$ is calculated by Equation (3), where $k_{c,90}$ is the factor of the compressive stress spreading perpendicular to the grain inside timber. Although $k_{c,90}$ varies according to the load cases and support configurations within the structural member, the minimal and maximal values imposed by the Amendment 1 of Eurocode 5 (EN 1995-1-1/A1 [28]) are 1 and 1.75, respectively. From reliable analytical models on the compressive stress spreading perpendicular to the grain [14], this factor can be estimated by Equation (4), where k = 1.1 is an experimental calibration factor and l_{eff} is the effective length of compressive stress spreading inside timber (Figure 6). The onset of wood fibers crushing was assumed in the present work for small deformations of 3–5%, leading to compressive stress dispersion at an inclination angle of 45° (1:1) under the loaded area. Nonetheless, high deformations of 10% should be considered when assessing the serviceability limit, with a slope of 34° (1.5:1) for the compressive stress spreading [13,14].

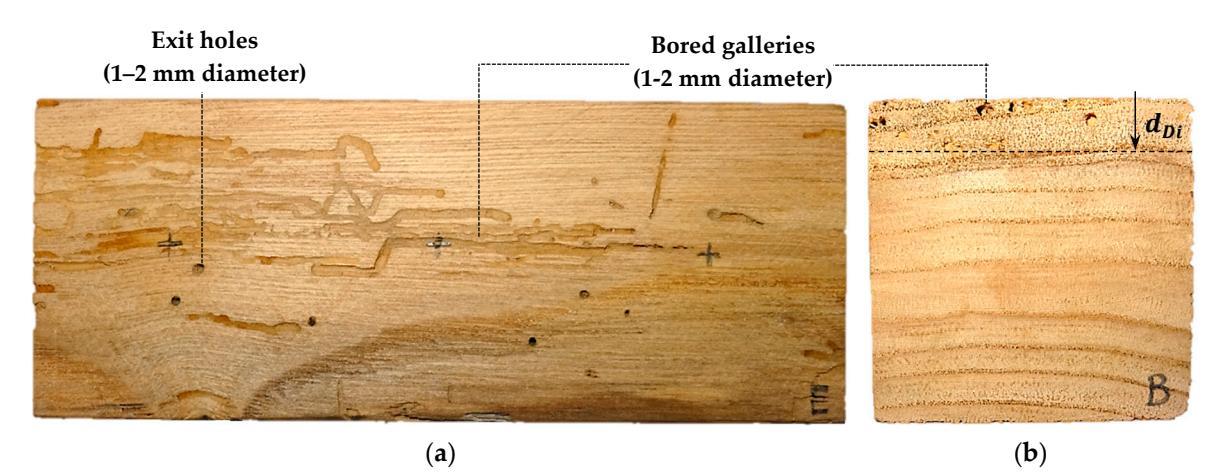
Figure 7. Upper face (a) and cross-section (b) of the insect deteriorated sample Di_1.

As a first characterization approach, a visual assessment was made on the upper face (E) and the cross-sections (C–D) for 12 biologically degraded timber samples (Figure 7a,b), in order to complete the experimental outcomes obtained from monotonic compression tests. To this end, two physical aspects of deteriorated wood were tackled: (1) Touch surface and (2) texture. In Table 1, some relationships might be established between the density loss ρ_L and the qualitative parameters previously stated. For instance, hard surface (HS) in respect with the upper face (E) could be related to timber samples with $\rho_L \leq 8.76\%$, whereas soft surface (SS) and friable texture (FT) were mostly observed for the other ones.

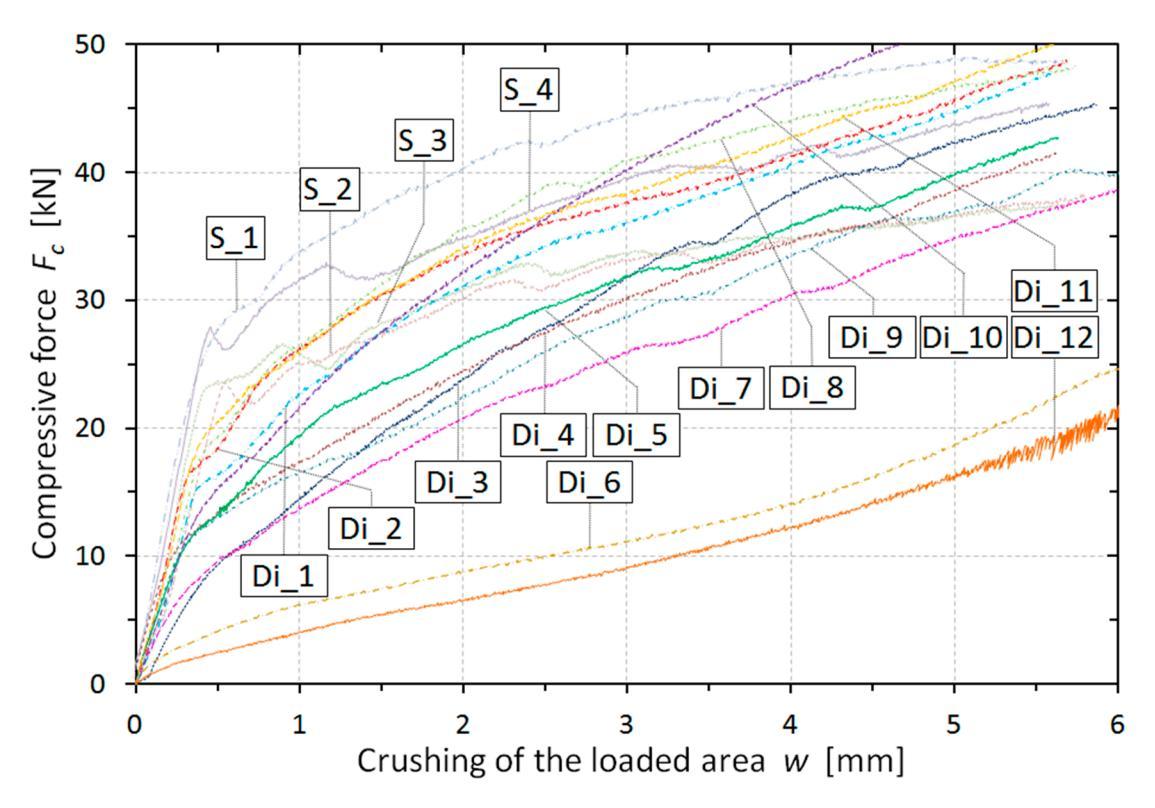
Figure 8. Compressive force-displacement curves perpendicular to the grain for the 4 sound (S) and 12 insect-deteriorated (Di) timber samples tested under monotonic compression.

For the 12 deteriorated samples, the compressive force-displacement responses perpendicular to the grain (Figure 8) increasingly fell down as the degradation level went up. As a matter of fact, both maximal elastic force and stiffness, which constitute the "elastic loading" part, were progressively reduced when the wood density loss was constantly rising. Thereby, an insect wood deterioration classification could be established in the future by correlating the loss of both maximal elastic force and stiffness with the density loss, based on a larger amount of anobiid-infested timber samples to test. On the other hand, the stiffness related to the "buckling and yielding" part slightly increased in comparison with those from sound samples. This phenomenon was due to the early grain densification inside the wood deteriorated layer under the compressive loading area [21,22]. Standing out among the others, the tested samples Di_6 and Di_12 presented flattened compressive force-displacement curves with maximal elastic force and stiffness both insignificant. This was a sign of high deterioration level. The whole vertical crushing *w* was concentrated under the loaded area over 10–15-mm depth on average (Figure 9b), due to the reduced stiffness of degraded timber samples. After ending the tests, 3–4-mm depth of timber embedment was observed on the upper face of the specimens at the former location of the loading steel plates.

Based on the force-displacement responses (Figure 8) and their maximal elastic force $F_{c,90}$ in compression inferred in accordance with EN 408 [12], the compressive strength $f_{c,90}$ and elastic modulus $E_{c,90}$ perpendicular to the grain in the radial direction were determined by Equations (2)–(4) for all anobiid-infested timber samples tested. Additionally, loss of compressive strength and elastic modulus, noted $f_{c,90,L}$ and $E_{c,90,L}$ (%), were calculated by both Equations (6) and (7), respectively, with the mean values of compressive strength $f_{c,90,s,m} = 6.11$ MPa and elastic modulus $E_{c,90,s,m} = 1132.85$ MPa from the 4 sound specimens tested. The values of all the parameters stated above are given in Table 2.

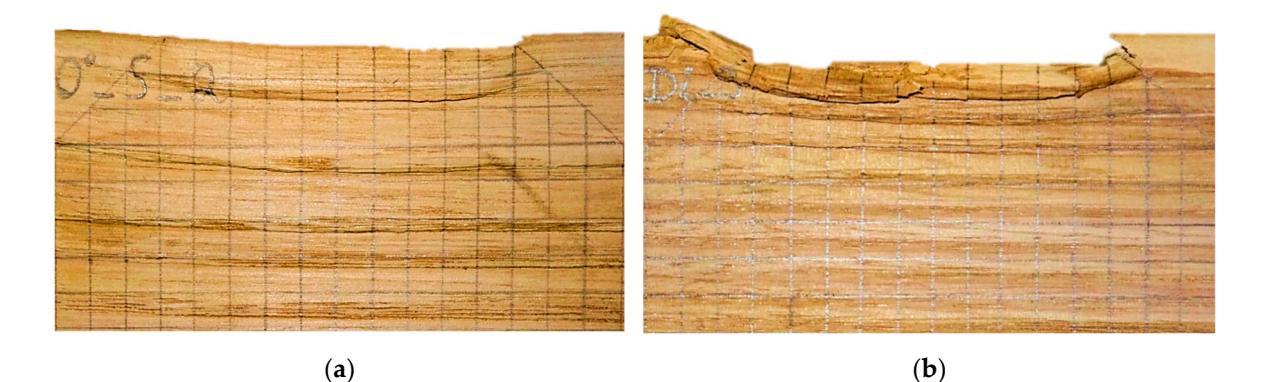
Figure 9. Crushing *w* perpendicular to the grain under the loaded area obtained after the tests for the sound (**a**) and insect-deteriorated (**b**) timber samples. Meshing dimensions of 5×5 mm.

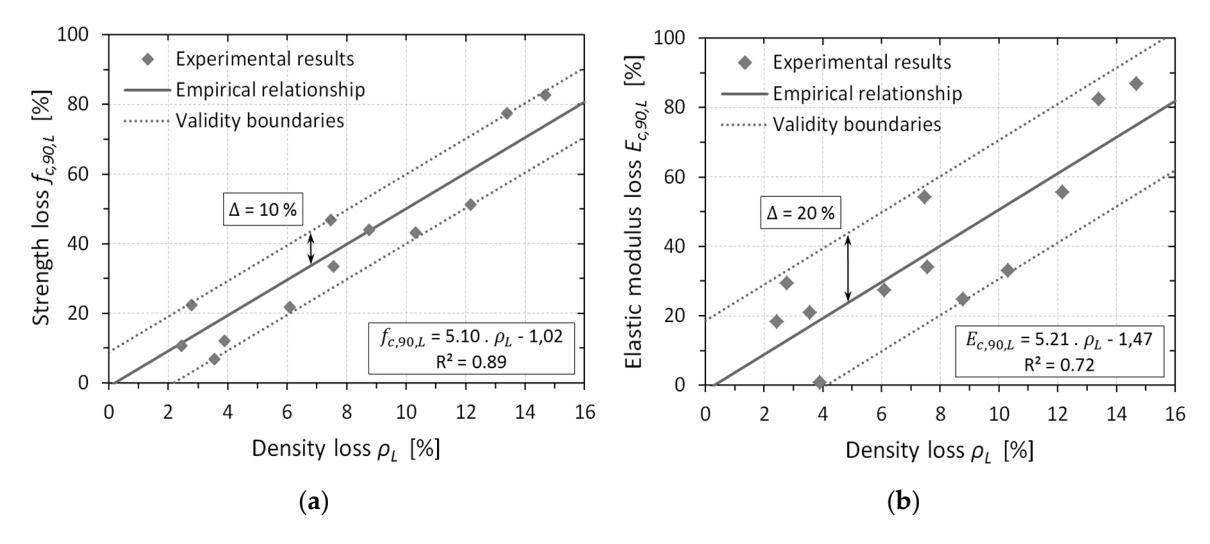
Figure 10. Experimental versus empirical values for the compressive strength loss $f_{c,90,L}$ (**a**) and elastic modulus loss $E_{c,90,L}$ (**b**) perpendicularly to the grain, in respect with the density loss ρ_L for insect-deteriorated samples tested.

The loss of compressive strength $f_{c,90,L}$ and elastic modulus $E_{c,90,L}$ assessed from 12 deteriorated timber samples were plotted on two graphs in respect with the density loss ρ_L (Figure 10). The linear regression method was used to establish strong empirical correlations between those stated parameters. Regarding the compressive strength loss, the experimental dots detailed on the first graph (Figure 10a) are quite condensed around the linear regression ($\mathbb{R}^2 = 0.89$, $\Delta = \pm 10\%$) expressed in Equation (8), whereas those plotted on the second graph (Figure 10b) are more diffused ($\mathbb{R}^2 = 0.72$, $\Delta = \pm 20\%$) in comparison with the related empirical Equation (9) for the elastic modulus loss. Such different fluctuations might come from the natural variability of wood mechanical properties, the short number of specimens tested, and the random diffusion of anobiid deterioration under the compressive loading area.
