Article Comparative Study of Chloride and Fluoride Induced Aluminum Pad Corrosion in Wire-Bonded Device Packaging Assembly

Keywords: wire-bonded device; halide contaminant; Al pad corrosion; corrosion inhibitor

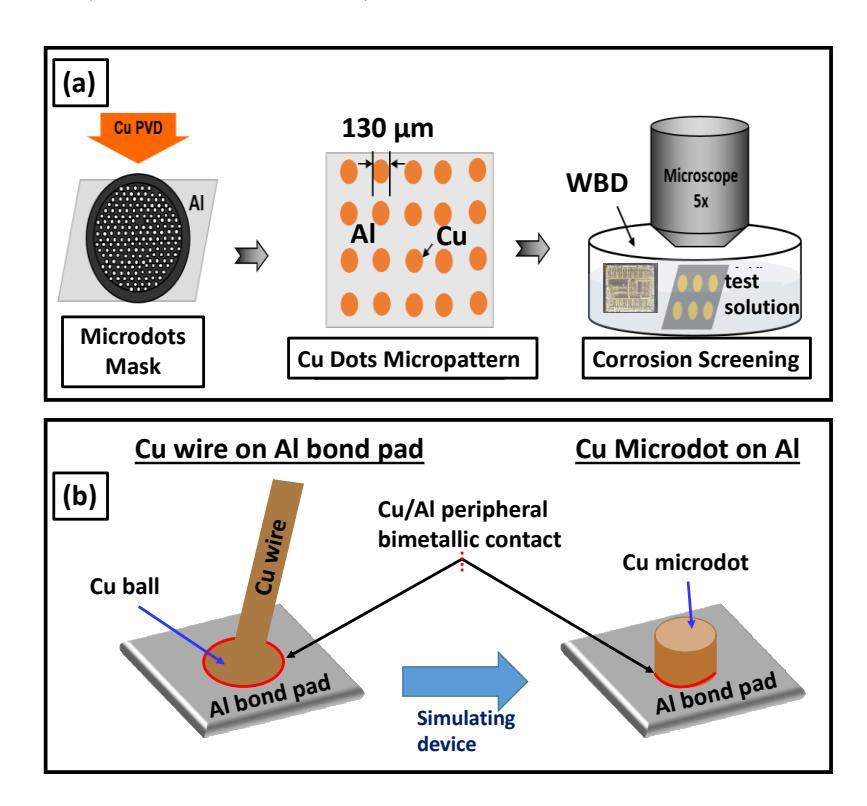
Figure 1. (a) Schematic representation of the immersion micropattern corrosion screening metrology and (b) micropattern sample peripheral bimetallic contact created to simulate the effect of Cu wire on the Al bond pad.

The Al samples mentioned in this study refer to Al alloyed with 0.5 wt% Cu. Corrosion screening was carried out by studying the real-time progression of corrosion under the microscope. The detailed procedures for the micropattern screening technique were described in this publication [17]. The micropatterns used in this study are shown in the Figure 1 schematic. The micropatterns were created by sputtering 130 µm diameter Cu microdots onto an Al (with 0.5 wt% Cu) substrate to imitate the Cu wire bonding to the Al bond pad scenario. The thickness of the dots ranged from 50 to 500 nm. A Nikon LV-150 optical microscope was used for monitoring and recording the corrosion progression. All chemicals were reagent grade and used as obtained from Merck. The dilute halide solutions were made by a series of dilutions from a 1000 ppm stock solution of NaCl and NaF, respectively, for Cl⁻ and F⁻ solutions. Ultrapure water from Millipore Sigma (resistivity, 18.1 M Ω , Burlington, VT, USA) was used in making solutions, rinsing samples, and performing dilutions. All pH adjustments were made using H₂SO₄ and NaOH (both reagent grades from Merck, Burlington, NJ, USA). All samples were rinsed with UPW before surface analysis. EM-EDX measurements of corroded samples were obtained from FEI Quanta ESEM scanning electron microscopes (Hillsboro, OR, USA) to study surface products and surface morphology. The gas evolution during corrosion was investigated by the method of headspace chromatography using a Thermo Finnigan gas chromatograph-mass spectrometer (GC-MS, Waltham, MA, USA). The WBD devices were immersed in Cl^- and F^- conditions separately in a silicone-sealed flask for more than 24 h, and the headspace gas was transferred to a GC–MS analyzer for composition identification. Potentiodynamic polarization was carried out using a CHI 760D potentiostat (Austin, TX, USA) in a three-electrode system (Al as the working electrode). Electrochemical studies were carried out in samples with a controlled area of 0.3 cm² exposure. The galvanic coupling current was measured using two electrodes (Cu and Al) immersed in the solution and electrically connected to a Keithley 2400 source meter (Solon, OH, USA). The chemical composition of the surface products was investigated using PHI 5000 VersaProbe Scanning XPS (Chanhassen, MN, USA).

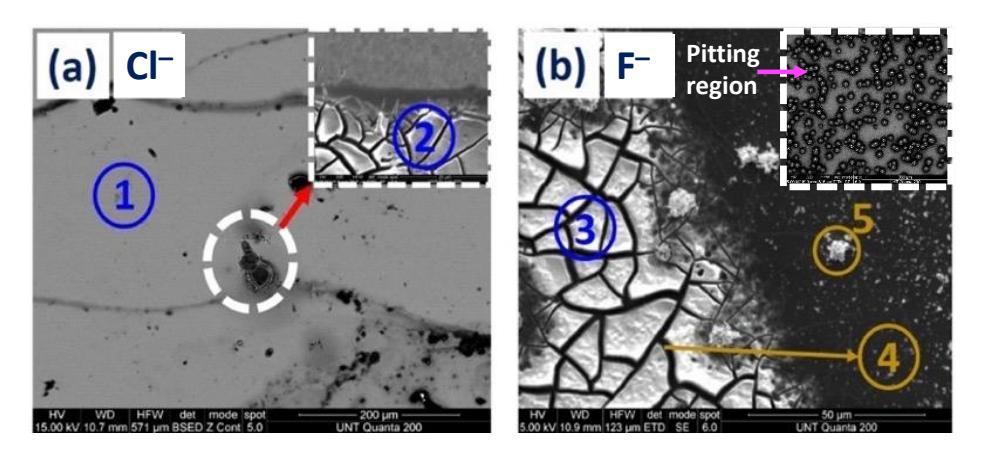
Figure 3. SEM analysis of corroded Al surface. (a) Al surface after 24 h immersion in 5 ppm Cl⁻ at pH 5. Inset (white dotted line): Close-in view of mud crack in Cl⁻-induced corrosion. (b) Al surface after 24 h immersion in 5 ppm F⁻ at pH 5—close-in view of mud cracks formed in F⁻-induced corrosion. Inset (white dotted line): Close-in view of the pitting region. Note: EDX analyzed the numbered cycle areas; results are listed in Table 1.

The SEM analyses of the corroded Al samples further corroborated the surface morphology difference after 24 h of corrosion. As shown in Figure 3, the F^- corrosion was characterized by extensive pitting (Figure 3b inset) all over the Al sample, whereas the Cl⁻ sample showed only surface roughening after 24 h with very few pitting spots. SEM imaging of the F^- -corroded sample on the pitting shows mud crack morphology on the Al surface with additional surface precipitates (Figure 3b). EDX analysis on the mud crack region and surface precipitates revealed an F^- signal on the sample, indicating the presence of Al-F surface products. The area between the mud crack islands showed minimal Al and O signals due to the extensive Al corrosion that reached the underlying Si substrate.

Table 1. EDS data for spots numbered in the SEM images in Figure 3.

The Cl⁻ sample showed no extensive pitting or widespread mud crack corrosion morphology, indicating a slow uptake of Cl⁻ ions by the Al oxide surface. Further zoomedin inspection of the pitting area revealed mud crack corrosion morphology but on a much smaller scale. EDX analysis on the corroded (surface roughened) area and mud crack region revealed the absence of a Cl⁻ signal on the Al substrate, implying Al-Cl surface products' absence. The presence of surface products in F⁻ supports the assertion of having different corrosion attacking mechanisms and different corrosion products in comparison with Cl⁻. The corroded Al EDX characterization and its elemental composition result are shown in Table 1.

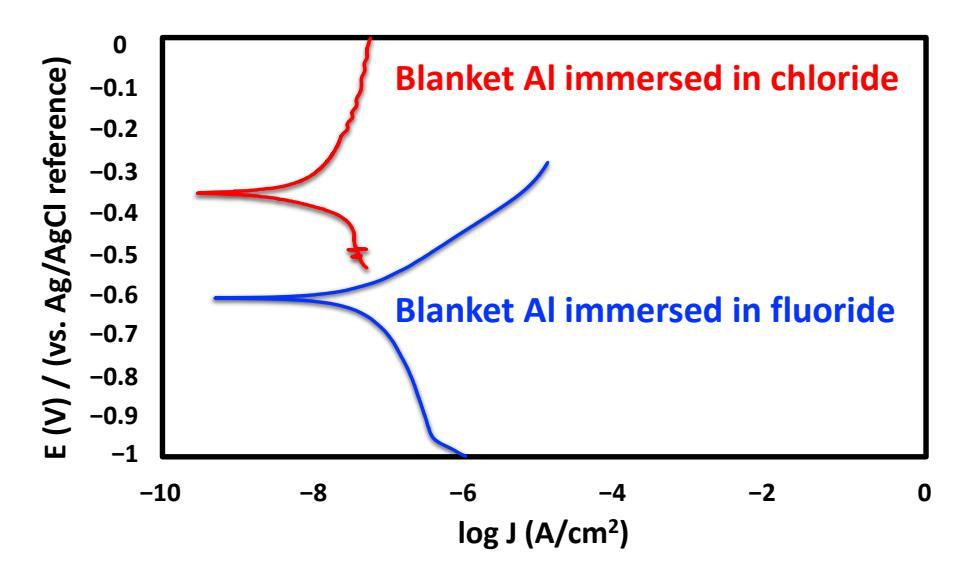
Figure 4. Tafel plot analysis of Al without bimetallic contact in Cl^- and F^- containing solutions (5 ppm, pH 5). The scan rate used is 0.001 V/s.

The Tafel plot analysis observed a similar corrosion trend as the above-mentioned corrosion screening on the blanket Al. As shown in Figure 4, the corrosion potential of Al in 5 ppm F⁻ solution ($E_{corr} = -0.62$ V) was considerably more negative than the corrosion potential in 5 ppm Cl⁻ solution ($E_{corr} = -0.37$ V). In addition, the corrosion current density of Al in F⁻ solution ($J_{corr} = 16.9$ nA/cm²) was close to 10 times higher than in Cl⁻ solution ($J_{corr} = 1.8$ nA/cm²). Therefore, the observed Tafel data supported the assertion that F⁻ ions can readily break down the passivation Al₂O₃ layer to result in significant pitting corrosion on the Al surface (see Figure 2c). In comparison, it is less thermodynamically favorable for Cl⁻ ions to break the passive Al₂O₃ layer, resulting in less corrosion observed on the Al substrate.

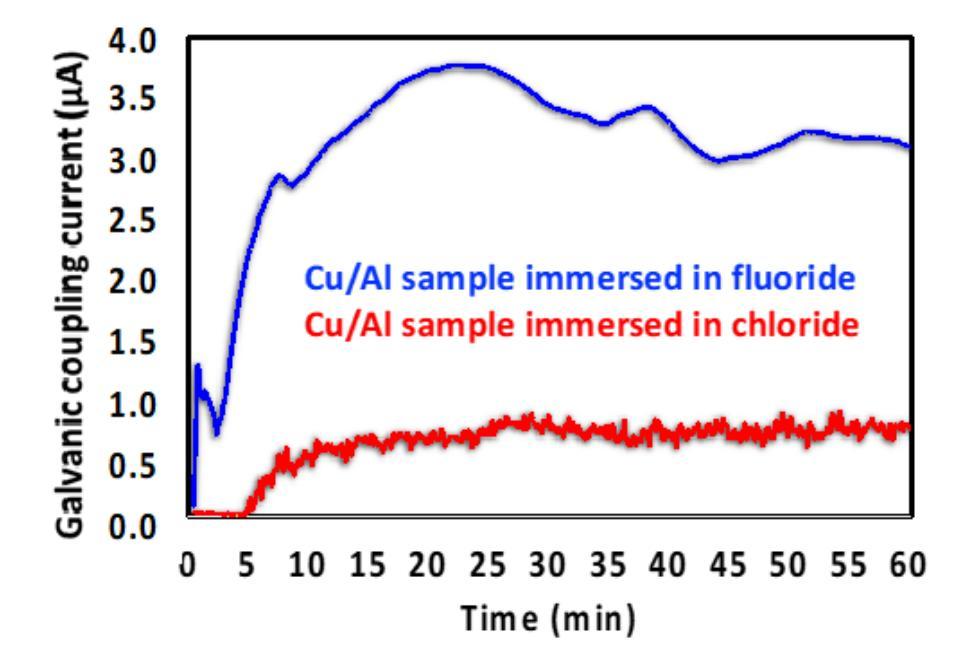
Figure 5. Galvanic coupling current for Cu-Al couple immersed in 5 ppm Cl⁻ and 5 ppm F⁻ solutions at pH 5.

Next, the galvanic corrosion currents were measured, as shown in Figure 5, by the galvanic coupling of Cu and Al electrodes while immersed in Cl⁻ or F⁻ solutions. In this Cu/Al couple, the Cu acted as the cathode and Al as the anode. The Cu/Al galvanic couple immersed in 5 ppm F⁻ solution showed the Al corrosion current increasing to near 4 μ A in about 20 min. The galvanic couple immersed in F⁻ solution for 60 min showed an average galvanic coupling current of ca. 3 μ A. Contrastingly, the galvanic couple immersed in 5 ppm Cl⁻ solution showed the onset of corrosion only after 5 min. The observed galvanic current was around 0.7 μ A, almost four times lesser than the observed current in F⁻ solution. The galvanic corrosion current measurement of the Cu/Al couple in F⁻ solution displayed the ready breakdown of passivating Al oxide in comparison with Cl⁻ solution similar to the observed Al Tafel plot analysis for blanket Al samples.

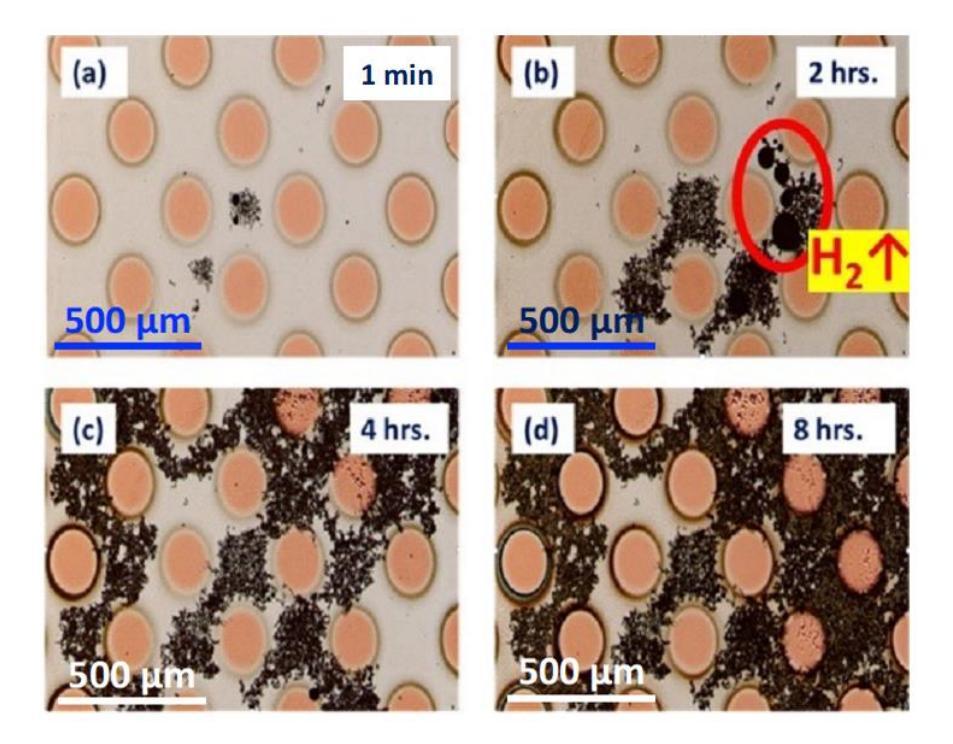
Figure 6. Micropattern corrosion screening of Al/Cu bimetallic contact immersed in 5 ppm Cl⁻ solution at pH 5. The images were taken (**a**) soon after immersion (**b**); immersion time = 2 h, (**c**) 4 h, (**d**) 8 h.

The Al corrosion under the influence of Cu/Al bimetallic contact was studied using micropattern samples to simulate the real-life Cu wire-bonded device situation. As shown in Figure 1, the standing Cu microdots represent the Cu bonding wires, which cover the Al surface to simulate Al bonding pads. Solutions of 5 ppm Cl^- and 5 ppm F^- were used at pH 5 to study Al corrosion in a bimetallic contact situation similar to that shown in Figure 2. As shown in Figure 6, the Al corrosion progression was starkly different with the presence and absence of a peripheral Cu bimetallic contact. In the absence of peripheral Cu bimetal contact (see Figure 2b), in a 5 ppm Cl⁻ solution at pH 5, Al showed minor corrosion, and the corrosion rate was much slower. However, the presence of Cu bimetallic contacts made the corrosion of the Al layer more aggressive, accompanied by immediate gas escape at the corrosion site. This gas was later analyzed and confirmed as hydrogen (H_2) gas using a GC–MS, shown in the later section of Figure 9. In addition, a dendritic structure was also formed on the corroded Al surface, resulting in cracks on the Al surface, similar to the mud-crack-like surface morphology. The addition of a bimetallic contact (Cu) on the Al surface helped the Cl⁻ ions break down the passivation layer on Al more readily, coupled with H_2 gas evolution, resulting in increased corrosion activity. As shown in Figure 6d, the Al surface was corroded entirely in only 8 h with bimetallic contact, compared with only minor corrosion observed on the Al blanket sample after 24 h (see Figure 2b).

formation, as the corrosion product was mainly $Al(OH)_3$. In addition, the observed H_2 gas evolution (Figure 6b) could generate high internal pressure to rupture and delaminate the Al film. This, in turn, caused more freshly exposed non-passivated Al metal to corrode and form more $Al(OH)_3$ dendrites.

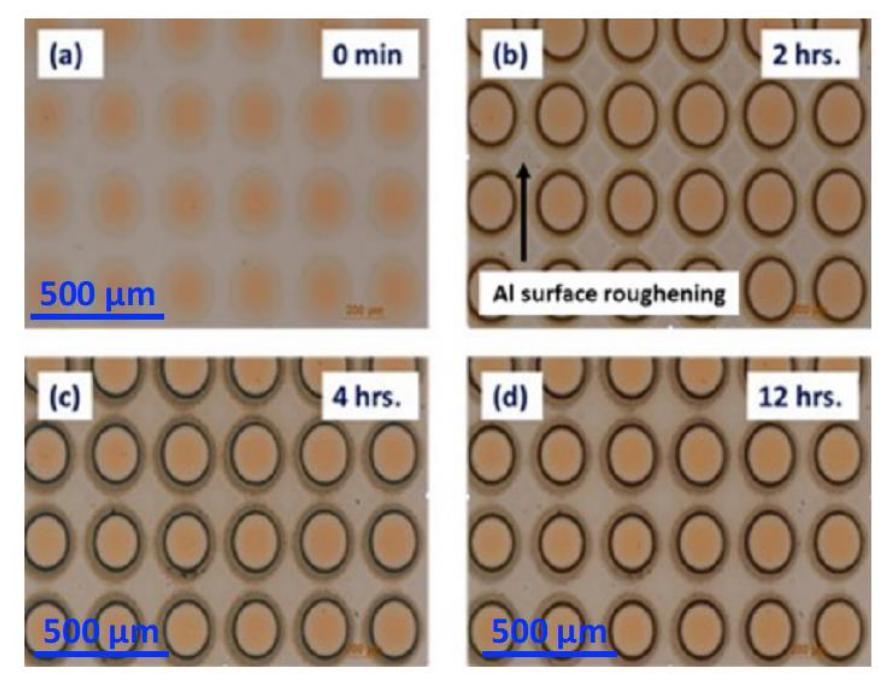
Figure 7. Micropattern corrosion screening of Al/Cu bimetallic contact immersed in 5 ppm F^- solution at pH 5. The images were taken at (**a**) 0 h after immersion; (**b**) immersion time = 2 h, (**c**) 4 h, (**d**) 12 h.

In the F^- corrosion study (see Figure 7), compared with Cl^- , the Al corrosion morphology screened by Cu micropattern corrosion was entirely different. Al corrosion was highly concentrated around the Cu/Al interface in the presence of F^- ions. Additionally, corrosion was observed in the Al substrate between the Cu dots. A significant contrast was that compared with the Cl^- corrosion mentioned earlier, no visible gas escape, dendrites, or mud cracks were seen in the F^- corrosion. Even after 12 h, the corrosion was limited to the Cu/Al interface and Al area. The Al between the Cu dots showed some removal, as evidenced by the fading color change observed in Figure 7b,d with minimal dendrite corrosion and no gas evolution.

In the F^- case, the corrosion morphology observed in Cu/Al bimetallic contact samples, as shown in Figures 7 and 11, was similar to the corrosion in blanket Al (Figure 2c). As observed in Figure 11, no dendrite or H₂ evolution was visibly observed; instead, Al dissolution was observed by forming significant surface product AlF₃, as confirmed by XPS, as shown in Figure 12. The AlF₃ product was slowly removed from the surface, revealing the underneath layer observed in Figure 12b. The mechanism of F^- corrosion was similar with and without the presence of bimetallic contact mainly due to this formation of this

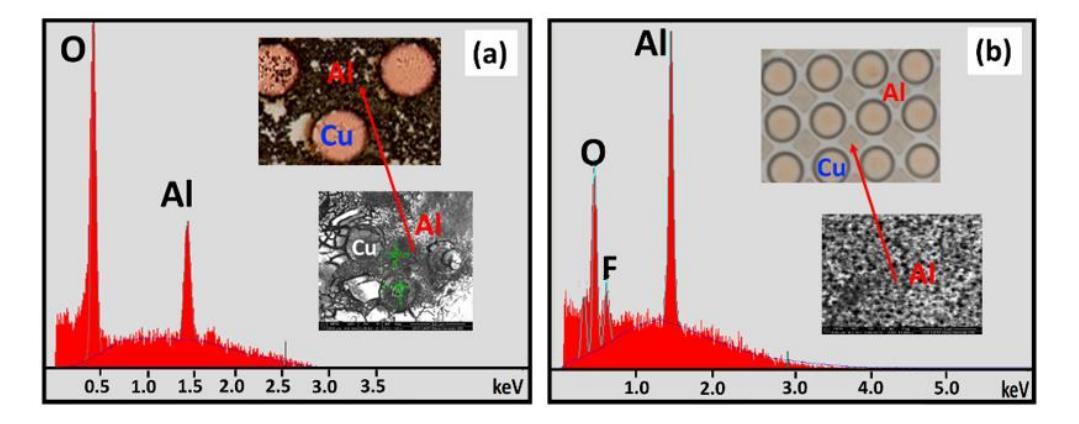
Figure 8. EDS analysis spectrum of corroded Cu microdot samples on Al after 44 h of immersion in (**a**) 5 ppm Cl⁻, pH 5, and (**b**) 5 ppm F⁻, pH 5 (inset: SEM and microscope image of the corroded samples).

After 44 h of immersion in 5 ppm Cl⁻ and 5 ppm F⁻, as shown in Figure 8, EDS analyses of the corroded samples revealed the difference in surface products between Cl⁻ and F⁻-immersed corrosion. The EDS spectrum of the severely corroded Al surface (Figure 8a) exposed to 5 ppm Cl⁻ showed mostly Al and O signals that suggested dendrite

In contrast, the EDS spectrum of F^- -corroded samples, as shown in Figure 8b, revealed an F^- signal in addition to O and Al signals, indicating that surface products such as AlF_x and $AlOF_x$ could form on the Al surface. In addition, it was observed that the SEM image of the corroded Al surface became rough without any dendrites, similar to the situation observed in the surface corrosion of the Al substrate.

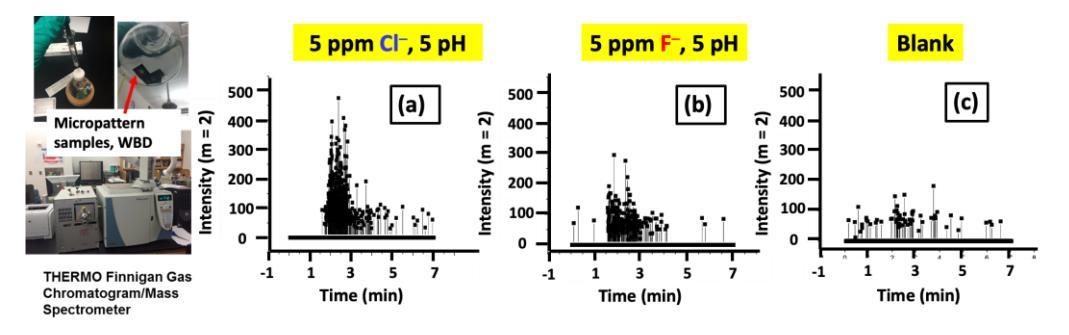
Figure 9. GC–MS analysis of H_2 evolution in microdot samples immersed for 40 h in 5 ppm, pH 5 solutions showing (**a**) intense gas evolution signal in Cl⁻ solution, (**b**) minimal gas evolution signal in F⁻ solution, (**c**) blank signal without any gas evolution.

The headspace chromatography analysis of gas evolved showed that under Cu/Al bimetallic contact, Cl⁻ contamination gave an extensive signal for H₂ (Figure 9a), whereas a minimal H₂ signal was observed for the F⁻ case (Figure 9b) in comparison with the blank (Figure 9c). The GC–MS data confirmed our hypothesis and corroborated well with what we observed in Cu micropattern corrosion screening (Figures 6 and 7).

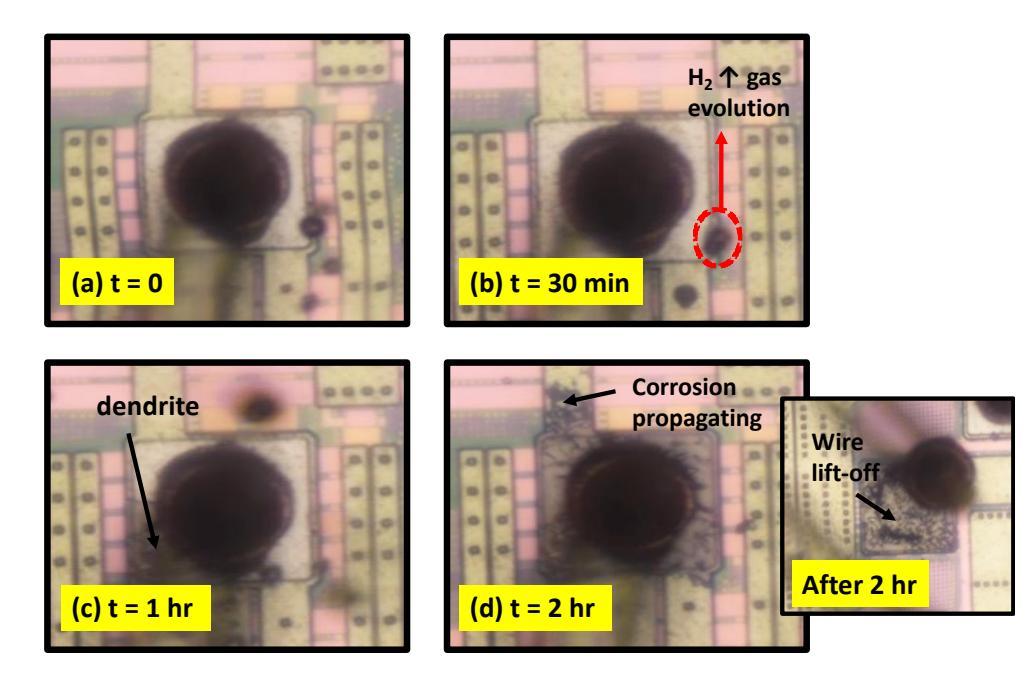
Figure 10. Real-time corrosion progression of WBD (Cu wire on Al bond pad) in 5 ppm Cl⁻, pH 5 solution (**a**) immediately after immersion, (**b**) H₂ evolution from Cu/Al interface, (**c**) dendrite initiation and propagation, and (**d**) complete corrosion of Al pad, resulting in Cu wire lift-off (wire lift-off microscope image, inset).

The in situ WBD immersion monitoring of the corrosion morphology in real time matched the corrosion morphology observed in the simulated micropattern immersion screening. The WBD with Cu wire on the Al bonding pad was immersed in a 5 ppm Cl⁻, pH 5 solution. The real-time imaging showed rapid H₂ gas escape, accompanied by rapid corrosion propagation with dendrite formation. Al bond pad corrosion extended underneath the Cu ball bond with the progress of time, causing the Cu wire to lift off from the Al pad. The corrosion screening data showed that even such low ppm levels of Cl⁻ concentration can result in aggressive Al pad corrosion, Cu bonding ball lift-off, and thus complete device failure in about 2 h, as shown in Figure 10d and inset.

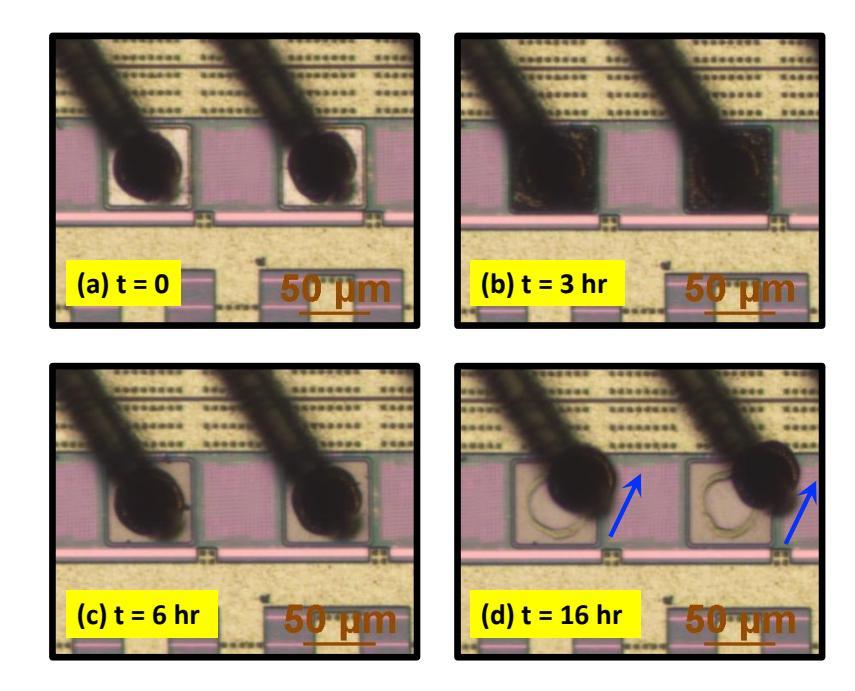
Figure 11. Real-time corrosion progression of WBD (Cu wire on Al bond pad) in 5 ppm F⁻, pH 5 solution (**a**) immediately after immersion; (**b**) Al pad completely corroded in about 3 h; (**c**) Al pad completely removed, revealing the underneath layer; and (**d**) Cu bonding ball lift-off, revealing no Al left on the bonded region.

Figure 11 shows the corrosion progress of WBD immersed in 5 ppm F⁻, pH 5 solution, which is very similar to the corrosion of micropatterned samples observed in F⁻. Further in situ investigation showed Al pad complete corrosion visible from its color change, as shown in Figure 11b, in about 3 h. Then the Al pad thin film was corroded entirely, revealing the underneath metallization layer, as shown in Figure 11c. The corrosion was then progressed by F⁻ ion contaminants seeping underneath the wire to corrode the pad buried underneath the ball bond, leading to wire lift-off in about 27 h. The wire lift-off in F⁻ corrosion was much slower than the Cl⁻ corrosion, which can be attributed to the absence of rapid H₂ evolution in the F⁻-induced Al corrosion process. The difference in corrosion morphology confirmed in blanket Al, micropattern Cu dot on Al, and WBD between Cl⁻ and F⁻ establishes that the mechanism of these contaminants is utterly different in their attacking nature towards the Al surface.

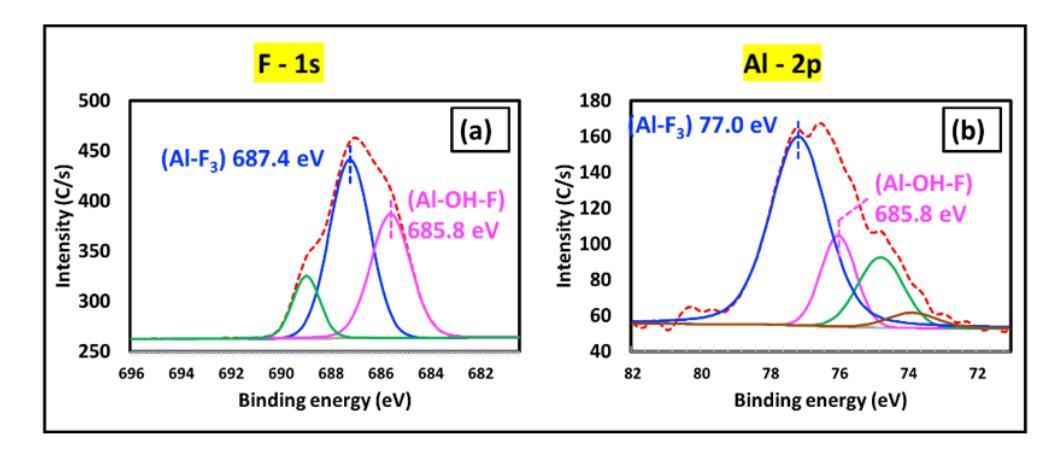
Figure 12. (a) F-1s core level and (b) Al 2p core level X-ray photoelectron spectra of the corroded Al pad immersed in 5 ppm F⁻, pH 5 solution after 3 h (red dotted lines reveal the original spectra before deconvolution).

As shown in Figure 12, XPS analysis of the 3 h corroded WBD (see Figure 10b) with the F⁻ surface products on Al was carried out to identify its bonding chemistry. The XPS spectrum in the region of the F-1s signal on the corroded black region was deconvoluted due to the presence of a shoulder, which showed the central peak at 687.4 eV corresponding to AlF₃ species present on the surface and the secondary peak at 685.8 eV related to the presence of aluminum oxyfluoride species (Figure 12a) [19]. The Al 2p spectrum investigation revealed a prominent peak of 77.0 eV after the deconvolution, confirming AlF₃ surface products as the main species during corrosion along with some Al-hydroxy-F species seen from the secondary peak observed at 75.8 eV, as shown in Figure 12b [20]. The additional green spectra observed with a peak at 689 eV and 74.6 eV corresponded to the organic fluorides, and the brown spectra observed with a peak at 73.8 eV corresponded to Al-O species on the corroded surface [21].

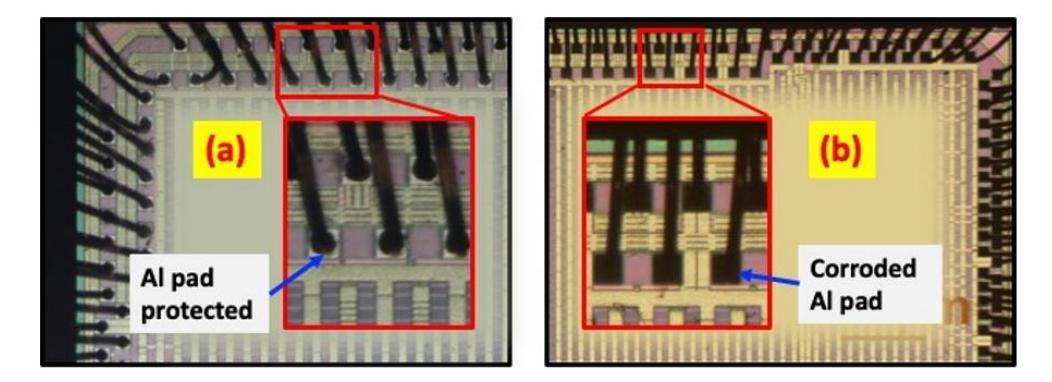
Figure 13. Copper-specific inhibitor coated to WBD immersed in (**a**) 5 ppm Cl⁻, pH 5 solution for more than 24 h showing Al pad protection and no Cu wire lift-off (inset: zoomed-in image of Al bond pad region remaining protected) and (**b**) 5 ppm F⁻, pH 5 solution for more than 24 h showing complete corrosion of Al bond pad (inset: zoomed-in image of Al bond pad region corroded).

For Cl⁻ corrosion, the potential prevention strategy proposed is to halt the H₂ evolution (cathodic reaction) by using an azole-based Cu-selective inhibitor to eliminate the galvanic contact, thereby preventing the redox corrosion process. A copper (cathode)-specific azole inhibitor was applied to the Cu wire, and the device was subjected to the same Cl⁻ corrosion condition. Figure 13a shows that the Cu selective inhibitor completely prevented H₂ gas evolution and inhibited corrosion dendrite formation on the Al bond pads. Contrastingly, F⁻, as a stronger etchant to the Al pad, leading to the formation of a less soluble AlF₃, received no protection from the same Cu-selective inhibitor, as shown in Figure 13b. This mechanistic investigation gave us key insight in identifying the difference in mechanism between the two halide contaminants and highlighted the need for further development of Al-specific inhibitors to protect WBDs from F⁻ corrosion.
