# Investigating the Potential of the Er:YAG Laser for the Removal of Cemented Dust from Limestone and Painted Plaster

**Abstract:** A successful application of Er:YAG laser for the cleaning of a restored Assyrian relief sculpture from the British Museum collection is presented. Displayed in the gallery, the sculpture has darkened over time due to the natural deposition of dirt, in particular on restored parts. Since traditional cleaning methods have demonstrated to be unsuccessful, a scientific investigation was performed to identify the composition of the soiling and the materials used for the restoration. The analysis suggested the presence of gypsum, calcium oxalate, carbonates and alumino-silicates on the encrustation. The molded plaster, composed of lime and gypsum and pigmented aggregates, was likely prepared at the end of the 19th century to mimic the stone color. It was repainted with what was identified as a modern oil-based overpaint, applied to cover darkening during a second conservation treatment in the 20th century. Laser trials were first performed on small areas of the objects and on mock-ups to determine the critical fluence thresholds of the surface, investigated

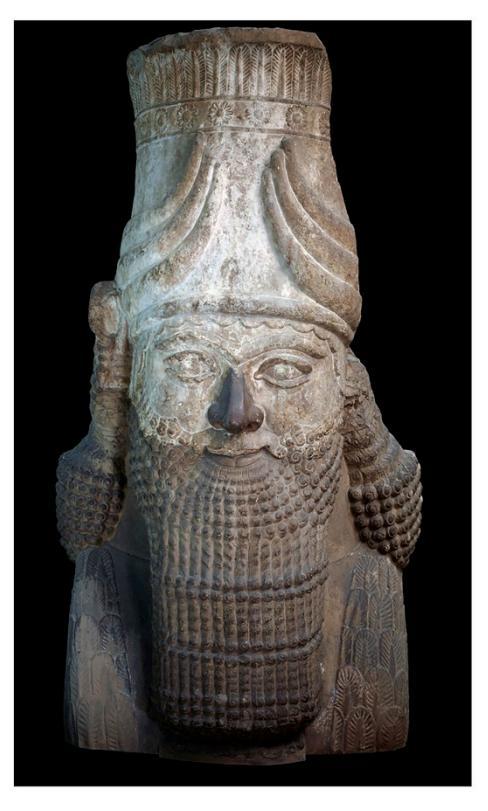
**Figure 1.** Human-headed winged bull (Registration number 1849,1222.1) before cleaning. The molded plaster (beard, nose, shoulders and hair) appears darker than the original limestone. ©Trustees of the British Museum.

Through visual examination, it was observed that the restored parts had been more affected by dust deposition than the original limestone. This had led to differential darkening, and cleaning of the restored parts was needed to improve the overall appearance of the sculpture.

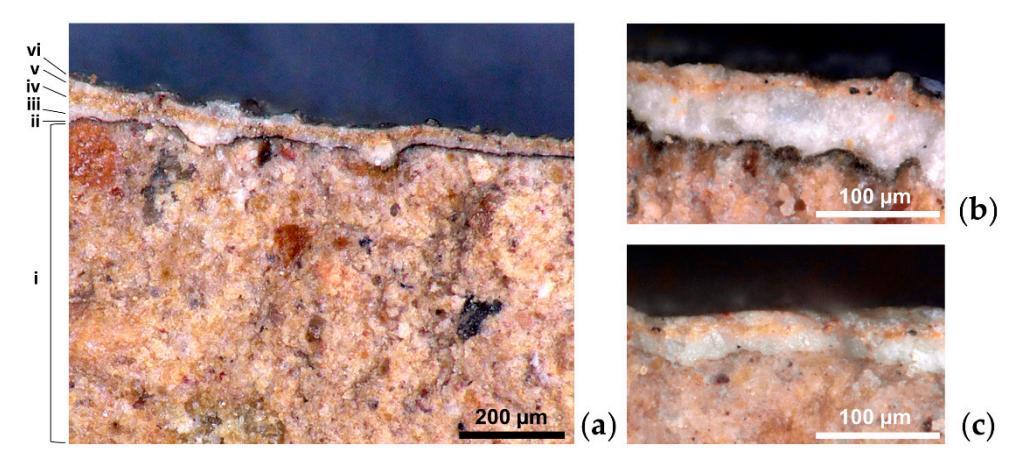
A cross-sectional examination is shown in Figure 2a. The layers identified were the following:

- A bulk of a late 19th-century restoration, a colored plaster, composed of a mixture of fine and coarse pigmented aggregates to imitate the color and texture of the original stone;
- A thin dark line, as shown at higher magnification in Figure 2b, possibly an early finishing material or organic coating, typical of historical plasterworks in the 19th century. It has probably darkened over time due to degradation and dirt deposition [16,56];
- A white overpaint, acting as a ground layer;
- An orange layer, not homogenous in thickness throughout the cross-sections;
- An additional thin white layer, found in some areas, possibly applied to lighten the surface of the restored parts and mimic the hue and texture of the original stone and intricate beard (Figure 2c);
- A thin dark deposition, i.e., cemented dirt.

**Figure 2.** Digital microphotographs of a restored part in cross-section, highlighting the stratigraphy (a) shows the bulk of the 19th-century restoration (i) and possibly an early finishing material or organic coating that has darkened due to deposition of dirt (ii), then repainted with coats of white (iii, v) and orange (iv) paint; a thin dark deposition layer (vi) is observed throughout the paint layer. The sequence of the stratigraphy is not homogenous throughout the restored part. (b) and (c) show close-ups of an area of the restored part with evidence of past dirt deposition (ii), then repainted (iii and iv), and of an area where an additional layer of white was applied to lighten the surface color (v). ©Trustees of the British Museum.

It is possible that the paint layers were added to the object during a later restoration campaign to reduce the contrast between the darkened areas of the restored parts (ii) and the original stone to refresh the color of the restoration [57]. The aim of laser cleaning was to remove layer (vi) only and uncover the paint layer.

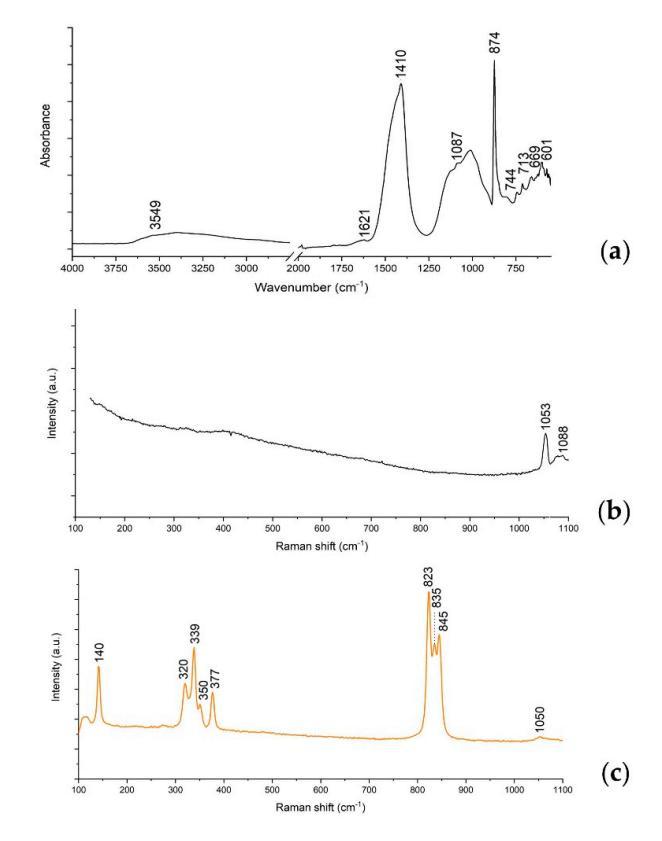
The FTIR analysis of the bulk of the restored parts (Figure 3a) revealed the presence of calcium carbonate (CaCO<sub>3</sub>) as the main component and reaction product of the carbonation process of lime plaster Ca(OH)<sub>2</sub>. The spectrum is characterized by the CO<sub>3</sub><sup>2–</sup>  $v_3$  asymmetric stretching mode at ~1410 cm<sup>-1</sup>, the  $v_1$  symmetric stretch at ~1087 cm<sup>-1</sup> and the O–C–O  $v_2$  out-of-plane bending mode at 874 cm<sup>-1</sup>. The  $v_4$  in-plane bending mode at 713 cm<sup>-1</sup> and 744 cm<sup>-1</sup> are assigned to calcite and vaterite, respectively, CaCO<sub>3</sub> polymorphs [58]. The broad vibration band in the region 900–1200 cm<sup>-1</sup> suggested the presence of Si–O groups, characteristic of clay minerals. Bands at 3549, 1621, 669 and 601 cm<sup>-1</sup> were attributed to gypsum. A broad absorption band in the OH stretching region was also observed due to the presence of structural hydroxyl groups [59]. EDX mapping highlighted Ca as the main element, as well as Si, Al, Fe in the inclusions. Elements such as S, K, Cl, Mg and Mn were also detected.

**Figure 3.** (a) FTIR spectrum of the bulk of the restored parts; Raman spectra ( $\lambda$  = 785 nm) of the white (b) and orange paint layers (c).

The Raman spectra of the white and orange paint layers are presented in Figure 3b,c. The analysis of the white layer revealed the presence of lead white pigment, i.e., lead carbonate (Pb(OH)<sub>2</sub>·2PbCO<sub>3</sub>). This was confirmed by the characteristic shift at 1053 (s) cm<sup>-1</sup> attributed to lead carbonate [60]. EDX analysis highlighted Pb as the main element, as well as Al and Ca. The paint also contains calcium carbonate as a filler, as suggested by the band at 1088 (vs) cm<sup>-1</sup> [60]. In the orange layer, Pb and Cr were detected as main components. The Raman spectrum (Figure 3c) showed bands at 140 (m), 320 (w), 339 (m), 350 (vw), 377 (m), 823 (vs), 835 (s), 845 (s) cm<sup>-1</sup>, attributed to chrome orange, i.e., basic lead chromate (PbCrO<sub>4</sub>·PbO) [60–62]. Chrome orange is a synthetic pigment that was widely used by artists at the end of the 19th century and the beginning of the 20th century [63,64]. EDX analysis on both thin dark layers highlighted the presence of Al and Ca, as main elements, as well as S, Si, Fe, Cu, K and Cl probably due to environmental pollution.

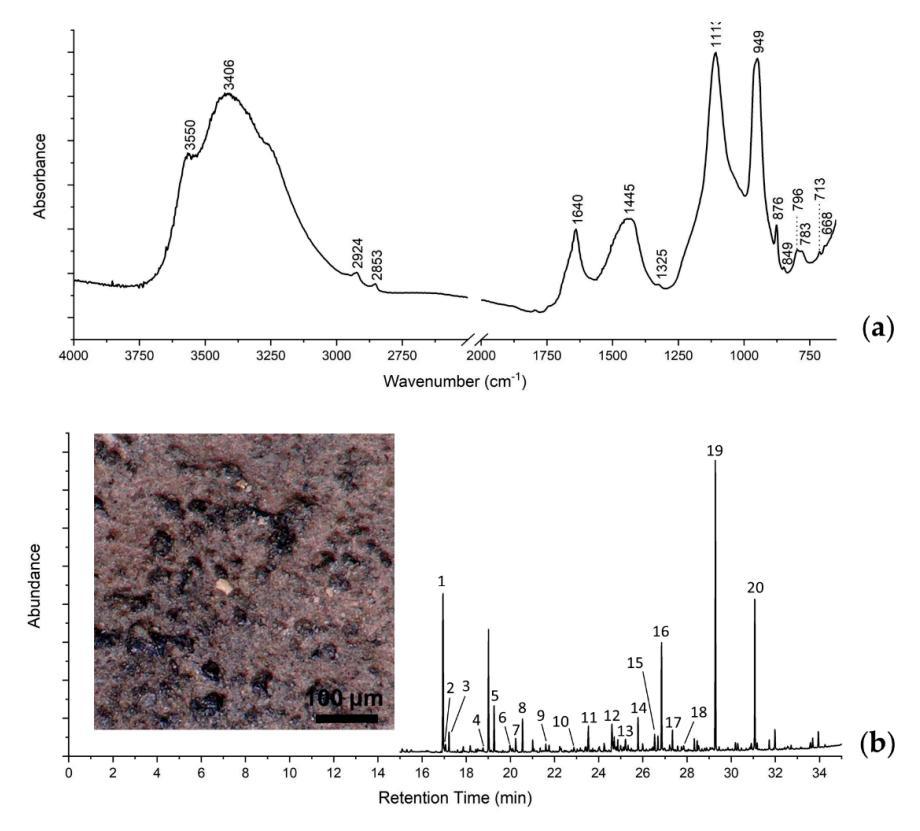
The FTIR spectrum on the surface prior to laser cleaning (Figure 4a) is characterized by a broad absorbance band centered around 3400 cm<sup>-1</sup>, suggesting that the dark layer is composed of materials that are rich in OH groups, main absorbers of the Er:YAG wavelength (2940 nm), highlighting the

potential of this particular laser for the removal of the unwanted layer [32,45]. The bands at ~3550, 3406 (OH stretching vibration), and additionally 1113 and 668 cm<sup>-1</sup> (S–O stretching and bending, respectively) indicated the presence of gypsum, whereas the bands at 1640, 1325 (C=O stretching vibration) and 783 cm<sup>-1</sup> (O–C–O bending vibration) suggested calcium oxalate [65]. The broadband centered at ~1445 cm<sup>-1</sup>, the sharp band at 876 cm<sup>-1</sup> and peak at 713 cm<sup>-1</sup> were attributed to calcite. Bands in the Si–O stretching region (900–1200 cm<sup>-1</sup>), in addition to 796 cm<sup>-1</sup>, suggested the presence of alumino-silicates, as confirmed by the EDX analysis. Peaks at 2924 and 2853 cm<sup>-1</sup> were attributed to the CH<sub>2</sub> stretching (asymmetric and symmetric, respectively) of aliphatic chains, highlighting the presence of organic compounds. The results suggested that the dark layer is mainly composed of gypsum, calcium oxalate, and inorganic components, consistent with observations on patinas and encrustations found on stone and marble in churches and outdoor environments due to weathering, biological activity, pollution and/or alteration of previous organic-based treatments [66,67]. The object, like other sculptures at the British Museum, was inevitably exposed to high levels of pollution in the 19th and 20th centuries, which have led to the formation of the dark cohesive layers [68].

**Figure 4.** Digital microphotograph and characterization of the soiling layer on the restored parts before cleaning with Er:YAG laser. (**a**) FTIR spectrum and (**b**) Py–GC–MS chromatogram: trimethylsilyl (TMS) derivatives of 1, lactic acid; 2, hexanoic acid; 3, glycolic acid; 4, heptanoic acid; 5 glycerol (2TMS); 6, benzoic acid; 7, octanoic acid; 8, glycerol (3TMS); 9, nonanoic acid; 10, decanoic acid; 11, triethylene glycol; 12, diethyl phthalate; 13, dodecanoic acid; 14, octanedioic acid; 15, triethylene glycol; 16, nonanedioic acid; 17, tetradecanoic acid; 18, decanedioic acid; 19, hexadecanoic acid; 20 octadecanoic acid. ©Trustees of the British Museum.

The total ion chromatogram (TIC) of the sample before cleaning showed the predominant presence of aliphatic mono– and dicarboxylic acids (Figure 4b). Among them, hexadecanoic (P–palmitic) and octadecanoic (S–stearic) acids showed the highest relative abundance, followed by nonanedioic (A–azelaic) acid. This was in agreement with the general composition of a drying oil obtained by analytical pyrolysis [79]. In particular, azelaic acid is the final product deriving from the auto-oxidation of the unsaturated side chains of a drying oil [80–82], thus showing a relatively high oxidation state of the oil. Py–GC–MS is not the right technique to speculate about the origin of the oil unless specific molecular markers are detected, e.g., 12–hydroxyl–9–cis–octadecenoic (ricinoleic) acid for castor oil [83]. No specific molecular marker was detected in our case. Moreover, parameters traditionally used in GC–MS analysis, such as A/P ratio and P/S ratio, cannot be considered in a quantitative way when pyrolysis is applied [84]. For all these reasons, no further information about the type of oil was obtained. Nevertheless, in addition to carboxylic acids, other minor compounds were detected, including glycerol and some phthalates (isobutyl, diethyl and dibutyl phthalates). These are known additives usually found in modern oil-based paint compositions to modify specific properties [85]. Phthalates are used as plasticizers, and glycerol is a common precursor of modern oil-based paint compositions [86,87]. Although the data did not allow us to further classify the type of binder, the results were generally consistent with a lead white modern oil-based paint with good drying properties, which is in agreement with both the supposed time of application (first half of the 19th century) and a rapid restoration use.

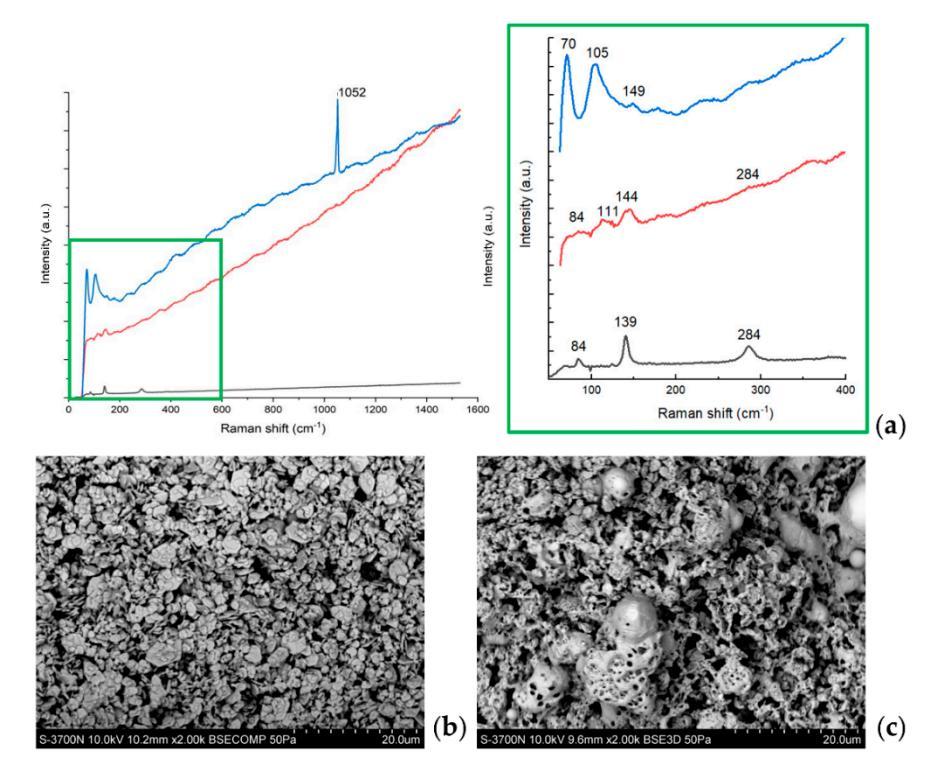
Laser tests were first performed on commercial pure lead white samples prepared in the laboratory to determine the critical fluence threshold (CFT) of the pigment and evaluate if discoloration may occur. CTF is defined as the lowest fluence (energy per surface unit) at which changes in the material are observed. The samples were irradiated in dry conditions with a single laser shot at increasing fluences, and surface changes, such as color, texture or gloss variations, were observed under a Dino-Lite

microscope. During the experiments, a CFT of 1.4–1.6 J/cm<sup>2</sup> was found when a color change (yellowing) was detected. Lead white, identified by the shift at 1052 (s)  $cm^{-1}$  before irradiation (Figure 5a, in blue), is converted to lead oxide (PbO), likely massicot and litharge, as evidenced by the broad bands centered at 84, 111, 144 and 284 cm<sup>-1</sup> in the Raman spectrum (Figure 5a, in red) [69]. Evidence of yellowing was also observed after several consecutive pulses at 1.2 J/cm<sup>2</sup>. However, it was found to be reversible. Temporary yellowing effects using the Nd:YAG laser (1064 nm) have been documented on medieval pigments [22,70], and it was reported that the duration of the color change could last from several hours to some days, depending on the laser energy applied. This has been described as a conversion mechanism of lead white into lead monoxide and consequent reconversion [23]. Alteration of pure pigment (without binders) has also been reported when irradiated by the four wavelengths (1064, 532, 355, 266 nm). The pigment turned grey and then black, resulting in a mixture of metallic lead (Pb), lead oxide (PbO) and lead dioxide (PbO<sub>2</sub>) forms. However, it regained its original color within one week after exposure to air and CO<sub>2</sub> [71]. Although the Er:YAG laser mechanism differs from the Nd:YAG laser, it is possible to assume that the energy transferred to the sample has locally sufficiently increased the temperature to induce the conversion. By increasing the fluence, a blackening of lead white was also observed, with some degree of reconversion. The Raman spectrum of blackened areas (Figure 5a, in black) is characterized by bands at 84, 139 and 284 cm<sup>-1</sup>, which closely resemble bands attributed to massicot. This has been described as a product of laser-induced thermal degradation of plattnerite (PbO<sub>2</sub>), deriving from the degradation of lead white [72]. Irradiation at fluences above 2.2 J/cm<sup>2</sup> caused permanent darkening of the pigment, which also remained after artificial aging. Blackening could be a result of the reduction to metallic lead [70,73], difficult to detect by Raman due to its poor scattering properties [69]. Permanent laser-induced degradation of lead white is shown in Figure 5b,c, where globules of metallic lead were observed after irradiation.

**Figure 5.** (a) Raman spectra ( $\lambda = 532$  nm) of lead white samples before irradiation (in blue), after irradiation at 1.4–1.6 J/cm<sup>2</sup> when yellowing occurred (in red) and when darkening was observed (in black); SEM images before (**b**) and after (**c**) laser irradiation at fluence above 2.2 J/cm<sup>2</sup>. ©Trustees of the British Museum.

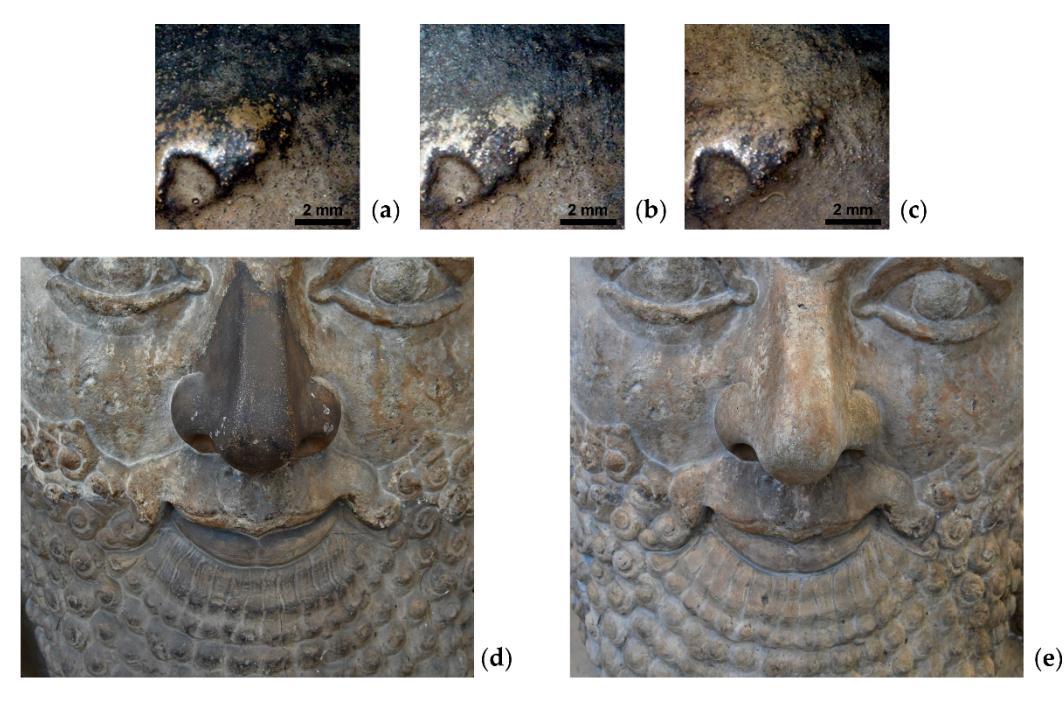
**Figure 6.** Digital microphotographs of the restored parts before (**a**), after laser irradiation (**b**) and after swabbing the residues with water (**c**); close-up of the nose before (**d**) and after cleaning was completed (**e**). ©Trustees of the British Museum.

To remove the soiling on the restored plaster parts (Figure 6a), irradiation tests with the Er:YAG laser were conducted with a fluence in the range of 1.1-1.8 J/cm<sup>2</sup> in dry and wet conditions with a 10–20 Hz pulse rate. Using a fluence of ~1.8 J/cm<sup>2</sup> and above in dry conditions caused cracking and abrasion of the paint layer, visible under high magnification. When used in wet conditions, a microdistillation mechanism was observed, due to the penetration of the solvent underneath the very thin dark layer and into the paint layers, causing the disaggregation of the surface and complete removal of the paint. This left the bulk of the restored part exposed. Cleaning of the restored part was achieved with fluences below 1.8 J/cm<sup>2</sup> in dry conditions. The irradiated area turned gray (Figure 6b), most likely due to the enhancement of light scattering phenomena caused by an increase in the surface roughness. The laser treatment was then followed by gentle swabbing using water to remove the soiling and obtain the desired cleaning result (Figure 6c). This was now possible as the overall surface area exposed is higher, improving the cleaning ability of the solvent. The surface was left to fully dry after swabbing, before continuing with the laser. Two-three laser passes were found to be sufficient to remove the dark layer, monitoring the cleaning with the portable microscope. A similar result was reported on the removal of a soot film embedded in the paint of an unvarnished 19th-century oil painting, where the contaminant was turned into fine dust, which was then wiped off with a moistened cotton swab [39]. Although the laser parameters used for the cleaning of the restored parts overlapped with the CFT found for the mock-ups, we did not observe discoloration of the underneath paint layer during cleaning, suggesting that the laser interacted with the dark layer only. Using a fluence very close or even higher than the CFT is not uncommon with the Er:YAG laser [35]. This is because the contaminant is typically not ablated by the Er:YAG laser irradiation, but its top surface is disrupted due to thermal effects. A strong absorber at 2940 nm, such as the dirt covering the sculpture (Figure 4a), acts as a thermal barrier for the material underneath as it absorbs most of the laser energy [33]. The key to using a fluence close to the CFT is to proceed one laser pass at a time. As soon as the top layer is disrupted, the laser stops being used, and the contaminant layer is removed using solvent through swabbing.

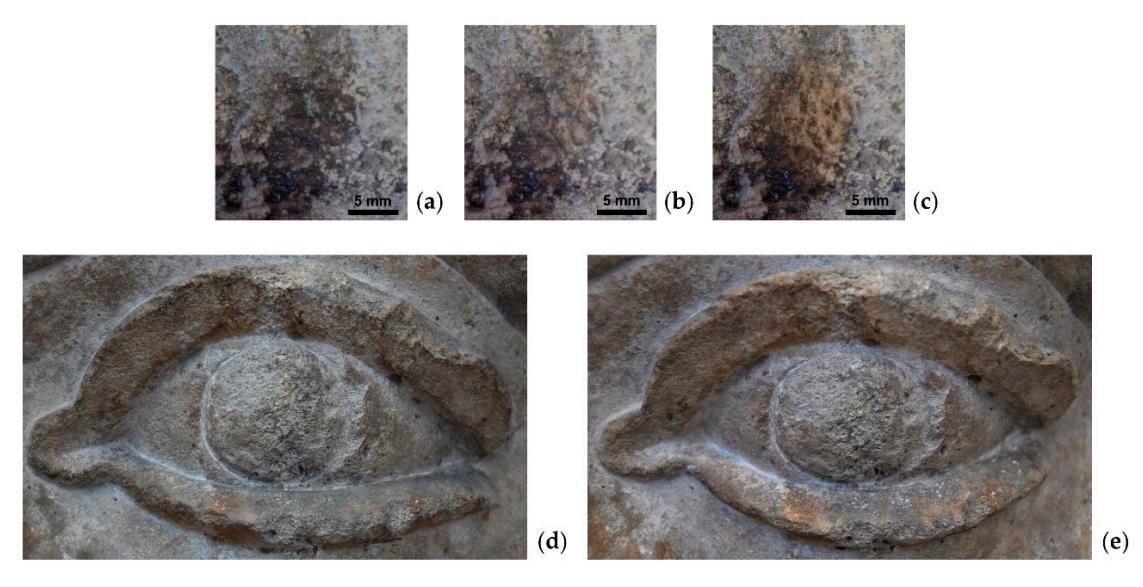
**Figure 7.** Digital microphotographs of the stone (eyebrow) before (**a**) after laser irradiation (**b**) and after swabbing with a 50:50 mixture of water and acetone (**c**). Close-up of the eye before (**d**) and after cleaning was completed (**e**), highlighting the natural pigmentation of the limestone. ©Trustees of the British Museum.

A similar approach was used for the limestone; however, on a much smaller scale (Figure 7a), as the original stone did not require as much cleaning as the restoration. In that case, cleaning was performed very locally at a fluence in the range of 1.6–1.8 J/cm<sup>2</sup> in dry conditions with a 10 Hz pulse rate (Figure 7b), followed by swabbing the irradiated area with a 50:50 mixture of water and acetone (Figure 7c). Cleaning of the stone allowed highlighting the natural pigmentation of the limestone, as shown in Figure 7d,e.

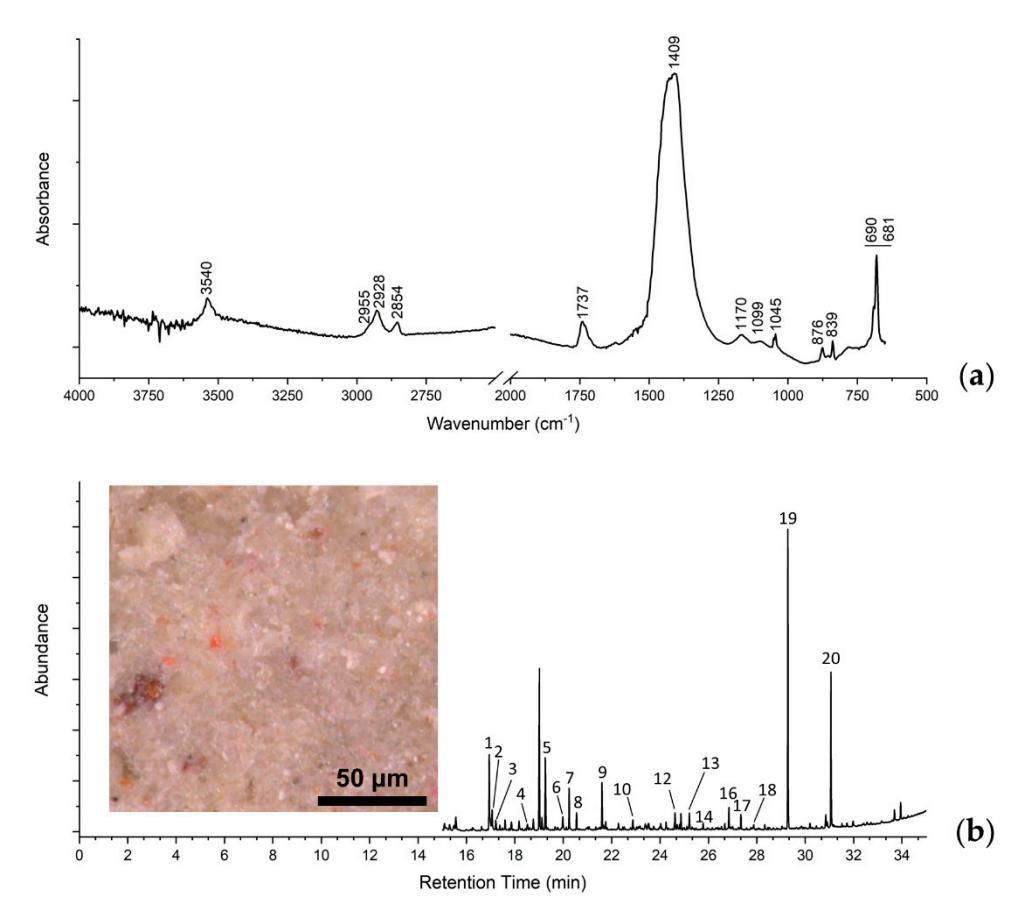
After cleaning the restored parts, a decrease of the broad absorption band in the OH region, as well as of the bands attributed to oxalates, sulfates and alumino-silicate components, was detected by FTIR, as shown in Figure 8a. This is consistent with the removal of the dark layer, highlighting the efficacy of the Er:YAG laser to target OH-rich materials. The IR spectrum is characterized by the  $CO_3^{2-}$  bands at 1409 cm<sup>-1</sup> ( $v_3$  asymmetric stretching), 1045 cm<sup>-1</sup> ( $v_1$  symmetric stretching), 839 cm<sup>-1</sup> ( $v_2$  out-of-plane bending), the split in the  $v_4$  in-plane bending vibration at 690 and 681 cm<sup>-1</sup> and the OH stretching vibration near 3540 cm<sup>-1</sup>, corresponding to lead carbonate of the painted surface [74]. Additionally, the presence of an organic binder was detected, indicated by the C=O stretching vibration bands of carboxylic acids and esters centered at ~1737 cm<sup>-1</sup>, the C–H stretching bands at 2955 (CH<sub>3</sub>), 2928 and 2854 cm<sup>-1</sup> (CH<sub>2</sub>, asymmetric and symmetric, respectively) and the C–O stretching bands of esters at 1170 and 1099 cm<sup>-1</sup>, suggesting the presence of an oil-based paint [75]. A small shoulder at ~1710 cm<sup>-1</sup> was also observed, which was attributed to C=O stretching vibrations due to the formation of free fatty acids as a result of hydrolysis of triglycerides and the formation of dicarboxylic acids due to oxidation [76]. The broad shoulder centered at ~1550 cm<sup>-1</sup> may indicate metal carboxylates as a result of metal soaps formation due to the interaction of lead salts with the oil binder [77,78].

**Figure 8.** Digital microphotograph and characterization of the surface layer after cleaning with Er:YAG laser and swabbing the residues with water. (**a**) FTIR spectrum and (**b**) Py–GC–MS chromatogram: refer to Figure 4 for labels.

The TIC of the sample after laser cleaning (Figure 8b) showed the presence of all the compounds identified in the sample before cleaning. However, a clear relative reduction of the dicarboxylic acids was observed. These are richer in OH groups, and the result was therefore interpreted as further proof of the efficacy of the laser treatment. Additionally, as dicarboxylic acids are not part of the cross-linked network of the polymer and are partially responsible for the yellowing of oil binders, their partial removal by laser contributed to the better appearance of the surface after laser cleaning.

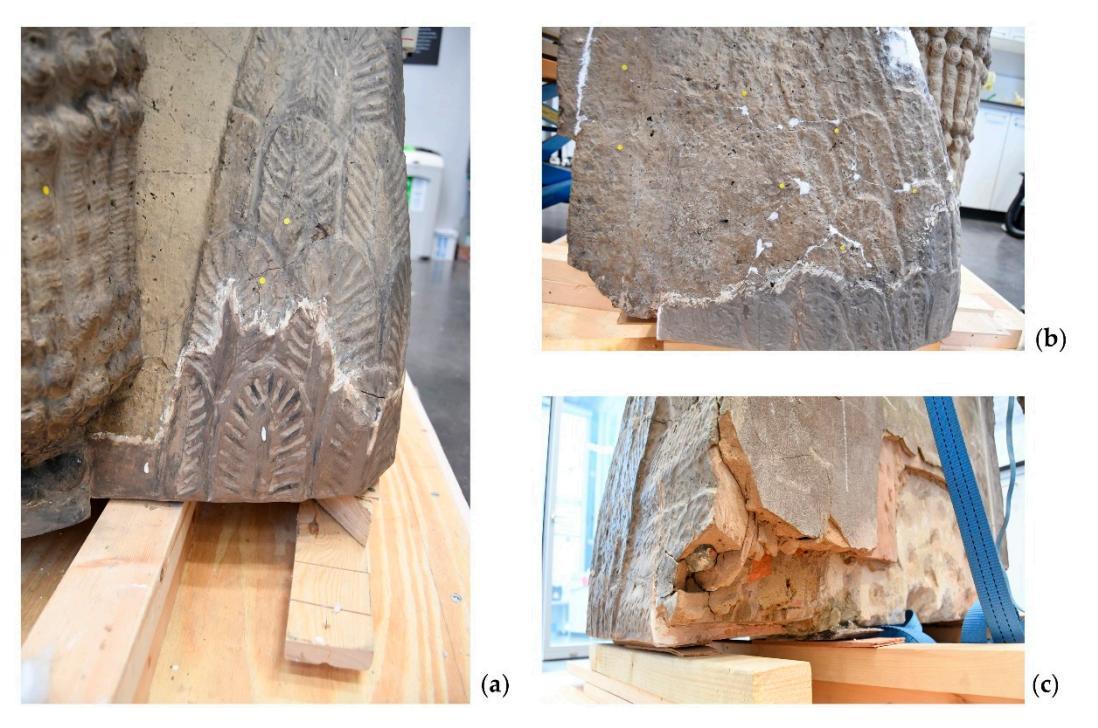
**Figure 9.** Detail of the late repair on the lower part of the sculpture. (**a**) Laser cleaning revealed that alternated dark and light brushstrokes of paint were used to repaint the damaged part, giving an inconsistent appearance in comparison with the original restoration (**b**). The repair was not completed in the back, allowing to check the condition of the internal structure of the restored parts (**c**). ©Trustees of the British Museum.

The later repair to the bottom part of the plaster was approached in a slightly different way. The overpaint, shown in Figure 9a, was uncovered after the laser cleaning. It was presumably acrylic paint, in accordance with the conservation materials used in the 1960s for retouches. It was removed using acetone from the plaster fill, which appeared to be structurally sound, and then toned down with acrylic paint.

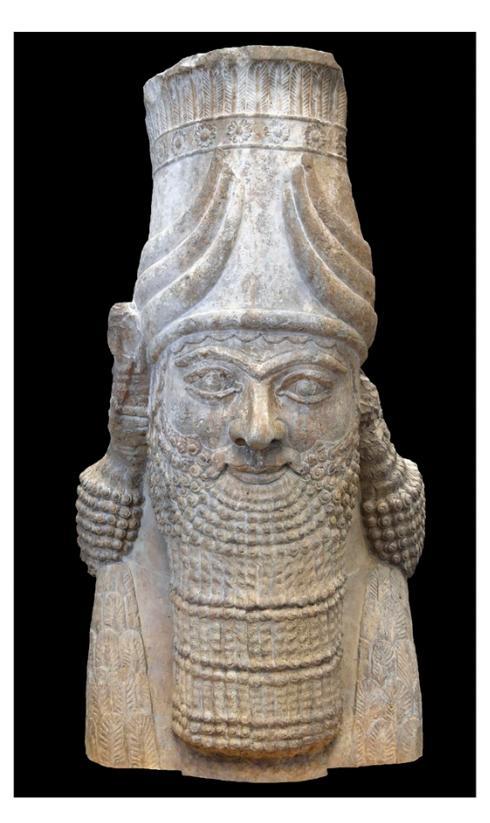
**Figure 10.** Human-headed winged bull (Registration Number 1849,1222.1) after cleaning, retouching and consolidation. ©Trustees of the British Museum.

The fill, which most likely was made as a result of damage to the lower part of the restoration, was completed only in the front and both sides of the sculpture, as shown in Figure 9b. The back remained untreated, with the outer layer of the cast missing (Figure 9c), probably left unfinished as it would not have been visible when displayed in the new location. This area allowed us to investigate the internal structure as well as evaluate the penetration of the consolidation treatment in real time. The edge of the remaining layer was consolidated where necessary, capped with the microballoons paste and finally toned down to color match the limestone (Figure 10).
