# Article Very-High-Cycle Fatigue Behaviors for Bearing Steel Microstructural Transformation

**Abstract:** It has been reported that the multiphase structure with martensite and a mixed structure obtained by the quenching and tempering of bearing steel shows high strength and ductility. However, there appears to be no study on the effects of very-high-cycle fatigue (VHCF) and ultrasonic nanocrystal surface modification (UNSM) of a new bearing steel required for the durability design of next-generation bearing steel. This study analyzed the characteristics of microstructure transformation associated with heat treatment cycles and studied and evaluated the fatigue strength characteristics by the UNSM. Fisheye cracks occur from small inclusions inside the specimen only in martensitic microstructure materials in the long-life range. And the characteristic of a double S-N curve in which the fatigue limit decreased in two stages appeared. However, fisheye cracks and double S-N curves did not appear in pearlite and mixed-structure materials.

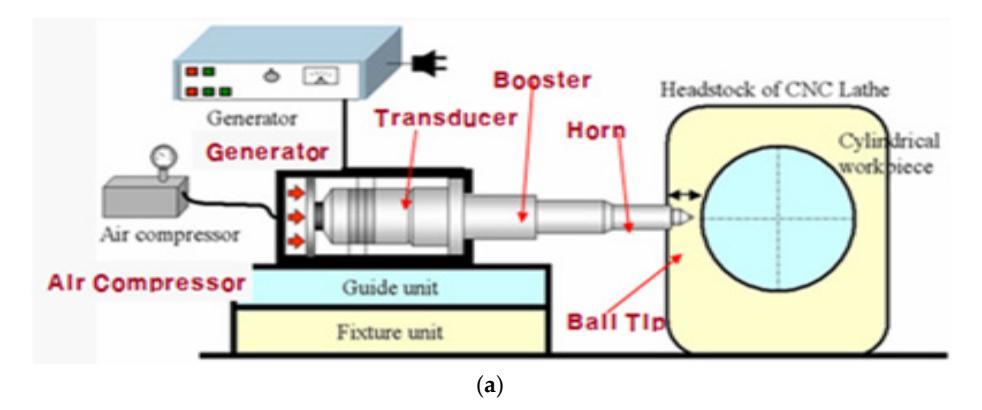
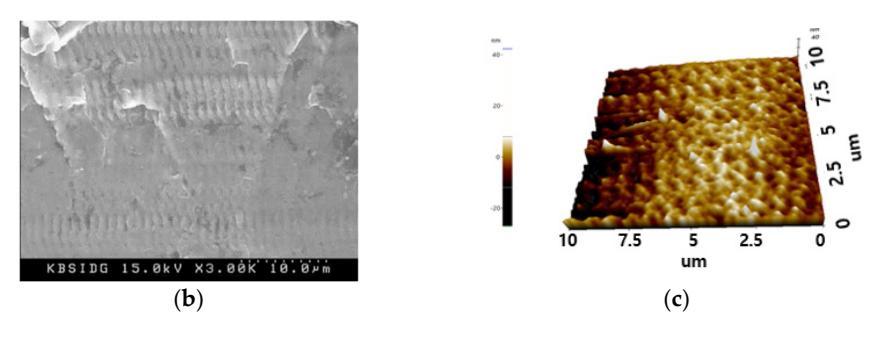
**Figure 1.** (a) UNSM system, (b) micro forging traces by SEM photo, and (c) 3D image of atomic force microscope (AFM) after UNSM treatment.

Figure 1a shows the processing system of UNSM, which consists of a generator that generates ultrasonic frequencies, an air compressor that applies a static load, a transducer that generates mechanical ultrasonic waves, a booster that amplifies the generated ultrasonic waves, a horn that transmits the amplified ultrasonic waves, and ultrasonic vibration energy. It consists of a ball tip that is ultimately delivered to the workpiece.

Figure 1b is an example of micro forging traces that appeared on the surface after UNSM treatment observed at 3 K $\times$  magnification using an SEM (scanning electron microscope, FE-SEM, S-4300, Hitachi, Japan).

Also, Figure 1c shows the traces of 3D forging using an atomic force microscope (AFM, Scanning Probe Microscope, NX20, Canton, MA, USA). When UNSM technology is applied to the surface in this way, it has characteristics such as the formation of micro-dimples on the surface, improvement in surface roughness, increase in surface hardness, nanoization of crystals, and formation of deep and large compressive residual stress. Therefore, in fields such as VHCF (very-high-cycle fatigue) and SCC (stress corrosion cracking), the increase in durability and fatigue strength is very large, and the tribology characteristics are improved and wear resistance is greatly improved by reducing the coefficient of friction [10–12].

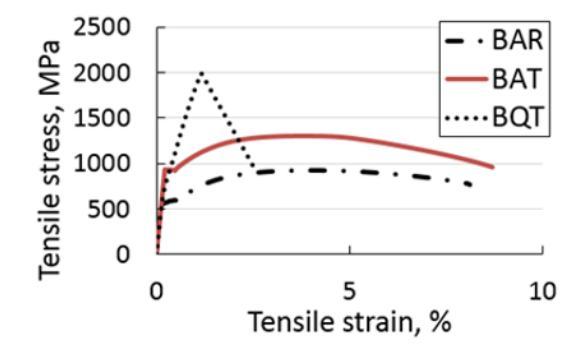
Figure 2. Stress-strain diagrams of a clean bearing steel.

The tensile test results in Figure 2 were received as an Excel file and organized into stress and strain diagrams. Here, the BAR is shown as a dashed line in the stress–strain diagram in Figure 2, and the results were obtained with a tensile strength of 926 MPa, a yield strength of 577 MPa, an elongation rate of 17.2%, and a reduction in area rate of 40.5%.

The BQT material is indicated by a dotted line and has a tensile strength of 1993 MPa, a yield strength of 1100 MPa, an elongation of 1.2%, and a reduction in area rate of 2.5%. Additionally, the BAT is indicated by a solid line and has a tensile strength of 1302 MPa, a yield strength of 929 MPa, an elongation rate of 17%, and a reduction in area rate of 48.1%.

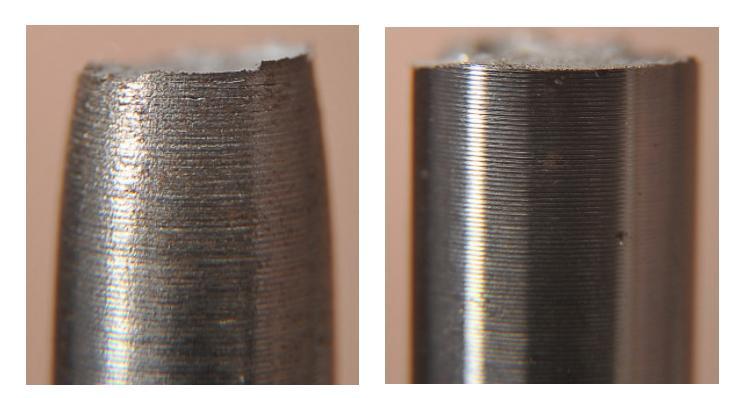
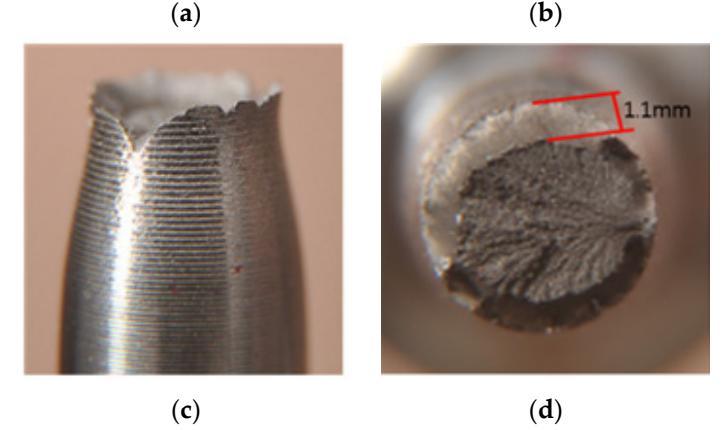
**Figure 3.** Visual observation of the side views of the tensile test specimens of the bearings: (**a**) BAR, (**b**) BQT, and (**c**) BAT. (**c**,**d**) is the fracture views of the BAT specimen, and the cup and cone are formed in a saw-tooth shape.

Figure 3a is a case where the side view of the tensile test piece of BAR was observed with an optical camera. In this picture, about 60% of the cup and cone shapes with a height of 0.25 mm were formed, and some local necking was formed.

Figure 3b shows the results of the BQT material. There were no cups and cones observed in Figure 3a, and there was little change in the diameter of the smooth part and little local shrinkage. Therefore, in the diagram in Figure 2, it fractured with little deformation. However, as shown in Figure 3c,d, the BAT material has cups and cones with a height of about 1.1 mm and a large width in a saw-tooth shape, so it can be determined that the diameter change and local shrinkage of the smooth part are large.

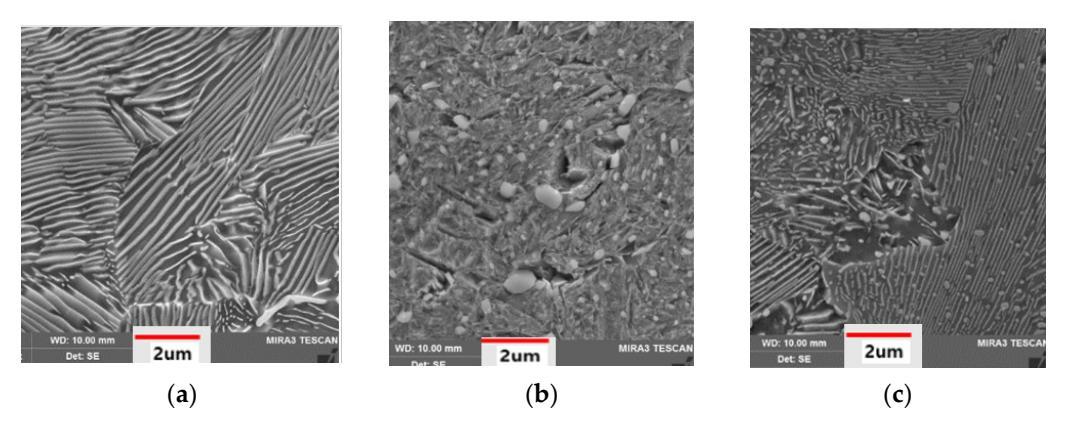
Figure 4. Example of SEM observation at 20,000× BAR (a), (b) BQT, and (c) BAT specimens.

Figure 4 shows examples of observation using a scanning electron microscope (SEM, S4200, Hitachi, Japan). The microstructure of the BAR in Figure 4a showed layered pearlite at 20 K $\times$ . Figure 4b is a BQT material, and martensite and retained austenite structures

were mainly observed at 20 K $\times$ . Figure 4c is of BAT material, and the pearlite structure and retained austenite structure are mixed.

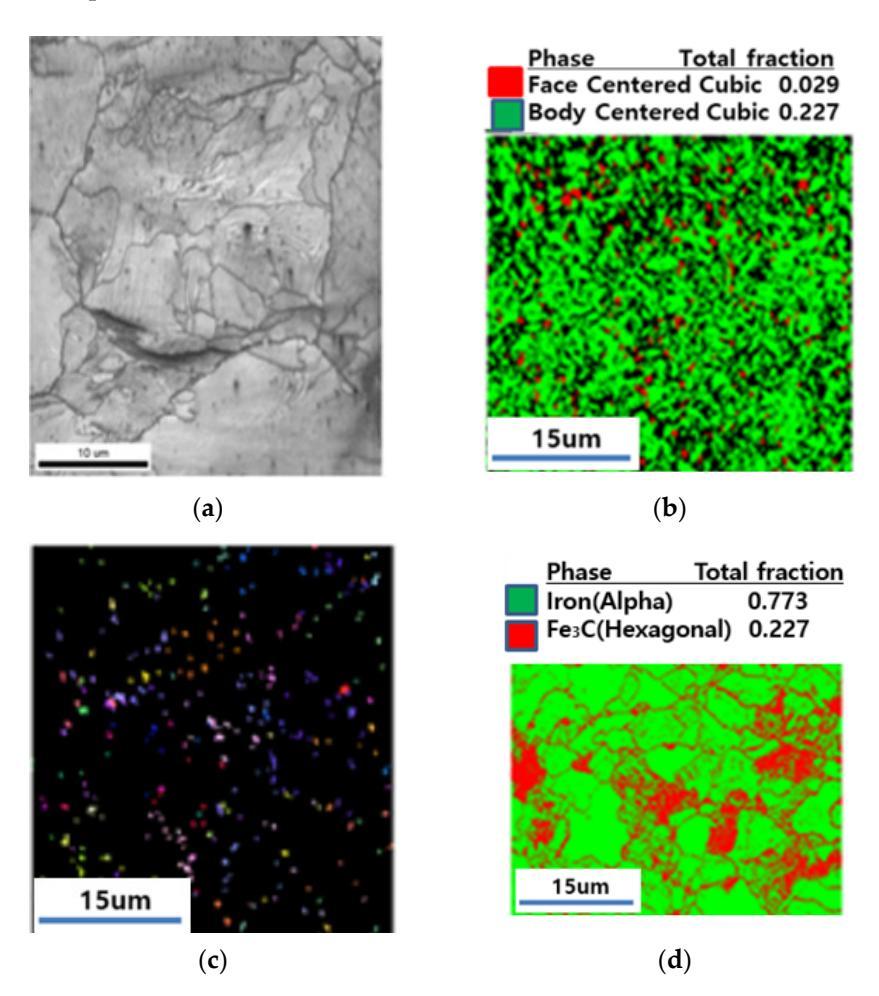
**Figure 5.** (a) EBSD data of BAR specimen IQ. (b) EBSD data of BQT specimen, phase map. (c) Comparison of FCC IPF by EBSD data of the BQT specimen at 5 K×; (d) EBSD data for BAT specimens. phase map.

Figure 5a shows data for BAR, and the average particle size of the microstructure is about 3.53  $\mu$ m (max. 19.53  $\mu$ m, min. 1.31  $\mu$ m). Figure 5a is an IQ (image quality) map showing the clarity of the electron beam diffraction pattern. The black area is the area where the IQ appears low and is due to increased crystal lattice distortion due to elastoplastic deformation.

Figure 5b is the phase map of BQT, which is a martensitic structure. What appears in light green in this map is  $\alpha$ -Fe (ferrite) with a body-centered cubic (BCC) crystal, with a ratio of 22.7%. Also, the small red dot is  $\gamma$ -Fe (austenite), which has a face-centered cubic (FCC) crystal structure and a ratio of 2.9%. Also, the part shown in black is the part that is not expressed during filtering because it does not meet the conditions.

In Figure 5b, lath-type martensite (BCT, body-centered tetragonal) has an average microstructure length of 1.67  $\mu$ m (max. 2.87  $\mu$ m, min. 0.31  $\mu$ m) and an average width of

Figure 5d is a map of the inverse pole of BAT. The grains are isotropic, and the average grain size of the structure is 3.89  $\mu$ m (max. 10.89  $\mu$ m, min. 0.98  $\mu$ m). In EBSD analysis,  $\alpha$ -Fe was 77.3% and Fe3C was 22.7%, showing insufficient microstructure transformation. In other words, BAT material has a lot of retained austenite and has high strength as FCC.

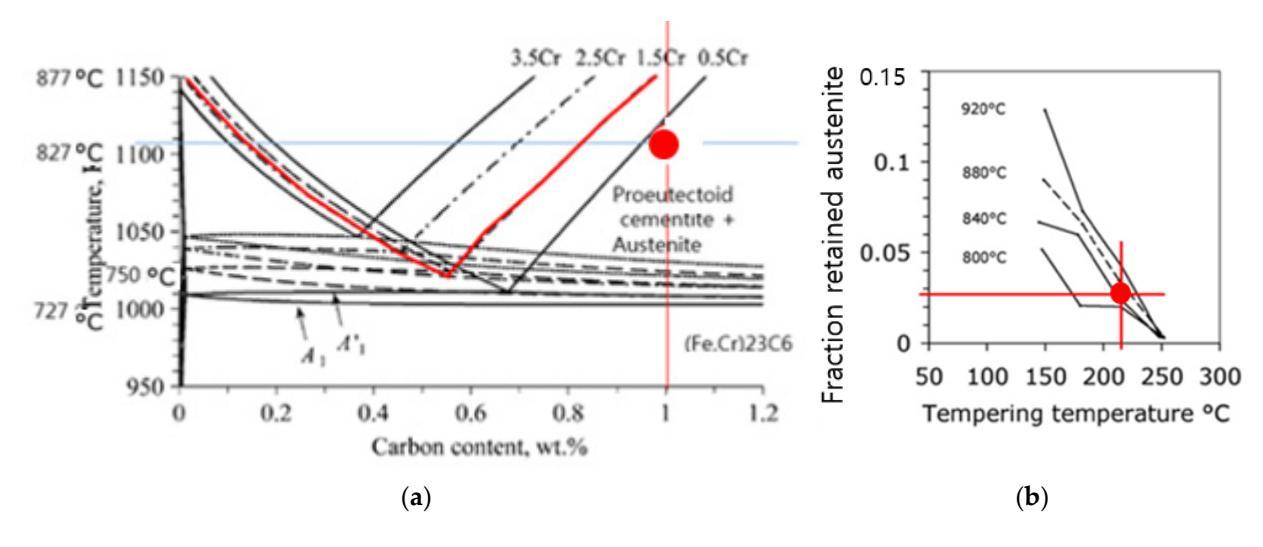
**Figure 6.** (a) The cementite spheroidization process in high-carbon steels with different chromium contents. (b) Data on retained austenite by tempering temperature and austenitizing temperature.

Figure 6a is the phase transformation diagram of the Fe-Fe3C system, which analyzes the structure formed by temperature and carbon content according to the Cr content [13]. Here, the new bearing steel has 1.0 C and 1.45 Cr as its main components, and its austenitization temperature is 840 °C (1113 K), so it corresponds to the red dot in the picture. This point is not austenite but an area where cementite and austenite are mixed. Therefore, layered cementite and retained austenite can be observed in Figure 4c.

Figure 6b shows data on the retained austenite ratio according to tempering temperature and austenitization temperature [13]. In these data, when analyzing the BQT material at a tempering temperature of 840 °C and 180 °C, the austenite ratio is in the range of about 0.057. When analyzing the BAT material at tempering temperatures of 840 °C and 220 °C, the austenite ratio is in the range of about 0.025. Therefore, it matches well with the observation of a large number of layered pearlite and small grains of retained austenite in the 20k times magnified photograph of the BAT material in Figure 4c.

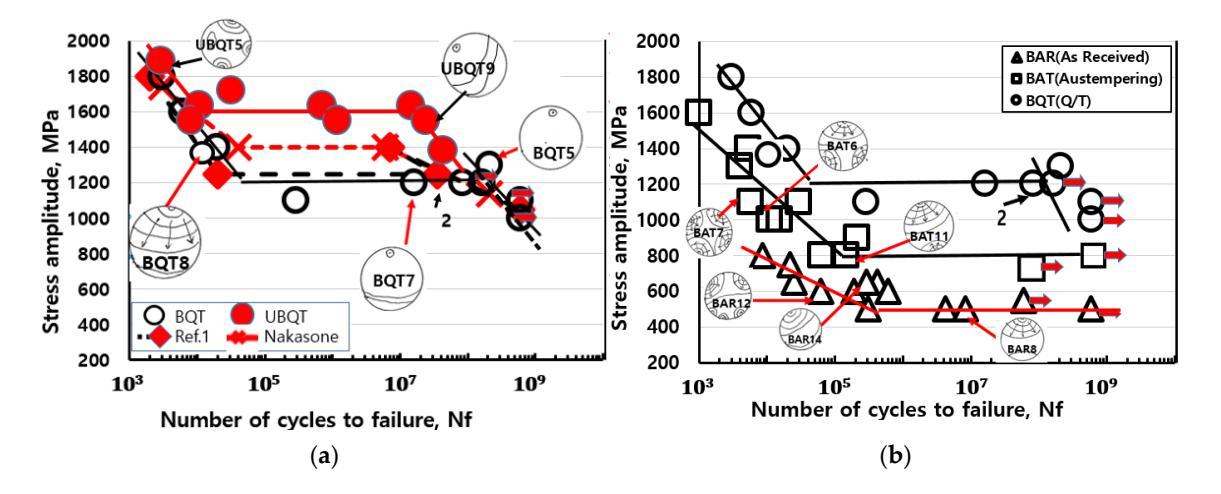
**Figure 7.** (a) Comparison of S-N curves of BQT-bearing specimen before and after UNSM treatment and other reference data [1–4]. (b) Comparison of S-N curves before heat treatment (BAR) and after heat treatment (BQT and BAT) of a new bearing specimen.

Figure 7a shows the S-N curve of BQT, a martensitic structure of new bearing steel, in the shape of ' $\bigcirc$ ', along with the results of ordinary bearing research (indicated by ' $\blacklozenge$ ' and a long dotted line) and Nakasone's data (indicated by 'X' and a dotted line) compared with [4].

In this figure, the fatigue limit of the BQT was shown at 1200 MPa, and the fatigue limit in the VHVF region showed a double S-N curve, which is a common feature in bearing steel [2–5]. In addition, in BQT material, all fisheye cracks occurred in the VHCF region after 10<sup>6</sup>.

In Figure 7a, the macroscopic fracture characteristics were sketched and compared to the S-N data of the BQT at three stress levels. The BQT8 at 1390 MPa developed and grew one surface crack and fractured at  $1.42 \times 10^4$ . In the BQT5 at 1300 MPa, one fisheye crack occurred, grew, and fractured at  $2.1 \times 10^8$ . In addition, one fisheye crack occurred and grew in the BQT7 at 1200 MPa and fractured at  $1.62 \times 10^7$ .

In addition, in Figure 7a, the macroscopic fracture characteristics were sketched on the S-N data of the UBQT material. UBQT5 material at 1900 MPa developed and grew three surface cracks and fractured at  $2.7 \times 10^3$ . UBQT9 material at 1550 MPa developed and grew one fisheye crack and fractured at  $2.2 \times 10^7$ .

In Figure 7b, the macroscopic fracture characteristics of the S-N data of the BAR material were sketched at three stress levels. In the BAR8 at 500 MPa, one surface crack occurred, grew, and fractured at a life of  $8.2 \times 10^6$ . The BAR12 at 600 MPa fractured at  $6.2 \times 10^4$  due to the occurrence, growth, and coalescence of five surface cracks. In addition, the BAR14 at 650 MPa developed and grew one surface crack and fractured at  $2.9 \times 10^5$ .

In Figure 7b, the macroscopic fracture characteristics were sketched and compared to the S-N data of the BAT material at three stress levels. The BAT7 at 1100 MPa developed,

In this figure, the fatigue limit of the BAR appeared at about 500 MPa, and the fatigue limit of the BAT appeared at 800 MPa, an increase of about 60% compared to the BAR. In addition, the fatigue limit of BQT was found at 1200 MPa, which was a significant increase of about 140% compared to BAR. In particular, the fatigue strength of BQT, which has a martensitic structure, increased significantly compared to BAR, and fisheye cracks occurred in the VHCF area. In addition, the characteristic of a double S-N curve, in which the fatigue limit that occurs in general bearing steels decreases in two stages, appeared.

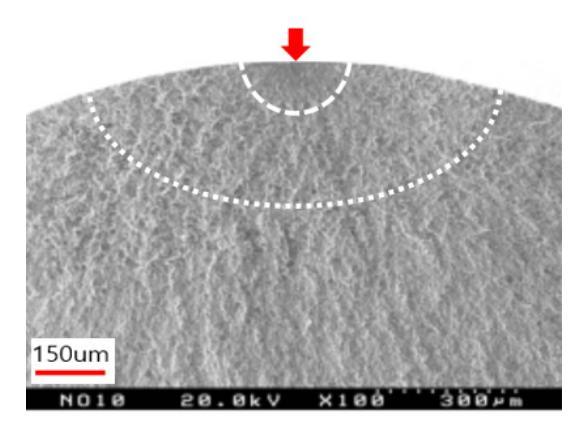
**Figure 8.** Fracture photo of a small surface crack that occurred and grew on the BQT8 specimen under 1390 MPa, Nf =  $1.42 \times 10^4$ .

Figure 8 shows the SEM observation of the fracture surface of BQT8 (1390 MPa, Nf =  $1.42 \times 10^4$ ), a martensitic structure of new bearing steel, at a magnification of  $100 \times$ . In other words, the area indicated by the arrow is the origin of the major crack that induced fatigue fracture and occurs on the surface. The dotted lines of the circle and oval in the picture show the form in which the surface crack occurred and progressed, initially forming a semicircle and gradually growing into an oval [1–7,14–21]. This SEM fracture image is

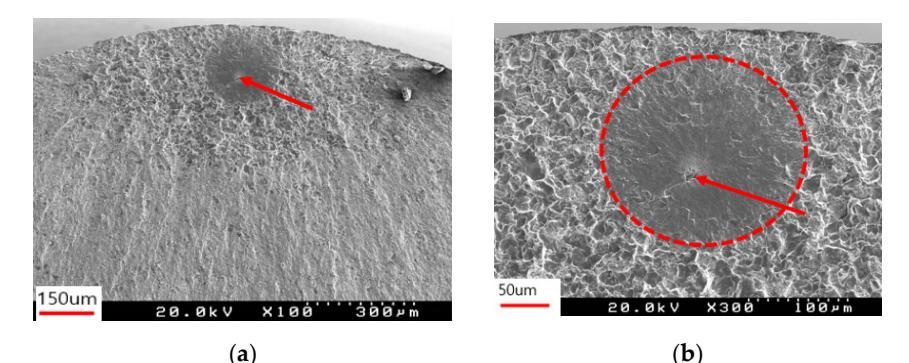
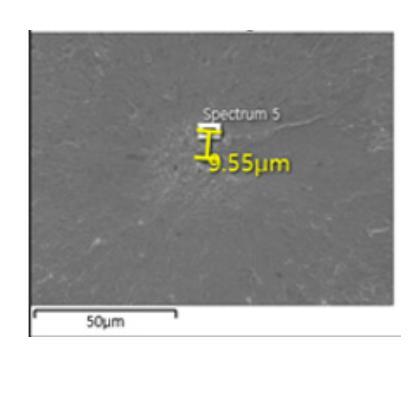
**Figure 9.** (a) is the observed case at  $100 \times$  and (b) is  $300 \times$  for BQT7 (1150 MPa, Nf =  $1.76 \times 10^7$ ). The EDS analysis results of the fish eye crack (b) are summarized in (c). TiN and Al2O3, which are commonly contained in bearing steel, were not detected. (d) shows a position 9.55 µm away from the point indicated by the arrow in Figure (b), and the component analysis here is summarized in (c).

Figure 9a is observed at  $100 \times$ , and Figure 9b is observed at  $300 \times$  on BQT7 material (1150 MPa, Nf =  $1.76 \times 10^7$ ). In this case, the internal originating fracture type that occurred inside the test specimen, indicated by a circle, is a fisheye crack with a fine granular area (FGA). Additionally, arrows indicate the location of cracks, such as inclusions that caused fisheye cracks. The occurrence and growth process of these fisheye cracks are similar to other research results [1–10,14–21].

The results of the EDS analysis of the center of this fisheye crack (Figure 9b) are shown in Figure 9c. Here, TiN and Al2O3, which are common inclusions in bearing steel, were not detected.

Figure 9d shows a position 9.55  $\mu$ m away from the point indicated by the arrow in Figure 9b, and the component analysis here is summarized in Figure 9c. Here too, Cr was detected at a slightly higher level, and C was detected at 14.31%. In addition, most of the samples were analyzed as Fe, and beyond the inclusions, 1.0% of C, 0.25% of Si, 0.35% of Mn, and 1.45% of Cr, which are the main components of the sample, appeared.

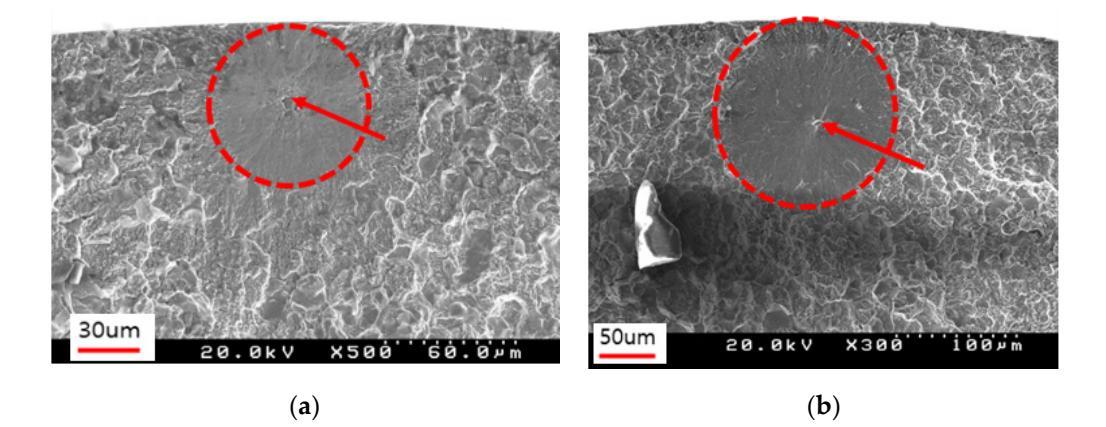
**Figure 10.** (a) shows the fracture surface of UBQT9 at  $500 \times (1550 \text{ MPa}, \text{Nf} = 2.2 \times 10^7)$  and is an FGA type. (b) is an observed example of  $300 \times (1400 \text{ MPa}, \text{Nf} = 3.75 \times 10^7)$  for UBQT6 material.

Figure 10a shows the fatigue fracture surface of the UBQT9 observed at  $500 \times (1550 \text{ MPa}, \text{ Nf} = 2.2 \times 10^7)$ . The fracture type that occurred inside the test specimen is a fisheye crack (FGA), indicated by a circle, and the arrow indicates the origin. Figure 10b shows the fatigue fracture surface of UBQT6 observed at  $300 \times (1400 \text{ MPa}, \text{ Nf} = 3.75 \times 10^7)$ . The two data were also similar to those of BQT material.

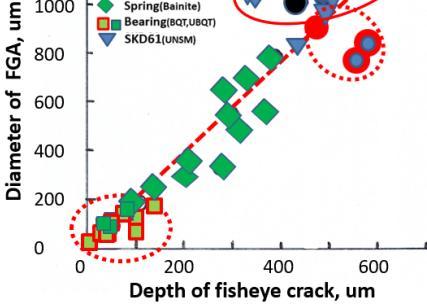
Figure 11. The relationship between fisheye crack depth and FGA diameter is compared with reference data.

Figure 11 simultaneously shows other research results on the relationship between the depth at which the fisheye crack occurred on the surface of the test specimen and the diameter of the FGA. That is, the data for bearing steels, SNCM420, SKD61 material, Ti-6Al-4V material, and bainite spring steel, are summarized in the figure and show good correlation with each other [3–6,8–12,22–24].

In the bearing steel that was the subject of this study, small fisheye cracks occurred close to the surface, as shown in the data indicated by the oval-shaped dotted line. That is, data on 10 fisheye cracks were compiled within a range of 19 to 150  $\mu$ m of the specimen surface and a diameter of the FGA within a range of 32 to 200 um. Similar to SKD61 material, the carburizing material, nitriding material, and Ti-6Al-4V material of SNCM420 summarized in this figure have data collected within the range of 350–600  $\mu$ m deep from the surface and 750–1100  $\mu$ m in terms of FGA diameter.

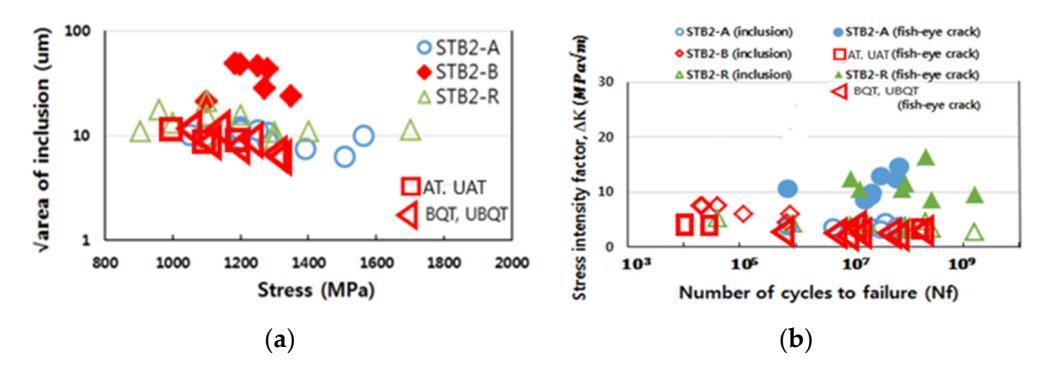
**Figure 12.** Comparison of bearing data of  $\sqrt{area}$  (**a**) and  $\Delta K$  (**b**) of the matrix where the fisheye crack occurred with BQT and UBQT specimens.

Figure 12a compares the relationship between bending stress and  $\sqrt{area}$  which is widely used in parameter analysis of inclusions and matrices, using the results of other bearing materials [2,3]. In this figure, it can be seen that the bearing material is widely distributed from a minimum of 7.6 to a maximum of 75.

However, BQT and UBQT materials are distributed from a minimum of 7.6 to a maximum of 14.3 and are marked with '<'. In other words, the diameter of the inclusions is on the smaller side, and as shown in the data, it tends to converge to a certain value. Other bearing result values also tended to converge around 10 and were in good agreement with the results of this study [2,3,14,17].

Figure 12b shows the  $\Delta K$  (stress intensity factor range) of the fisheye crack inclusions and matrix, respectively, and compares them with the data of four types of bearing steel and spring steel.
