# Fretting Fatigue as a Limiting Factor on the Durability of Friction Stir Welded Lap Joints Using AA2099-T83 and AA2060-T8E30 Aluminium Alloys

Egoitz Aldanondo <sup>1</sup>,\*<sup>1</sup>, Oier Zubiri <sup>1</sup>, Javier Vivas <sup>1</sup>, Pedro Álvarez <sup>1</sup>, and Iñaki Hurtado <sup>2</sup>

**Keywords:** friction stir welding; lap joint; surface treatment; sealant; hoop stress; fretting fatigue; Al-Li alloys

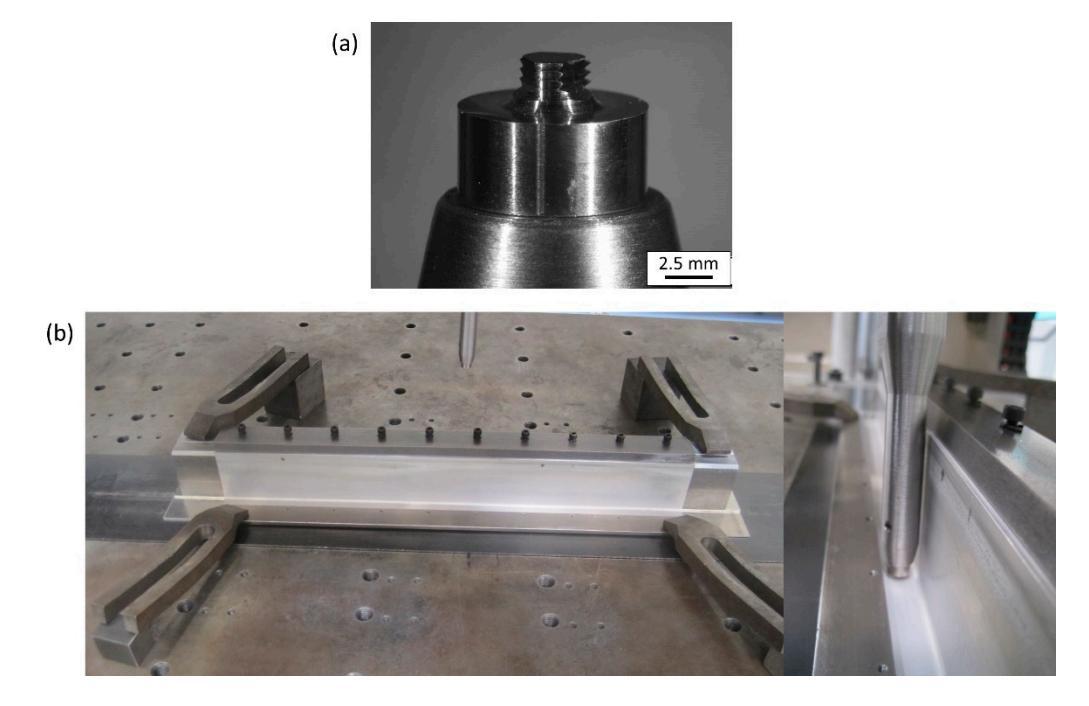
Figure 1. (a) FSW tool and (b) Setup for the FSW process.

The Z-shaped AA2099-T83 stringers and the AA2060-T8E30 skins were friction stirwelded at LORTEK in the overlap configuration in an I-STIR PDS 4 machine operated in force control. 500-mm-long stringers were friction stir welded in the central position of 600-mm-long and 200-mm-wide skins. The FSW tool (Figure 1a) consisted of a probe with three flats and a mixed thread with a diameter of 4 mm and a length of 2.5 mm. The shoulder had a flat shoulder of 10 mm in diameter. The fixtures and clamping system used for the positioning and clamping of the Z-shaped stringer on top of the skin are shown in Figure 1b.

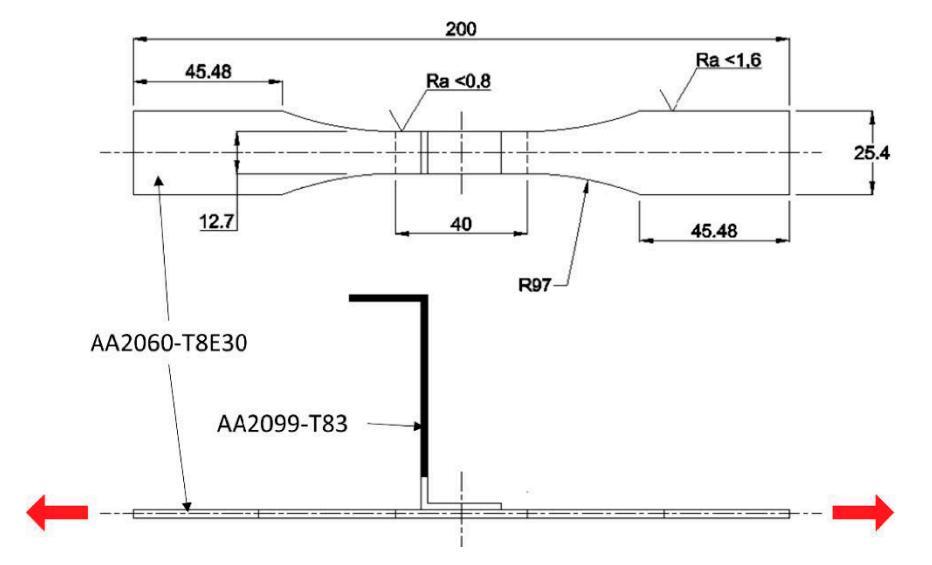
**Figure 2.** FSW specimens machined from the coupons used for the static tensile and fatigue tests under hoop-stress loading conditions (indicated by the red arrows).

The FSW coupons C01-C06 were characterised by metallographic characterisation, microhardness measurements, static tensile tests and fatigue tests under hoop-stress loading conditions. In this loading condition, tensile stresses are applied to the AA2060-T8E30 skin as is shown by the red arrows in Figure 2.

Specimens for static tensile tests and fatigue tests were prepared following the recommendation by the BS EN 6072 standard. 30-mm-wide specimens were cut from the welded coupons using electrical discharge machining (EDM) and final mechanical milling was applied to achieve the final geometry. The geometry of the final specimens is shown in Figure 2. For the static tensile tests, a Zwick Roell Z100 tensile testing machine with a load capacity of 100 kN was used at a constant testing speed of 1.6 mm/min. The fatigue behaviour of the FSW joints was studied by fatigue strength data as represented in basic S-N diagrams. The fatigue performance was evaluated using an MTS hydraulic testing machine. Fatigue tests were conducted in load control, using a sinusoidal waveform at 10 Hz and R = 0.1. Fatigue stress levels among 15–70% of the AA2060-T8E30 base material's yield strength were applied as hoop-stress loading on the AA2060-T8E30 skin. During the fatigue tests, an IR camera (model FLIR A655sc series) was employed to record the temperature field evolution on the surface of the specimens. Optical field-of-view conditions were achieved by installing the camera at a distance of approximately 0.5 m between specimens and the lens of the camera. After finishing the fatigue tests, the fractured specimens were examined using scanning electron microscopy (SEM) as well as energy dispersive spectroscopy (EDS) to determine the fatigue crack behaviour and the influence of the weld microstructure and surface conditions on the nucleation site.

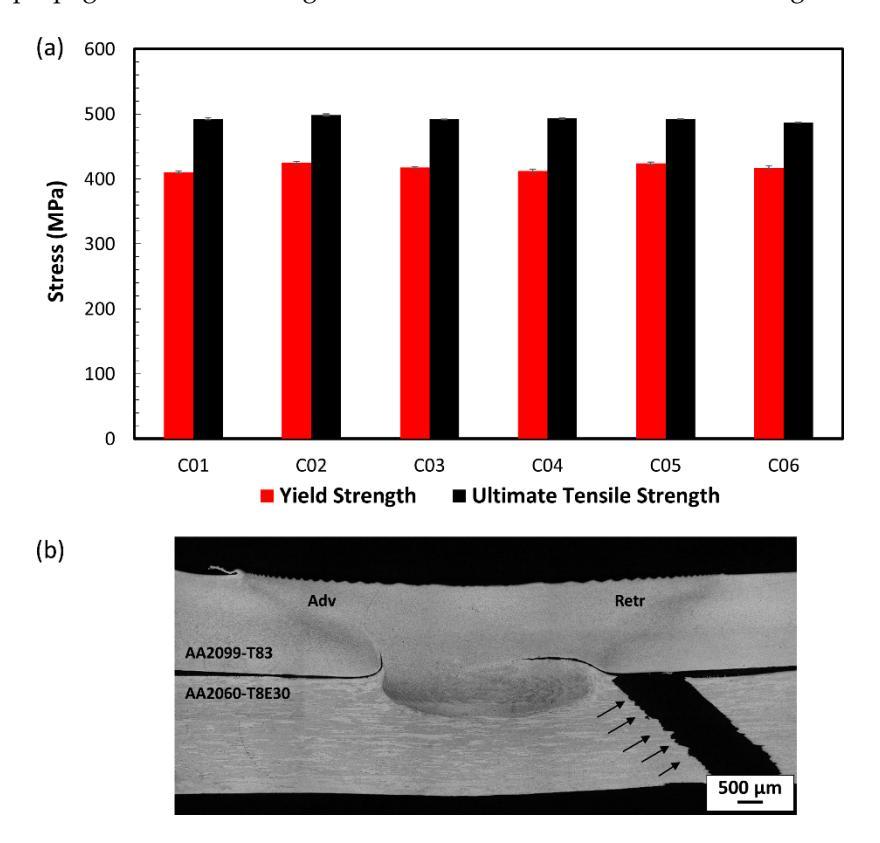
**Figure 3.** (a) Yield strength and ultimate tensile strength values obtained for specimens machined from C01–C06 and (b) metallographic cross-section of a fractured C01 (non-treated without sealant) specimen showing the fracture initiation at the HAZ.

Static tensile tests were performed under hoop-stress loading conditions with specimens machined from coupons C01–C06. Two specimens from each coupon were tested showing very similar results. A summary of the obtained results can be observed in Figure 3a. Very similar yield stress and UTS values were obtained for all specimens showing no significant influence of the surface treatments and sealant application in the performance of the FSW joints. Yield strength values between 410–424 MPa were obtained showing a minor variability of approximately 3% among all tested specimens. In terms of UTS, a variability of approximately 2% was observed with values between 486–498 MPa. All specimens showed an equivalent fracture mode with an initiation in the HAZ and propagation at 45° through the AA2060-T8E30 skin as shown in Figure 3b.

The initiation of the fracture in the HAZ can be explained by the hardness reduction of the AA2060-T8E30 base material in this zone, in addition to the coincidence with the lowest effective thickness of the AA2060-T8E30 sheet in the close vicinity of the FSW joint. Figure 4 shows the microhardness values obtained for the AA2060-T8E30 alloy in a scan of indentations performed parallel to the interface between the AA2060-T8E30 sheet and the

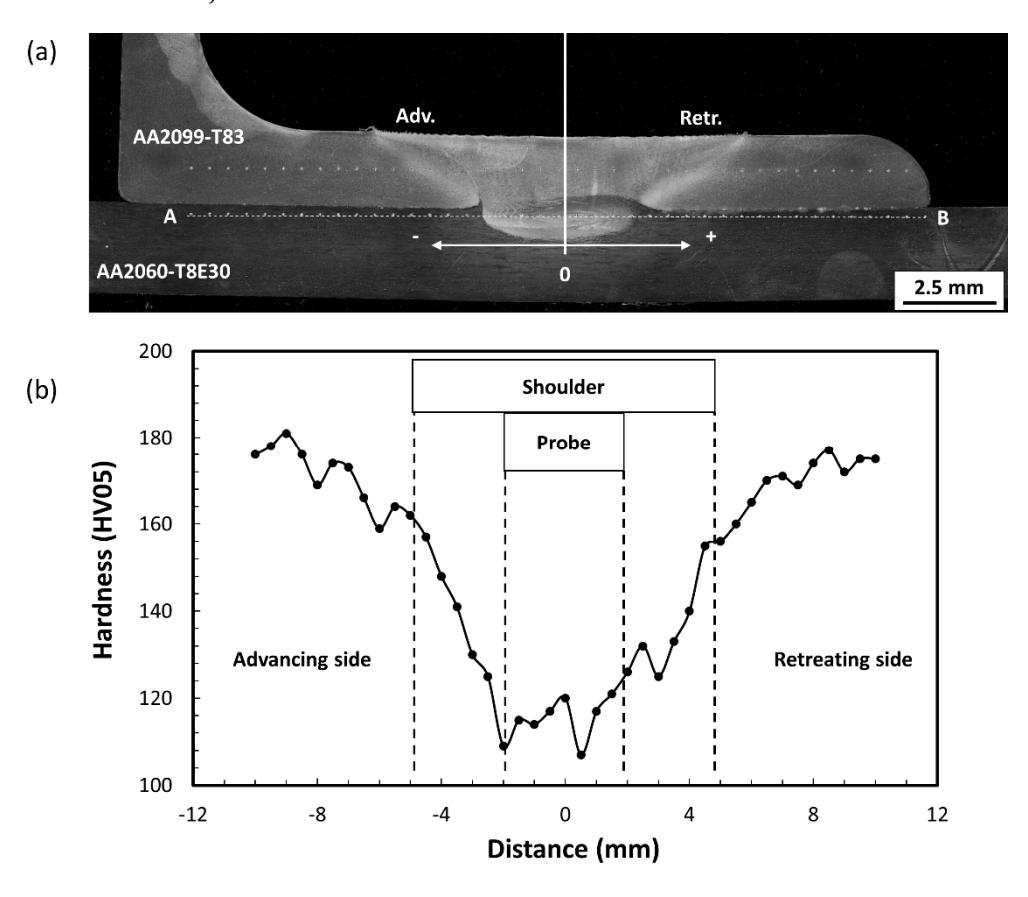
**Figure 4.** (a) Metallographic cross-section of a specimen obtained from coupon C01 and (b) microhardness scan measurements in the A–B line shown in Figure 4a.

AA2099-T83 stringer (A–B line in Figure 4a). Although the lowest values of approximately 110 HV0.5 were obtained in the stir zone (SZ), the larger effective thickness provided by the FSW joint in this zone compensates for the lower strength avoiding the fracture through the SZ. The hardness increases to values in the range of 120–130 HV0.5 in the HAZ of the advancing and retreating sides, where the effective thickness of the AA2060-T8E30 sheet decreases to its minimum value of 2.5 mm. Thus, the fracture is initiated in the region where the thickness is the lowest and the hardness values are still significantly low in the HAZ of the FSW joints.

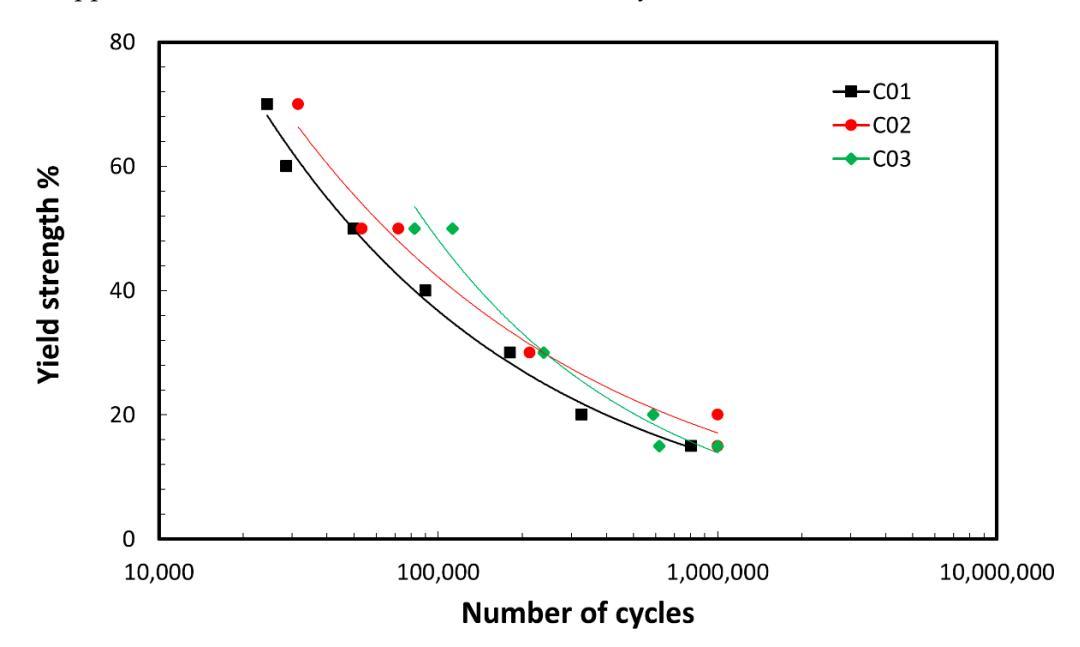
**Figure 5.** S-N curves of FSW joints showing a comparison between FSW specimens produced with bare aluminium alloys (C01) and surface-treated aluminium alloys without sealant (C02 and C03).

Figure 5 shows the comparison between the FSW joints produced using bare aluminium alloys (C01) and those produced using surface-treated aluminium alloys, TFSAA in C02 and Sol-Gel treatment in C03. According to these results, surface-treated FSW joints obtained from C02 and C03 showed a slightly better fatigue behavior and extended life compared to the FSW joints obtained from the coupon C01. A similar conclusion can be obtained from the results shown in Figure 6, where the fatigue life of FSW joints obtained from coupon C01 is compared to the ones produced using the same bare aluminium substrates, but sealant in the stringer-skin interface prior to FSW (coupon C04). The fatigue specimens containing sealant showed a better fatigue performance and durability in comparison with the reference FSW joints from coupon C01. Figure 7 shows the comparison between the reference FSW joints machined from coupon C01 and those obtained from the

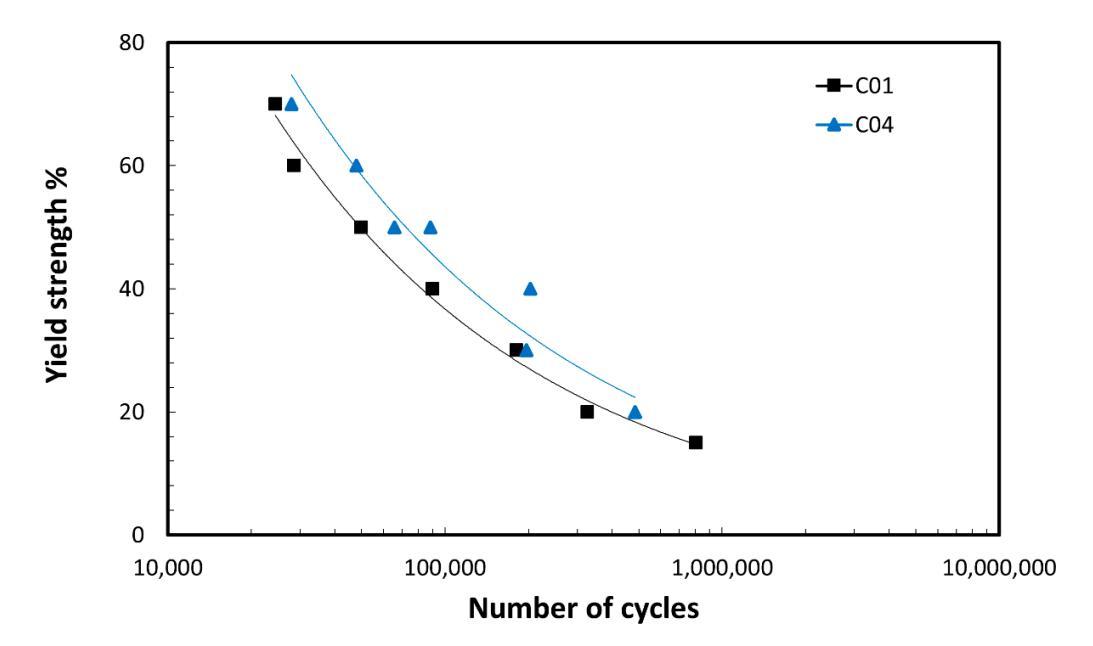
**Figure 6.** S-N curves of FSW joints showing a comparison between FSW specimens produced with bare aluminium alloys without sealant (C01) and with sealant (C04).

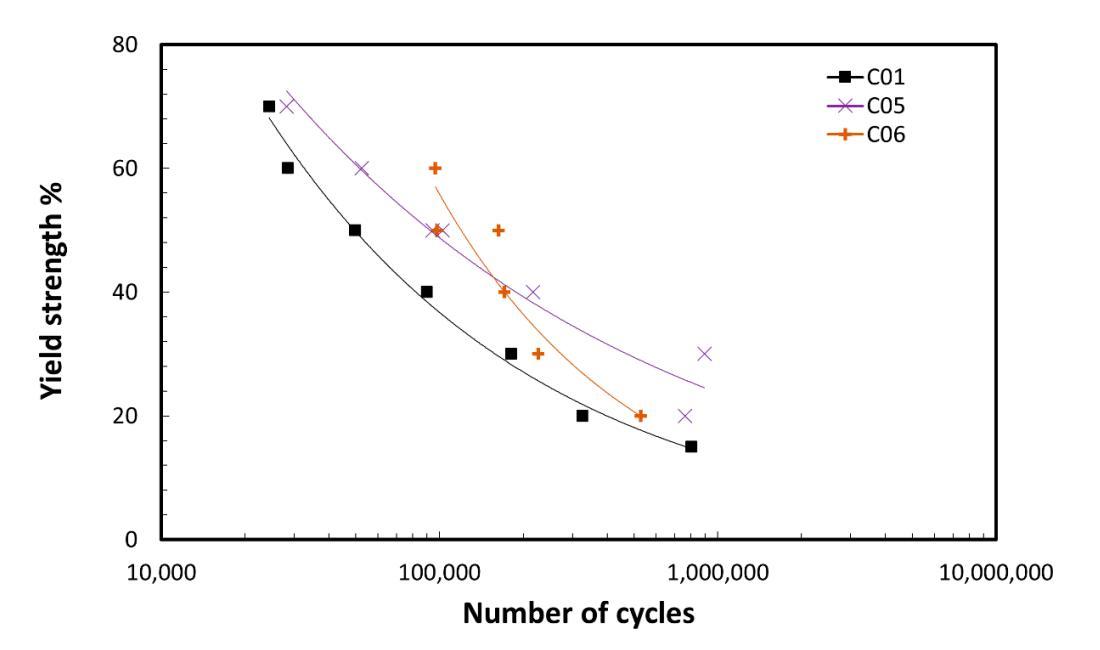
**Figure 7.** S-N curves of FSW joints showing a comparison between FSW specimens produced with bare aluminium alloys without sealant (C01) and surface-treated aluminium alloys with sealant (C05 and C06).

coupons produced using a combination of surface-treated aluminium alloys and sealant in the stringer-skin interface, coupons C05 and C06. Once again, the FSW joints containing surface treatments and sealant showed a longer fatigue life than the reference FSW joints. According to these results it could be stated that both the use of surface-treated aluminium alloys and the application of sealant improved the fatigue life of the FSW joints, when they are applied either in an individual or a combined way.

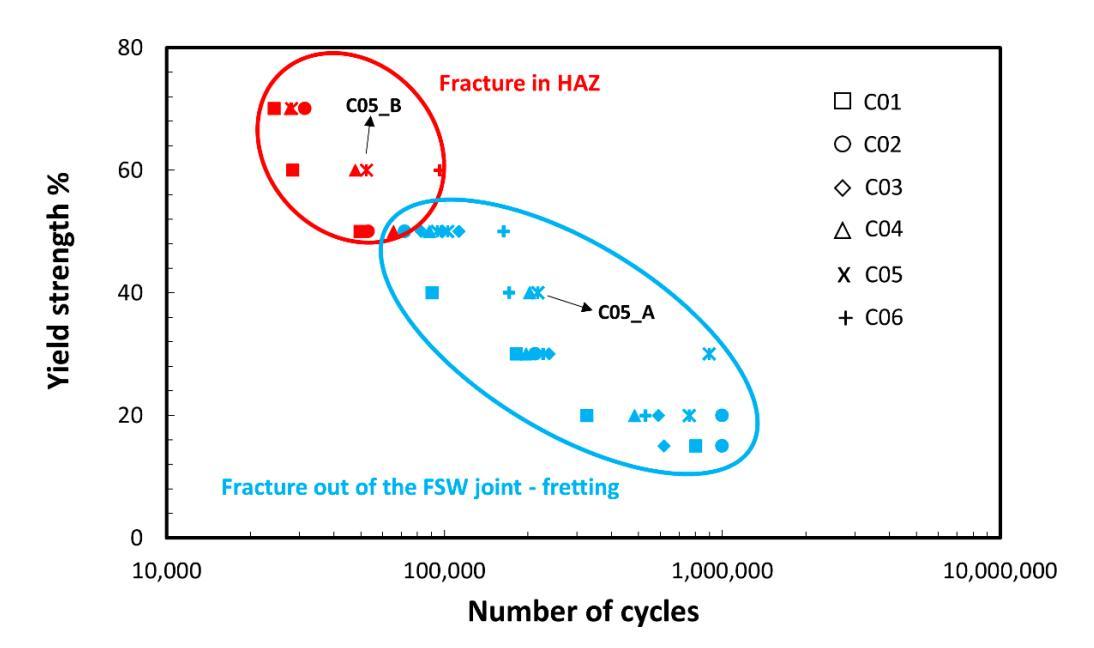
**Figure 8.** S-N data of FSW joints showing different fracture modes in high- and low-stress loading conditions.

The fracture analysis of the FSW joints in the fatigue tests allowed us to distinguish two main fracture modes as shown in the S-N data represented in Figure 8. The specimens tested in high-stress loading conditions showed failures at a relatively low number of cycles with a fracture initiation and propagation in the HAZ of the FSW joint (indicated in red in Figure 8). On the other hand, the specimens tested in low-stress loading conditions presented a higher number of cycles until fracture and they showed a fracture located out of the FSW joint (indicated in blue in Figure 8). This type of failure could be related to fretting fatigue phenomena [25,26] occurring at random locations in the contacting stringer-skin interface out of the FSW joints, generating an initial damage and fracture initiation point for a later fracture out of the FSW joint.

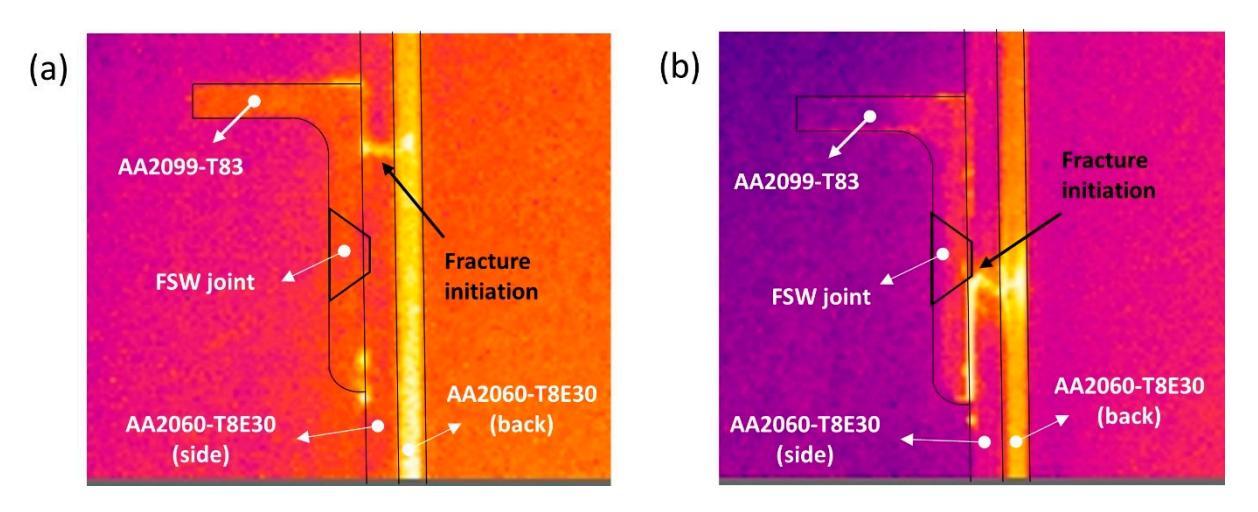
**Figure 9.** Thermographic images of FSW joints showing the instant of the fracture in the fatigue tests; (a) specimen C05\_A showing the fracture out of the FSW joint at 216,817 cycles and (b) specimen C05\_B showing the fracture in the HAZ at 52,306 cycles.

The monitoring of the FSW specimens during the fatigue tests by IR thermography allowed us to capture the instants when the fracture occurred for the two different failure modes identified (Figure 9). The positions of the AA2099-T83 stringer, the AA2060-T8E30 skin and the FSW joint were highlighted with black lines for a better clarity of the images. The image in Figure 9a shows the instant when the fracture of the specimen C05\_A, which was tested at relatively low stress conditions as indicated in Figure 8, occurred. It can be clearly observed that the fracture initiation and final fracture occurred out of the FSW joint after 216,817 cycles. On the other hand, the image in Figure 9b shows the instant of the fracture of the specimen C05\_B, tested in high-stress loading conditions (Figure 8). It can be observed that the fracture occurs in the HAZ of the FSW joint after 52,306 cycles. Although it was not possible to achieve an accurate quantification of temperature variations during the fatigue tests, IR thermography allowed us to clearly distinguish the fracture initiation points. Thus, IR thermography was found to be an effective technique to carry out qualitative studies in the fatigue tests of FSW joints.

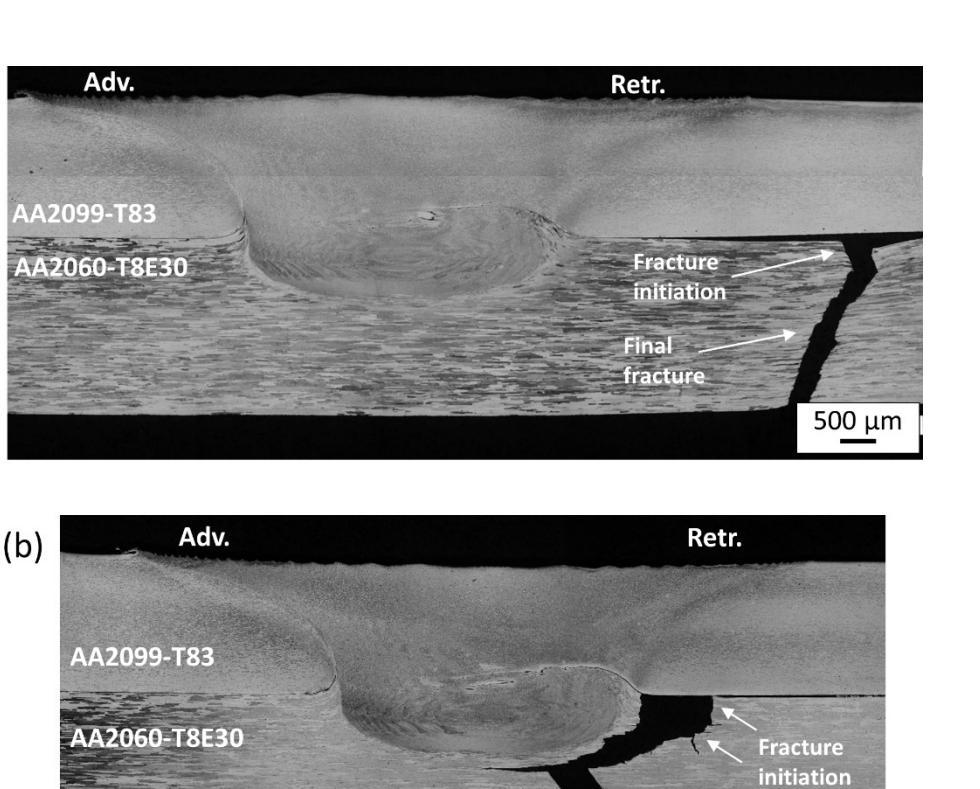
**Figure 10.** Metallographic cross-sections of FSW showing different fracture modes; (**a**) specimen from coupon C05 tested at 30% of the YS showing the fracture out of the FSW joint and (**b**) specimen from coupon C05 tested at 70% of the YS showing the fracture in the HAZ.

Similar results were obtained after the metallographic characterisation of specimens fractured in fatigue tests (Figure 10). The cross-section shown in Figure 10a corresponds to a specimen machined from coupon C05 that failed in low-stress loading conditions after 897,334 cycles. It can be clearly observed that the fracture initiation and final failure occur out of the FSW joint. On the other hand, the cross-section of a specimen tested in high-stress loading conditions can be observed in Figure 10b. A fracture initiation and crack growth through the HAZ can be clearly observed prior to the final fracture after 28,187 cycles.

Therefore, from these results, it could be stated that specimens tested in high-stress loading conditions presented a fracture initiation in the HAZ in a similar zone as in the fractures observed in the static tensile tests (Figure 3b). However, the crack growth occurs along the HAZ due to the reduced hardness of the material in this zone. The specimens tested under low-stress conditions showed a fracture out of the FSW joint due to fretting effects produced as a consequence of the frictional contact and sliding movement between the stringer and the skin at their interface. The precise location of the fracture initiation point was randomly distributed along the stringer-skin interface out of the FSW joint, depending on the damage accumulation caused by the frictional contact and the sliding movement between the stringer and the skin.

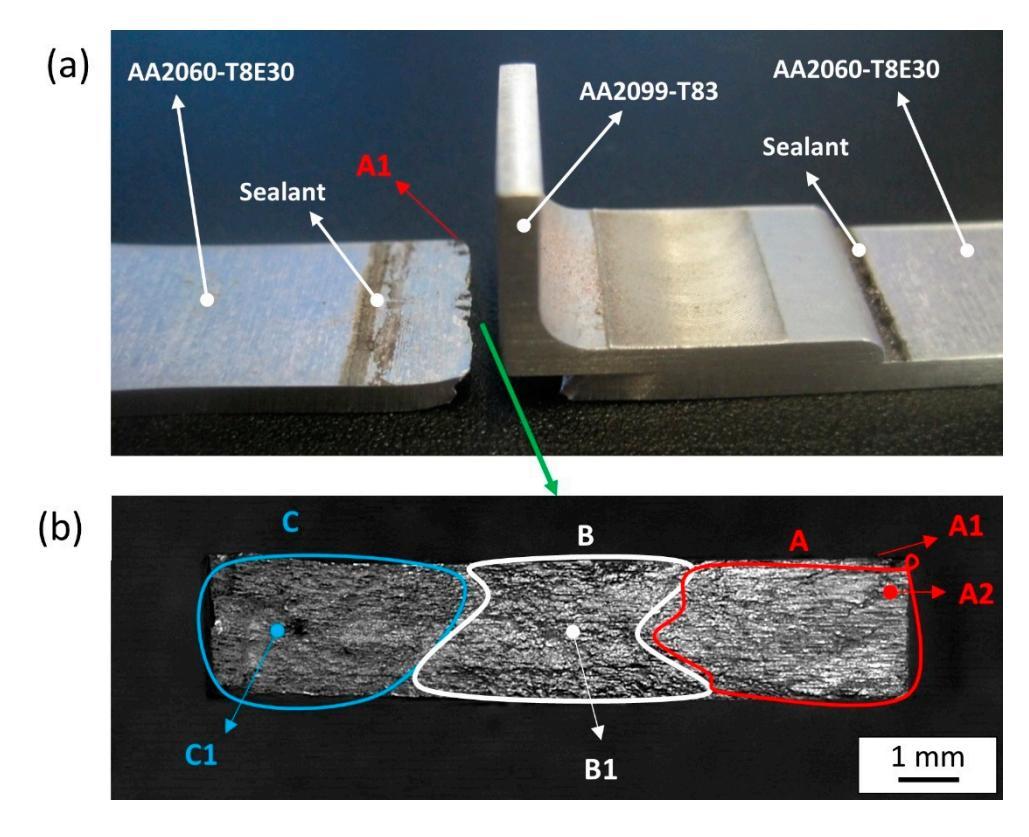
**Figure 11.** Fracture surface analysis of specimen C05\_A showing the fracture out of the FSW joint at 216,817 cycles (**a**) general view of the fractured specimen and (**b**) perpendicular view of the fracture surface indicated by the green arrow.

The fracture surfaces were investigated in more detail using SEM and EDS techniques. The results obtained in the analysis of the specimen C05\_A, which was tested in low-stress loading conditions, are shown in Figures 11–13. A general view of the fractured specimen can be observed in Figure 11a and a more detailed view of the fracture surface in Figure 11b. Small regions of black phases were observed at the stringer-skin matching interface, which are indicated as point A1 in Figure 11a, suggesting these phases could act as fatigue crack nucleation points. A detailed analysis of these black phases indicated as regions A1-1 and A1-2 in Figure 12 revealed that they consisted of accumulated aluminium oxides as a result of local sliding and frictional contact between the stringer and skin surfaces at the point A1. Once the fatigue crack was initiated at this point, three main regions were observed for its propagation, indicated as zones A, B and C in Figure 11b. A detailed observation of the fracture surface by SEM allowed us to identify these zones and representative SEM images are shown in Figure 13.

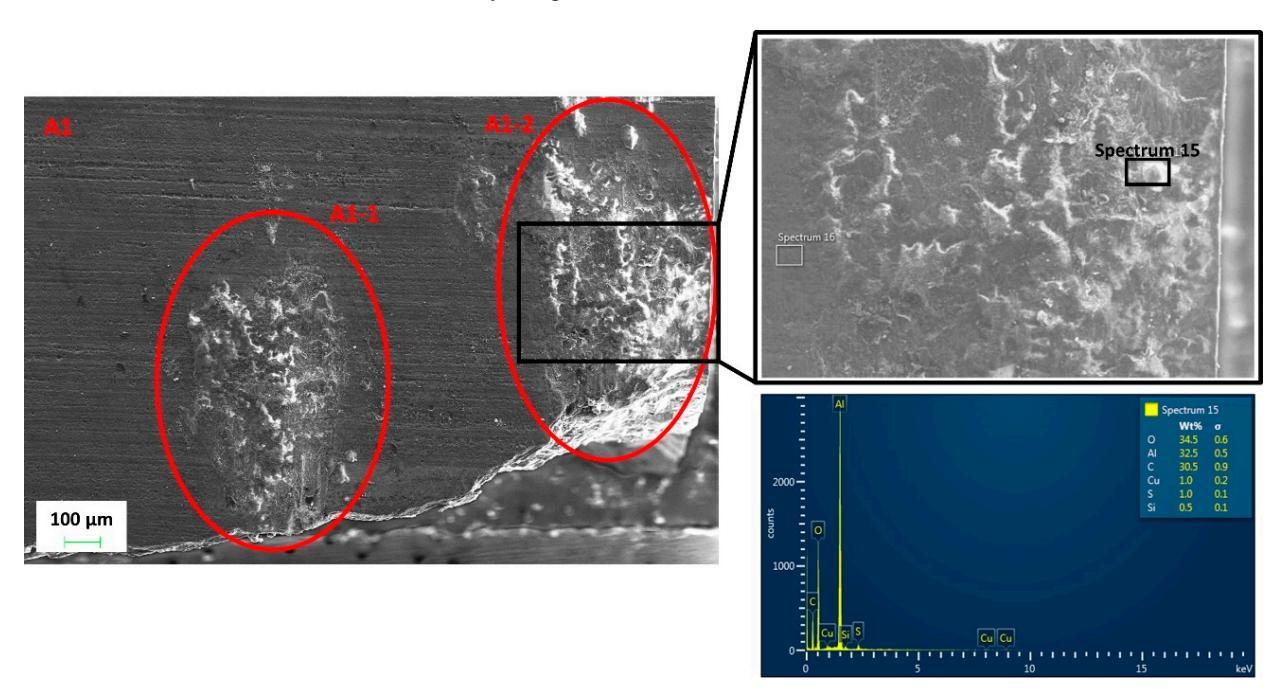
Figure 12. SEM image and EDS analysis of the zone A1 indicated in Figure 11.

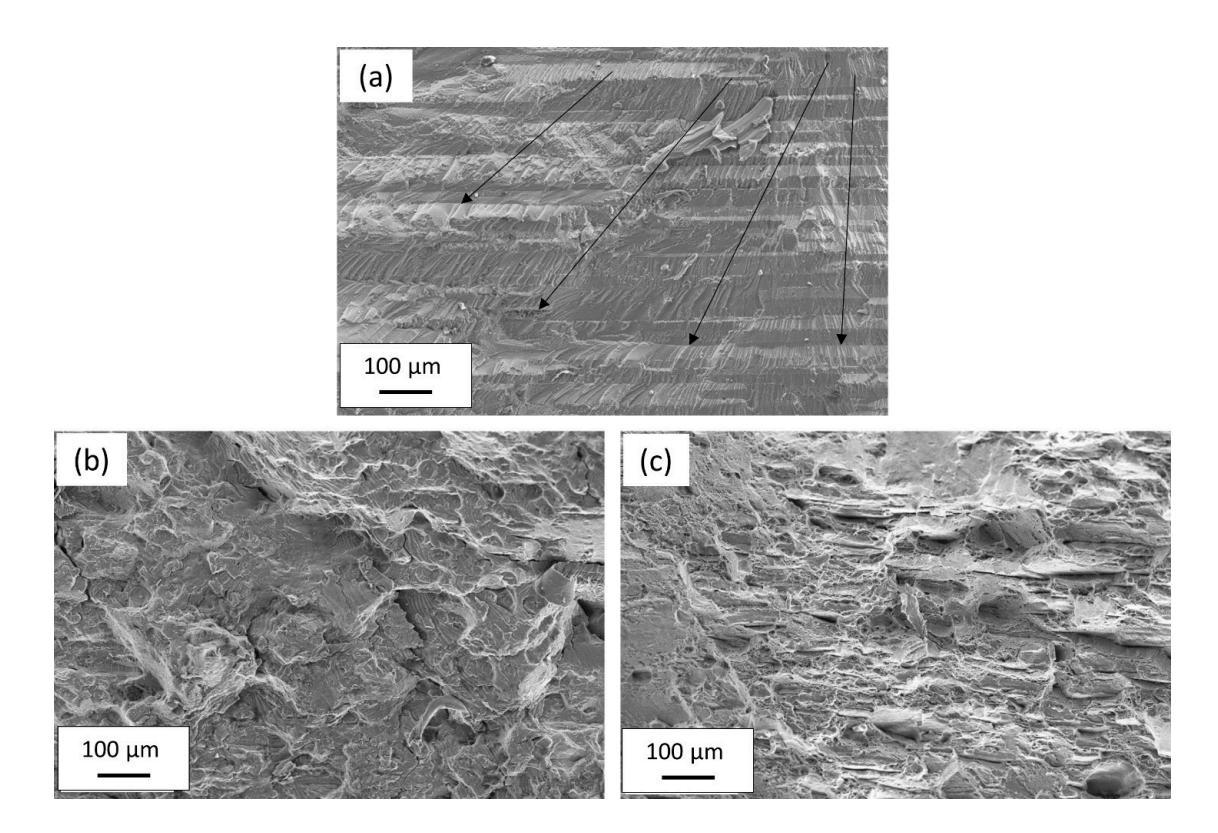
**Figure 13.** SEM observations of the fracture surface of specimen C05\_A shown in Figure 11b; (**a**) image obtained at point A2 indicated in Figure 11b; (**b**) point B1 in Figure 11b and (**c**) point C1 in Figure 11b.

Figure 13a shows a SEM image obtained at point A2 indicated in Figure 11b, which is considered to be close to the initial fatigue crack nucleation point. A very flat surface without significant plastic deformation and the progress of the crack during the cyclic loading of the fatigue test can be observed. This propagation goes from the top surface towards the bottom in thickness as well as from the edge of the specimen towards its centre as indicated by the arrows in Figure 13a. A representative SEM image of the transition zone B obtained at point B1 indicated in Figure 11b can be observed in Figure 13b. A combination of zones showing limited plastic deformation and crack growth bands with other zones showing dimples indicative of ductile fracture with significant plastic deformation could be observed in Figure 13c. A surface formed of multiple dimples indicative of substantial plastic deformation and ductile fracture could be observed, which was representative of zone C, where the final fracture occurred.

This type of fracture, originated by oxides accumulated at the stringer-skin interface, was representative of the fractures caused by fretting effects in low-stress loading conditions and after a relatively high number of cycles. Thus, fretting effects are the main limiting factor of the fatigue life of stringer-skin FSW joints in the overlap configuration in the high-cycle fatigue regime.

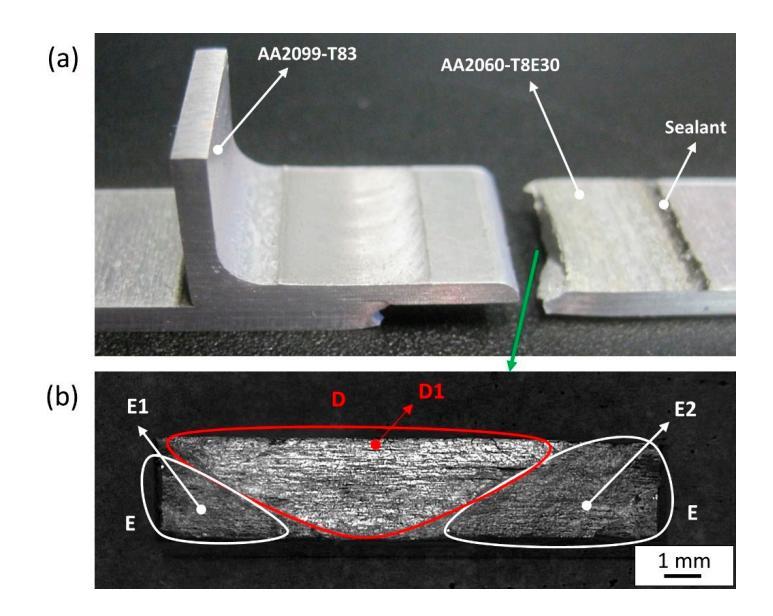
**Figure 14.** Fracture surface analysis of specimen C05\_B showing the fracture in the HAZ at 52,306 cycles; (a) general view of the fractured specimen and (b) perpendicular view of the fracture surface indicated by the green arrow.

The fractures that occurred in high-stress loading conditions were also investigated by SEM observation of the fracture surfaces. The results obtained in the analysis of the specimen C05\_B, that presented a representative fracture in the HAZ of the FSW joint, are shown in Figures 14 and 15. The general view of the fractured specimen can be observed in Figure 14a. No presence of black phases was observed at the stringer-skin interface. A more detailed view of the fracture surface can be observed in Figure 14b showing the main zones which form the final fracture surface: the fatigue crack nucleation and propagation zone (indicated as D) as well as the final fracture zone (indicated as E). Representative images obtained by SEM showing the characteristics of these zones can be observed in Figure 15. Thus, Figure 15a shows details of the initial fatigue crack nucleation point indicated as point D1 in Figure 14b. A flat surface showing no plastic deformation can be observed where propagation bands starting at the top surface indicate the fracture initiation point. The propagation of the fatigue crack, which is indicated by the black arrows in Figure 15a, goes from the top surface towards the bottom in the thickness direction and from the central zone towards the edges in the width of the specimen. Once the crack propagates to cover the zone D, the final fracture occurs in the zone E. SEM images obtained at points E1 and E2 indicated in Figure 14b are shown in Figures 15b and 15c, respectively. Multiple dimples can be observed in these zones indicating a ductile fracture with plastic deformation.

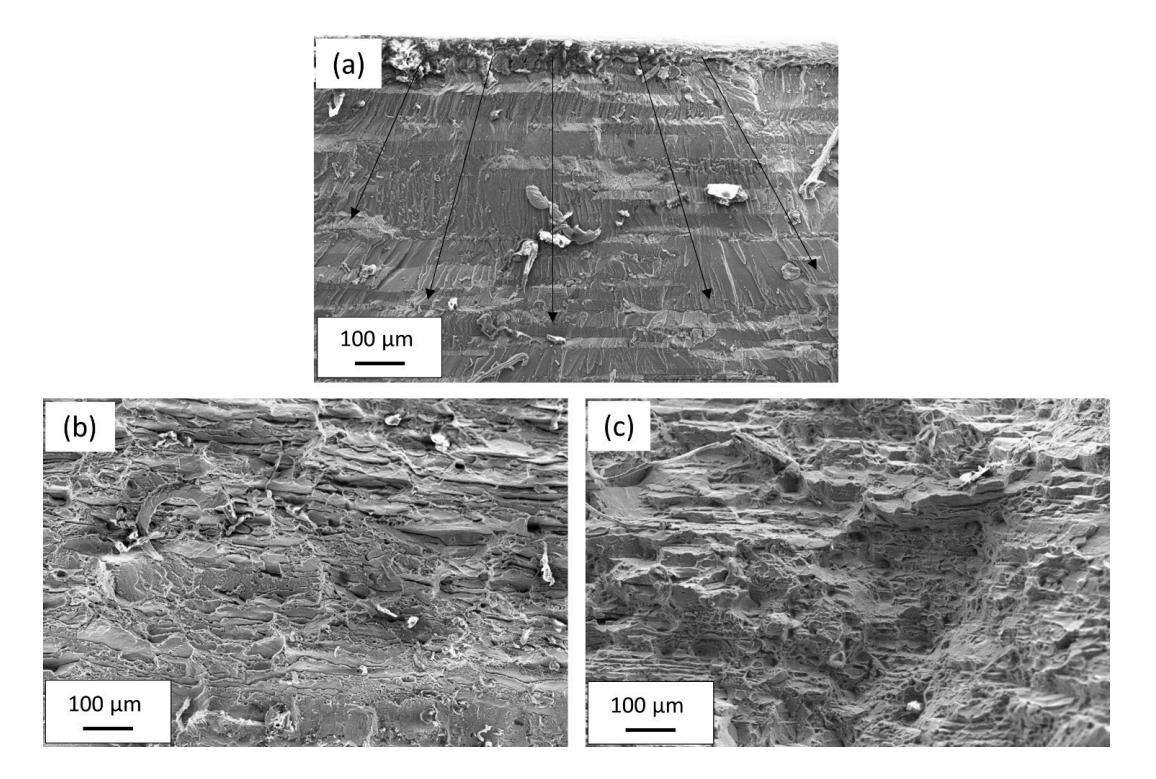
**Figure 15.** SEM observations of the fracture surface of specimen C05\_B shown in Figure 14b; (**a**) image obtained at point D1 indicated in Figure 14b; (**b**) point E1 in Figure 14b and (**c**) point E2 in Figure 14b.
