Article Unraveling Magnet Structural Defects in Permanent Magnet Synchronous Machines—Harmonic Diagnosis and Performance Signatures

Citation: Abdolmaleki, M.; Asef, P.; Vagg, C. Unraveling Magnet Structural Defects in Permanent Magnet Synchronous Machines— Harmonic Diagnosis and Performance Signatures. *Magnetism* **2024**, *4*, 348–367. https://doi.org/10.3390/ magnetism4040023

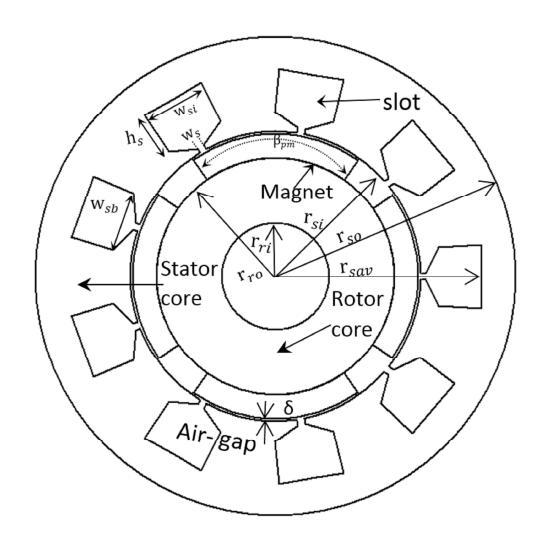
Figure 1. Cross-sectional presentation of the studied SPMSM.

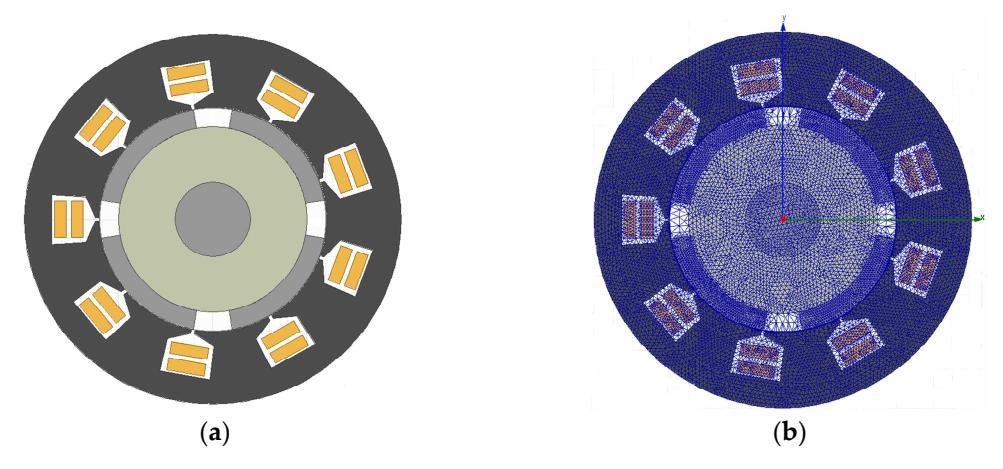
Figure 2. Cross-sectional view of the model in Ansys Maxwell: (a) 2D CAD and (b) meshed model.

In Figure 2a, the healthy model without magnet structural defects (i.e., cracking fault) is presented. The performance of the healthy and faulty motors under the full load

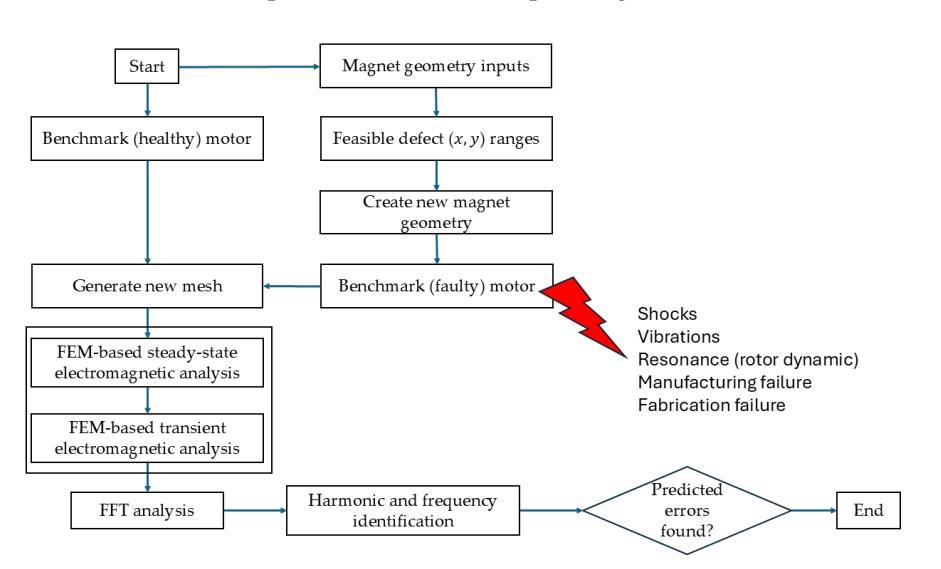
Figure 3. Proposed methodology to investigate harmonic and performance signatures in motors.

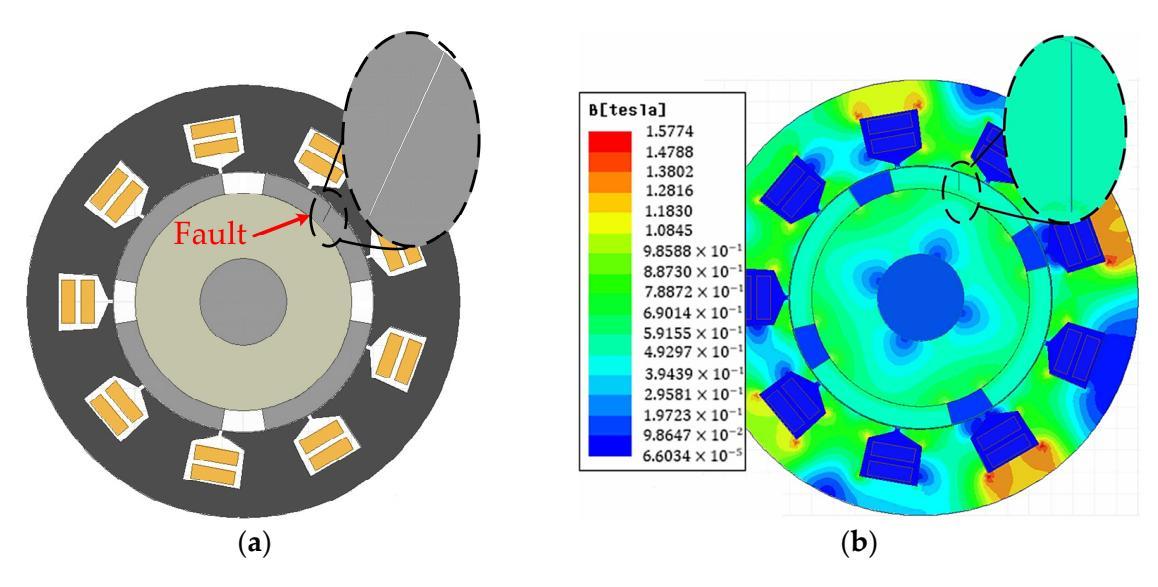
Figure 4. Faulty SPMSM associated with fault type A in the 2D FEM environment, (**a**) CAD modeling, and (**b**) corresponding flux density distribution.

First, for the type A initial fault, one crack of a magnet in the rotor was created as a structural fault by making a crack with a width of 0.08 mm and depth of 8 mm, which is shown in Figure 4a. The influence of such a crack was analyzed for the demagnetization fault predictions. In Figure 4b, the impact of the crack can be observed on the magnetic flux density distribution. As can be seen, the magnetic flux density is weakened in the crack area, which indicates the reduction in the magnetic property of the PM.

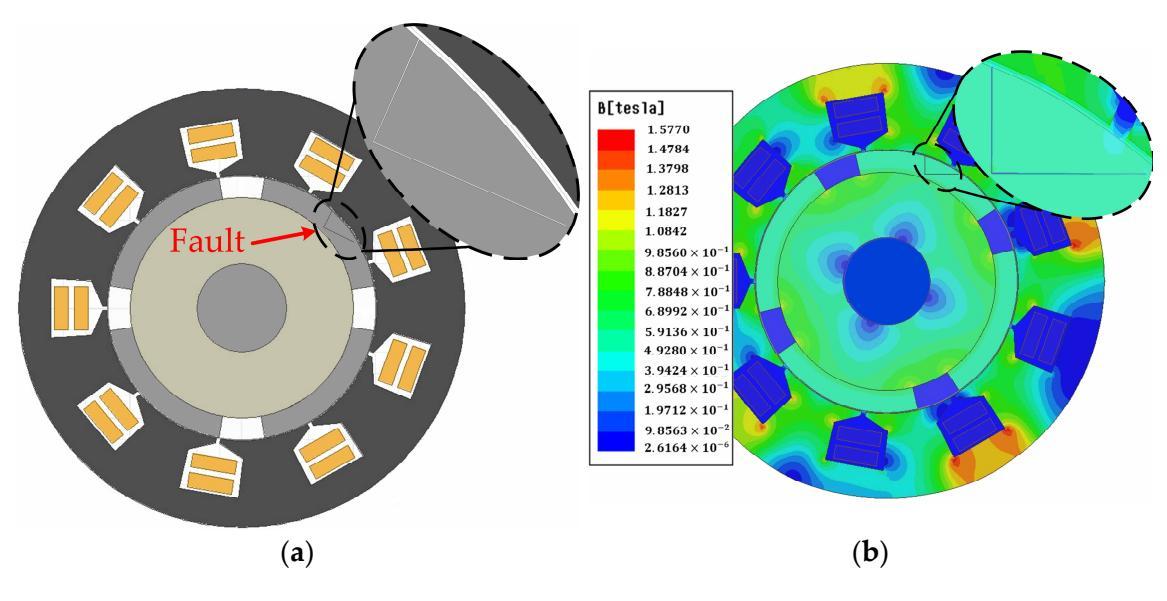
Figure 5. Faulty SPMSM with fault type B using 2D FEM: (a) CAD modeling; (b) flux density distribution.

Next, due to the mechanical properties of powder-based PMs, once there is a crack in the magnet, its length (severity) is likely to increase during the machine operation due to vibrations and cyclic loading (internal stress variations). In Figure 5a, the type B fault is shown, which has gradually increased compared to the type A fault. In this stage, the depth length of the crack increased to 15 mm. Figure 5b shows the flux density distribution. It can be seen that as the crack increases, the magnetic flux density is further weakened, which can result in a more significant reduction in the magnetic properties of the magnet and considerable impacts on motor performance.

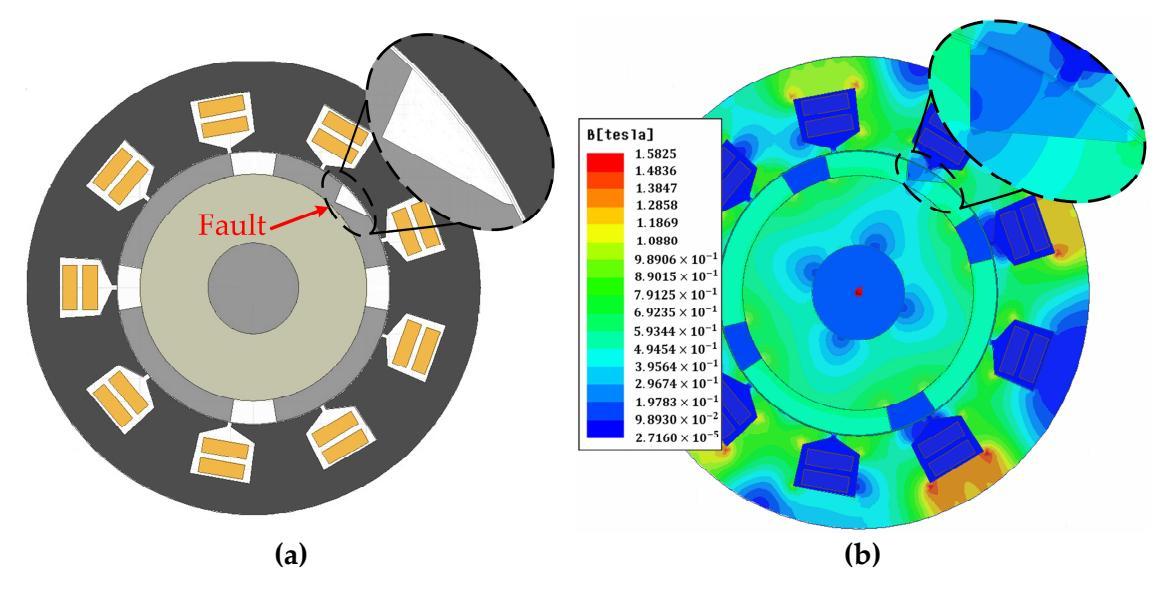
Figure 6. Faulty SPMSM with fault type C using 2D FEM: (a) CAD modeling; (b) flux density distribution.

Next, due to the brittle nature of magnet materials, cracks are likely to propagate and eventually lead to a partial breakage of the PM. In this section, the partially broken magnet caused by cracks is studied. The area of the healthy and defective magnet is 673.871 and 595.191 mm², respectively. The area of the removed part of the magnet is 78.68 mm². In Figure 6a, fault type C, which is the most critical fault, is presented. The magnetic flux density distribution is simulated and shown in Figure 6b. It can be seen that the magnetic flux density is weakened considerably, and its magnitude is reduced in the broken area. This result reveals that the magnetic field strength of the magnet decreased significantly.

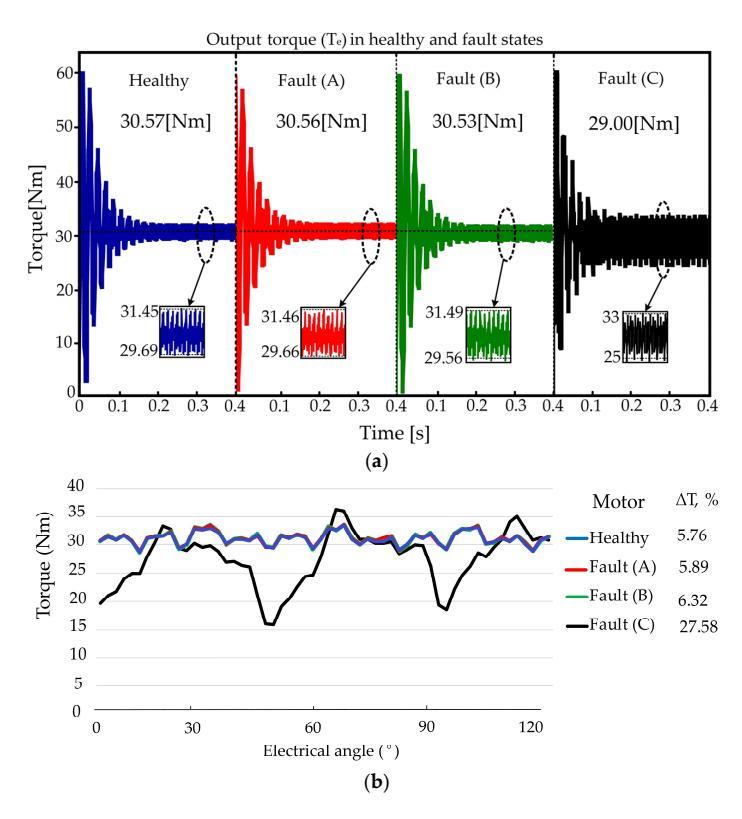
The simulation results of the healthy and faulty motors with type A-C faults using 2D FEM are shown in Figures 7 and 8. The simulation was carried out for 0.4 s. The magnets were magnetized radially. The PMSM driving torque was set to vary with the torque angle, which is the difference between the phase angles of the supplied and induced voltages. In terms of boundary conditions, magnetic flux density at independent and dependent boundaries match each other. The employed magnetic transient solver uses arbitrary time-varying voltage or current sources, set in an external circuit fully coupled with field quantities. The stator windings were set to stranded with a resistance of 0.052483 Ω .

The predicted output torque of healthy and faulty motors under A-C faults is shown in Figure 7a. The average output torque is considered equal to the load torque, TL = 30.57 Nm in blue. The torque curve under fault type A is shown in Figure 7a in red, in which the torque ripple is almost similar to the healthy state and increased slightly. Also, the average rated load torque slightly decreased to TL = 30.56 Nm. The output torque with a type B fault is presented in Figure 7a in green; the torque ripple in this increased fault increased slightly again from the type A fault and healthy motor. The average rated load torque decreased to TL = 30.53 Nm. The output torque with a type C fault is shown in Figure 7a in black; the torque ripple produced in the output torque has larger values compared to the healthy motor and either of the other faults (A or B). The output torque decreased from 30.57 Nm to 29 Nm, which is more than 5%. Figure 7b demonstrates the same output torque against the electrical angle for better visualization of magnet structural defects. The results report a critical increase in torque ripple by 27.5% and a drop in average torque by 5% only when a magnet is partially broken in the rotor.

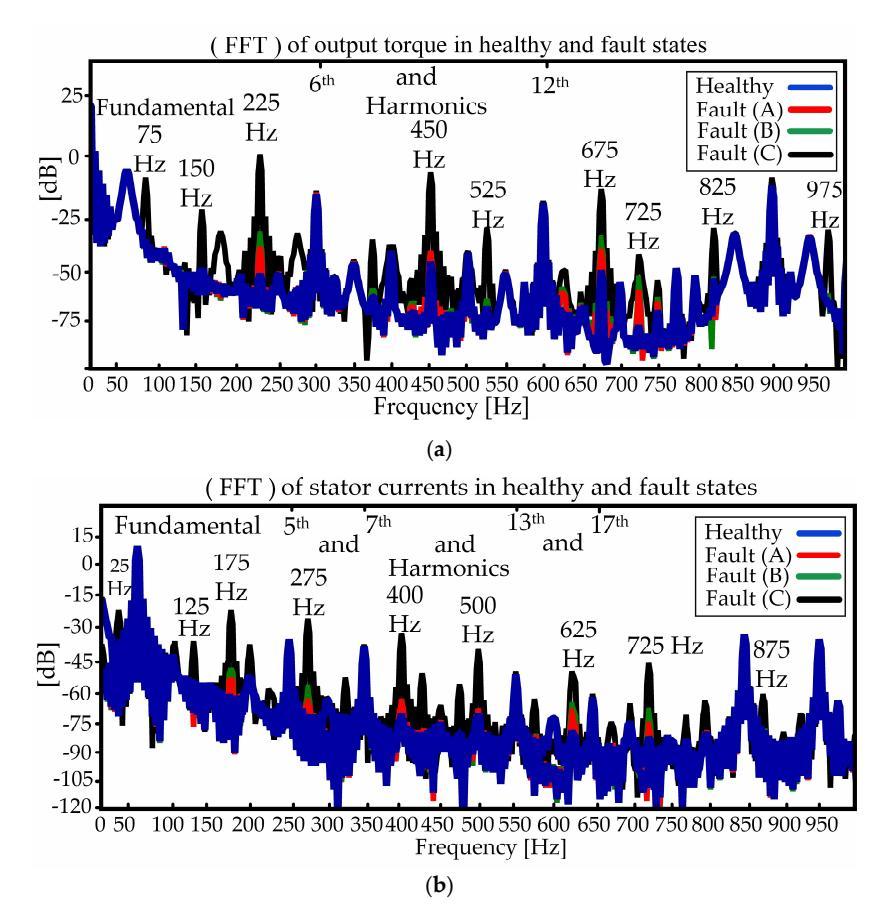
Figure 8. Harmonic content analysis using FEM simulation results and rated load states for healthy and faulty motors with A–C faults: (a) FFT of output torque; (b) FFT of stator currents.

The simulation performed in 0.4 s with full load in the healthy and type A–C faulty motor states could be observed on the torque and current in the frequency domain as demonstrated in Figure 8a,b. The frequency spectrum of the output torque and current in the healthy and type A–C faulty motor states was computed using the fast Fourier transform (FFT), presented in Figure 8a,b. In fault A, the crack is still small. However, the amplitude of some harmonics increased compared to the healthy FFT results in red. For example, in the torque spectrum, the amplitudes of 225, 450, 675, and 725 Hz frequencies clearly increased. Among these, the 225 and 725 Hz frequencies represented the most changes compared to other harmonic components, which can be considered more index and reliable components, and the 675 Hz frequency can be considered another component. The FFT of the stator currents in the type A fault is provided in Figure 8b. In the current spectrum, the amplitudes of 175, 275, 400, 625, and 725 Hz frequencies had a more significant impact and created the most changes compared to other increased harmonics. Surprisingly, the 175 and 275 Hz frequencies did not appear until before the fault, which can be considered more index and reliable components in the type A fault in the current spectrum. It can also be seen in the torque spectrum that amplitudes of 225, 675, and 725 Hz frequencies in green increased again when the type B fault and the length of the crack increased, and frequencies 725 and 225 Hz showed the most significant changes during fault types A and B; thereby, these two frequencies can be considered as more indicative and reliable components in detecting fault types A and B. The frequency of 675 Hz can be considered as another component. As revealed in Figure 8b by the harmonic content analysis of stator currents in fault type B in green, the amplitudes of frequencies 175, 275, 625, and 725 Hz drastically strengthened with the increase in fault. The amplitudes of frequencies 175 and 275 Hz, which appeared with the type A fault, also increased again. Hence, these two frequencies can be considered as more indicative and reliable components in detecting type A and type B faults in the current spectrum. It should be noted that the 625 and 725 Hz frequencies can be considered as other components. The harmonic content analysis of the torque in fault type C is shown in Figure 8a in black. More harmonics have appeared in the faulty motor under fault type C, which indicates an increase in the severity of the demagnetization fault. This can lead to noise, vibration, harshness (NVH), and other negative effects on the motor. It is very important to detect and monitor the fault in the first place due to its minor impacts on the motor performance. Figure 8a shows that the 75 Hz frequency did not appear in the torque spectrum until before the magnet was partially broken, which has the most influential change compared to other frequencies. The effect of this fault on the sidebands of the third and fourth harmonics, respectively, was observed in the spectrum of the torque and current. The 175 Hz harmonic can also be defined as significant, which could be introduced as other fault indices. However, the change in behavior of these two components is like other harmonics during faults, in which the 75 Hz frequency is the most prominent and therefore the most impactful and reliable metric for the detection of fault type C. The harmonic content analysis of the stator currents under the C fault state is

shown in Figure 8b in black. As can be seen, the harmonic components increased when the PM was partially broken (fault type C). The 25 Hz and 125 Hz frequencies did not appear in the spectrum of the stator currents before the type C fault, yet they can be seen with the impact created in this type of fault. These two components in the frequency spectrum of stator currents cause the most changes compared to other components. The behavior of other components was similar with increasing cracks: the 25 Hz frequency had the most impact and was the most dominant and reliable component for the diagnosing of fault type C using the stator currents. The 125 Hz frequency can be considered another index for the detection of the partially broken magnet fault.

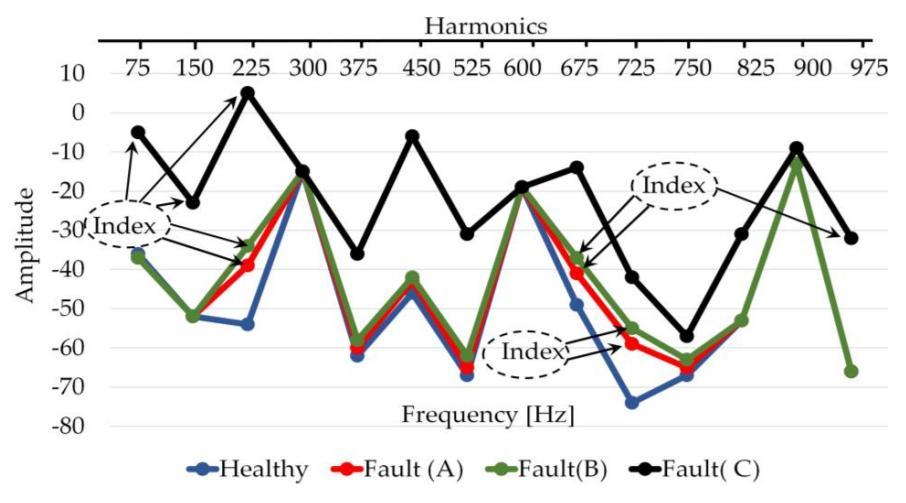
Figure 9. Comparison of the amplitude of the harmonics (index) appearing in the output torque in healthy and faulty motors, consecutively.

The comparison of the amplitudes of harmonics appearing in the spectrum of the output torque and stator currents in healthy and faulty motor states is displayed in Figures 9 and 10. Reducing the output torque reduces the total rated power of the motor. The output power was simulated based on the rated load. In Figure 11a,b, the changes in the output torque and total power of the healthy and faulty motors under faults A–C are demonstrated. The results confirm cracks (i.e., types A and B) due to the decrease in torque, respectively, from 30.57 Nm to 30.56 and 30.53 Nm. These magnet structural defects can reduce the torque by less than 0.2% and result in the partial failure of the magnet (i.e., type C) due to the decrease in torque from 30.57 to 29 Nm. It can reduce the torque by more than 5%. Therefore, these defects can result in less than 2% and over 5% performance prediction errors (i.e., torque and total loss), respectively.

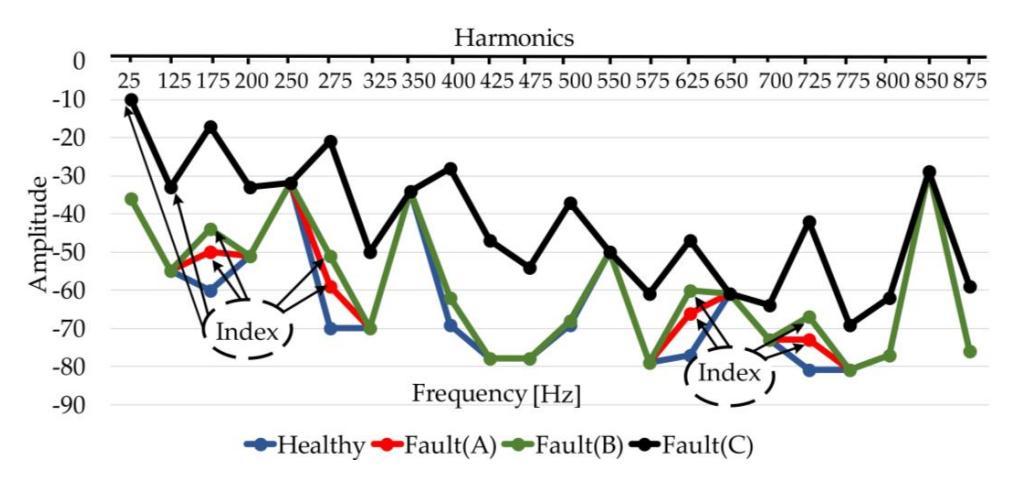
Figure 10. Comparison of the amplitude of the harmonics (index) appearing in the stator currents in healthy and faulty motors.

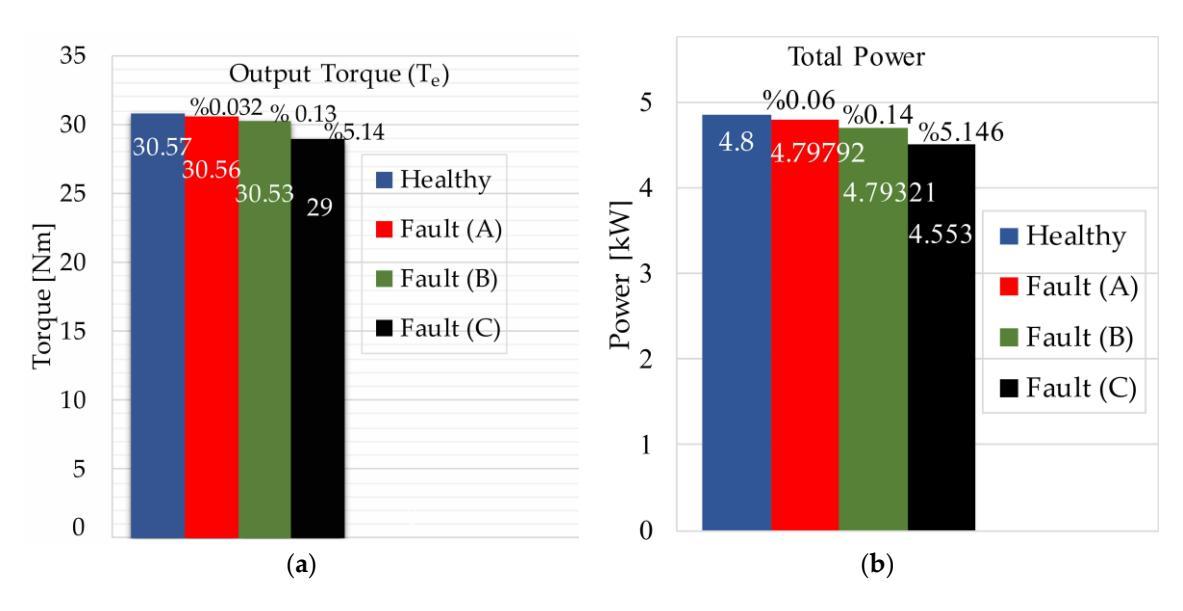
Figure 11. The impact of the demagnetization faults for the healthy and faulty motors under faults A–C: (**a**) the output torque; and (**b**) total power.

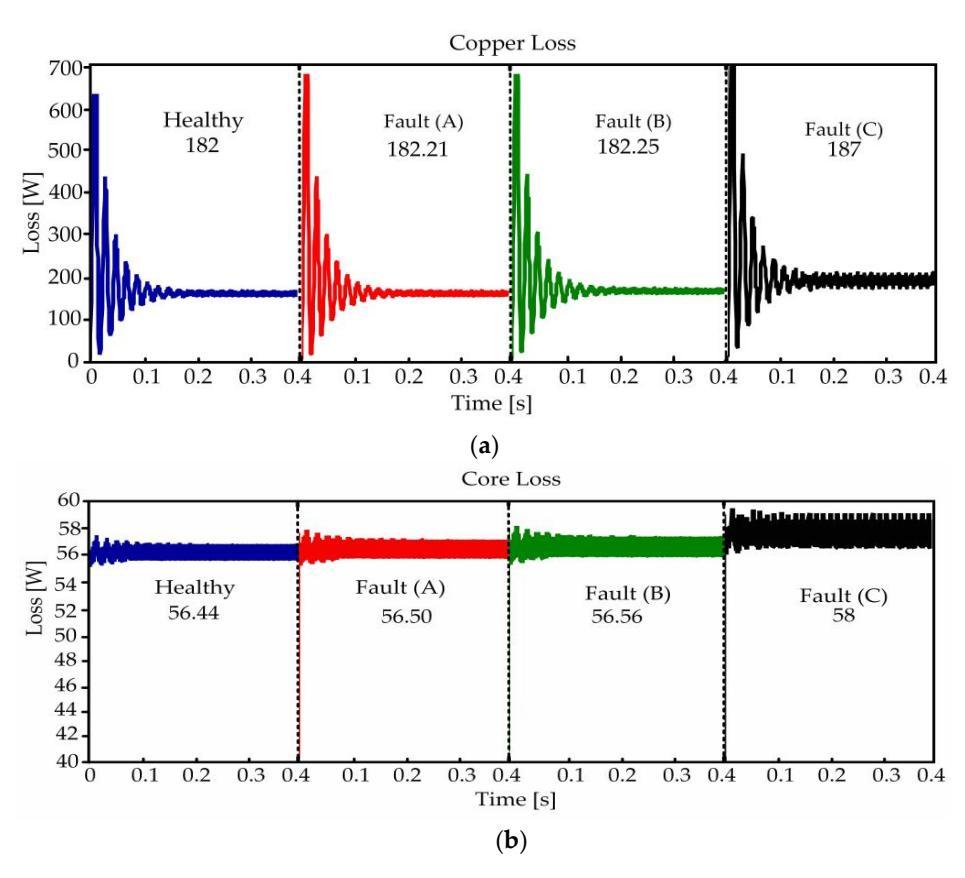
Figure 12. Impact of faults on losses of healthy and faulty motors: (a) copper loss; (b) core loss.

In this section, the impact of the structural defects on the losses and efficiency of healthy and faulty motors is analyzed. The typical motor control of maximum torque per voltage (MTPV) is used to calculate the torque–speed curve, which conforms to the maximum potential of mechanical torque of a motor from the base speed to the maximum speed point. The magnet fault causes a negative effect on the motor, leading to higher losses. Figure 12a,b show the copper and core losses of the motor in healthy and faulty states A–C computed by FEM under starting and loading states with a full load. The copper loss increased by 2.7% from 182 W to 187 W, and the core loss increased by 3.5% from 56 W to 58 W. As the fault severity increases in the same faulty magnet or in other potential poles, by nature the losses increase further. Note that the faulty states were predicted and observed only for a single PM; the harmonics and associated demagnetization faults increase if more magnets are affected.

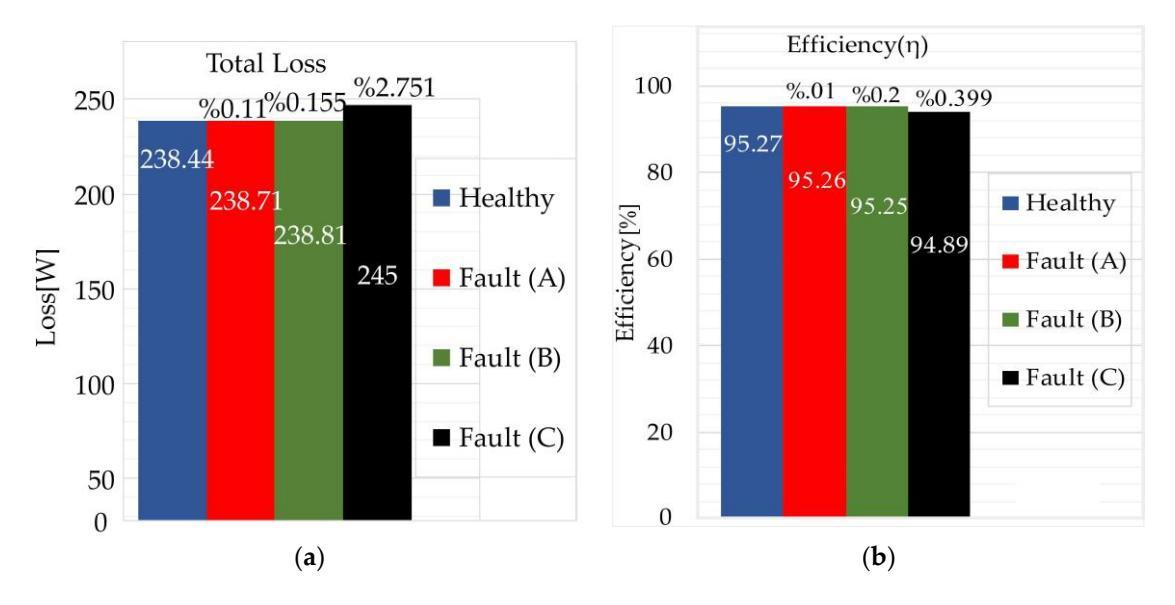
Figure 13. The changes in the total loss and efficiency of the healthy and faulty motors under faults A–C: (**a**) total loss; (**b**) efficiency.

The total loss and efficiency for both healthy and faulty motors under faults A–C, based on FEM, is calculated and presented in Figure 13a,b. As shown, the change in the total loss and efficiency of the motor in healthy and faulty states A–C have considerable impacts on the SPMSM's efficiency. A comparison of the obtained simulation results of the healthy and faulty motors with faults A–C is given in Table 4.

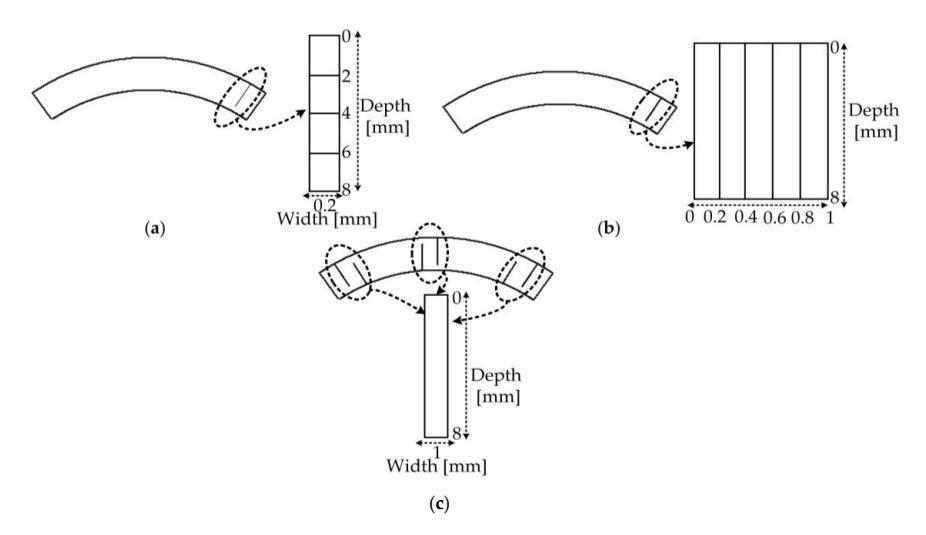
Figure 14. Impact analysis of other types of alternative crack faults with depth, width, and different directions across the magnet. (**a**) depth cracking study; (**b**) depth and width cracking study; (**c**) depth and width cracking study in different magnet locations.

In order to analyze the accuracy of the proposed method of crack fault and crack propagation, various cracks with different depths, widths, and locations were analyzed and simulated as shown in Figure 14a–c. To assess the fault, first, a crack with a width of 0.2 mm and a depth of 2 mm is created in the corner of the magnet. Then, the depth of the crack is increased by 2 mm in each step up to a depth of 8 mm, which is shown in

Figure 14a. In the next step, the width of the crack with a depth of 8 mm is analyzed for an increase of 0.2 mm in each step up to a width of 1 mm, which is shown in Figure 14b. In the next step, six cracks with a depth of 8 mm and a width of 1 mm are created on the magnet in different directions as shown in Figure 14c. With the diffusion and addition of each crack, the results are simulated and analyzed. The results of the simulation were analyzed in the domain of frequency spectrum on the output torque, stator currents, torque ripple, average output torque, and rated power of the motor in healthy and faulty conditions. The simulation of the first crack according to Figure 15a was conducted using Ansys Maxwell, which can be seen in Figure 15a. Figure 15b,c indicate the frequency spectrum of the output torque and stator current, respectively. As can be seen in Figure 15b, the amplitude of the frequency components of 225, 450, 675, and 725 Hz in the torque spectrum, which were introduced as fault indicators, increased with the increase in crack length.

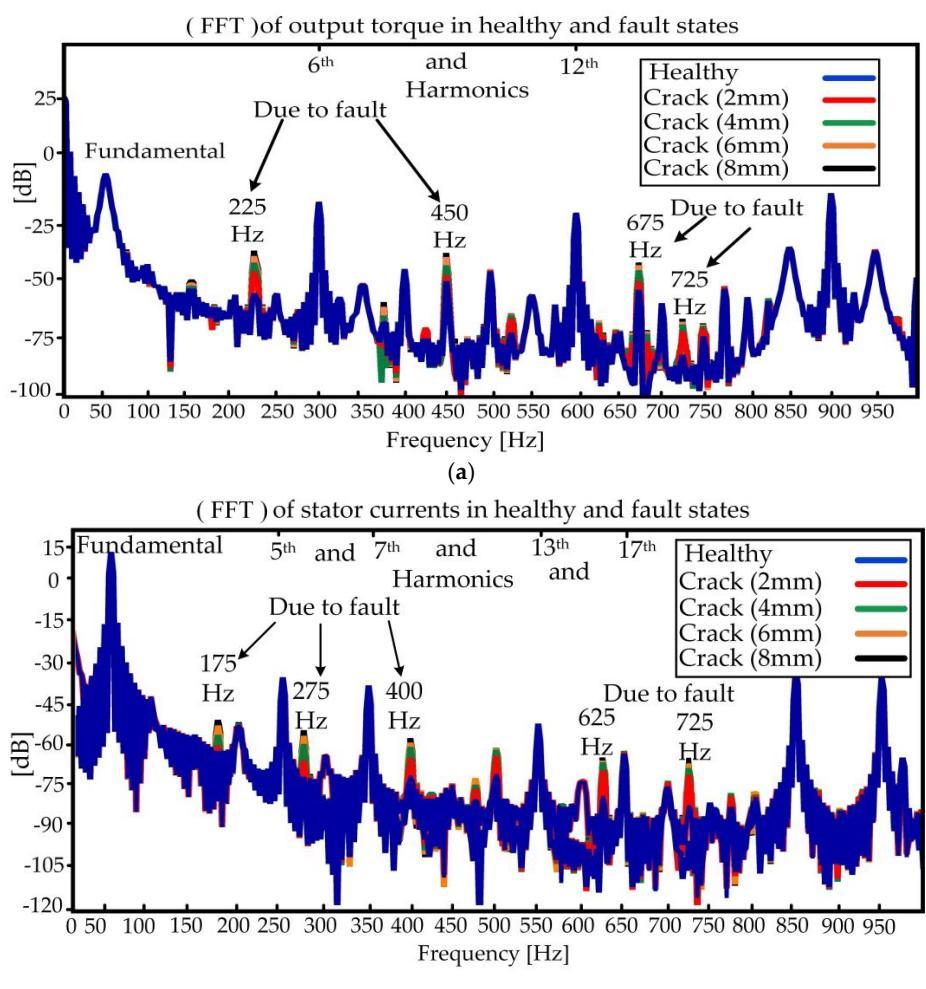
Figure 16. Harmonic content analysis using FEM when fault 1 occurs at rated load torque with the faulty SPMSM: (**a**) harmonic content analysis of output torque using FFT in healthy and faulty states; (**b**) harmonic content analysis of stator currents under healthy and fault conditions.

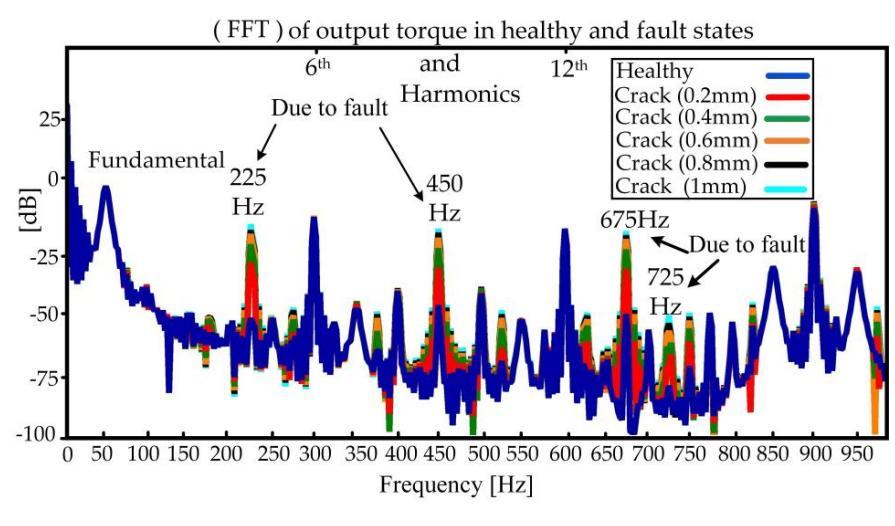
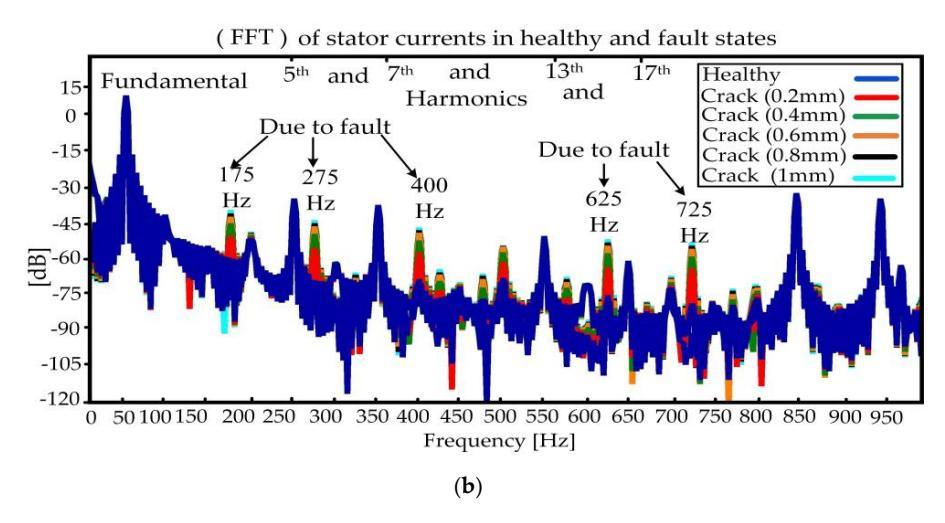
Figure 17. Harmonic content analysis using FEM when fault 2 occurs at rated load torque with the faulty SPMSM: (**a**) harmonic content analysis of output torque using FFT in healthy and faulty states; (**b**) harmonic content analysis of stator currents in healthy and fault states.

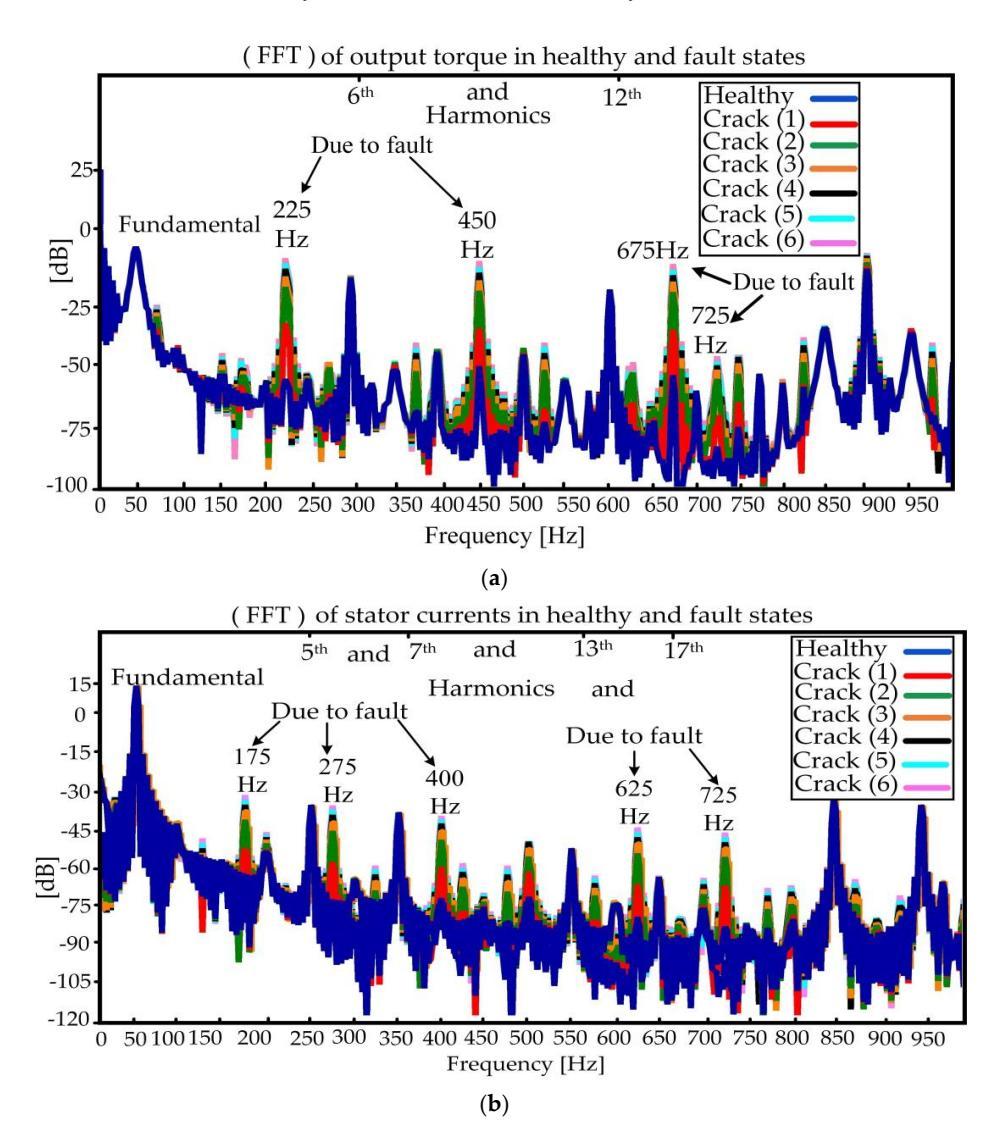
Figure 18. Harmonic content analysis using FEM when fault 3 occurs in rated load torque with the faulty SPMSM: (**a**) harmonic content analysis of output torque using FFT in healthy and faulty states; (**b**) harmonic content analysis of stator currents in healthy and fault states.
