Article Hydrogen-Induced Delayed Cracking in TRIP-Aided Lean-Alloyed Ferritic-Austenitic Stainless Steels

Abstract: Susceptibility of three lean-alloyed ferritic-austenitic stainless steels to hydrogen-induced delayed cracking was examined, concentrating on internal hydrogen contained in the materials after production operations. The aim was to study the role of strain-induced austenite to martensite transformation in the delayed cracking susceptibility. According to the conducted deep drawing tests and constant load tensile testing, the studied materials seem not to be particularly susceptible to delayed cracking. Delayed cracks were only occasionally initiated in two of the materials at high local stress levels. However, if a delayed crack arrest tendency of the austenite phase in a duplex microstructure. According to electron microscopy examination and electron backscattering diffraction analysis, the fracture mode was predominantly cleavage, and cracks propagated along the body-centered cubic (BCC) phases ferrite and α' -martensite. The BCC crystal structure enables fast diffusion of hydrogen to the crack tip area. No delayed cracking was observed in the stainless steel that h

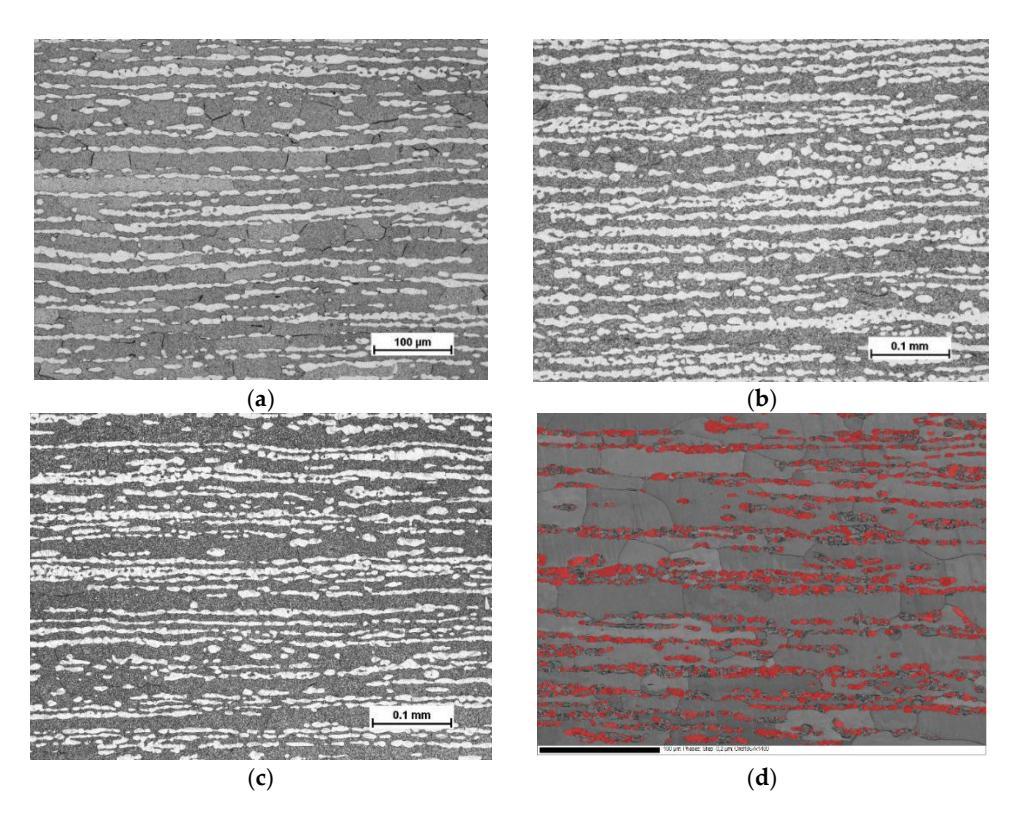
Optical micrographs of the test materials, taken from a cross-section of rolling vs. normal direction of the cold-rolled sheets, are presented in Figure 1a–c. The Beraha etchant colored the ferrite phase darker and left the austenite phase lighter. In Figure 1d, a SEM backscattering electron image revealing grain and phase boundaries, and austenite phase colored with red, is presented for the steel C. It is evident that despite careful specimen preparation and electro-polishing, mechanical grinding has induced martensite transformation in some austenitic areas. According to the EBSD characterization, grain size of ferrite was markedly larger than that of austenite, particularly along the rolling direction.

Figure 1. Microstructure of the studied materials: (a) steel A; (b) steel B; (c) and (d) steel C.

The microstructure of the test materials was studied by optical microscopy with Nikon Epiphot 200 microscope (Nikon Instruments, Tokyo, Japan). The specimens were ground up to 2500 grit with SiC abrasive papers and then electro-polished with A2 electrolyte at 35 V for 20–25 s. A modified Beraha etchant (1.0 g K₂S₂O₅, 15 mL HCl, and 85 mL H₂O) was used to reveal the two-phase microstructure.

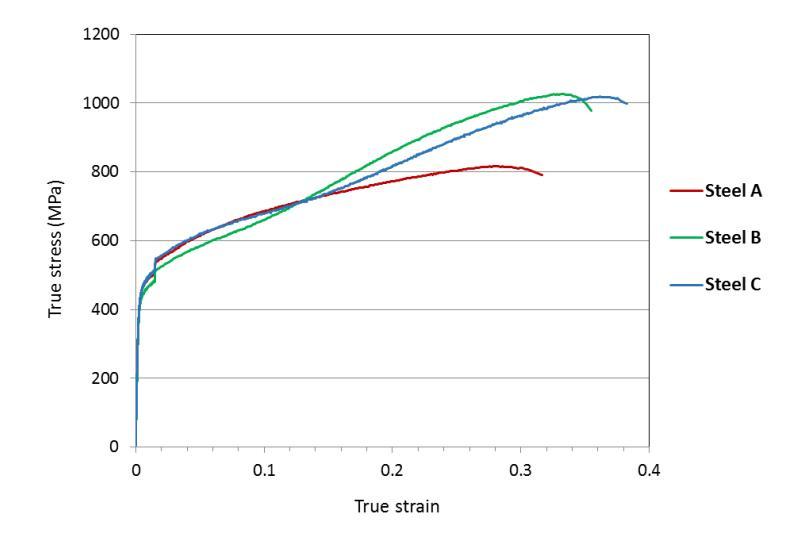
The measured true stress-true strain curves for the test materials, tested in uniaxial tensile loading along the rolling direction, are presented in Figure 2. The presented data is an average of three specimens for each material. The step in the curves soon after the yield point is due to the change of strain rate after 1.5% strain. A distinct increase in the slope is seen in the curves of steel B and steel C after about 0.13 true strain, which indicates increased strain hardening rate. Tensile properties of the studied materials, and standard deviation, are presented in Table 1. Markedly higher elongation and ultimate tensile strength were attained in steels B and C in comparison to steel A.

Figure 2. Tensile true stress-true strain graphs for the studied materials.

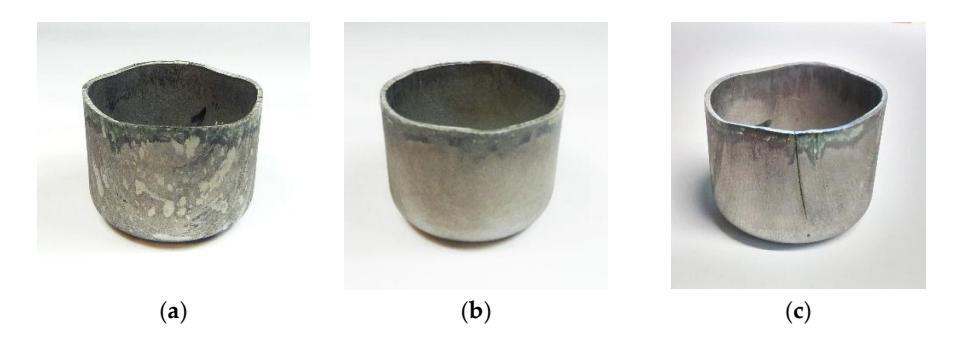
Swift cup testing for these materials was successful up to drawing ratio of 2.0. At drawing ratios 2.1 and above, the cups cracked in the most thinned area near the punch radius. In Swift deep drawing testing, there was no delayed cracking occurring in the cups of steel A and steel B at drawing ratios 1.8 and 2.0. However, in steel C an individual crack was observed in one of the cups at drawing ratio 2.0 within 0.5 h from the forming operation. Pictures of Swift cups at DR 2.0 are presented in Figure 3.

Figure 3. Deep-drawn cups at DR 2.0: (a) steel A; (b) steel B; and (c) steel C.

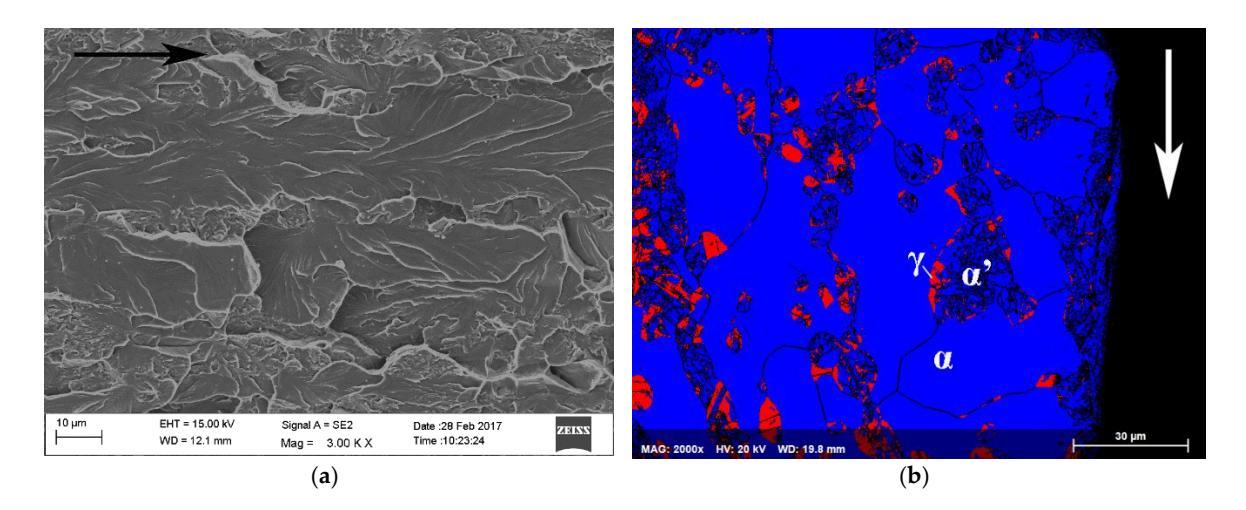
Fracture surface of the delayed cracking in steel C cup is presented in Figure 4a. Crack initiation occurred at the upper edge of the cup. The fracture mode was transgranular cleavage. Large faceted cleavage fracture dominated in the ferrite phase, and quasi-cleavage fracture associated with slight plastic deformation was observed in the austenite phase. An EBSD phase map from the cross-section of the fracture surface is presented in Figure 4b. Austenite (FCC) phase is colored with red and ferrite (BCC) and α' -martensite (BCC) phases with blue. Austenitic areas have been partly transformed to α' -martensite, especially in the immediate vicinity of the crack edge. According to Satmagan measurements, average austenite content at this location in the cup wall was 8%.

Figure 4. Fracture surface (**a**) and EBSD phase map (**b**) of the delayed crack in the cup of steel C at DR 2.0. The direction of crack propagation is marked with arrows.

According to the deep drawing and constant load tensile testing, the studied materials seem not to be particularly susceptible to delayed cracking. For example, in the Swift cup tests cracking was only observed in one cup of steel C at the highest drawing ratio 2.0. The crack was suspected to have initiated from a stress concentrator, possibly a local material inhomogeneity or poor edge quality of the Swift cup blank. The Swift cup test is commonly used in steel industry for evaluating formability of different steels and their possible susceptibility to delayed cracking. It provides a convenient way of comparing the performance of various sheet metals. However, the exact same stress state is not necessarily reproduced in repeated tests.

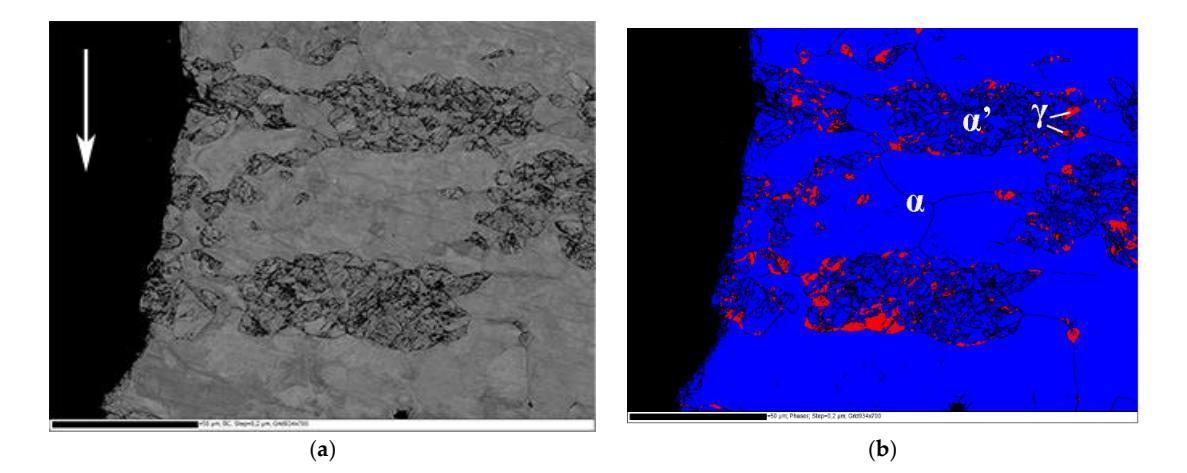
A backscattering electron image and EBSD phase map from the cross-section of the fracture surface of the constant load tensile test specimen of steel B tested at applied stress ratio 0.945 are presented in Figure 5a,b. Austenite (FCC) phase is colored with red and BCC-phases ferrite and α' -martensite phase with blue. The microstructure in the immediate vicinity of the fracture surface consisted almost completely of BCC structure, so cracking seemed to propagate along the ferrite and α' -martensite phases.

Figure 5. A backscattering electron image (**a**) and EBSD phase map (**b**) of the fracture path in steel B constant load specimen. The direction of crack propagation is marked with an arrow in (**a**).

The distribution of the phases in duplex stainless steels plays a significant role in crack propagation through hydrogen embrittled material [25]. In a strongly banded duplex microstructure the orientation of the austenite islands perpendicular to the crack propagation direction promotes effective crack arrest. In this study, the constant load tensile testing was conducted in the rolling direction of the material, i.e., the delayed crack initiating from the notch root propagated perpendicular to the banded dual-phase microstructure. However, when the austenite was metastable, it was transformed to strain-induced α' -martensite, which facilitated hydrogen diffusion and decreased the crack arrest tendency of the austenite phase in the duplex microstructure and the cracks propagated easily through ferrite and martensite.

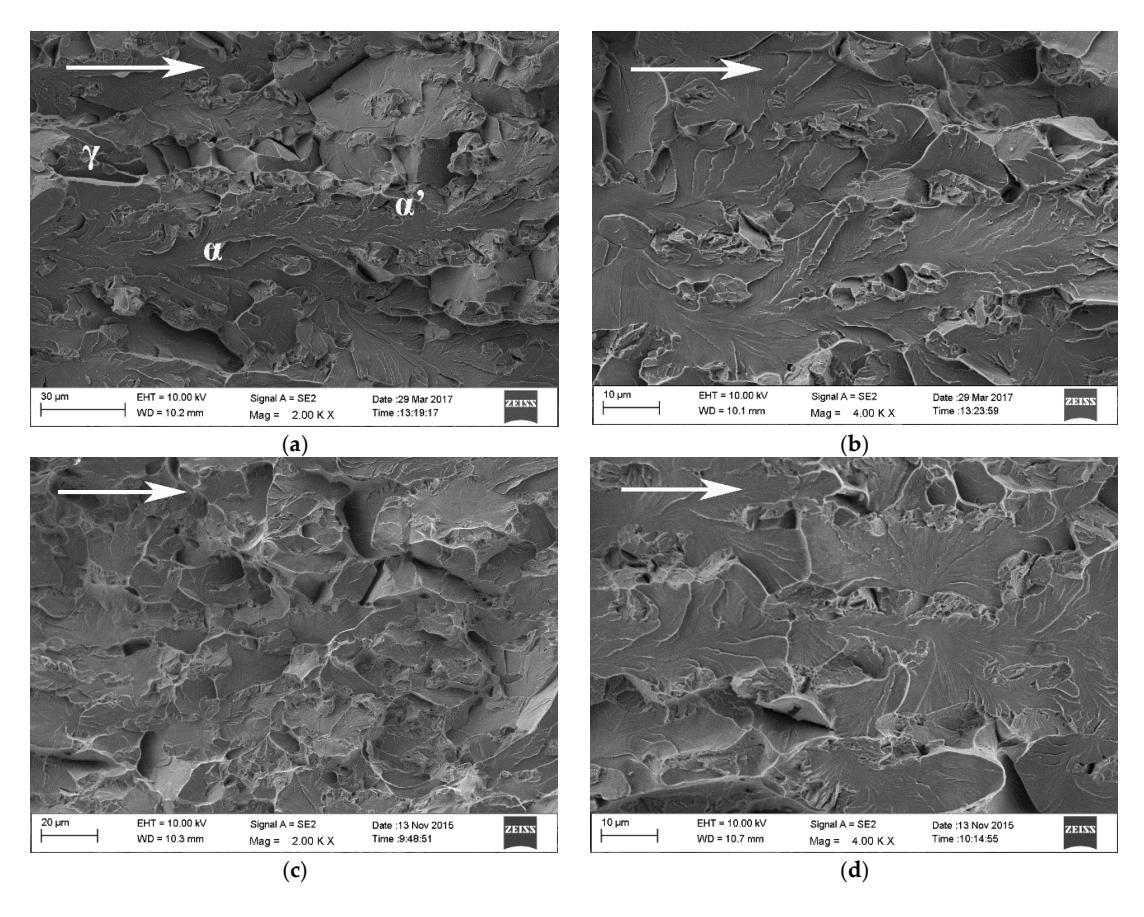
Fracture surface of steel B constant load tensile specimen that broke after 103 h is presented in Figure 6a,b and that of steel C constant load tensile specimen that broke after 241 h in Figure 6c,d.

The direction of crack propagation is marked in the figures with arrows. The fracture mechanism in both materials was predominantly cleavage along the ferrite phase. The regions of prior austenite, transformed mostly to α' -martensite during the pre-straining of the specimens and crack propagation, are clearly distinguishable on the fracture surfaces. Delayed fracture in the constant load tensile test specimens initiates at the notch root. A flat triangular area, associated with high stress triaxiality, is typically visible on the fracture surface.

Figure 6. Fracture surfaces of constant load tensile specimens of steel B (a,b) and steel C (c,d).
