# Article Evaluation of Protective Coatings for High-Corrosivity Category Atmospheres in Offshore Applications

**Abstract:** The interest in renewable energies obtained from the resources availed in the ocean has increased during the last few years. However, the harsh atmospheric conditions in marine environments is a major drawback in the design of offshore structures. The protective systems that are employed to preserve offshore steel structures are regulated by several standards (ISO 12944, NORSOK M-501), which classify the corrosivity category of offshore installations as C5-M and Im2. In this work, three coatings employed in offshore components protection have been evaluated according to these standards by performing weathering aging tests in different climatic cabinets. The coatings studied were a thermally sprayed carbide coating with an organic sealant (C1), a thermally sprayed aluminum (TSA) coating with an organic topcoat (C2), and an epoxydic organic coating reinforced with ceramic platelets (C3). The only coating that reached the higher categories in all the tests was the C2 coating. The C1 coating presented ferric corrosion products coming from the substrate in some o

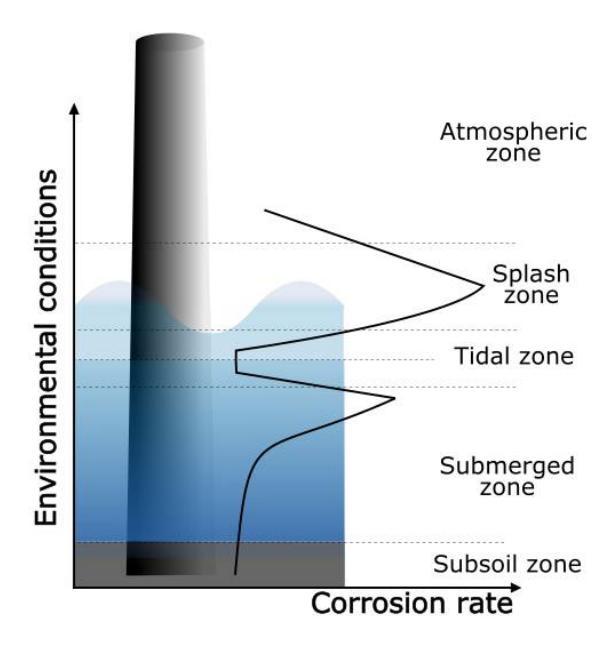
Figure 1. Zones of corrosion and relative corrosion rate depending on the exposure zone.

- Atmospheric zone: This zone is located above the sea level, and the severity of corrosion is related to the time of wetness, during which electrochemical processes take place. There is a direct relationship between atmospheric salt content and corrosion rate. Materials are also exposed to solar radiation, which deteriorates the performance of organic coatings.

- **Splash zone:** This section in the structure is intermittently wetted, due to tides and the wind. The corrosion rate of metals in this zone is the highest, due to the aerated condition, which makes the access of dissolved oxygen for electrochemical reactions easy. Since it is continuously being wetted, chlorides can concentrate on the surface while the water films dry. Furthermore, the impinging of seawater containing sand and other flowing matter adds a mechanical component to the materials' deterioration in this exposure zone.

- **Tidal zone:** The materials are alternately submerged and exposed to the splash zone, as the tide fluctuates. In the submerged condition, materials are exposed to a well-aerated seawater, which favors the attachment and growth of biofouling. The corrosion rate is influenced by the tidal flow, with higher corrosion rates with increasing movements.
- **Submerged zone:** The section of the structure that is always immersed in the sea. The corrosion rate in this zone depends on the availability of oxygen to be transported to the cathodic sites of the materials' surfaces. As oxygen concentration varies with depth, decreasing with increasing distance to the surface, the corrosion rate is also slower at higher depths.
- **Subsoil:** In the buried structure, the oxygen concentration is low, and hydrogen sulfide may be present.

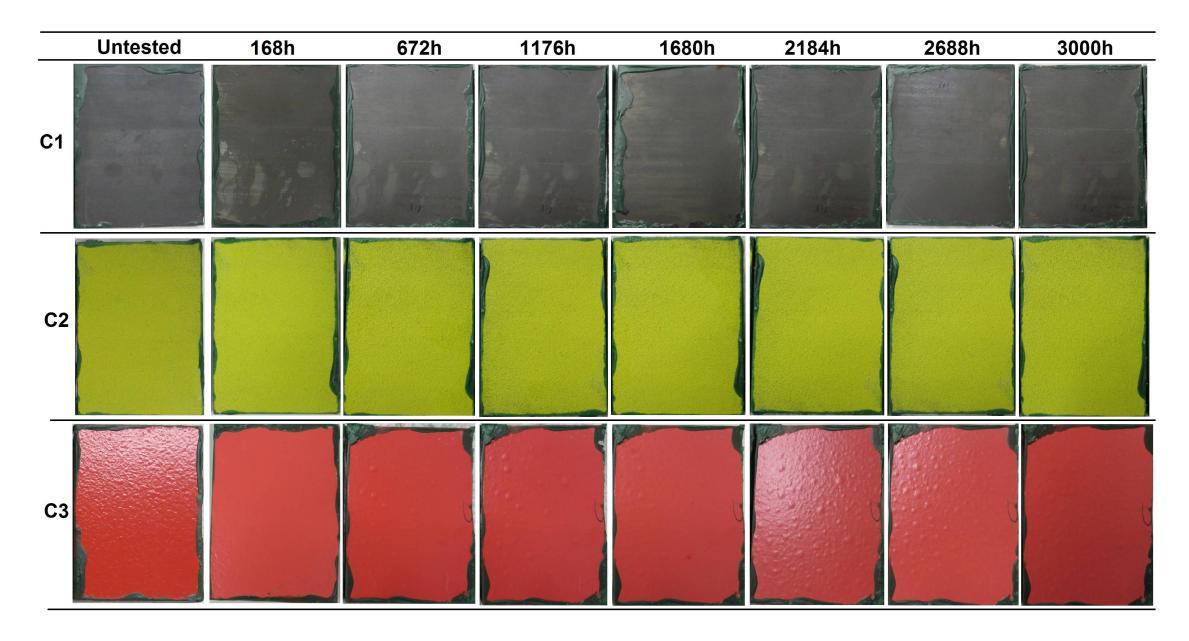
**Figure 2.** Visual appearance of the R4-coated samples at different evaluations during the immersion test in accordance with the ISO 2812 standard.

Immersion tests were performed to evaluate the resistance of the coatings to water immersion. The surface state of the coatings at different evaluation times is presented in Figure 2, in which one of the three samples of each coating system is presented as representative.

In the first evaluation after 168 h of immersion, C1 coating samples presented some decolorized zones in the surface. This could be a consequence of the partial removal of the organic sealant of few µm (Table 2) [20] applied on top of the sprayed carbide. After 336 h, two small ferritic pits were detected in one of the samples. The discoloration of the samples was more evident with increasing exposure time. In the evaluation performed at 1344 h, ferric corrosion was observed in the edges of the samples, close to the insulating wax, which was formed due to a cavitation effect, and by the possible penetration of water under the wax leading to the corrosion of the underneath steel. This corrosion slightly spread with time, but no corrosion sign was detected in the middle zone of the surface. At the end of the test (3000 h), the tone of the tested samples was a more brownish color, and several decolorized and brighter zones were distinguished as a consequence of the sealant loss. The corrosion present in the edges was not considered as a coating failure, since it was observed to be caused by a non-adequate insulating property of the organic wax. The microscopic analysis of the surface revealed some isolated pits along the surface, in a density lower than 1% of the total exposed surface (Figure 3).

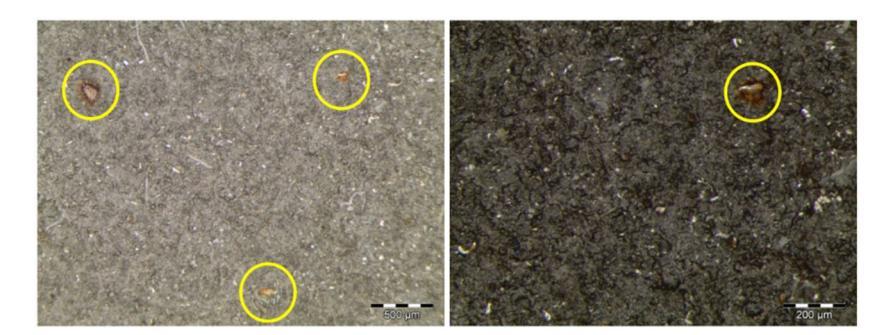
Figure 3. Optical microscopies of the C1 coating surface showing isolated ferric corrosion pits.

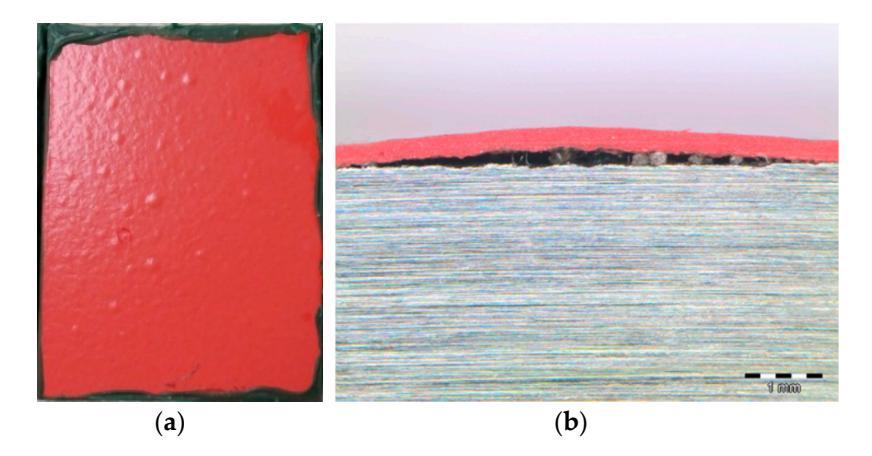
**Figure 4.** Surface state of sample No.2 of the C3 coating showing blisters after 504 h of immersion (**a**) and micrograph of the ferric corrosion products formed under the blister (**b**).

The samples of C3 coating presented a loss of brightness from the first evaluation at 168 h of exposure, showing a considerably paler tone. After 504 h, blisters appeared in one of the three samples (Figure 4), which was removed from the chamber thereafter. The microscopic analysis of the transversal surface of one of the blisters showed the presence of ferric corrosion products, revealing the underneath corrosion of the substrate by electrolyte penetration through the coating. In the next evaluation, at 672 h, some blisters were detected in the other two samples. The samples were kept in the chamber until 3000 h of immersion were reached, and the blisters were observed to increase in both size and number with higher exposure time. At the end of the test, the surface of the two samples remaining on the chamber was entirely covered with blisters (Figure 2). In accordance with the UNE EN-ISO 4628-2 standard [27], the blistering grade of the three samples was the following:

- C3-sample No.1: 4 (S4)
- C3-sample No.2: 2 (S4) (removed from the chamber after 504 h of immersion)
- C3-sample No.2: 4 (S5)

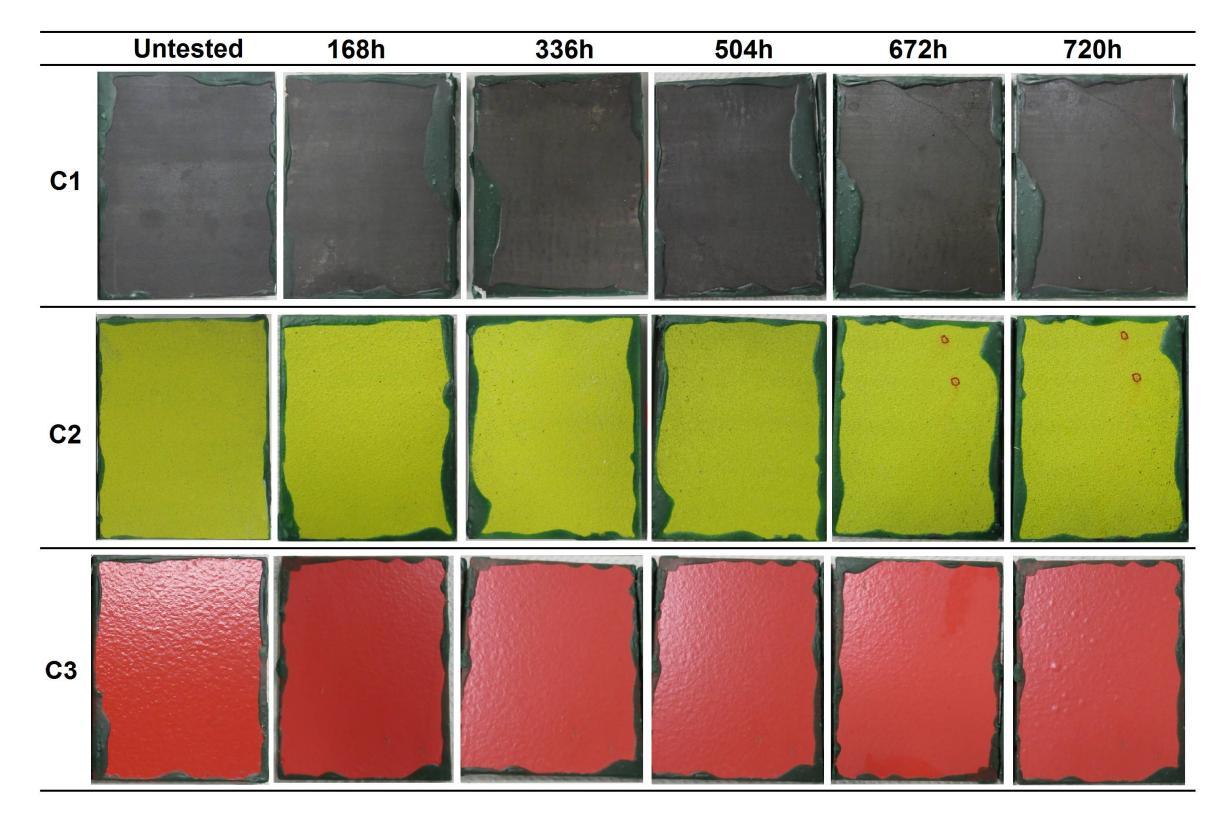
**Figure 5.** Visual appearance of the coatings' surfaces at different evaluations during the condensation tests at constant humidity (CH) according to the ISO 6270-2 standard.

In the three exposure atmospheres, the C1 coating presented some decolorized zones in the surface after several hours in the cabinet, which was a consequence of the partial elimination of the sealant applied on top of the sprayed carbide. This was observed after 110 in the CH test, and after 278 h in the AHT and AT tests. Furthermore, ferric corrosion was observed to appear in all the samples close to edges. As previously explained for the samples of the insulating wax, and was not considered as a coating failure. In the three test atmospheres, the color of the coating changed with increasing exposure, which was a consequence of the sealant degradation, acquiring a more reddish tone (Figures 5–7). In the AHT test, some characteristic red/brown-colored corrosion products were observed in the center of one of the samples, but the surface coverage by these corrosion products did not exceed 1%, so the coating was considered to pass the three tests successfully, with a C5-M (high) category (ISO 12944-6).

In the case of the C2 coating, all the samples presented some red spots on the surface, corresponding to ferric oxides. However, these oxides did not come from substrate corrosion, but rather from the corrosion of metallic particles that were embedded in the coating surface during the sample machining process. No significant changes were observed in the coating during the exposure to any of the three condensation atmospheres in terms of ferric corrosion, blistering, cracking, or color change. In the CH test, the presence of white salt deposits arising from the oxidation of the aluminum layer was detected after 614 h. In the case of the AHT tests, the three coated samples were intact after 720 h of exposure, even without the presence of white salts. Finally, in the AT test, white salt deposits appeared after 336 h in one of the three samples. Therefore, considering the minor changes undergone at the three testing atmospheres, the C2 coating passed the three condensation tests, achieving a C5-M (high) category (ISO 12944-6).

The samples of the C3 coating showed color and brightness loss after several hours of exposure, but no presence of ferric corrosion, cracks, or other defects was detected during the evaluations. The only defects appeared in the CH test samples, which presented a significant part of the surface covered by blisters. However, in the AHT and AT tests, no blister appeared in any of the coated samples after 720 h in the chamber. According to the UNE EN-ISO 4628-2 standard [27], the blistering grade of the three samples of the CH test was the following:

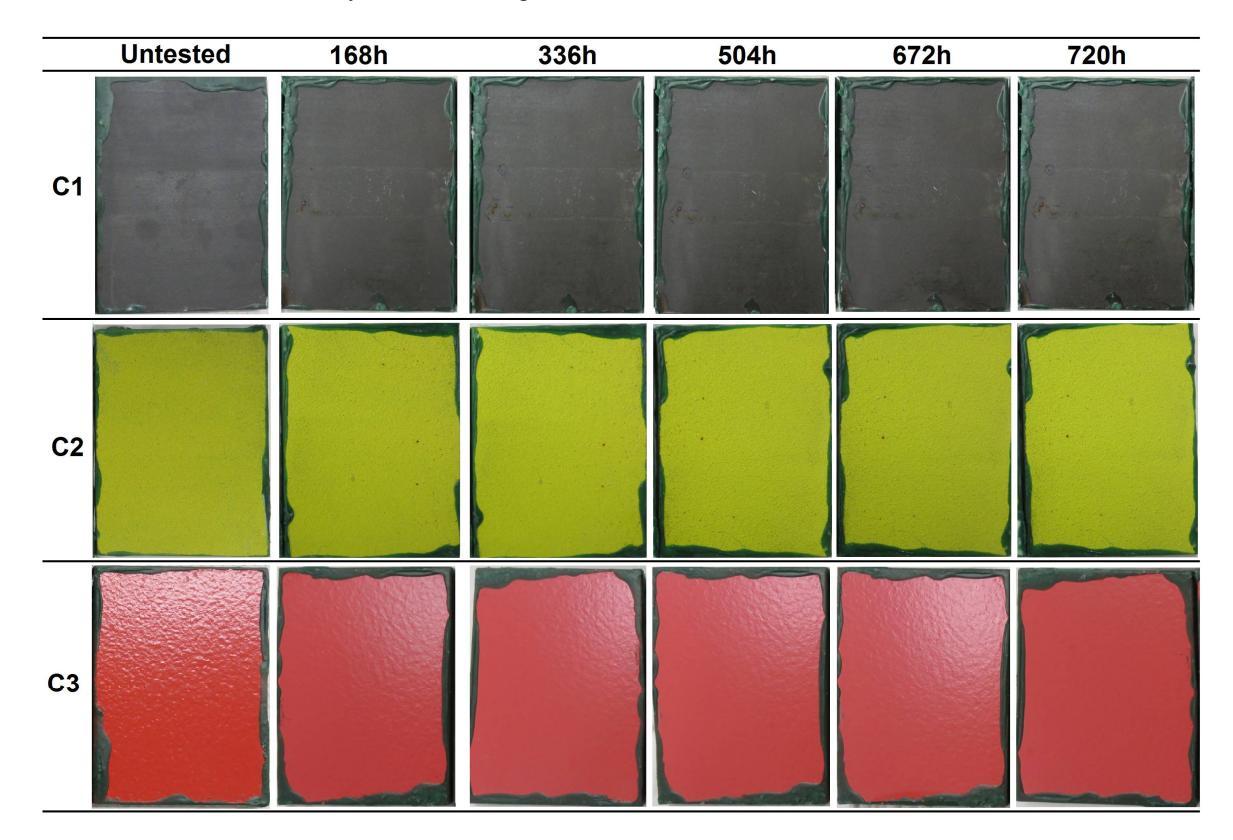
**Figure 6.** Visual appearance of the coatings' surfaces at different evaluations during the condensation tests alternating humidity and temperature (AHT) according to the ISO 6270-2 standard.

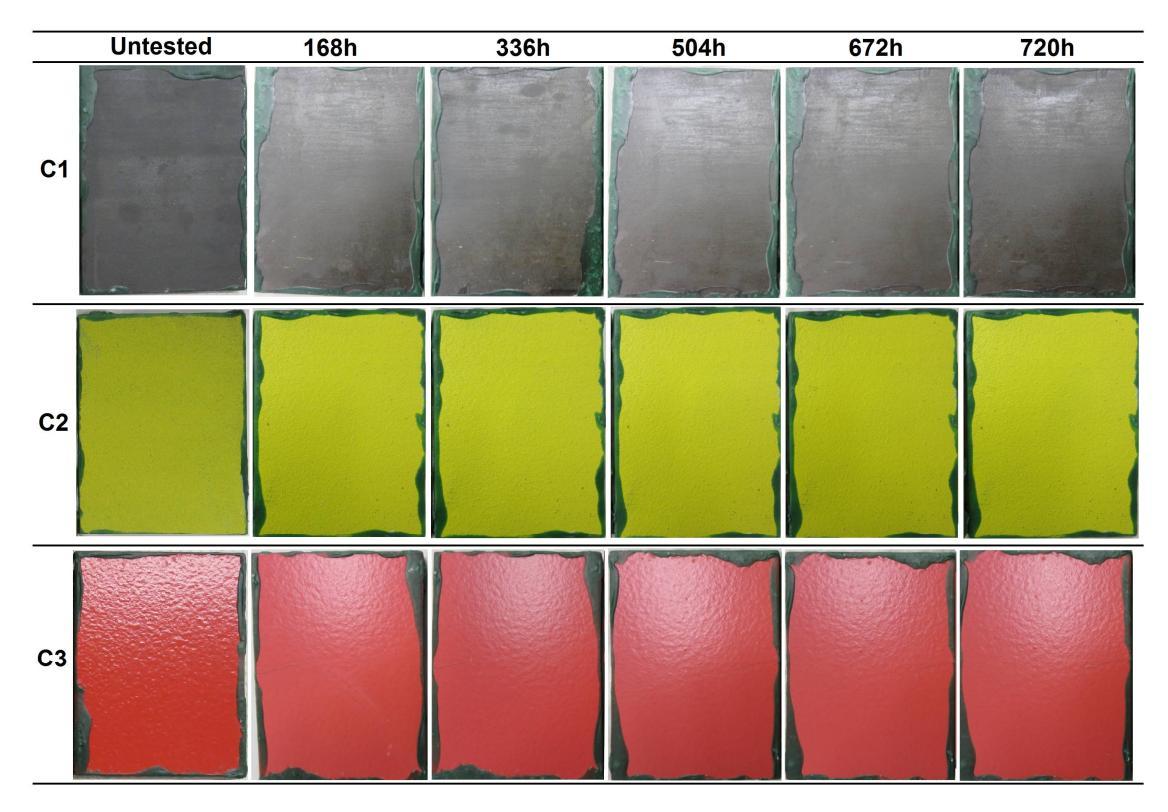
**Figure 7.** Visual appearance of the coatings' surfaces at different evaluations during the condensation tests with alternating temperature (AT) according to the ISO 6270-2 standard.

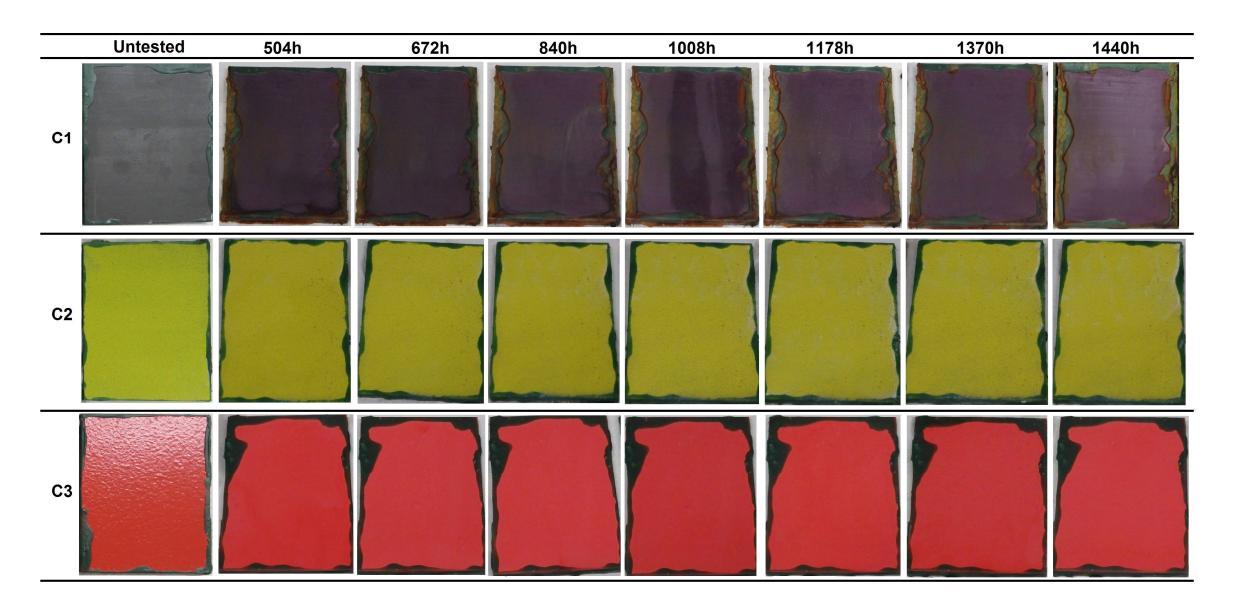
**Figure 8.** Visual appearance of the coatings' surfaces without incision at different evaluations during 1440 h of exposure to salt spray, according to the ISO 9227 standard.

The coatings were exposed to neutral salt spray conditions to evaluate the resistance to a saline corrosive environment. The evolution of the surface state of the three coatings without incision during the exposure to salt spray atmosphere at different evaluation times is depicted in Figure 8. The final appearance of the scribed samples after 1440 h in the chamber is shown in Figure 9 for the C2 and C3 coatings. Table 6 summarizes the degradation observed in the coatings for the different evaluations, in terms of the surface percentage covered by ferric corrosion or white salts in the samples without incision, and the progression of the ferric corrosion on the scribed coatings.

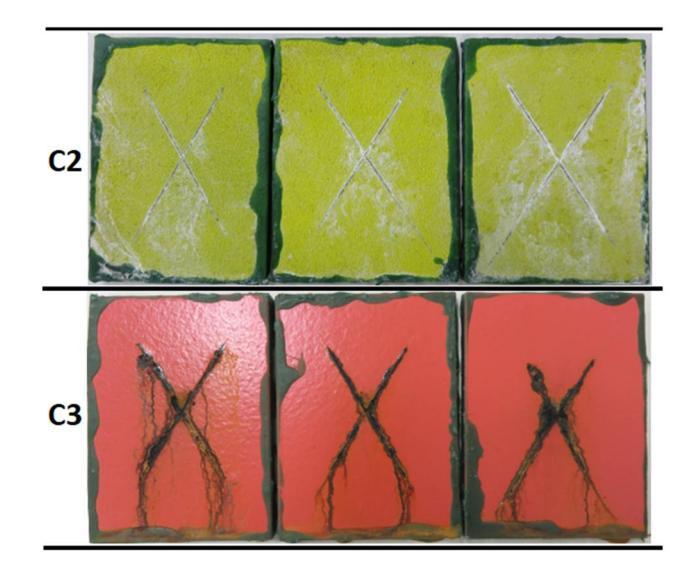
**Figure 9.** Visual appearance of the coatings surface without incision at different evaluations during 1440 h of exposure to salt spray, according to the ISO 9227 standard.

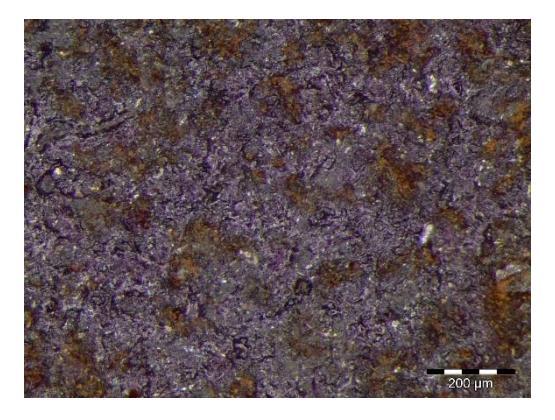
**Figure 10.** Surface estate of the C1 coating after 1440 h of exposure to neutral salt spray showing a high density of ferric corrosion pits along the whole exposed surface.

The C1 coating remained unaltered for the first 504 h of exposure, after which corrosion was observed to spread in all the samples. After 1440 h in the chamber, four of the six samples presented with 25–30% of the surface covered by ferric corrosion. The color of the coating changed significantly with exposure time, acquiring a purple tonality. The surface analysis by means of a magnifying glass revealed the presence of ferric pits that were homogeneously distributed along the whole exposed surface (Figure 10). The oxidation grade of the coating was Ri4 (S2), in accordance with the designation of the UNE-EN ISO 4628-3 standard [27] for a rusted area of around the 8% of the exposed surface.

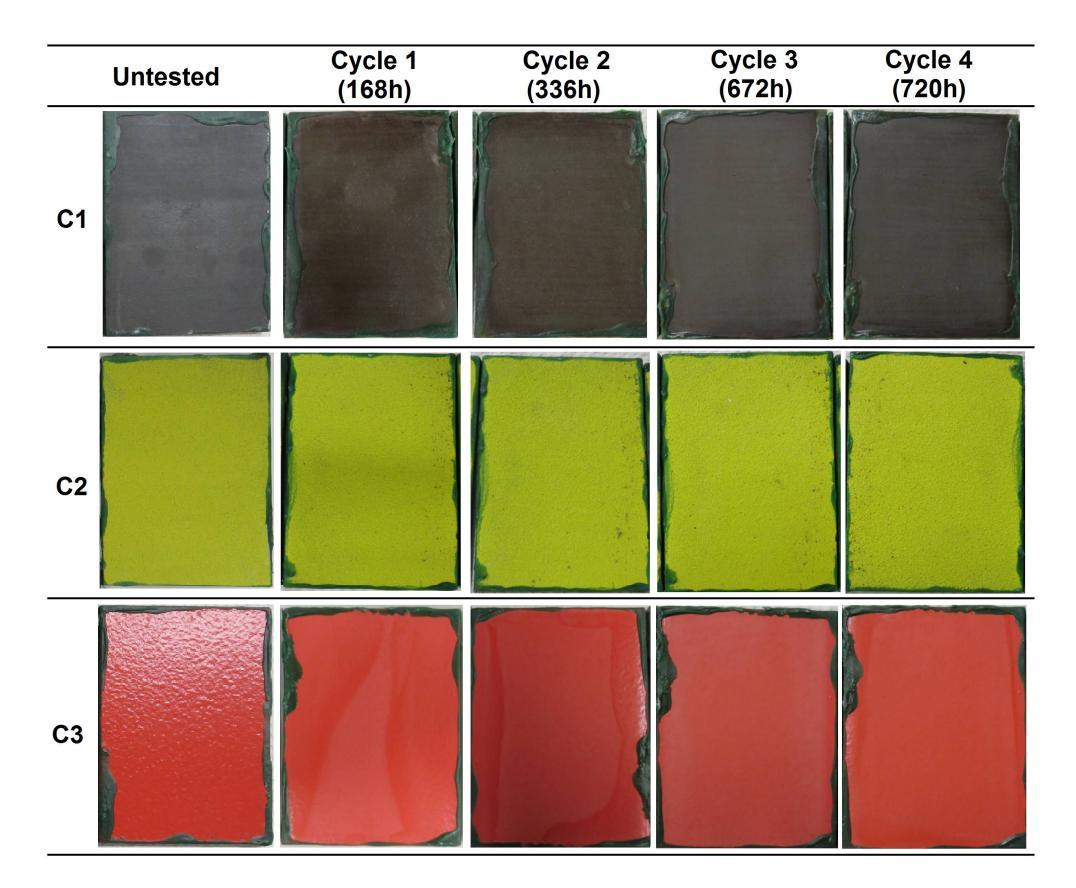
**Figure 11.** Visual appearance of the coatings' surfaces after 720 h of exposure to combined aging according to the ISO 12944-9 and NORSOK M-501 standards.

In the combined aging test, the coatings were exposed to different atmospheres, so as to reproduce the climatic conditions of the marine environment. The samples were subjected to UV radiation, water condensation, salt spray, and low temperature. The evolution of the surface state of the three coatings at different exposition times is depicted in Figure 11. The degradation degree in terms of the ferric corrosion coverage of the samples and blistering are summarized in Table 7.

The C3 coating showed discoloration and a significant loss of brightness from the first exposure to UV radiation, especially at the center of the samples. The color change to a paler tone was more noticeable with increasing exposure to weathering conditions, but no other defects such as blisters or ferric corrosion were observed in any sample.
