Article Evaluation of Technical Condition and Durability of Wooden Shaft Guides with Application of Non-Destructive and Semi-Destructive Testing Methods

Abstract: This article addresses the issue of the durability of mining shaft equipment elements. Shafts as a transport route are one of the most exploited parts of a mine. Consequently, their components are exposed to high mechanical stresses, which cause the deterioration of their mechanical properties. In the case of shafts with timber components, elements such as the shaft guides are evaluated on a purely macroscopic basis and are often unnecessarily replaced. This paper presents the possibilities for the application of non-destructive methods (ultrasound and laser scanning) and semi-destructive methods (sclerometric and drill resistance tests). The experimental results suggest that it was possible to derive correlations between penetration depth and drill resistance tests with bulk density. However, these tests were not directly correlated with flexural strength. The ultrasound studies did not indicate a significant relationship with the physical or mechanical properties. In contrast, the method of comparing the variation (wea

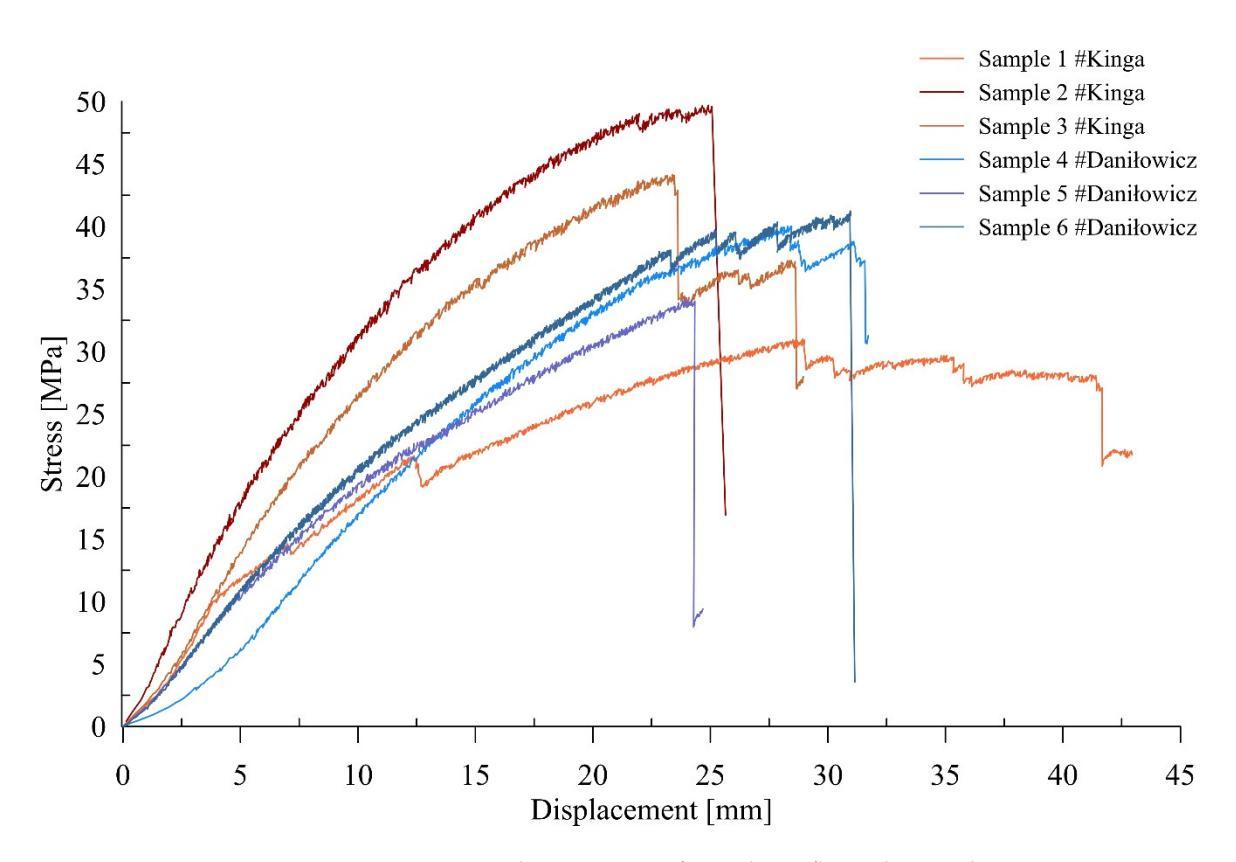
Figure 4. Stress-strain characteristics of samples in flexural strength tests.

Figure 4 presents the stress-strain characteristics of the samples in flexural strength tests. It can be observed that the laminated wood guide is characterized by the greatest strength and stiffness. The values of the deformation parameters of the Daniłowicz shaft guides are similar; in the case of the Kinga shaft guides, they differ from each other.

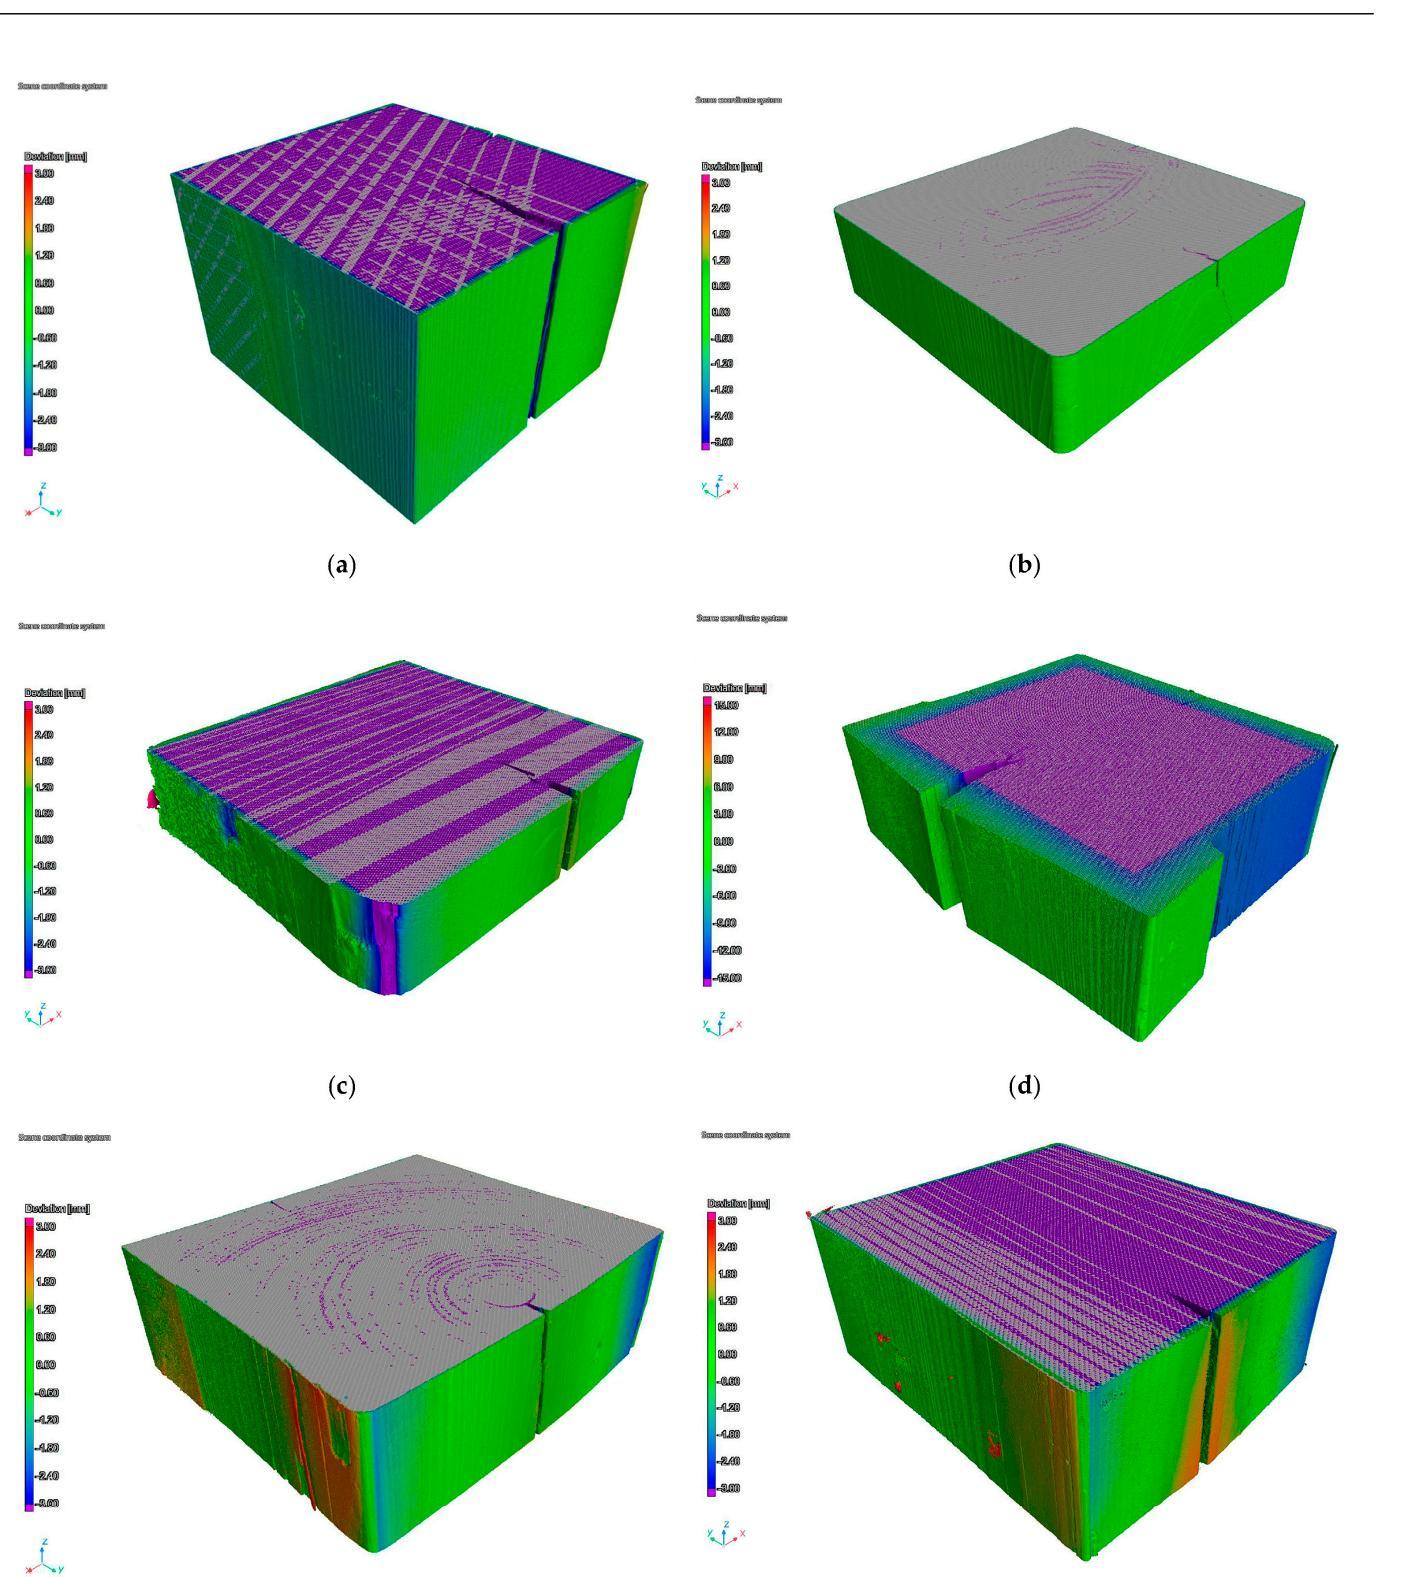
Figure 5. Images of changes in the shape of samples according to CT; (**a**) sample one; (**b**); sample two; (**c**) sample three; (**d**) sample four (larger scale); (**e**) sample five; (**f**) sample six.

The purpose of the CT analysis was a volumetric analysis and a comparison of the obtained shapes and dimensions of the samples and the CAD models. The results of the analysis are images of samples showing the differences between the dimensions of the models and samples. Color is a measure of the shape and dimensions deviation of the samples. The results of the test are shown in Figure 5.

The values of deviation measured for sample three did not exceed 1.0 mm. However, it should be noted that both positive and negative values were obtained. This reflects the surface deformation shown in Figure 5c, which is an effect of conveyance loading at the shaft outset. Similarly to sample one, the maximum values of deviation were caused by longitudinal fractures and additionally by a rounded corner of the guide, which can be seen in Figure 5c.

Sample four, due to long-lasting loads caused by the slipping plate acting on the guide, was characterized as having the greatest values of deviation (Figure 5d). Its long-term operation resulted in a deviation reaching -11.0 mm, which can be seen in Figure 9d. Positive values of deviation were also recorded in the area of the longitudinal fracture of the sample, which indicates distortion.

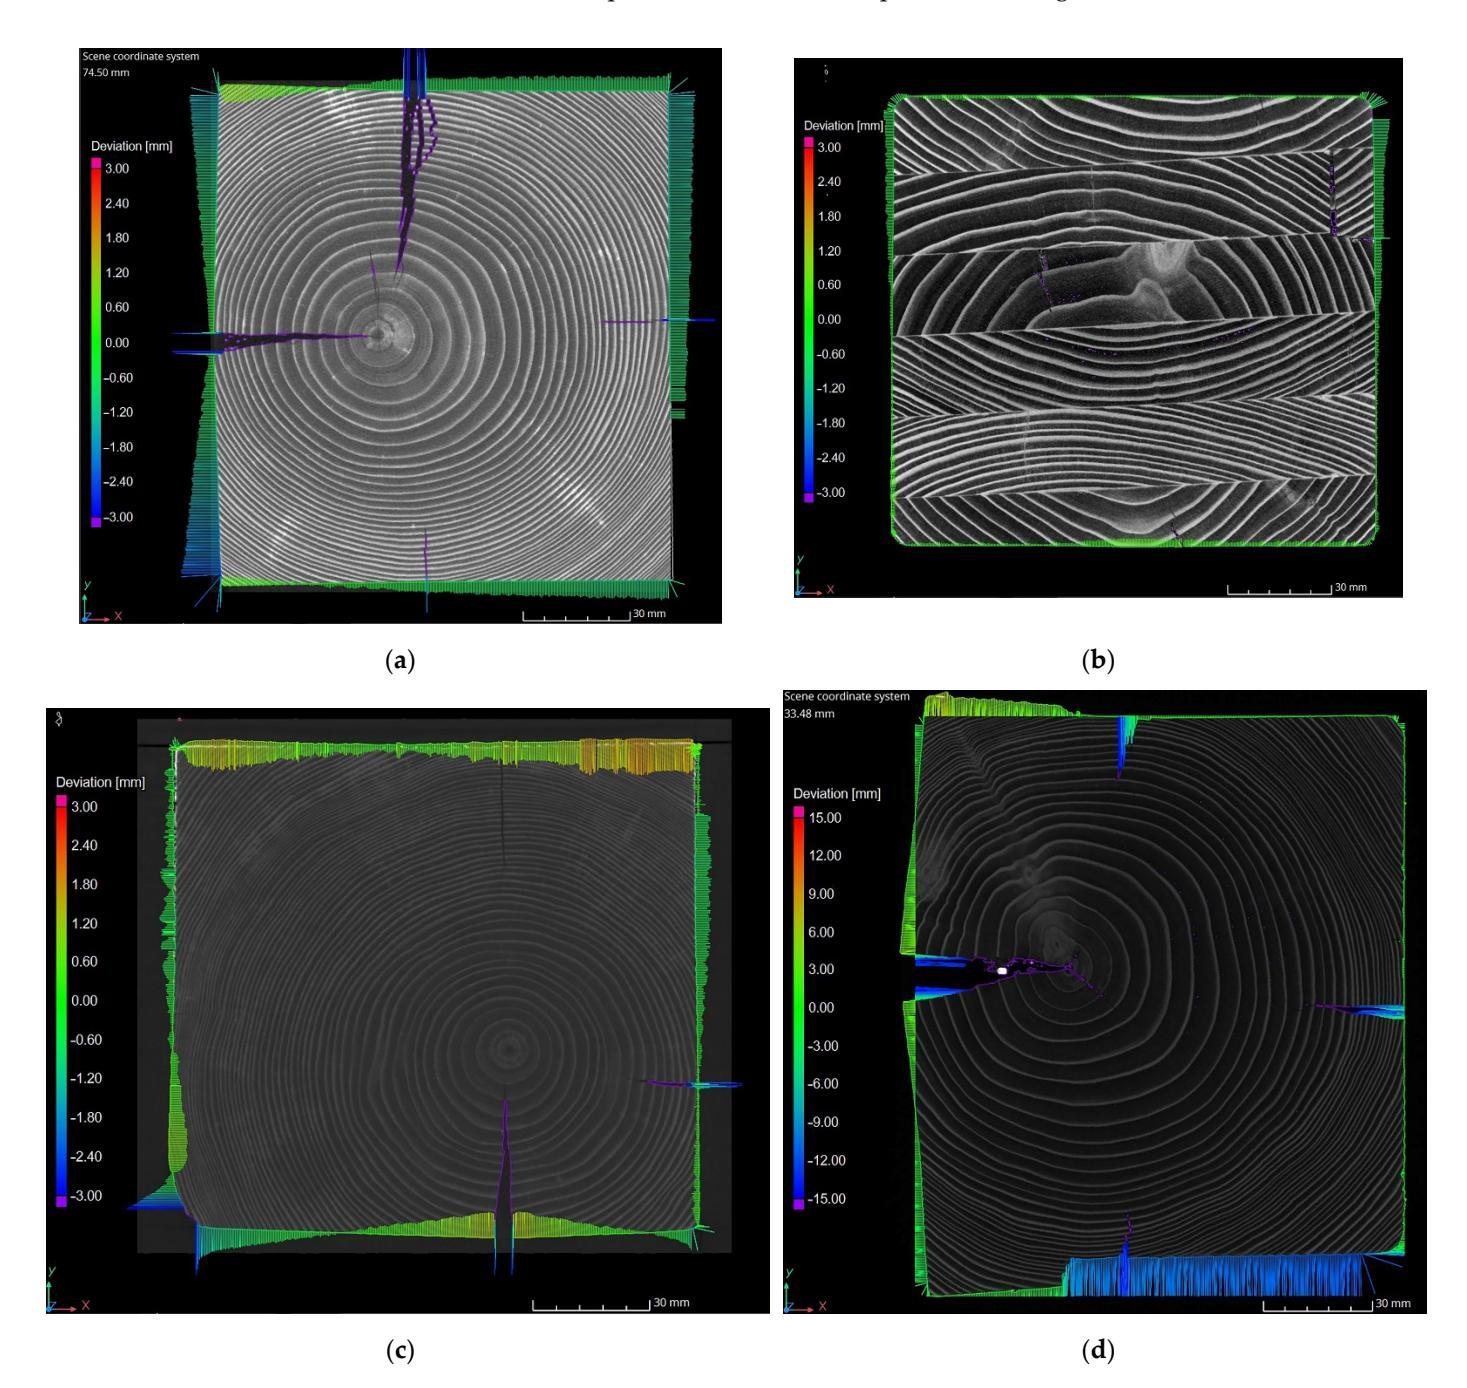
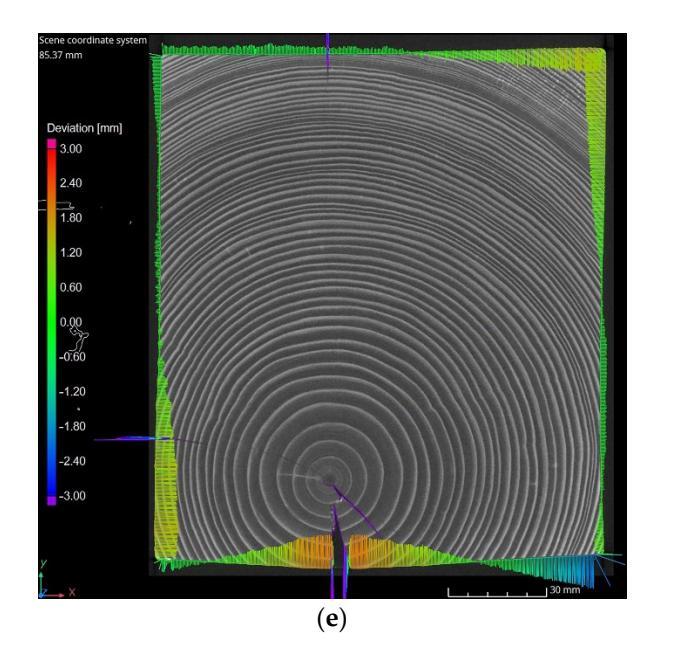
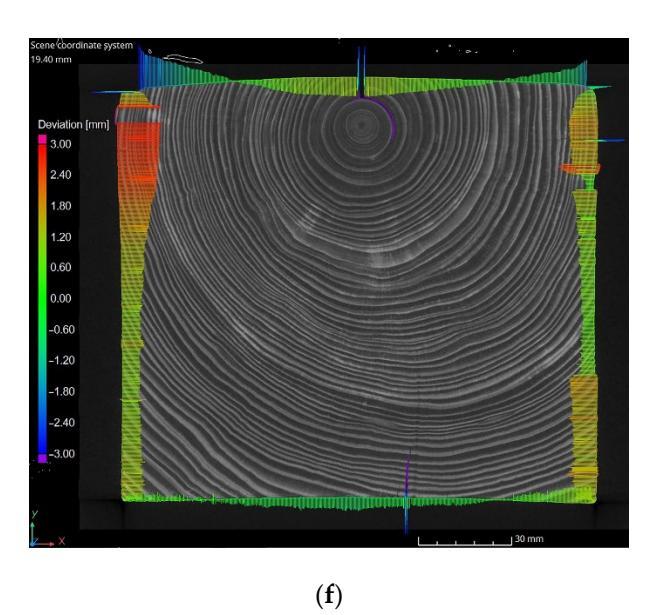
An analysis comprising bar charts showing shape variations was conducted for selected samples' cross-sections. Positive values (bars inside a cross-section) are sections of the sample where the area of the measured surface is greater than surface of the CAD model, while negative values (bars outside a cross-section) are sections where the real area or the sample cross-section is smaller than the area of the CAD model. Sample four had the greatest values of the deviation, reaching 15 mm. The smallest deviation was measured for sample two. Other samples were characterized by a variable geometry of cross-sections; however, the values of their deviation did not exceed 3.0 mm. Bar charts of the deviations of the selected samples' cross-sections are presented in Figure 6.

Sample two was characterized as having both the smallest number (Figure 9b) and value (Figure 6b) of the deviation. The obtained values of approximately 0.5 mm do not exceed the error margin. Such results prove the high durability of the laminated guide.

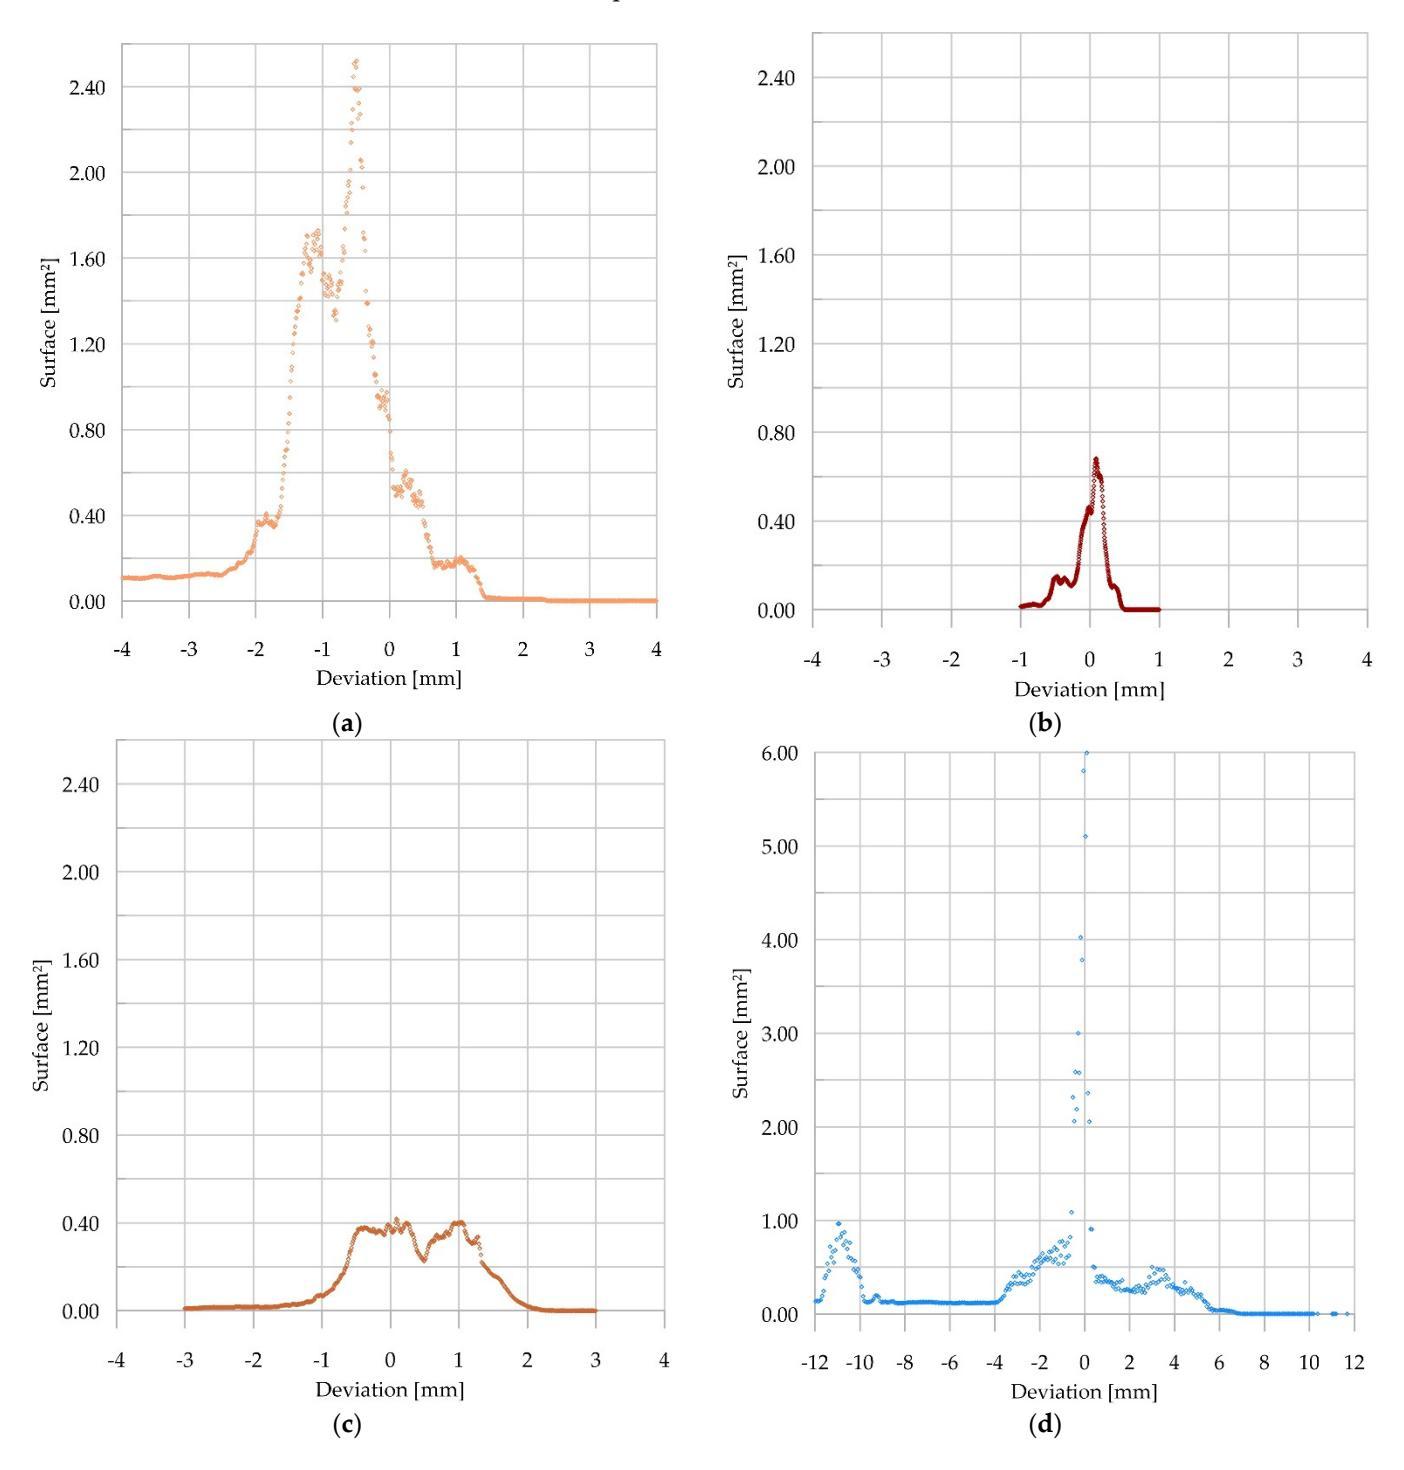
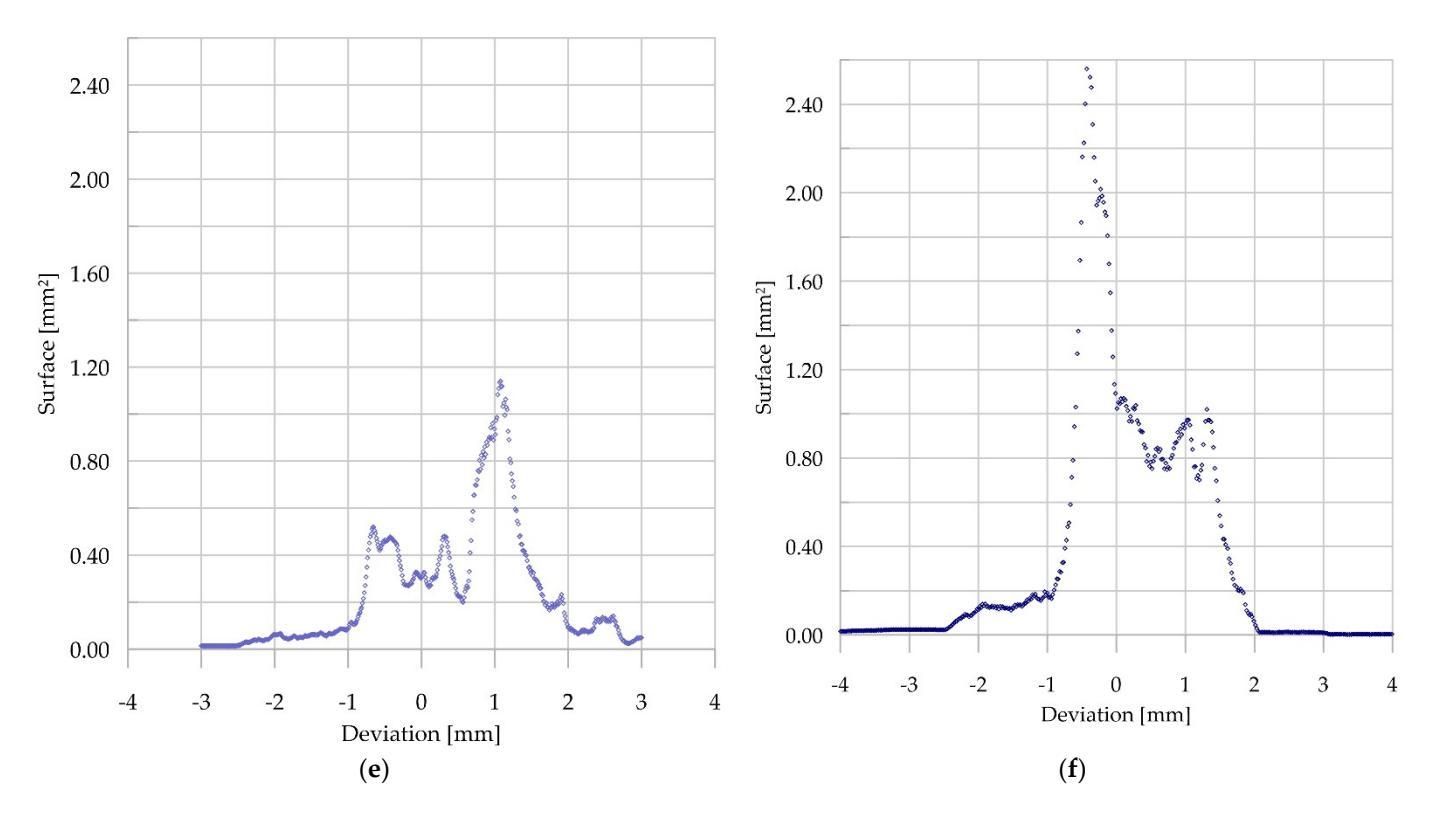
Figure 9. Distribution of deviation of guide samples; (**a**) sample one; (**b**) sample two; (**c**) sample three; (**d**) sample four; (**e**) sample five; (**f**) sample six.

In CT analysis, the quantity of geometric deviation of the samples was determined as a measure of the guides' quality. Figure 9 presents the average area of the guide samples in a given distance from reference CAD models. The calculated values of the deviation refer to a section of the sample of 1.0 mm in height. It was assumed that the selected section of the sample is statistically repetitive. On both sides of the zero value, irregular falls of the diagram can be observed. This can be interpreted as an effect of defects, fractures (negative values), or distortion (positive values).

The negative value of the surface deviation of sample one (Figure 9a) was a result of the conveyance's guide rollers' influence. Most of the recorded deviations were in the range of -0.2 to -1.5 mm. The value of the deviation on the edge of the sample reached -2.8 mm. The peaks of the deviation values were caused by longitudinal fractures.

Similarly to sample three, the values of deviation recorded for samples five and six were about 2.0 mm (in the case of sample six they locally reached 3.0 mm). It should be emphasised that both positive and negative values were recorded, which illustrates surface deviation as shown in Figure 5e,f. The maximum values of deviation were measured in areas of longitudinal fractures, similarly to samples one and three, and near the rounded corners of the guides.
