Article Investigation of the Neutralizing Behaviors of Cement-Based Materials Using a New pH Indicator Formulated from February Orchid Petals

Abstract: Investigation of the neutralizing behavior of concrete is essential, as it can help reveal the durability properties of concrete structures. In this paper, anthocyanin extracted from February orchid (F. orchid) petals was used to characterize the neutralized (carbonated, leached, and sulfate-attacked) regions of cement-based materials. The durability of F. orchid indicator was evaluated through comparison between discoloring behaviors of fresh and aged F. orchid indicators, and the capability of the new indicator in neutralization characterization was then verified by combining indicator (phenolphthalein, malachite green, indigo carmine, or thymolphthalein) spray, X-ray computed tomography (CT), and the X-ray attenuation method (XRAM). The result in the present study showed that, with a lower color intensity as compared to phenolphthalein/thymolphthalein, F. orchid indicator was less preferable in studying carbonation but a better choice in characterizing leaching and sulfate attack of cement-based materials. In addition, a sharp c

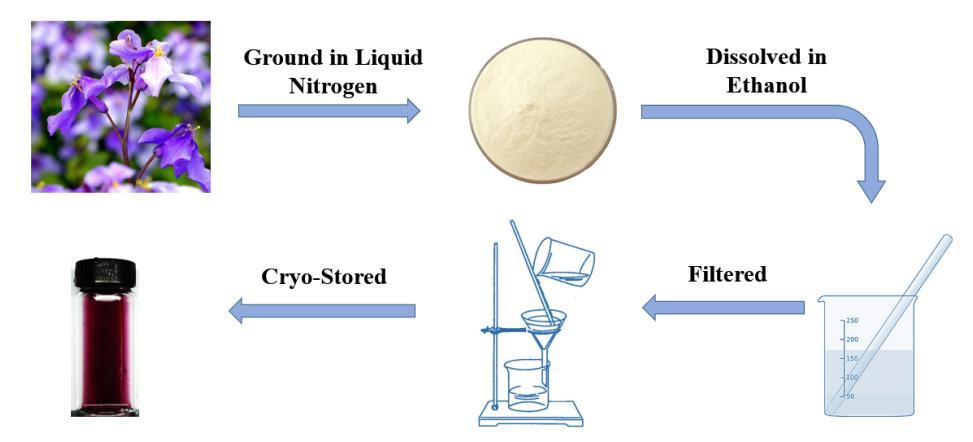
Figure 1. Formulating procedure of F. orchid indicator.

The detailed formulating procedures are as follows. Fresh F. orchid flowers from the university campus were collected. The petals were then separated and refrigerated at $4 \degree C$ (most-widely adopted temperature for the preservation of organic compounds [41,42]). Next, petals were rinsed with de-ionized water, mixed with liquid nitrogen in a mortar, and ground into powder with a pestle. Subsequently, 50 g of frozen powder was taken and dissolved in 100 mL of ethanol. The mix was settled for no less than 24 h to guarantee full dissolution. Finally, the ethanol solution was filtered and condensed under reduced pressure to complete the formulation process (see Figure 1). The F. orchid indicator was stored in a sealed dark glass bottle. Note that both fresh and aged (cryopreserved at approximately $-5 \degree C$ for 3 months) pH indicators were prepared in the present study, which promises examination of the indicator's durability.

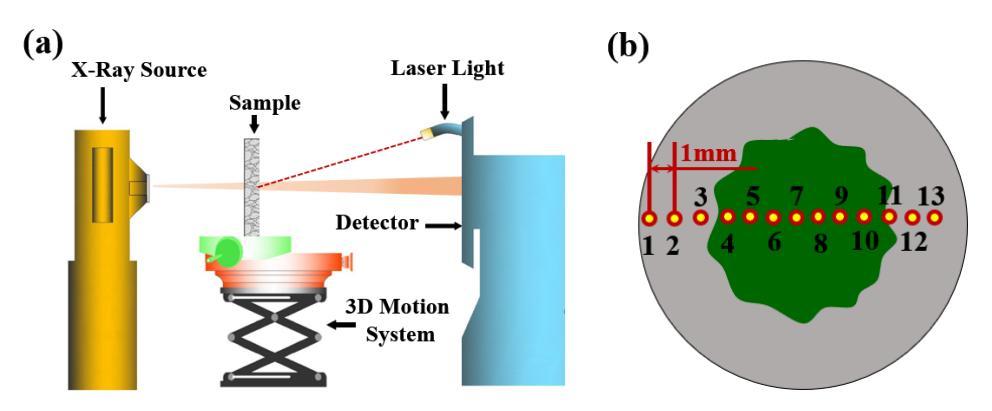
Figure 2. XRAM apparatus and sampling position. (a) Schematic of XRAM apparatus; (b) sampling location.

still during multiple scans (working voltage: 70 kV; working current: 0.6 mA; filter quality: 0.5 mm aluminum sheet). Laser light was used to geometrically align the position of the specimen from multiple scans, and a 3D moving table was adopted to control the motion of the tested sample (see Figure 2a). For each neutralized sample, 13 points horizontally from left to right, passing through the center of the scanned sample, were selected as the testing points. The horizontal distance between adjacent points was 1 mm, and the distance from point 1 to the left corner of the tested specimen was set as 1 mm (see Figure 2b).

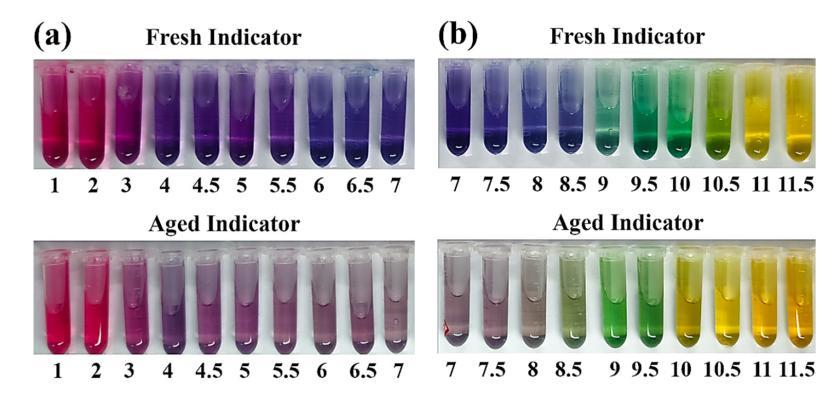
Figure 3. Discoloring behavior of fresh and aged F. orchid indicators exposed to pH ranges of (**a**) 1.0 to 7.0 and (**b**) 7.0 to 11.5.

Figure 3 shows the discoloring behavior of F. orchid indicator in the pH range of 1.0 to 11.5. Obviously, the indicator presented a wide range of colors when facing environments of varying pH: when the surrounding pH was lower than 4, the indicator presented as pink. The indicator color at the acidic state was close to that of F. orchid petals, which implied that the pH of the cell solution for F. orchid petals was acidic, and the acidic condition was, therefore, expected to be beneficial for the durability of F. orchid indicator. When the surrounding pH increased to a range of 4.0 to 8.5, due to the reversible formation of quinonoidal anhydrobase [43,44], the color of fresh indicator shifted to blue, while for aged indicator, a similar discoloration with weaker color intensity was presented, signifying partial degradation of the indicator. When the surrounding pH was further enhanced to a level higher than 9, the color of green started to emerge. Noticing that the discoloration pH was fixed at 9 for both fresh and aged F. orchid indicators, the reliability of F. orchid indicator, even partly degraded, was validated as suitable for neutralization characterization. Eventually, when facing an alkaline environment with a pH higher than

10, F. orchid indicator changed to yellow, demonstrating the irreversible formation of chalcone (degradation) [45].

Compared between Figures 3 and 6, the discoloring behavior in both figures was different. The inner pH of the non-neutralized region was higher than 12 [46,50]; thus, it should exhibit a yellow color after spraying with F. orchid indicator according to Figure 3. However, in Figure 6, green instead of yellow was presented. The discrepancy illustrated a postponed emergence of indicator expiration, which was most probably caused by the varying ratio of the F. orchid indicator volume to the examined solution volume: unlike phenolphthalein, anthocyanin was highly unstable and, thus, inclined to degrade (turning yellow) under a high-alkaline environment. In Figure 3, only a few drops of F. orchid indicator were dropped into the tested solution, so anthocyanin with complete contact to the test solution lost its efficiency immediately, while in Figure 6, only the exposed cross-section was in contact with the F. orchid indicator, so anthocyanin under that condition could survive longer, hence presenting as green. In addition, after spraying with F. orchid indicator, it was also noticed that the color intensity of the non-leached/nonsulfate-attacked region was weaker compared to that of the non-carbonated region, even though the pH within three regions should be similar. The incompatibility was most likely caused by higher humidity levels in specimens exposed to leaching/sulfate attack: as

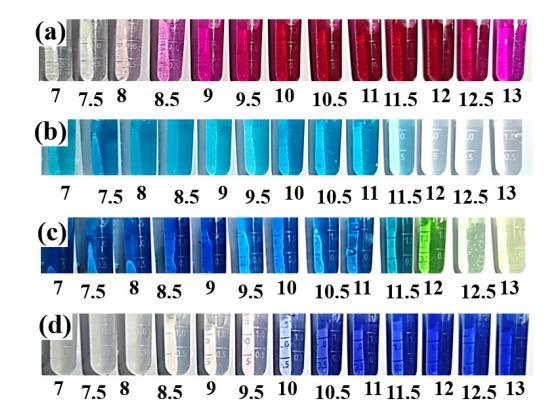
Figure 4. Discoloration behavior of (**a**) phenolphthalein, (**b**) malachite green, (**c**) indigo carmine, and (**d**) thymolphthalein exposed to varying pH.

To better evaluate the discoloration behavior of F. orchid indicator, similar discoloration tests were performed on four pH indicators used worldwide in durability analysis (phenolphthalein, malachite green, indigo carmine, and thymolphthalein), as shown in Figure 4. From the pH of 7.0 up to 13, phenolphthalein, malachite green, indigo carmine, and thymolphthalein turned from colorless, light blue, dark blue, and colorless, respectively, to pink, colorless, yellow, and blue. The discoloration pHs of phenolphthalein, malachite green, indigo carmine, and thymolphthalein in the pH range of 7 to 13 were approximately 8.5, 12, 12, and 10, respectively. Apparently, the discoloration pH of anthocyanin (about 9) was in between those of phenolphthalein (about 8.5) and thymolphthalein (about 10), but significantly lower those of malachite green (about 12) and indigo carmine (about 12). Note here that the pH of the carbonation front is within the pH range of 8.5 to 10 [34], and indigo carmine and malachite green can present larger but sill reliable carbonated areas due to their higher discoloration pH [19,26]. For leaching and sulfate attack, the use of pH indicators was less reported, and the effectiveness of pH indicator, therefore, needed further experimental validation.

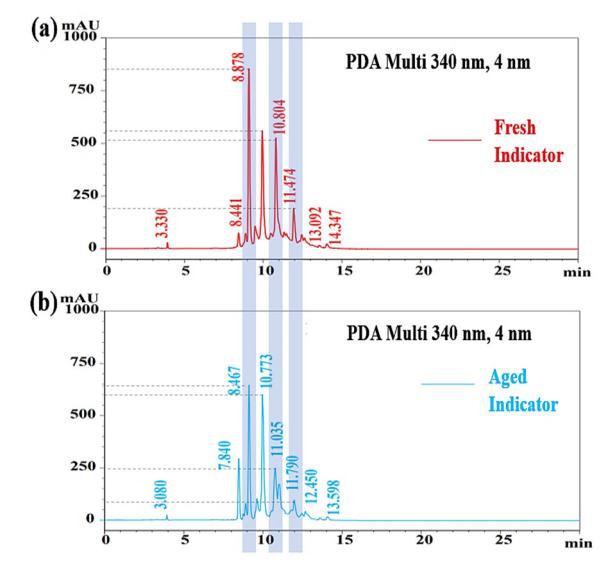
Figure 5. Chromatograms of (a) fresh and (b) aged F. orchid indicators.

Figure 5 shows the chromatograms of fresh and aged F. orchid indicators. The chromatograms were obtained from high-performance liquid chromatography (HPLC), which was essential in present study. This was because HPLC could help balance the concentration of the new developed indicator, which was achieved through holding the height of the 10 min peak at 550 mAU. As shown in Figure 4, even after three months of cryopreservation, the height of the 10 min peak remained almost unchanged, which verified that the adopted peak was suitable as the concentration calibrator. In addition, chromatograms obtained from HPLC could also be used to evaluate the stability of F. orchid indicator. Although each peak in both Figure 5a,b was related to each other, the peak heights of anthocyanins (marked by gray bars) were significantly reduced after three months of cryopreservation. The result evidenced the degradation of F. orchid indicator, which complied with the discoloring behavior in Figure 3.

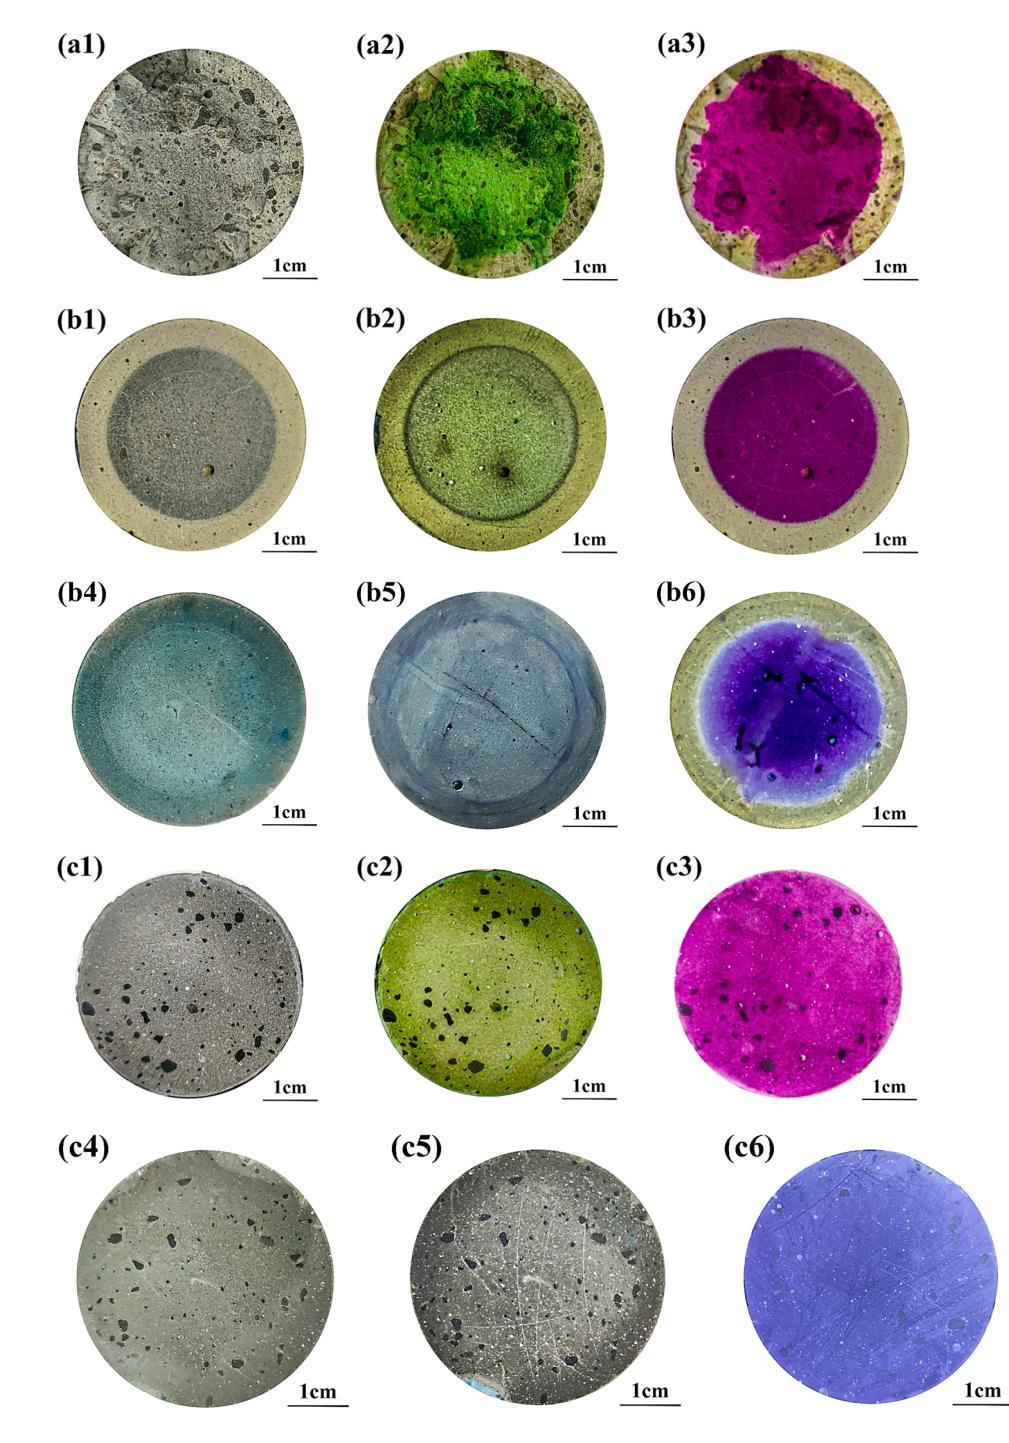
Figure 6. Partly neutralized sample before and after pH indicator spray. 'a', 'b', and 'c' stand for partly carbonated, leached, and sulfate-attacked sample, respectively; suffix '1', '2', '3', '4', '5', and '6' stand for specimens before spraying and spraying with anthocyanin, phenolphthalein, malachite green, indigo carmine, and thymolphthalein, respectively.

The cross-sections of the partly carbonated specimen after spraying with F. orchid indicator and phenolphthalein are shown, respectively, in Figure 6(a2,a3). After spraying with F. orchid indicator, the carbonated (boundary) and non-carbonated (core) region turned khaki and green, respectively, while after spraying with phenolphthalein, the non-carbonated region changed into pink/fuchsia, and the carbonated region remained colorless. As the pH of pore solution gradually reduced from higher than 12 to lower than 9 during carbonation [10], the reduction in pH was sufficient to incur discoloration of both F. orchid indicator (see Figure 3) and phenolphthalein. For indigo carmine and thymolphthalein, their effectiveness in carbonation characterization has been confirmed previously [19–25,32]. Nonetheless, note that the carbonation front shape was irregular after carbonation, and

an accurate recognition of the carbonated area appears more difficult, while essential. Therefore, when dealing with carbonation, phenolphthalein/thymolphthalein appear more suitable over F. orchid indicator, as they illustrate a clearer boundary area due to their high color intensities. For the new F. orchid indicator, even though the indicator is also workable, the carbonated area read will be less clear compared to phenolphthalein or thymolphthalein.

cyanin, phenolphthalein, and thymolphthalein in leaching tests (see Figure 6(b2,b3,b6)). For the cross-section sprayed with malachite green or indigo carmine, the leached area after spraying appeared even vaguer than that before spraying. The result was reasonable considering that the discoloration pH of malachite green or indigo carmine was about 12 (see Figure 4), and the leached and non-leached area should appear blue and colorless (yellow), respectively, when spraying with malachite (indigo carmine). Obviously, the leached area after spraying (tinged with blue) reduced the color difference between leached and non-leached areas, making the process less recognizable. Compared with the carbonation front, the shape of the leaching front was more regular, and this discrepancy between shapes of carbonation and the leaching front was also reported in the literature [47,49]. The varying serving conditions are referred here to explain the difference: the leaching test was performed underwater, while carbonation was mostly carried out under an intermediate humidity (usually of 40–60% [49,50]). As pores in cement-based materials remained fully saturated throughout leaching, drying shrinkage caused by humidity evolution was largely avoided, and a regular-shaped leaching front was, thus, generated due to the absence of cracking. For carbonation, because the pores were not fully saturated, the fluctuations in inner humidity, drying shrinkage [51,52], and carbonation shrinkage [53] were inevitable, both of which incurred cracking. Later, CO₂ was preferable to diffuse through the cracks, forming an irregular-shaped carbonation front.

For sulfate attack, it is interesting to point out that only F. orchid indicator and indigo carmine appeared effective, while none of the remaining pH indicators worked. A possible reason is given here: even though the inner pH of the sulfate-attacked area decreased, the reduction was insufficient to trigger discoloration of any pH indicators presented in Figure 6 [54,55]. Therefore, similar to the non-eroded area, the sulfate-attacked area displayed as green, pink, colorless, yellow, and blue, respectively, after spraying with F. orchid indicator, phenolphthalein, malachite green, indigo carmine, and thymolphthalein. Regardless, sulfate attack deteriorated the microstructure of cement-based materials [54], and pigment could then infiltrate into the sulfate-attacked area, causing color accumulation (appearance of deep green and deep gray, respectively, for F. orchid indicator and indigo carmine). For phenolphthalein or thymolphthalein, even though pigment infiltration was also performed, the color accumulation was less observable considering the high color intensity of the indicator itself. As for malachite green, the pigment accumulation was also non-observable, as the indicator appeared colorless within the sulfate-attacked area. Color accumulation can also explain the dark ring connecting the non-leached and leached area (see Figure 6(b2)), as the ring zone also acquired insufficient pH reduction and a porous microstructure, and infiltration of pigment within the leaching front was equally possible. The assumption here is further verified by the microstructural result in the following section.

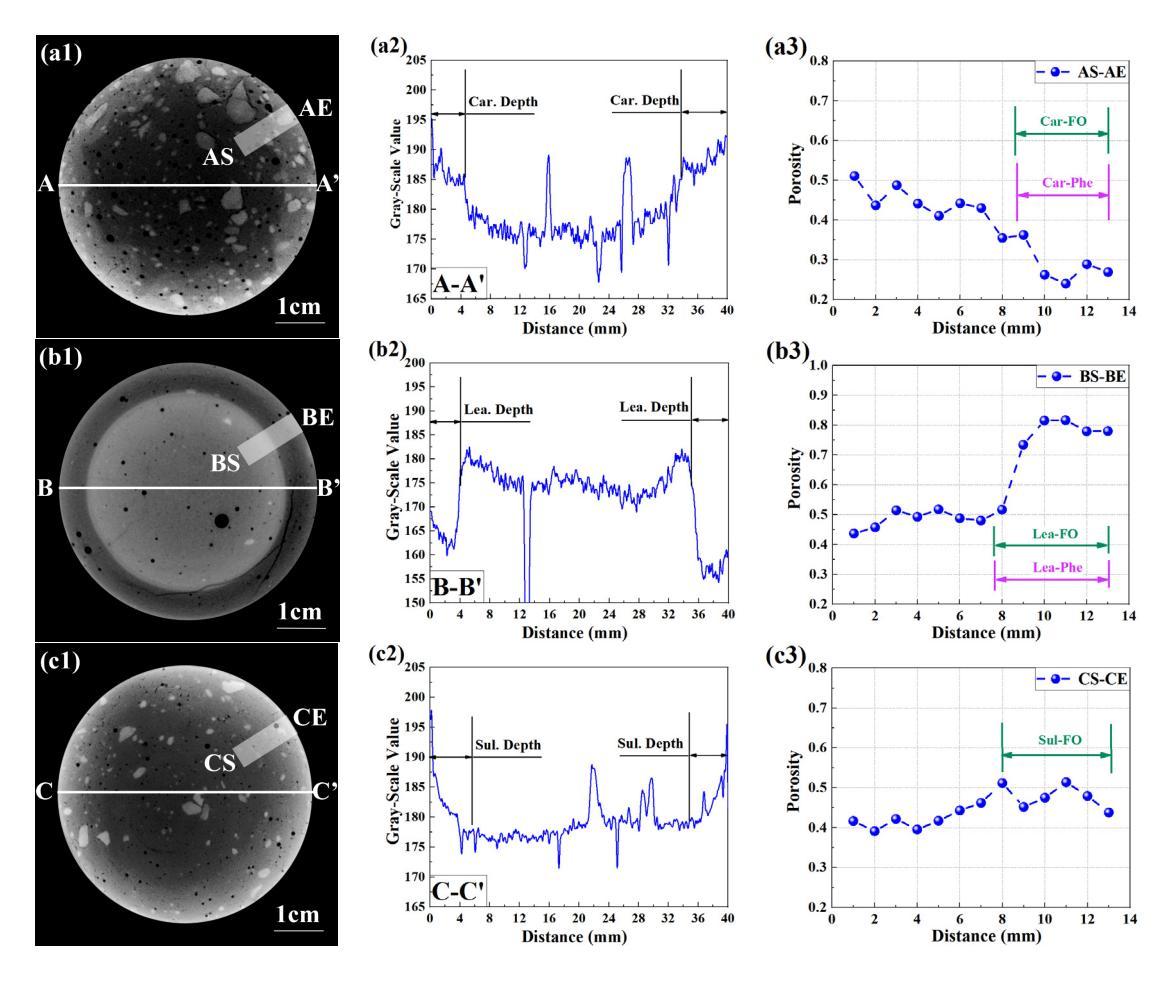
Figure 7. Neutralized regions based on CT and XRAM. 'a', 'b', and 'c' stand for partly carbonated, leached, and sulfate-attacked sample, respectively; suffix '1' stands for the rendered cross-section based on CT; suffix '2' and '3' stand, respectively, for the 1D grayscale value and 1D porosity distribution. FO: F. orchid indicator; Phe: phenolphthalein.

Partly neutralized specimens were further scanned with CT, based on which the reliability of F. orchid indicator was verified. Figure 7(a1–c1) present the typical cross-sections rendered from the partly carbonated, leached, and sulfate-attacked specimen, respectively. Note that each image in Figure 7 was aligned with the related image in Figure 6, and both images can be drawn directly for comparison.

The attenuation coefficient of cement-based material increased after carbonation or sulfate attack. On the contrary, compared with the non-leached core, the leached surface was significantly darker, highlighting the drastic loss of calcium-bearing materials. Despite the difference, carbonated, leached, and sulfate-attacked regions were all clearly revealed through CT scans, and the result showed high consistency with that revealed through spraying with F. orchid indicator, which served as compelling evidence that the newly developed pH indicator was trustable in neutralization characterization.

To quantitatively evaluate the reliability of F. orchid indicator, linear profiles of grayscale values collected from 2D renderings were plotted (see Figure 7(a2-c2)). The

grayscale values of non-carbonated, non-leached, and non-sulfate-attacked regions were in the range of 170–180, and randomly encountered peaks and valleys were observable on 1D profiles, representing the unhydrated cement particles or macro-pores. The grayscale values of the carbonated, leached, and sulfate-attacked region were in the range of 185–190, 155–170, and 175–190, respectively, which quantitatively revealed an increased attenuation coefficient by CO_2 or sulfate binding, but a reduced one by leaching. In addition, grayscale values at both ends of the 1D profile were larger than that of the inner neutralized area, which was due to the artifact of beam hardening (inevitable during CT scan [56]). Nonetheless, a sharp increase (reduction) was observed on the 1D carbonation (leaching) profile, which suggested that the carbonation (leaching) in the present study was a diffusion-controlling progress. Based on a similar carbonation (leaching) depth read from the 1D grayscale value profile and from local pH, the reliability of F. orchid indicator in the neutralization characterization was confirmed again. An exception was encountered in sulfate attack, where no clear front was observed on its 1D profile. The result highlighted the fact that sulfate attack in the present study was not solely controlled by diffusion. The sulfate-attacked depth could still be read as approximately 5 mm, which agreed with that based on spraying with F. orchid indicator.

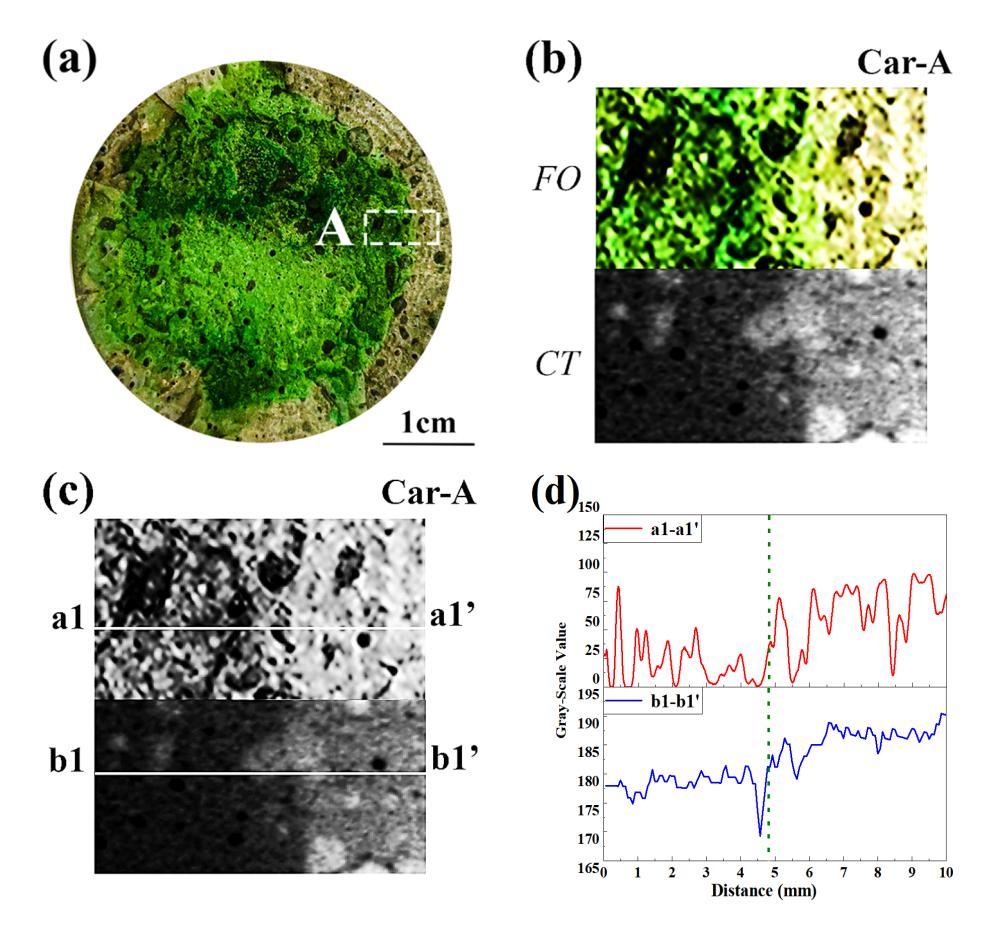
Figure 8. Partly carbonated specimen. (**a**) Cross-section sprayed with F. orchid indicator; (**b**) magnified local image of A and related CT image; (**c**) Binarized image of (**b**); (**d**) 1D distribution of grayscale value along a1-a1' and b1-b1' in (**c**).

Figure 8a shows the cross-section of the partly carbonated specimen after spraying with F. orchid indicator. To better demonstrate the details of the carbonation front, the local image and its related CT rendering were magnified, as shown in Figure 8b. Apparently, the carbonated region revealed though indicator spray showed high consistency with that revealed through CT, despite the boundary being relatively vague compared with that based on phenolphthalein. To quantitatively illustrate the scale of the carbonation front, the image in Figure 8b was binarized (see Figure 8c), and 1D distributions of the grayscale value were then plotted (see Figure 8d). As a sharp carbonation front was observable from

the 1D grayscale value profile based on both the indicator spray and CT scan, the progress in the present study was revealed to be under the control of diffusion.

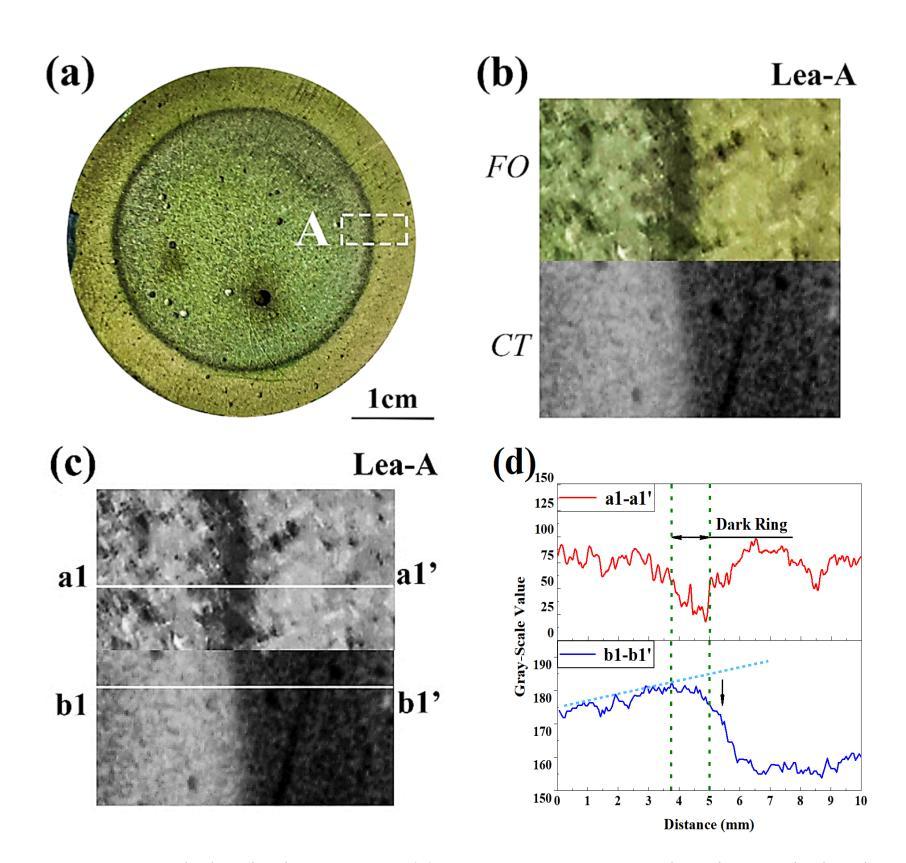
Figure 9. Partly leached specimen. (**a**) Cross-section sprayed with F. orchid indicator; (**b**) magnified local image of A and related CT image; (**c**) binarized image of (**b**); (**d**) 1D distribution of grayscale value along a1-a1' and b1-b1' in (**c**).

For leaching, following a similar strategy, the cross-section, magnified local image, binarized image, and 1D distribution of grayscale values are shown, respectively, in Figure 9a–d. Because of the dilution effect, the color difference between the leached and non-leached area was less significant. Fortunately, the leaching front was presented as a dark ring, connecting the non-leached and leached area. Even though calcium-bearing materials were partly lost within the leaching front (see the reduced grayscale value near the leaching front in Figure 9d, where a blue dashed guideline is presented showing the expected grayscale value without leaching), the pH of the leaching front was still insufficient to trigger discoloration of anthocyanin. Therefore, the leaching front remained green after spraying with F. orchid indicator. Regardless, the microstructure of the leaching front was more porous as compared to the non-leached area (see Figure 7(b3)), so a larger amount of anthocyanin could reside in this area, causing color accumulation (emergence of deep green). Read from Figure 9d, the width of the leaching front was estimated to be 1–2 mm.

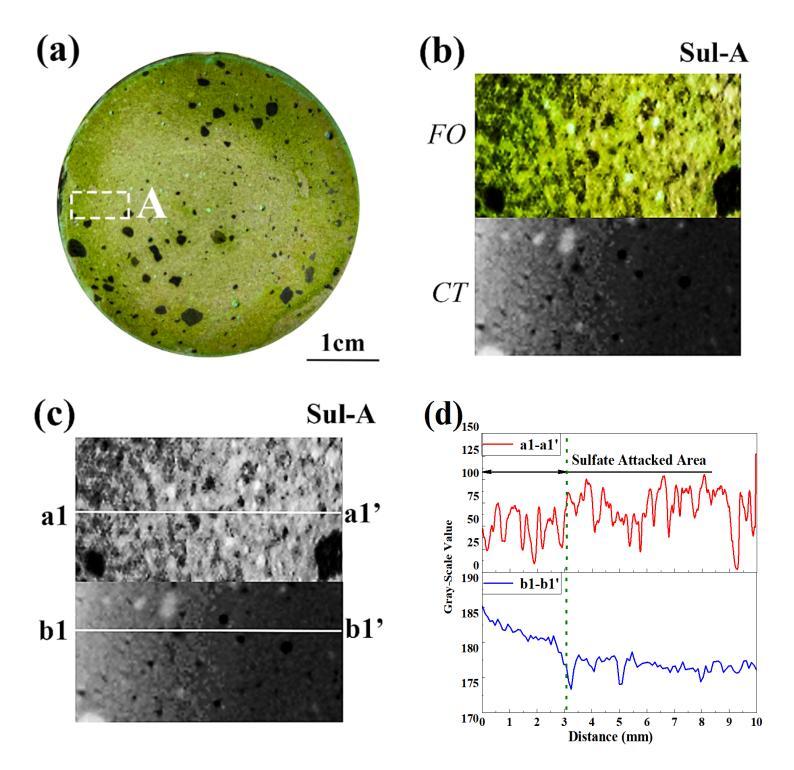
Figure 10. Partly sulfate-attacked specimen. (**a**) Cross-section sprayed with F. orchid indicator; (**b**) magnified local image of A and related CT image; (**c**) binarized image of (**b**); (**d**) 1D distribution of grayscale value along a1-a1' and b1-b1' in (**c**).

Figure 10 presents the cross section, local image, binarized image, and 1D distribution of grayscale values for the partly sulfate-attacked specimen. Similar to leaching, the efficiency of F. orchid indicator in characterizing the sulfate-attacked region was highlighted. Better yet, the obtained sulfate-attacked depth was compatible with that based on CT (see Figure 10d), which highlighted the effectiveness of F. orchid indicator in characterizing sulfate attack.

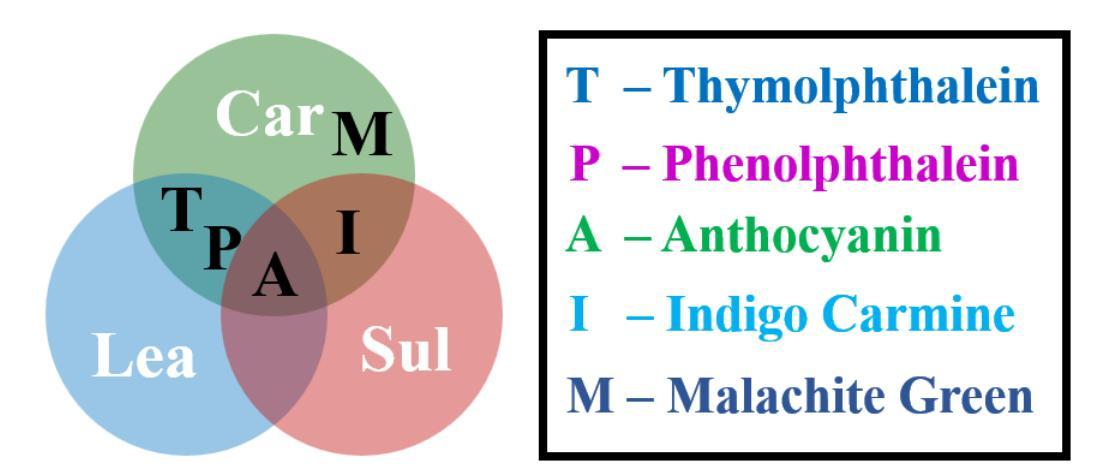
Figure 11. Suitable circumstances for each pH indicator.

The benefits of promoting F. orchid indicator are clear, because the F. orchid plant is nontoxic, and the indicator based on the F. orchid source is, thus, safer. In addition, due to weaker color intensity, color accumulation caused by pigment residing in porous media can be better observed by anthocyanin spray. Even though indigo carmine is also capable of catching the sulfate-attacked area, the indicator failed to clearly illustrate the leaching front. Based on the result, the newly developed F. orchid indicator is referred here as a universal pH indicator, which is effective in carbonation, leaching, and sulfate-attack characterization. Circumstances suitable for phenolphthalein, malachite green, indigo carmine, thymolphthalein, and newly developed F. orchid indicator (anthocyanin) are concluded accordingly in Figure 11.
