Abstract: As critical components in offshore wind turbine (OWT) systems, pitch bearings require exceptional fatigue resistance to ensure the extended operational lifespan and structural reliability demanded by marine environments. Failure of these bearings due to rolling contact fatigue (RCF) can severely affect the economic efficiency of offshore wind turbines and potentially lead to safety accidents involving both humans and machinery. A simulation model for pitch bearings used in a 3 MW OWT is established to study the RCF behavior under operational conditions based on continuum damage mechanics. Both the elastic and plastic damage are considered in the damage process through a Python script. A user subroutine UMAT is programmed to depict the gradual deterioration of mechanical properties. The results indicate that the fatigue damage of the raceway exhibits significant nonlinear characteristics, with elastic damage playing a predominant role in determining its fatigue life under operational conditions.

Citation: He, H.; Chen, Y.; Liu, Y.; Zhu, Y.; Jin, X. Rolling Contact Fatigue Behavior of Pitch Bearing Raceway in Offshore Wind Turbines. *Materials* **2025**, *18*, 1816. https:

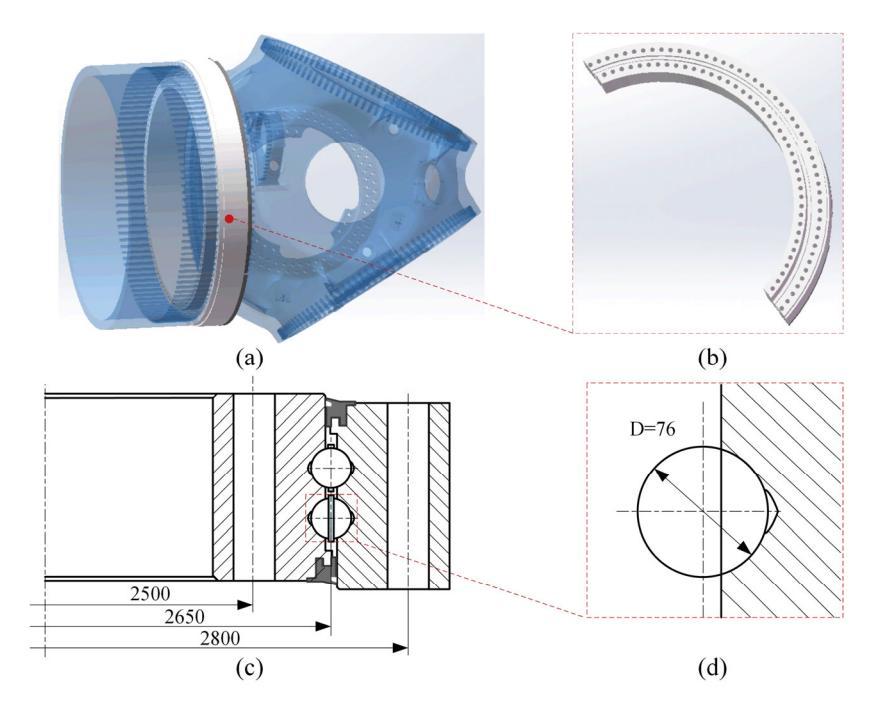
Figure 1. The 3D geometric structure and the 2D model of the pitch bearing; (**a**) the geometric structure of a wind turbine; (**b**) the 3D geometric structure of the pitch bearing; (**c**) the 2D geometric structure of the pitch bearing; (**d**) the contact condition between the roller and the outer ring raceway.

The pitch bearing used originated from a 3 MW offshore wind turbine. Figure 1a shows the geometric structure of this wind turbine, which included three blades and three pitch bearings. Figures 1b and 1c display the 3D geometric structure and the 2D model of the pitch bearing, respectively. The pitch bearing is a double row four-point contact ball bearing. The pitch bearing had an outer ring, an inner ring, and rollers. Each bearing contained 92 rollers. The diameters of the outer ring pitch, the inner ring pitch, and the roller pitch were 2800 mm, 2650 mm, and 2500 mm, as shown in Figure 1c. The diameter of the rollers was 76 mm. Figure 1d shows the contact condition between the roller and the outer ring raceway. During the working process, each roller contacted the outer raceway at two distinct contact points to transfer the applied load.

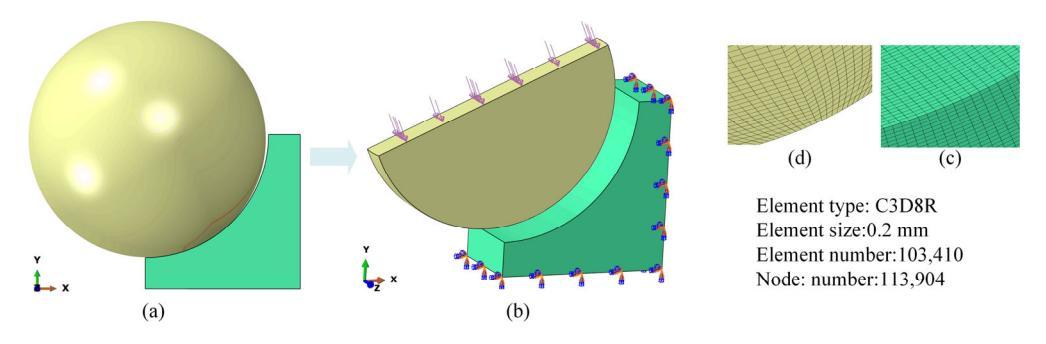
Figure 2. The simulation model for roller–raceway contact; (**a**) the half-contact model between the roller and the bearing raceway; (**b**) the equivalent finite element model; (**c**,**d**) the mesh detail around the contact area.

All the rollers exhibited identical loading histories throughout the service process, resulting in a symmetrical stress distribution pattern. Hence, a simplified equivalent finite element model of the roller-pitch bearing raceway was established to analyze the fatigue behavior of the bearing inner raceway. Figure 2a shows a half-contact model between

the roller and the bearing raceway according to symmetry features. Figure 2b displays the equivalent finite element model considering the loading and boundary conditions. Figure 2c,d show the mesh detail around the contact area. The element type for the roller and raceway was chosen as C3D8R to balance precision and computational cost. The minimum mesh size in the contact area was 0.2 mm. The total element and node numbers were 103,410 and 113,904, respectively. A gradually large mesh away from the contact area was applied to reduce the simulation time. The operation load was 159,529 N. Python script v3.9 was used for the finite element simulation including the pre-processor module (Step, Load, and Mesh sections) and post-processor module.

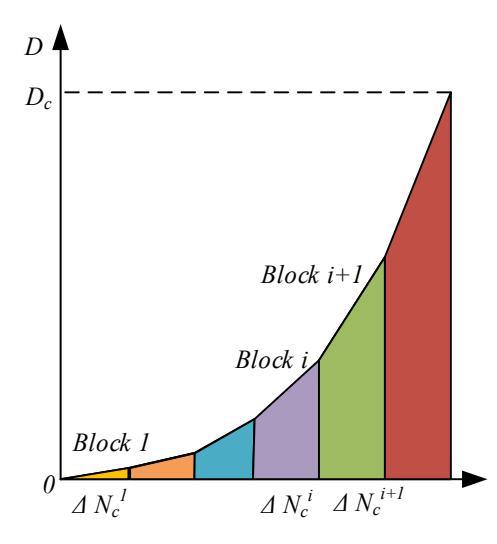
Figure 3. Damage accumulation using the "jump-in-cycles" method.

The designed fatigue life of a pitch bearing is more than a million loading cycles, which is difficult to simulate in ABAQUS v2022. Hence, the "jump-in-cycles" method [41] is used to accelerate the simulation process, as shown in Figure 3. It is assumed that the stress and strain fields remain constant during a ΔN_c loading cycle (which is expressed as a loading block). The damage rate in the constant ΔN_c remains the same accordingly. When damage accumulates to the critical value 1, fatigue failure occurs, and the corresponding loading cycle is the fatigue life.

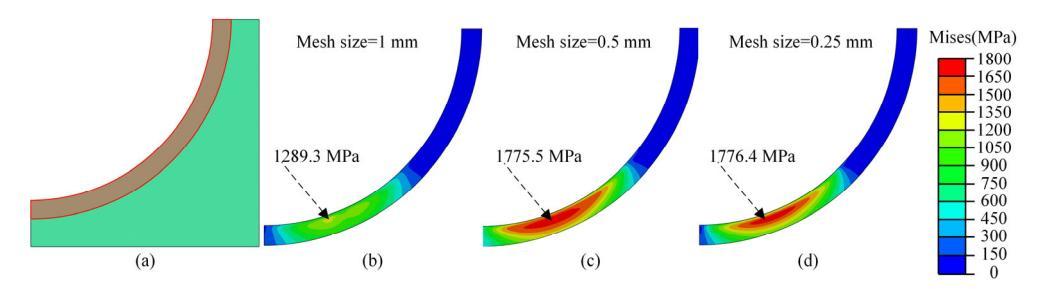
Figure 4. The von Mises stress for different minimum mesh sizes; (**a**) the fine mesh area; (**b**) the von Mises stress for mesh size 1 mm; (**c**) the von Mises stress for mesh size 0.5 mm; (**d**) the von Mises stress for e mesh size 0.25 mm.

Figure 4 shows the von Mises stress contours for various minimum mesh sizes. The results indicate that the stress response escalated as the minimum mesh size diminished, eventually converging to a specific value. Notably, the maximum von Mises stress increased from 1289.3 MPa to 1775.5 MPa and 1776.4 MPa as the minimum mesh size decreased from 1 mm to 0.5 mm and 0.25 mm, respectively. These findings indicate that the stress responses for minimum mesh sizes of 0.25 mm and 0.5 mm exhibit equivalent precision. Consequently, to optimize computational efficiency while maintaining solution accuracy, a minimum mesh size of 0.5 mm was selected in the present study.

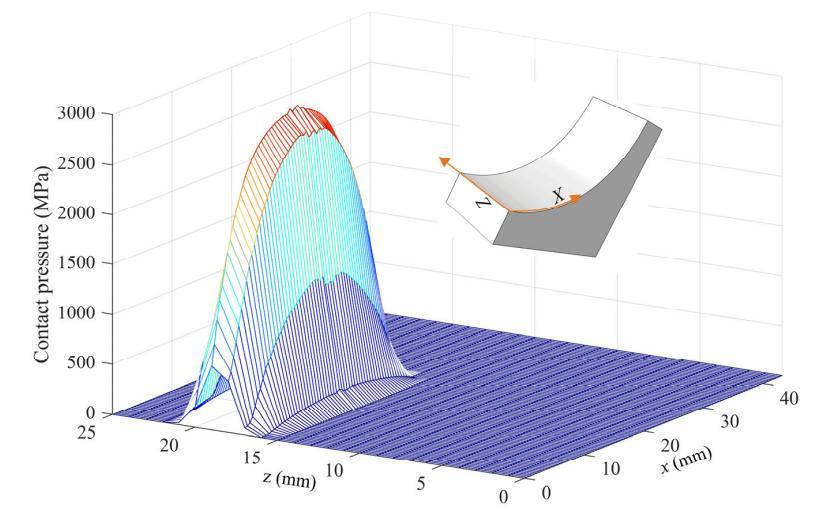
Figure 5. The contact pressure when the raceway is loaded through the roller.

Figure 5 shows the contact pressure when the raceway was loaded through the roller. The contact pressure was highly concentrated in a very small area; the contact widths in the x and z (the rolling direction) directions were 27 mm and 6 mm, respectively. The contact width in the z-direction was significantly smaller than the roller diameter (76 mm), while the contact width in the x-direction demonstrated a greater value due to the semi-circular profile of the raceway along that axis. The maximum contact pressure under the operation condition was about 3307 MPa, which occurred at the 14 mm position in the x-direction.

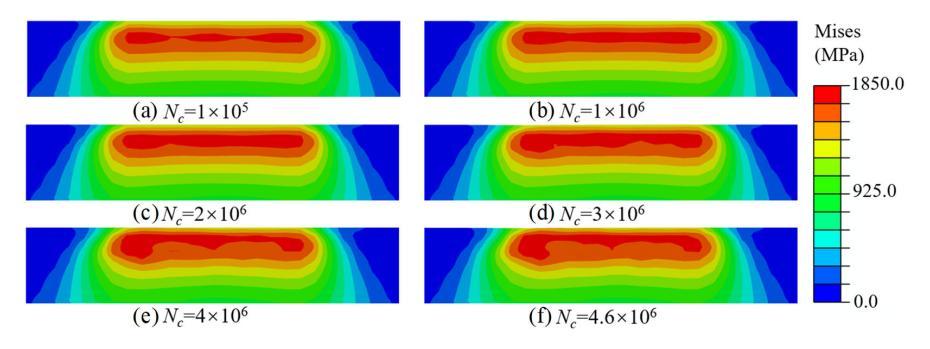
Figure 6. Evolution of maximum von Mises stress in the subsurface of the raceway.

Figures 6 and 7 show the contours of maximum σ_{eq} and $\Delta \tau$ throughout a complete loading cycle. It was found that the maximum values of σ_{eq} and $\Delta \tau$ occurred at a subsurface depth beneath the raceway surface rather than at the contact surface. Theoretically, the value of maximum σ_{eq} and $\Delta \tau$ should be identical at the same depth. However, the influence of friction force and simulation error leads to a slight variation in the stress response along the depth direction. Additionally, it was observed that the contours for both stresses did not change significantly during most of the fatigue lifetime. This is because the observed stress variation under a constant load amplitude is primarily attributable to the degradation of the raceway mechanical properties, whereas the degradation of material mechanical properties is very slow throughout the majority of the fatigue life cycle.

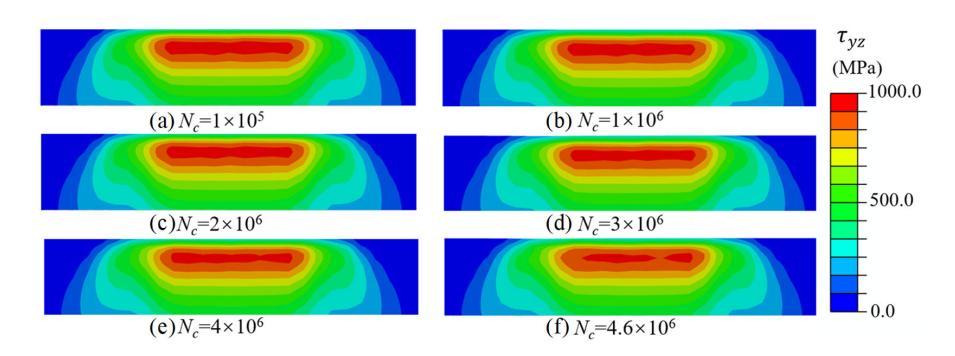
Figure 7. Evolution of shear stress range in the subsurface of the raceway.

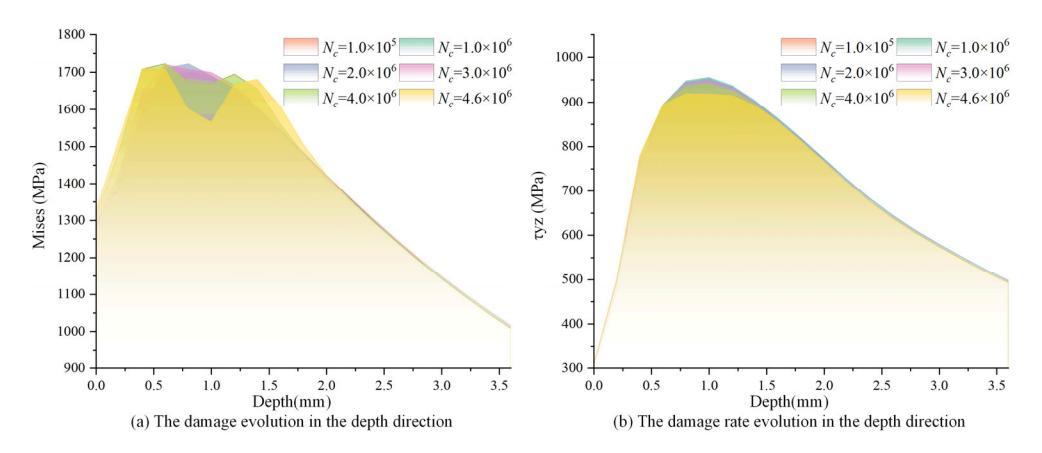
Figure 8. Evolutions of the maximum σ_{eq} and $\Delta \tau$ in the depth direction for different loading cycles.

Figure 8 shows the evolution of the maximum σ_{eq} and $\Delta\tau$ in the depth direction across varying loading cycles. Both maximum σ_{eq} and $\Delta\tau$ gradually decreased as the loading cycle increased. Meanwhile, the reduction in stress was most significant near the critical element. For example, when the loading cycle increased from 1 to 4.6 million, the von Mises stress decreased from 1722 MPa in the initial state to 1601 MPa in the critical damage state for the critical element, with a 7% drop. Correspondingly, the shear stress range decreased from 947 MPa to 918 MPa, with a 3% drop. This is because the load-bearing capacity of material point is gradually weakened as the fatigue damage accumulates. Subsequently, the material stress in the critical point decreases.

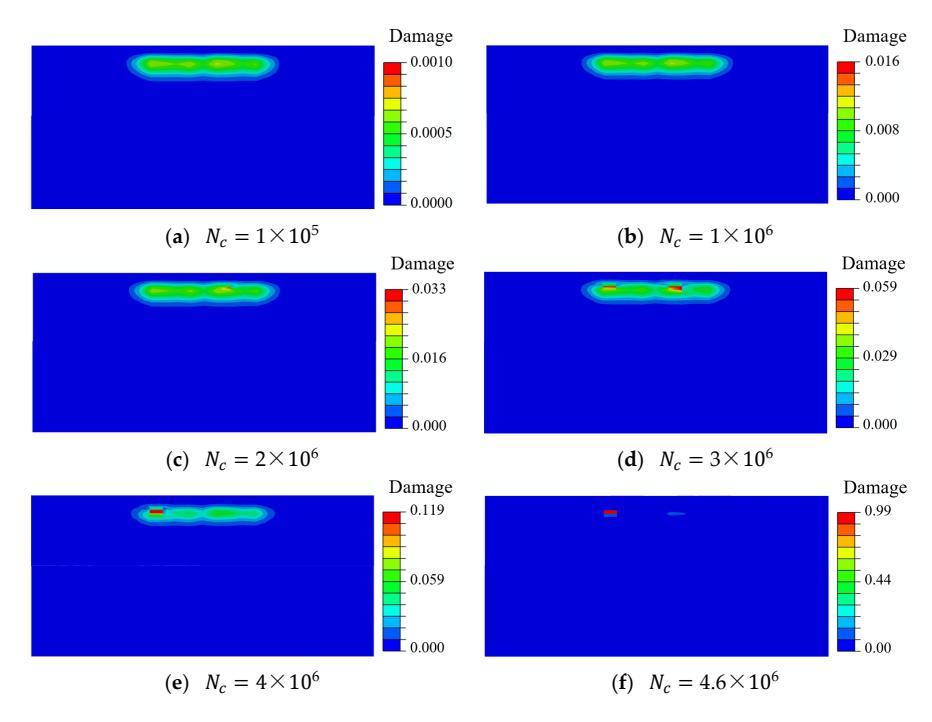
Figure 9 shows the evolution of the fatigue damage contour under different numbers of loading cycles for the pitch bearing. The constant ΔN_c was set as 100,000. The accumulated damage under different loading cycles was concentrated near the region with the maximum von Mises stress and the shear stress range, and the damage of material points within this region increased as the loading cycle increased. The maximum subsurface damage accumulated from 0.119 to the threshold value of unity after an additional 0.6 million loading cycles. This indicates that the accumulation of damage exhibits nonlinear characteristics, and the damage rate gradually accelerates. Figure 10 depicts the evolution of the damage rate as the loading cycle increased, the damage rate exhibited a high degree of similarity to the evolution of damage.

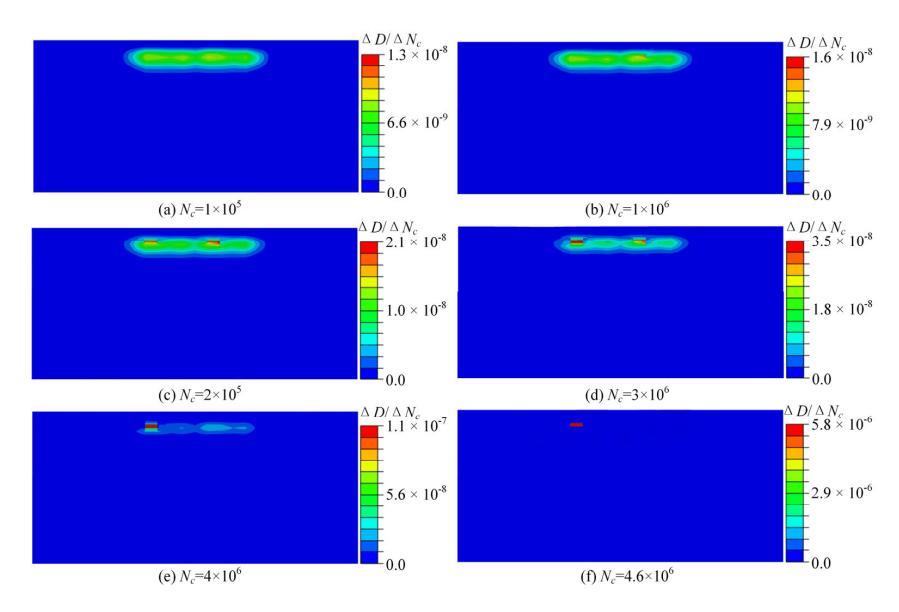
Figure 10. The evolution of damage rate.

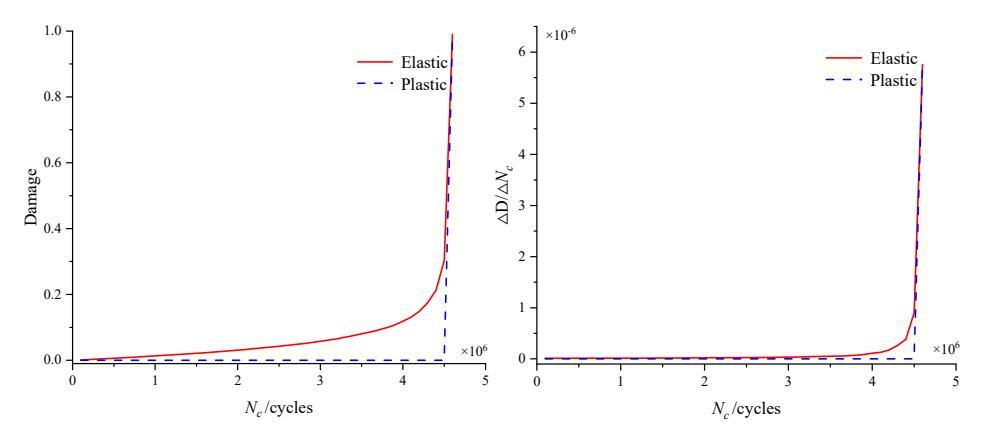
Figure 11. The evolution of elastic and plastic damage and damage rates.

The material element that first reaches the damage critical value is defined as the critical element. Figure 11 shows the evolution of elastic and plastic damage and damage rate of the critical element. It is revealed that both the elastic damage and damage rate grow exponentially. The elastic damage rate grew slowly in the early stage of rolling contact, which led to a slow accumulation of damage at the critical point. However, with the increase in the loading cycle, the material properties such as elastic modulus and damage rate. Hence, the damage rate increased sharply to the critical value in the last 10% of the remaining lifetime. In addition, it was found that the plastic damage was almost zero for most of the lifetime, indicating that no plastic deformation occurred under this load amplitude in the early stage; thus, no plastic damage accumulation was caused. It was revealed that the fatigue life of the pitch bearing was dominated by the elastic damage.

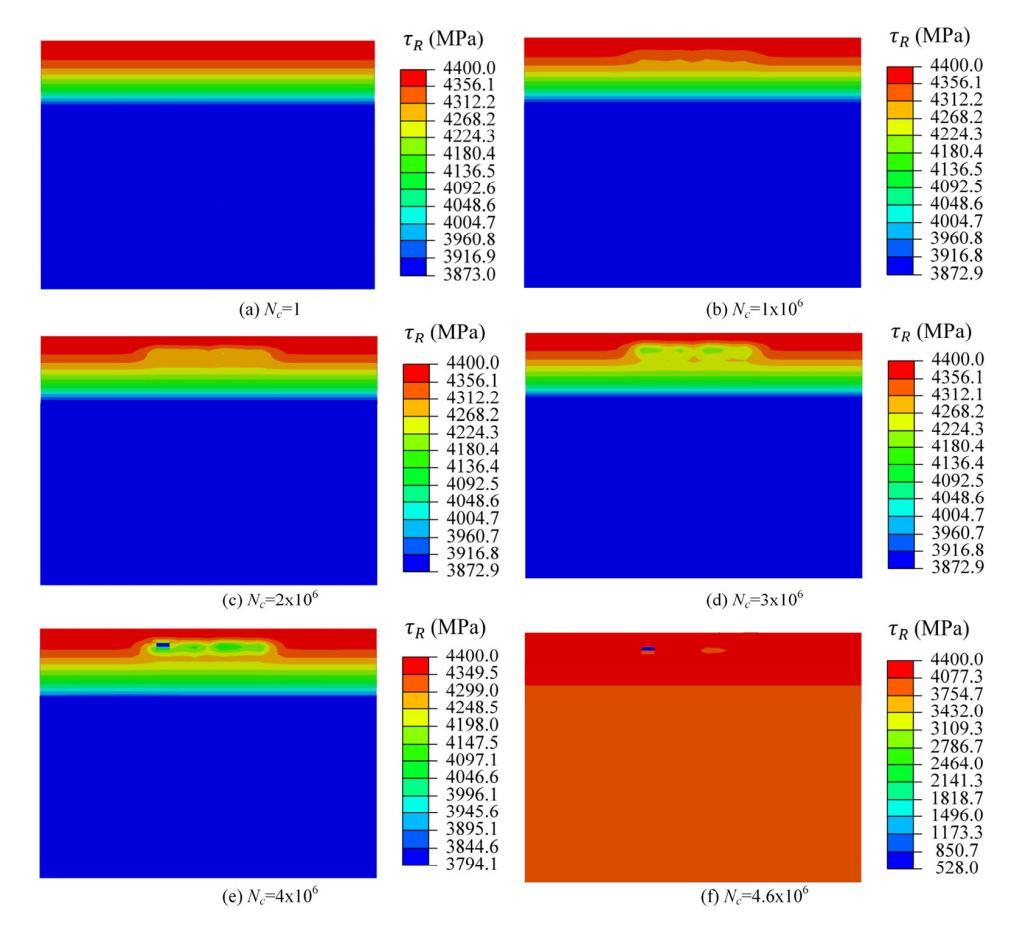
Figure 12. The evolution of elastic damage-related parameter τ_R .

Figure 12 shows the evolution of elastic damage-related parameter τ_R as the loading cycle increased. τ_R is highly related to the material hardness; the hardness remains constant at the same depth, so τ_R is the same. τ_R gradually decreased from the maximum value of 4400 MPa on the surface to 3873 MPa in the core for the un-damaged raceway, as shown in Figure 10a. In addition, the evolution of τ_R represents the damage accumulation of material points. The damage of material point increased with the increase in the loading cycle, and further led to the deterioration of hardness, results in a decrease in τ_R . For example, τ_R decreased from the initial maximum value 4400 MPa to the minimum value 528 MPa for the critical element when the loading cycle increased from 1 to 4.6 million.

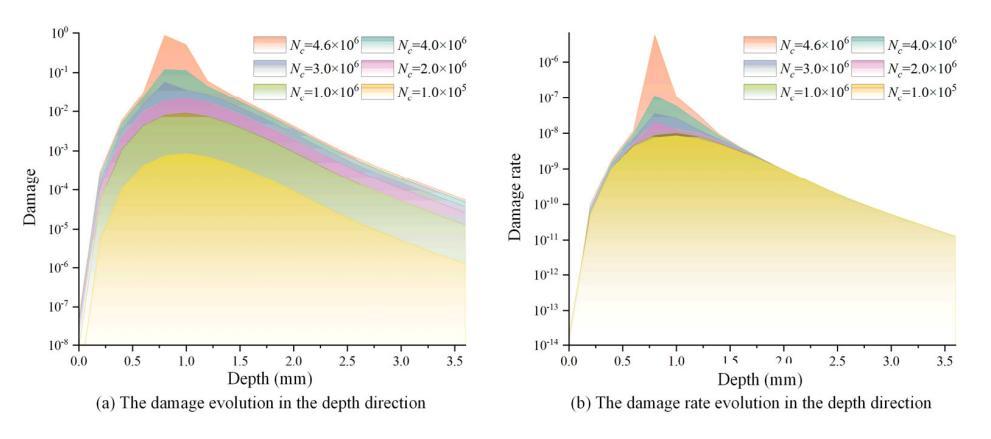
Figure 13. Evolutions of damage and damage rate in the depth direction for different number of cycles.

Figure 13 shows the evolutions of damage and damage rate in the depth direction for different loading cycles. Both the damage and damage rate first increased to the maximum at 0.80 mm and then decreased as the depth increased. When the loading cycle reached 4.6 million times, the damage rate depicted a sudden growth in the depth of 0.8 mm, and the cumulative damage reached the critical value of unity meanwhile, leading to the fatigue failure of the bearing raceway.
