# Article Satellite Imagery-Based Damage Assessment on Nineveh and Nebi Yunus Archaeological Site in Iraq

Abstract: During the last decades, archaeological site looting throughout Iraq has increased significantly up to a point where some of the most famous and relevant ancient Mesopotamian cities are currently threatened in their integrity. Several important archaeological monuments and artifacts have been destroyed, due to ISIL attacks and associated looting. Since 2016, the policies of the European Union have been increasingly harsh to condemn these atrocious acts of destruction. In such a scenario, the European Union Satellite Centre can be an invaluable instrument for the identification and assessment of the damage in areas occupied by ISIL. A detailed view of the damage suffered by the Nineveh and Nebi Yunus ancient sites, in Iraq, was assessed via visual inspection. The analysis was conducted considering the main events that occurred in the city of Mosul, between November 2013 and March 2018. More than 25 satellite images, new acquisitions and archived, supported by collateral data, allowed the detection and classification of the damage occurred over time. A description of t

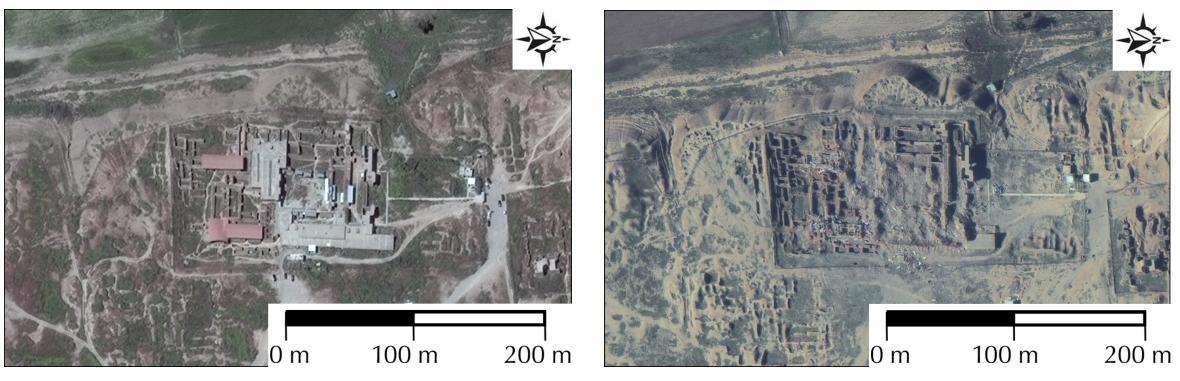
(**a**) GeoEye-1, 21 August 2014

(b) WorldViev-2, 12 March 2018

**Figure 4.** Destruction damage type related to demolition. The northwest palace of Nimrud had an interpretation center and protective structures that have been demolished ©DigitalGlobe.

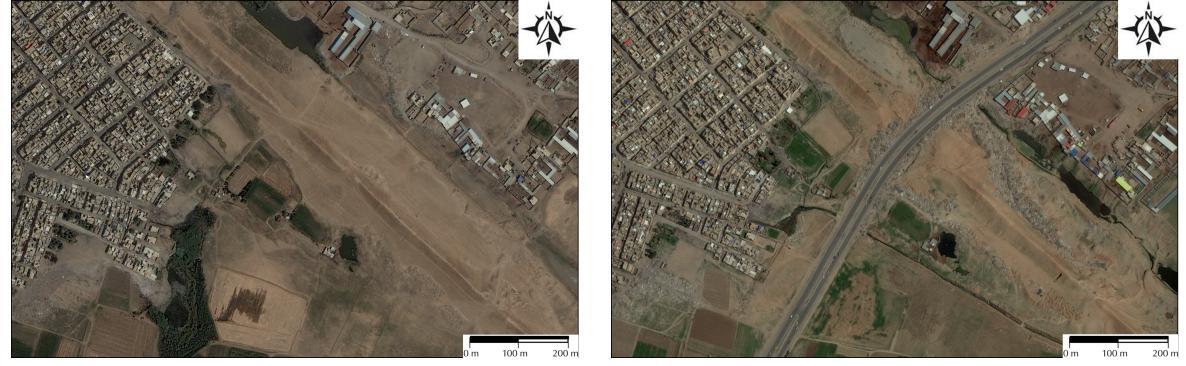
(a) GeoEye-1, 21 August 2014

(**b**) WorldViev-2, 12 March 2018

**Figure 5.** Partial destruction and construction damage types due to large infrastructure, such as highways passing through the area, have damaged ancient walls©DigitalGlobe.

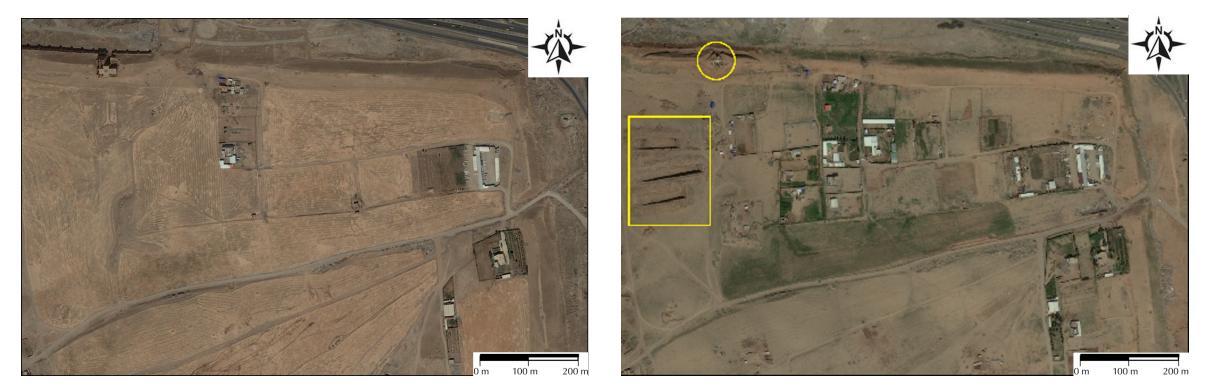
(a) QuickBird, 30 July 2014

(**b**) WorldViev-2, 12 March 2018

**Figure 6.** Construction damage type related to uncontrolled construction activities. Trenches affecting buried heritage have been opened and new buildings have been constructed over cultural heritage site (highlighted in yellow)©DigitalGlobe.

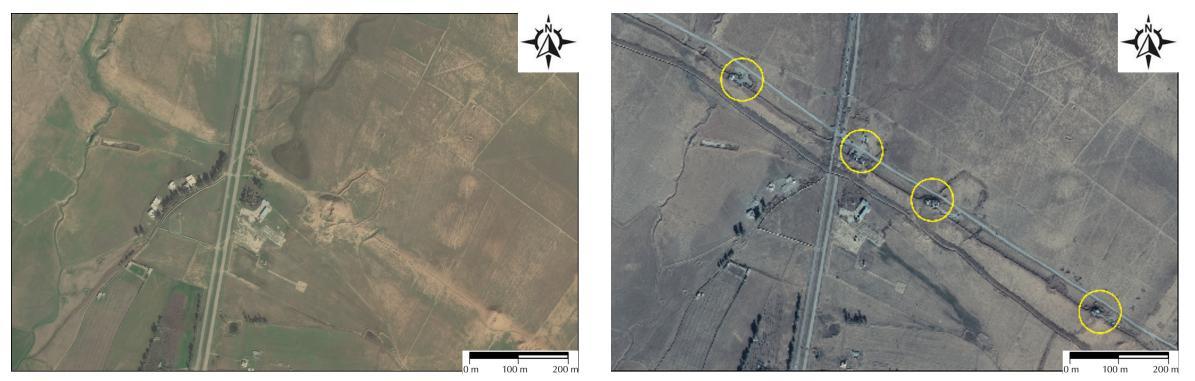
(**a**) GeoEye-1, 12 February 2016

(b) WorldView-2, 6 December 2016

**Figure 7.** Construction damage type related to new defence position including strongholds, revetments and trenches directly over cultural heritage sites (highlighted in yellow) ©DigitalGlobe.

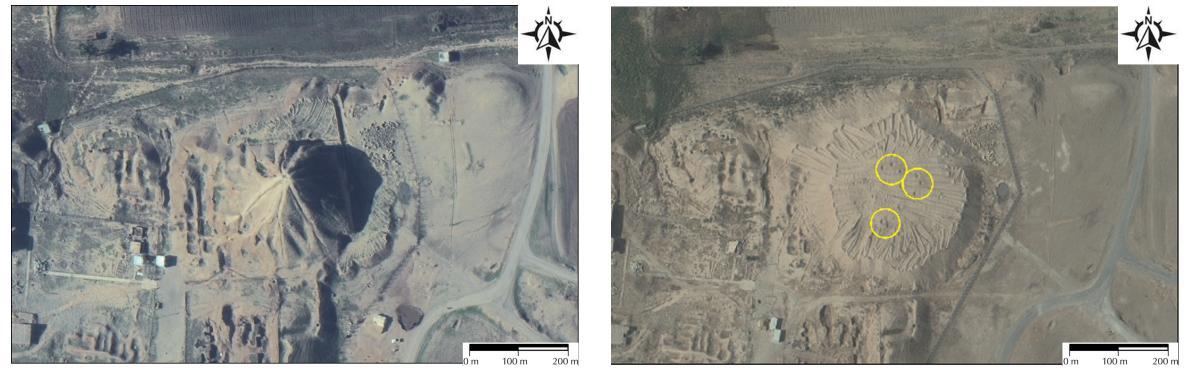
(a) WorldView-3, 2 December 2015

(b) WorldView-3, 25 October 2017

**Figure 8.** Earth movement damage type. The Ziggurat of Nimrud was bulldozed to the ground. The marks of the bulldoze are clearly visible in the image, as well as posterior looting in the form of small excavations (highlighted in yellow) ©DigitalGlobe.

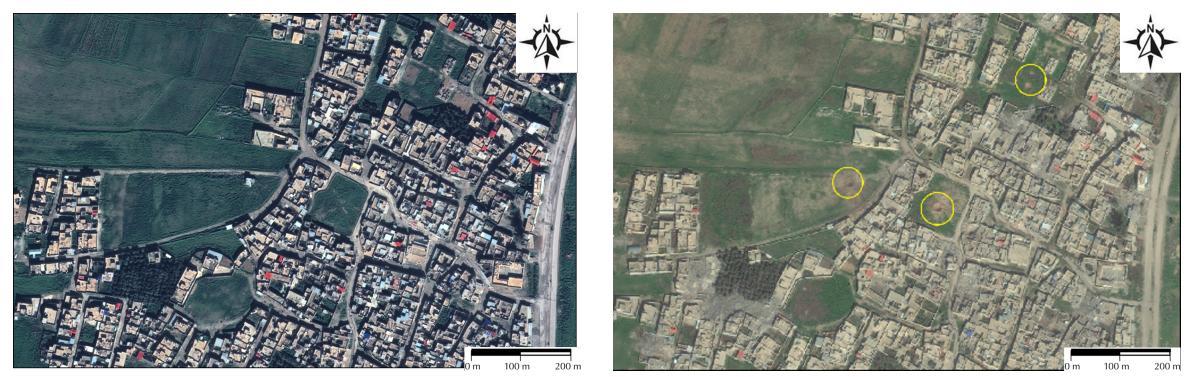
(a) WorldView-2, 21 August 2015

(**b**) GeoEye-1, 12 February 2016

**Figure 9.** Weapon impact damage type, where impact craters can be identified in the imagery (highlighted in yellow) ©DigitalGlobe.

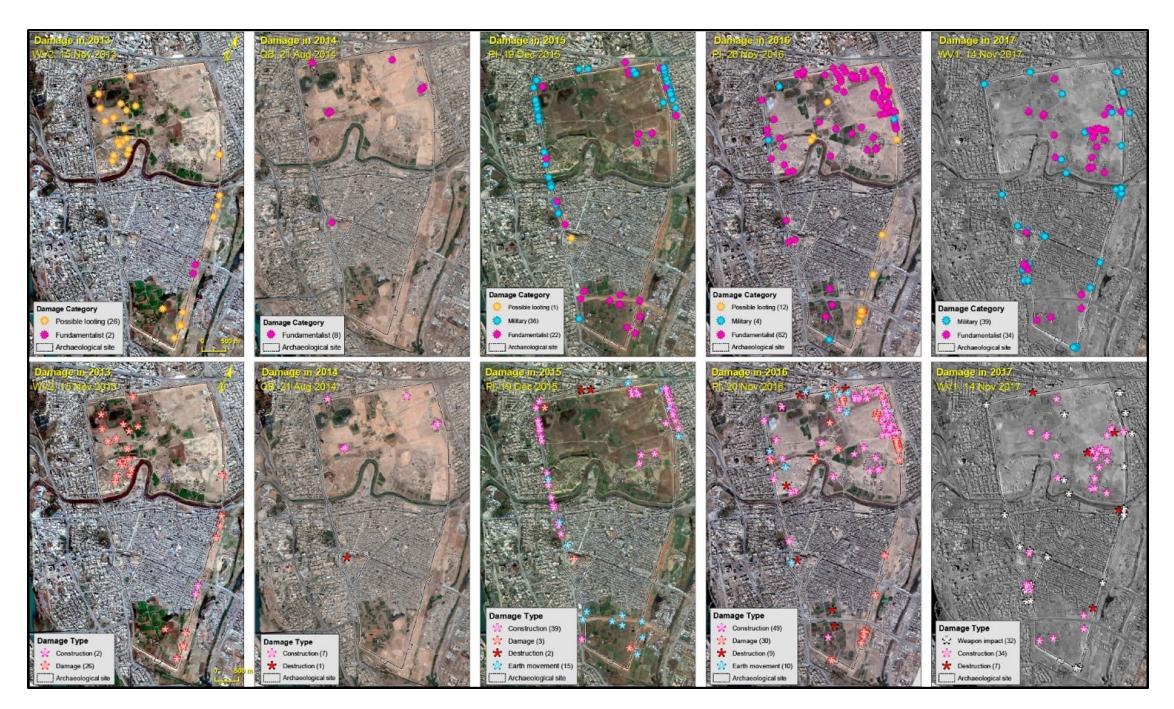
Figure 10. Distribution of damage by category (top-half) and type (bottom-half) per year (2013-2018).

In the areas of interest corresponding to the Nineveh and Nebi Yunus sites (around five square kilometers), a total of 268 points have been identified and classified (Figure 10). Each point of damage or change observed has been encoded into a geodatabase with its corresponding category, type, and date of the image associated.

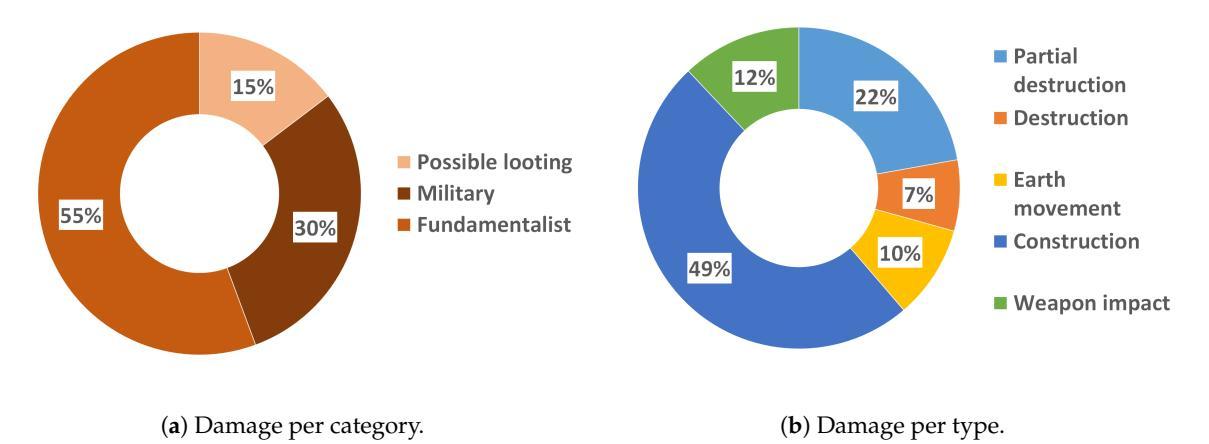
Figure 11. Distribution of damage in the overall period (November 2013–March 2018).

As reported in Figure 11, the damage observed over the entire period (November 2013–March 2018) has been assessed as mostly falling under the fundamentalist category (55%), followed by military-related damage (30%) and possible looting (15%). As regards the type of damage, construction-related damage predominated (49% of all cases), followed by partial destruction (22%), weapon impact (12%), earth movement (10%), and destruction (7%). The predominance of construction-related damage reflects the expansion of housing and farms (the area of Nineveh was already occupied with dwellings), as well as temporary military checkpoints and booths erected and dismantled along the site perimeter during the monitoring period.

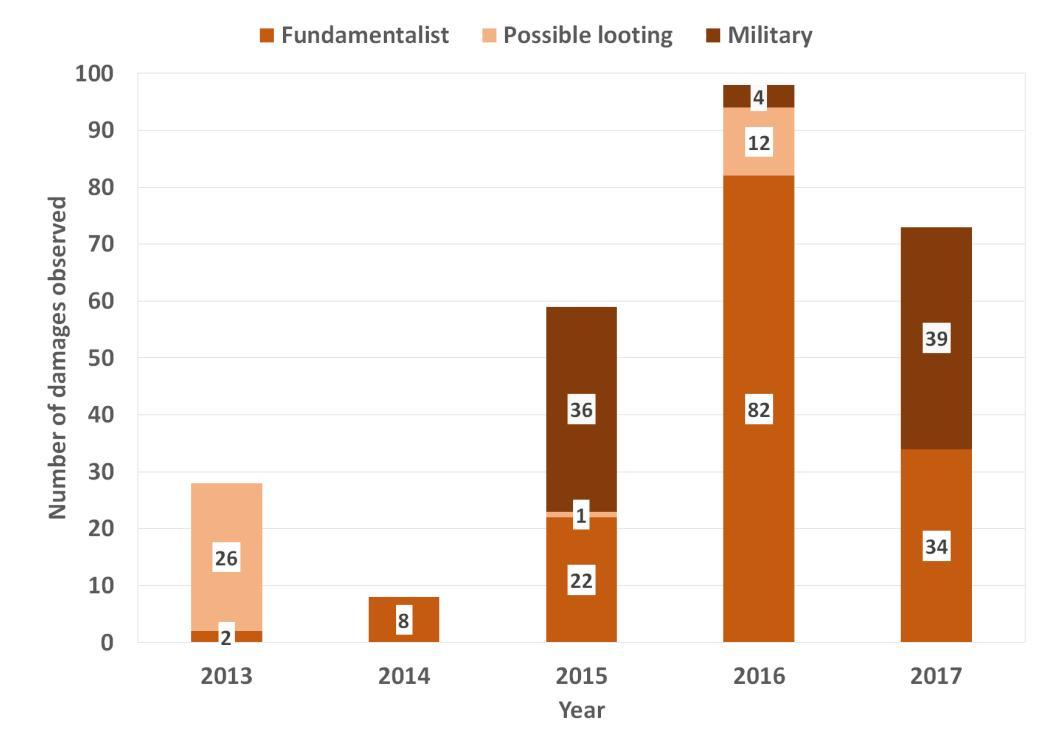
**Figure 12.** Distribution of damage by category observed over the entire period (November 2013–March 2018).

Figure 12 shows that, during 2013–2016, the fundamentalist component of the damage to cultural heritage grew exponentially. This trend follows the sequence of events reported in Table 1 and is directly related to the escalation of ISIL activities in the area. ISIL's cultural heritage devastation started in 2014 when the Mosque of Prophet Jonas was blown up, and continued during 2015 and 2016.

Between 2016 and 2017, the inversion of the fundamentalist damage category trend, and the corresponding increase of the military one, reflects the evolution of the conflict in Iraq, which saw the advance of government forces and the consequent retreat of ISIL militias. This trend can be also found considering the distribution of type of damage, as shown below.

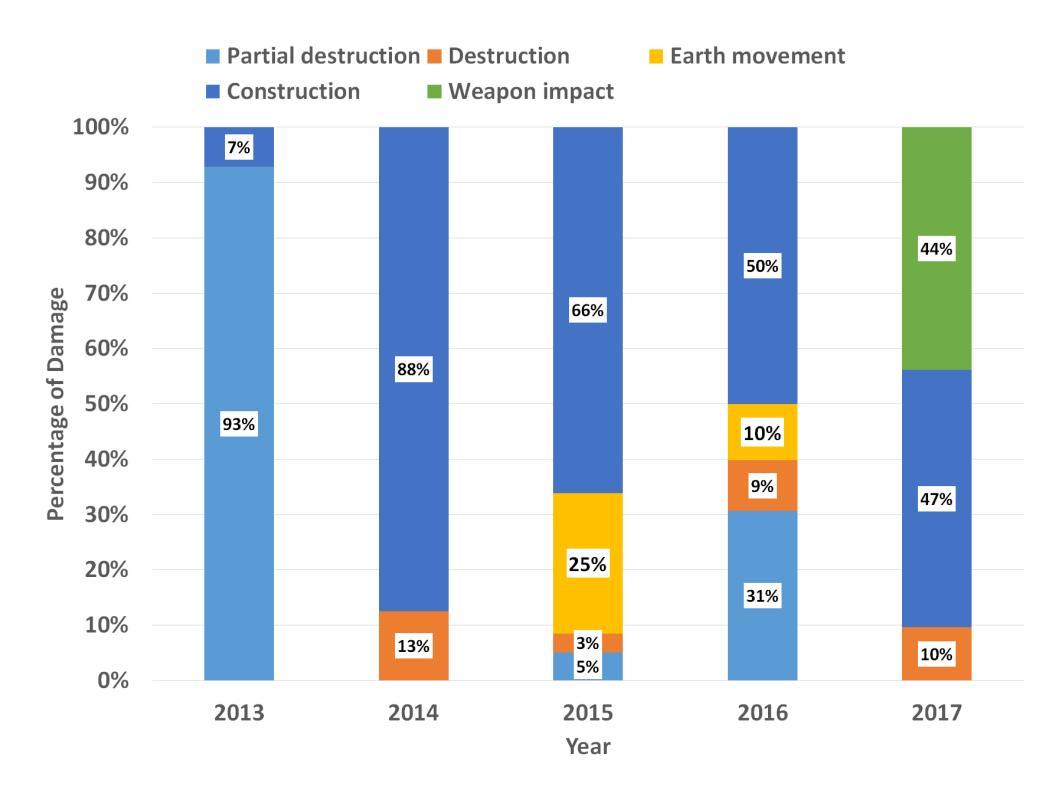
**Figure 13.** Percentage of damage by type observed respect to the total (100%) over the entire period (November 2013–March 2018).

Analyzing the yearly distribution of damage by type, Figure 13 highlights that the predominant component of the damage in 2013, i.e., partial destruction with 93% of the total damage observed, has been completely replaced by the construction type just one year after (2014). The component of construction type damage between 2014 and 2017 reduce its percentage up to reach 47%. In that year, as identified in Figure 13, the starting of armed clashes in the city produced evident components of weapon impact damage type (44%).

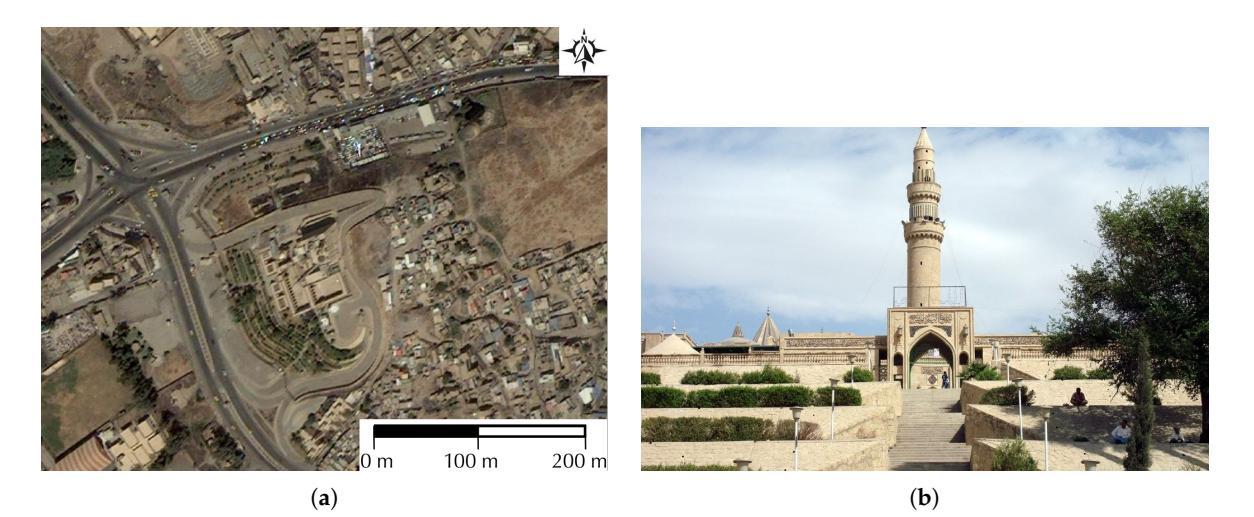
**Figure 15.** Overview of the Nebi Yunus Mosque before the destruction: (**a**) QuickBird, 19 July 2014 ©DigitalGlobe; and (**b**) ground picture in 2013 [74].

This site was severely damaged between July 2014 and April 2016. The first satellite image considered, a Quickbird image of 19 July 2014, shows the status of the Mosque before the attack (Figure 15a). A ground picture dated 2013 shows a ground view of the Mosque before the presence of ISIL within Mosul city (Figure 15b). The main parts of the mosque (such as the main prayer hall, minaret, and dome) were recognizable.

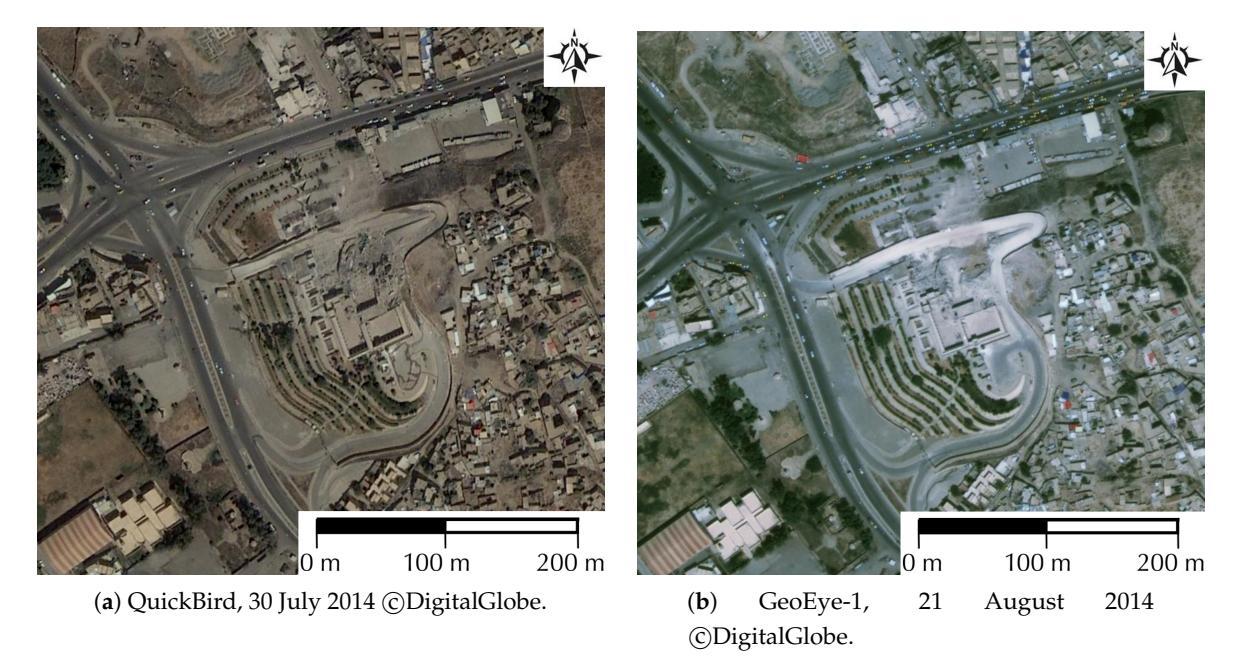
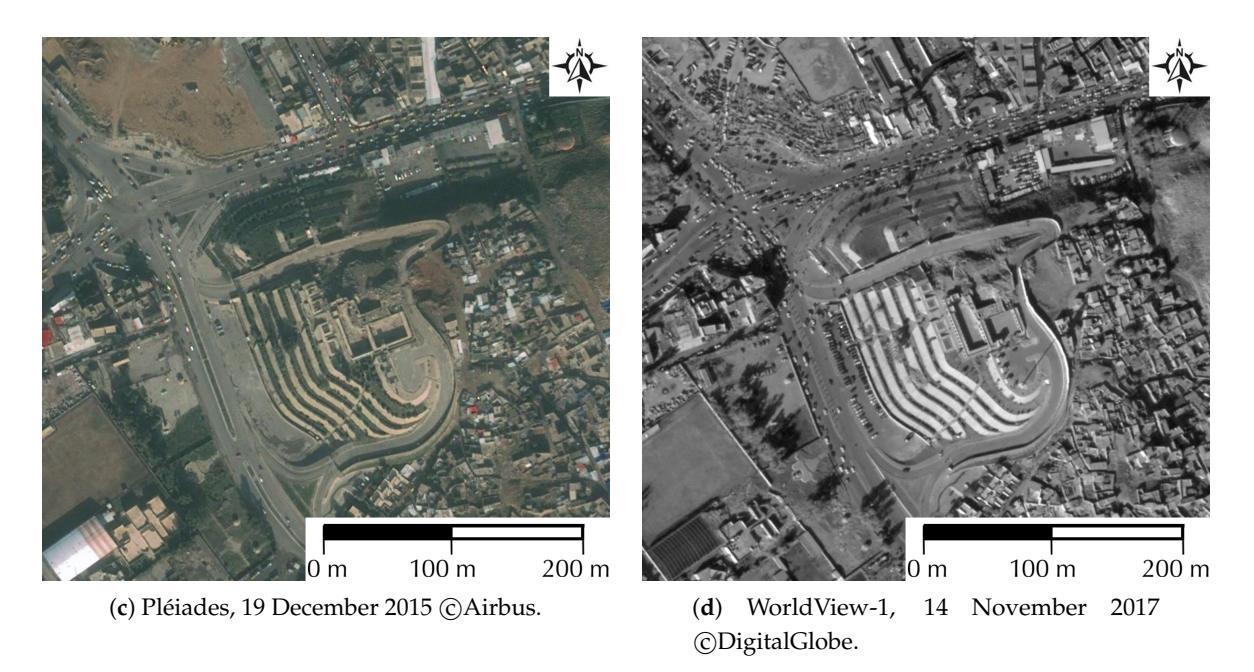
Figure 17. Satellite imagery of the Nebi Yunus Mosque (2014–2017).

Late July 2014, ISIL released a video showing the destruction of Jonah's tomb (Figure 16). In the Quickbird satellite imagery of 30 July 2014, after the explosion, the main parts of the mosque (main prayer hall, minaret, and domes) and some of the secondary parts (ablution and part of the courtyard) have been observed destroyed (Figure 17a). After this destruction, construction equipment, and several earthworks have been observed at the site of the former mosque's prayer hall and its eastside in the GeoEye-1 satellite imagery of 21 August 2014 (Figure 17b).

Besides, in the Pléiades-1 satellite imagery of 19 December 2015, a new secondary entrance has been detected at one side of the access road. The excavations could have been due to gain access to the palace of King Esarhaddon, located under the former mosque, and discovered by ISIL (Figure 17c). In the WorldView-1 satellite imagery of 14 November 2017, a high volume of light utility vehicles starts to be observed at the parking area to the west of the former mosque. In the same image, the secondary entrance appeared to be closed at that time (Figure 17d). Nebi Yunus suffered heavy damage, and possible plundering during the monitoring period. It has not been possible to understand if some cultural artifacts were removed from the mosque before the explosion.

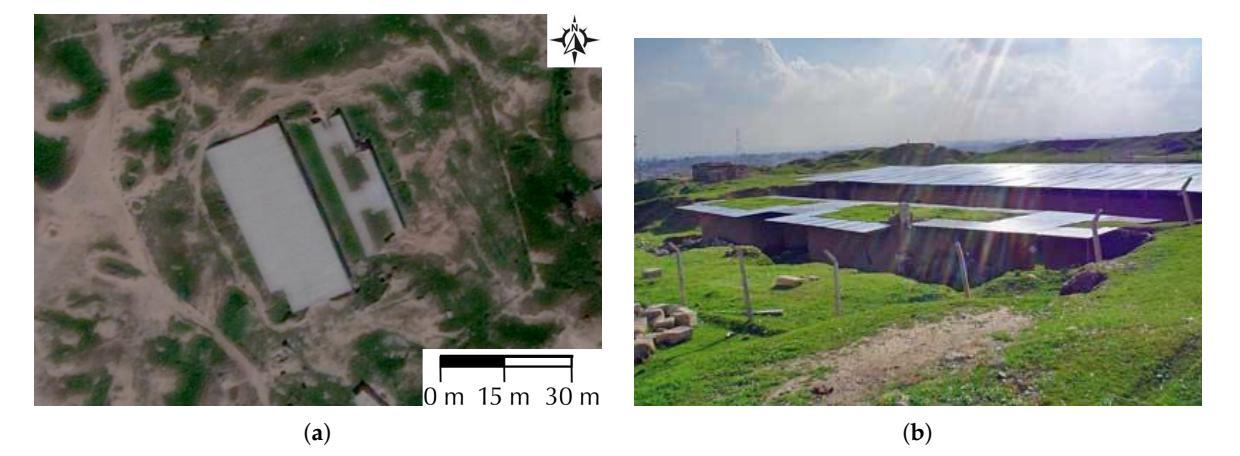
**Figure 19.** Overview of the Sennacherib Palace before the destruction: (**a**) GeoEye-1, 1 April 2016 ©DigitalGlobe; and (**b**) ground picture of Sennacherib's Palace 2011 [75].

On the Kouyunjik hill, about 20 m above the surrounding plain of the ancient site, the remains of the ancient Sennacherib's Palace were located (Figure 18). The palace was destroyed between April and May 2016. Figure 19a shows the Palace before the attacks in a GeoEye-1 image of 1 April 2016, while Figure 19b shows the corresponding ground view before the presence of ISIL within city of Mosul (2011). In the WorldView-2 image of 2 May 2016, the roof that is protecting the site has been removed, but no signs of the explosion have been observed, with largely intact reliefs being left in the open/exposed to the meteorological elements (Figure 20a). Later in the month, as reported in the WorldView-3 image of 21 May 2016, the Palace has been destroyed, probably with explosives. Possible raw materials (former structure frames) have been observed amongst the remaining debris within the site perimeter (Figure 20b). On 11 August 2016, the previously observed raw materials were no longer present (Figure 20c).

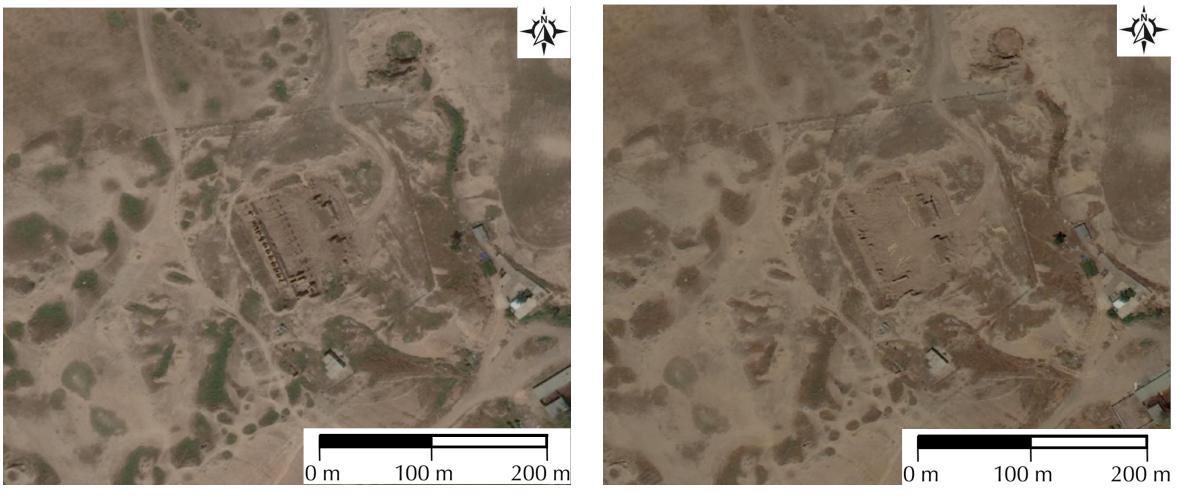
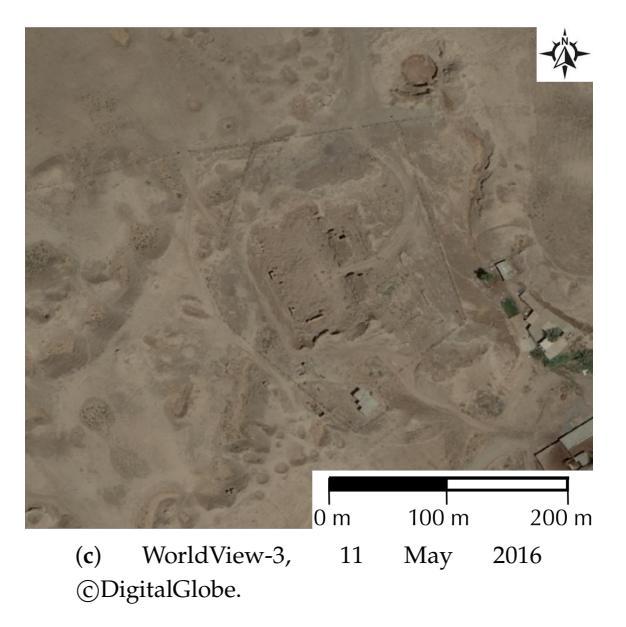
Figure 20. Satellite imagery of Sennacherib Palace (2016).

The Sennacherib's Palace suffered almost total destruction; large parts of the ruins and artifacts have probably been removed from the site and transported to unknown locations.

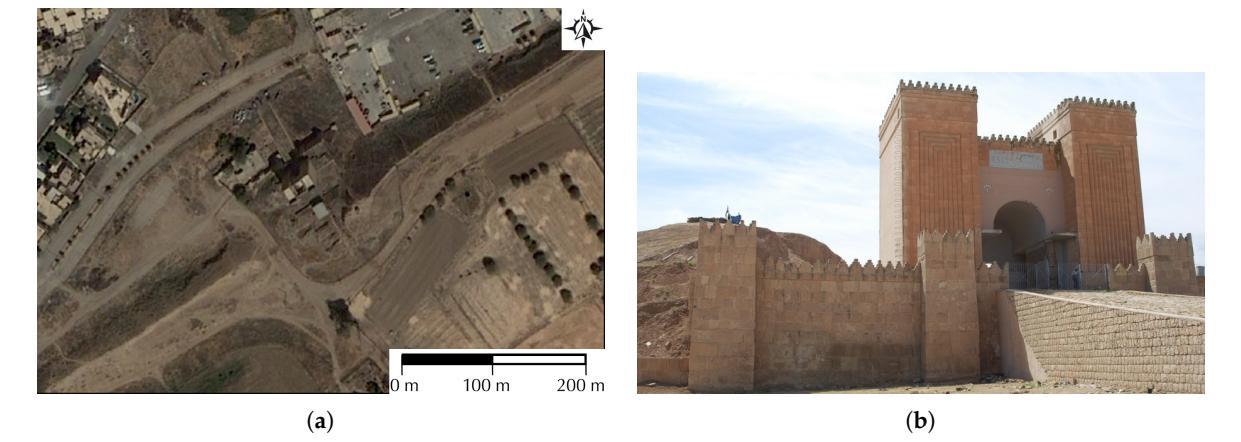
In Figure 22a, a GeoEye-1 image acquired on 21 August 2014 confirms the integrity of the Nergal Gate, as reported in a ground view picture of 2006 (Figure 22b). The access ramp, the ancient rock wall on both sides of the gate, and some pre-existing excavations are visible.

**Figure 22.** Overview of the Nergal Gate before the destruction: (**a**) GeoEye-1, 21 August 2014 ©DigitalGlobe; and (**b**) ground view as seen in 2006 [76].

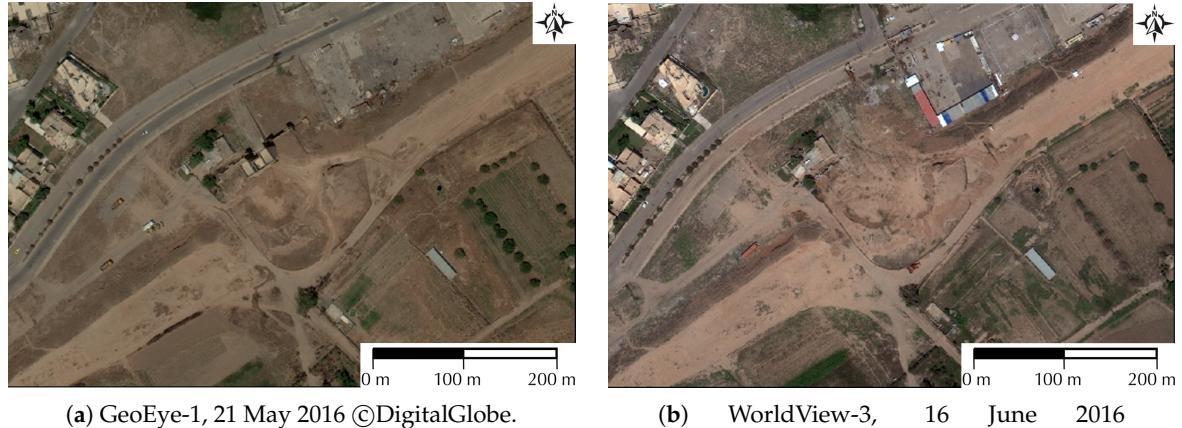
Figure 24. Satellite imagery of Nergal Gate (2016).

The analysis of the satellite image acquired on 21 May 2016 (Figure 24a) confirmed the presence of heavy equipment vehicles in the area at that time. The ruins of the gate and the pre-existing excavations have been demolished.

In June 2016, the site perimeter appeared leveled and covered with earth, as documented by the WorldView-3 satellite image acquired on 16 June 2016. Only the remains of the former access ramp were visible. No vehicle or human activity has been observed around at that time (Figure 24b).

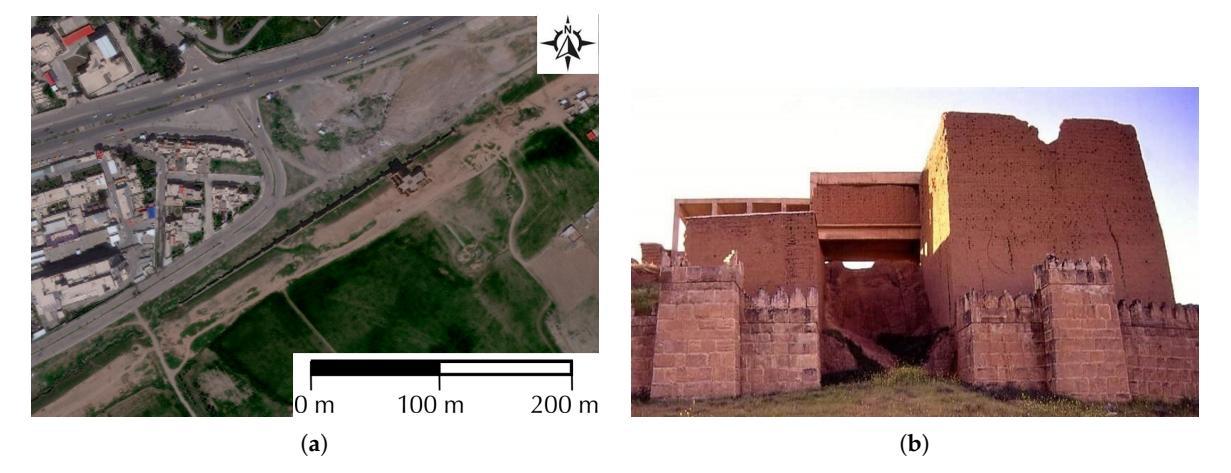
Adad Gate was one of the former gates of Nineveh, located within the northern site perimeter (Figure 25), where ancient ruins have been severely damaged or destroyed during the monitoring period. The Adad Gate ruins and the ancient rock wall were visible on both sides of the gate in the GeoEye-1 satellite imagery dated 1 April 2016 (Figure 26a) and in the ground picture (Figure 26b) acquired before the ISIL presence in the area (before 2013).

**Figure 26.** Overview of Adad Gate before the destruction: (**a**) GeoEye-1, 1 April 2016 ©DigitalGlobe; and (**b**) ground view (before 2013) [77].

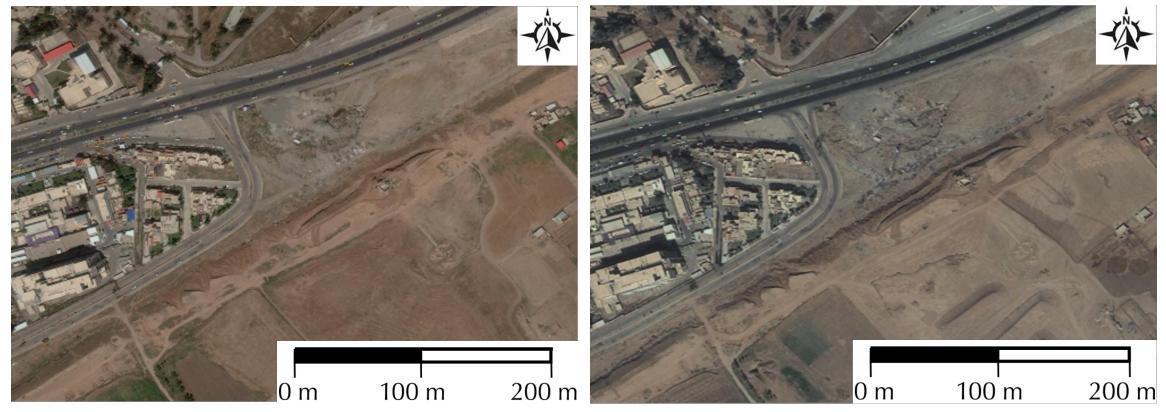
Figure 27. Satellite imagery of Adad Gate (2016).

In the WorldView-3 image on 2 May 2016, the ruins of the gate have been partially demolished and an entire section of the ancient rocky wall has been destroyed, leveled, and probably covered with earth (Figure 27a).

In the Pléiades-1 satellite imagery of 9 October 2016, some of the rocky wall debris previously observed have been removed from the area and new revetments have been raised (Figure 27b). Figure 29 reports a comparison of two WorldView-2 satellite images dated November 2013 and May 2018 of the northern limit of Nineveh Site, where Adad and Nergal Gates were located. It is evident that the area suffered near total destruction during the ISIL presence; large parts of the ruins and artifacts have been probably removed from the site and transported to unknown locations during the destruction process.

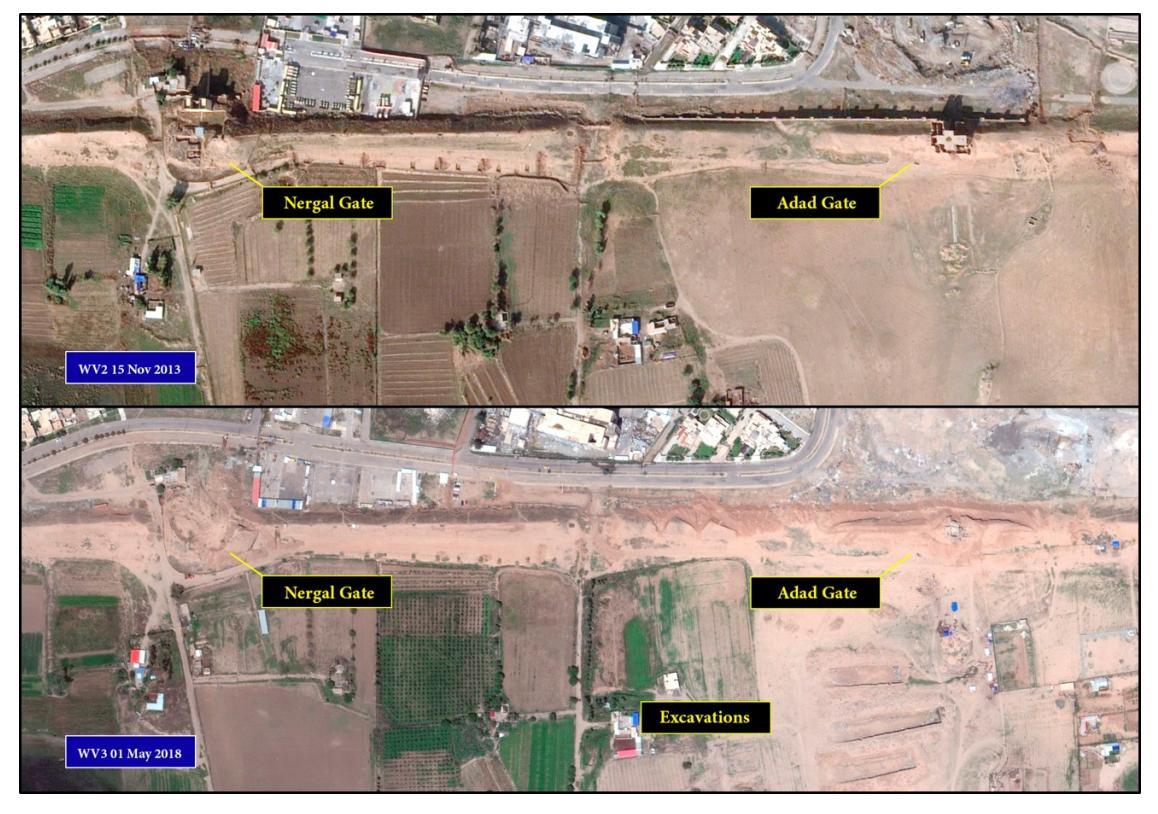
**Figure 29.** Visual comparison of the damages produced on Nergal and Adad Gates sites between 15 November 2013 (WorldView-2) and 1 May 2018 (WorldView-2), ©DigitalGlobe.

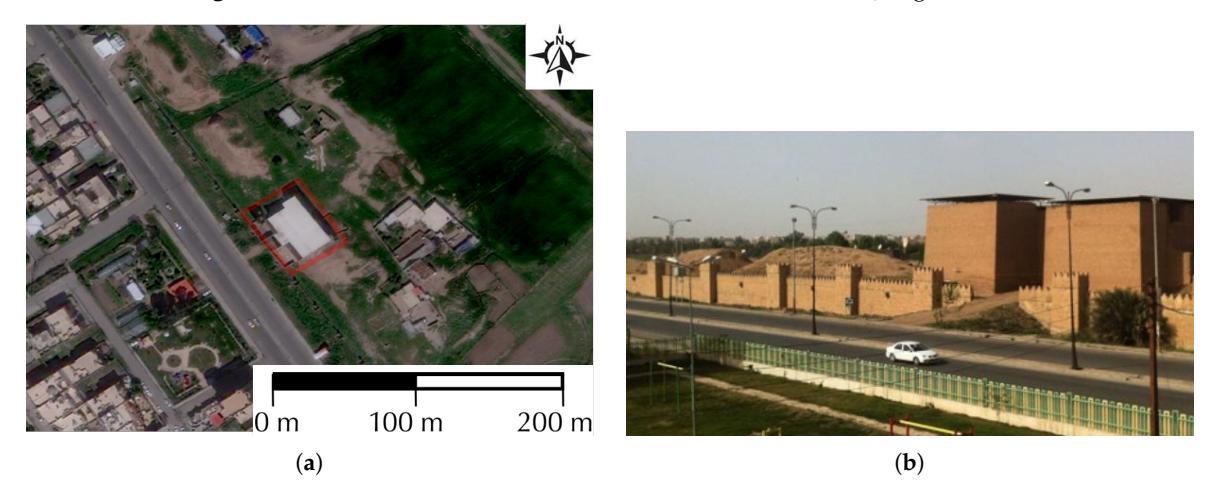
Mashki Gate was one of the former gates of Nineveh, located within the western site perimeter (Figure 30), where ancient ruins have been severely damaged or destroyed during the monitoring period. In the GeoEye-1 imagery dated 1 April 2014 and in the ground picture dated before the presence of ISIL in Mosul (Figure 31a,b, respectively), Mashki Gate ruins and the ancient rock wall were visible and in good status, at both sides of the gate.

**Figure 31.** Overview of Mashki Gate before the destruction: (**a**) GeoEye-1, 1 April 2016 ©DigitalGlobe; and (**b**) ground view (April 1990) [77].

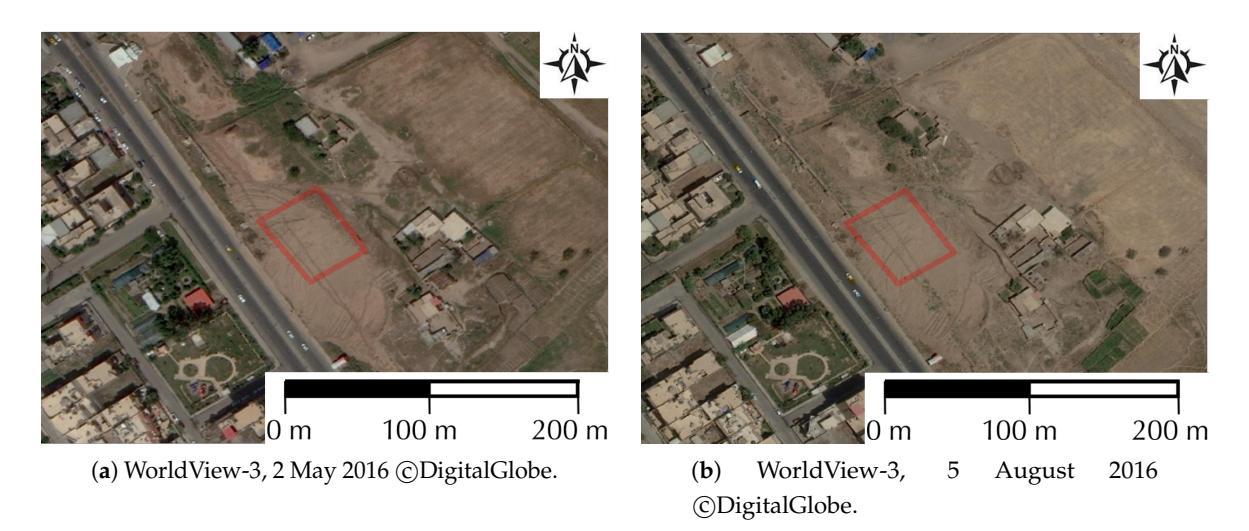
However, in Aug 2016, two sections of the destroyed walls have been recovered by removing the nearby earth (Figure 32b).
