Article Multi-Parameter Optical Monitoring Solution Applied to Underground Medium-Voltage Electric Power Distribution Networks

Abstract: This work presents a multi-parameter optical fiber monitoring solution applied to an underground power distribution network. The monitoring system demonstrated herein uses Fiber Bragg Grating (FBG) sensors to measure multiple parameters, such as the distributed temperature of the power cable, external temperature and current of the transformers, liquid level, and intrusion in the underground manholes. To monitor partial discharges of cable connections, we used sensors that detect radio frequency signals. The system was characterized in the laboratory and tested in underground distribution networks. We present here the technical details of the laboratory characterization, system installation, and the results of 6 months of network monitoring. The data obtained for temperature sensors in the field tests show a thermal behavior depending on the day/night cycle and the season. The temperature levels measured on the conductors indicated that in high-temperature periods, the maximum current specified for the conductor must be reduced, according to the

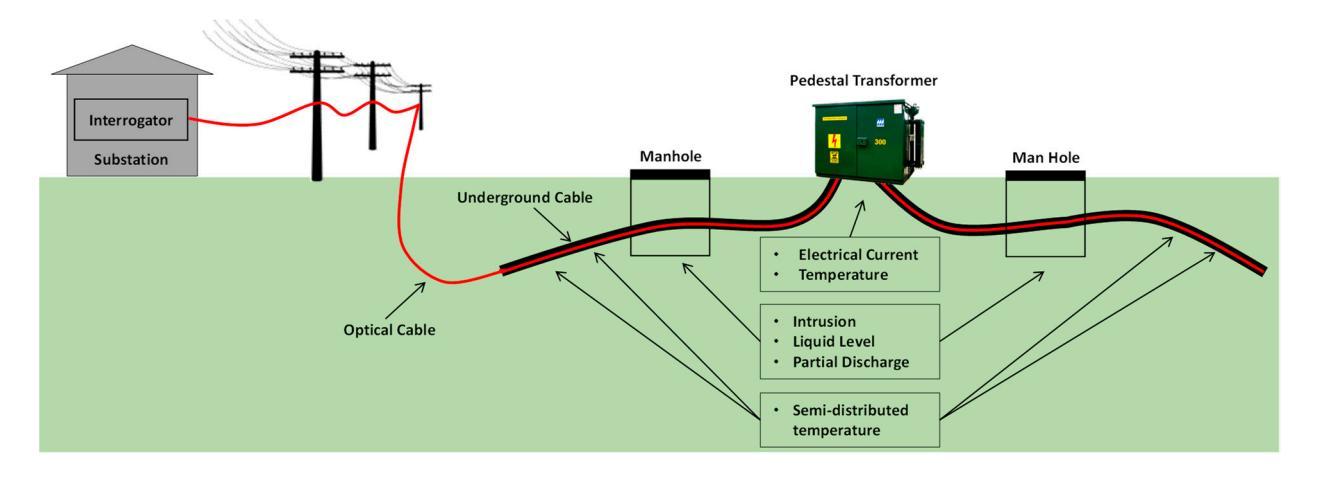
Figure 1. The proposed monitoring system.

Figure 1 shows the generic idea of the proposed monitoring system. The interrogator is placed in a substation control room some kilometers away from the underground distribution lines. Optical aerial cables belonging to the utility company are used to transport the interrogator signals to monitor underground distribution lines and elements.

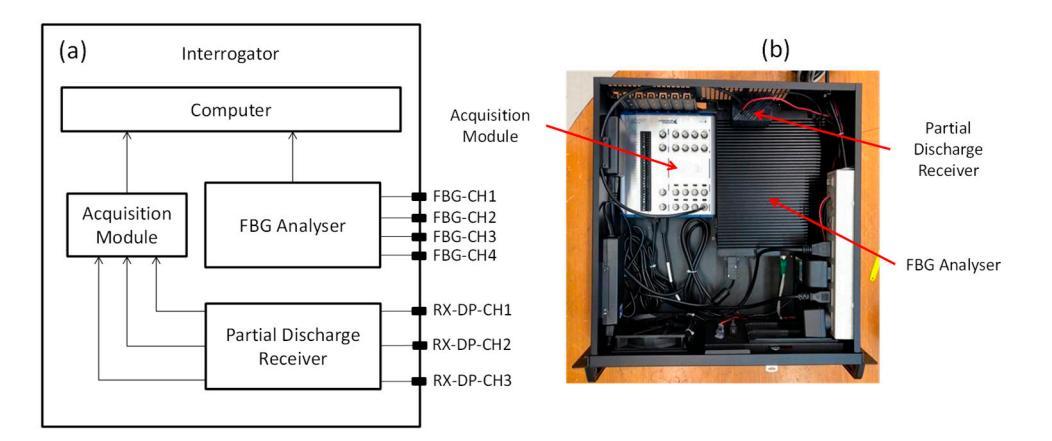
Figure 2. (a) Interrogator block diagram and (b) interrogator modules.

Figure 2a shows the block diagram of the interrogator of the monitoring system. As previously mentioned, the monitoring system is based on FBG and PD-LD technologies. In this way, the interrogator is composed of two different approaches. For FBG sensors, we used a commercial module (Hyperion si155 supplied by LunaInc, Roanoke, VA, USA) based on tunable laser technology. This module has four channels, a sweep rate of 1 kHz, and works in the spectral range from 1500 to 1600 nm. The PD-LD module is composed of a 155 MHz optical receiver followed by an RF detector based on an AD8310 integrated circuit and a DAQ board (DAQ-USB-6361 supplied by National Instruments, Austin, TX, USA). Both modules send the data to the main computer, where the data are analyzed and recorded by a self-developed LabVIEW application. Figure 2b shows the modules of the interrogator.

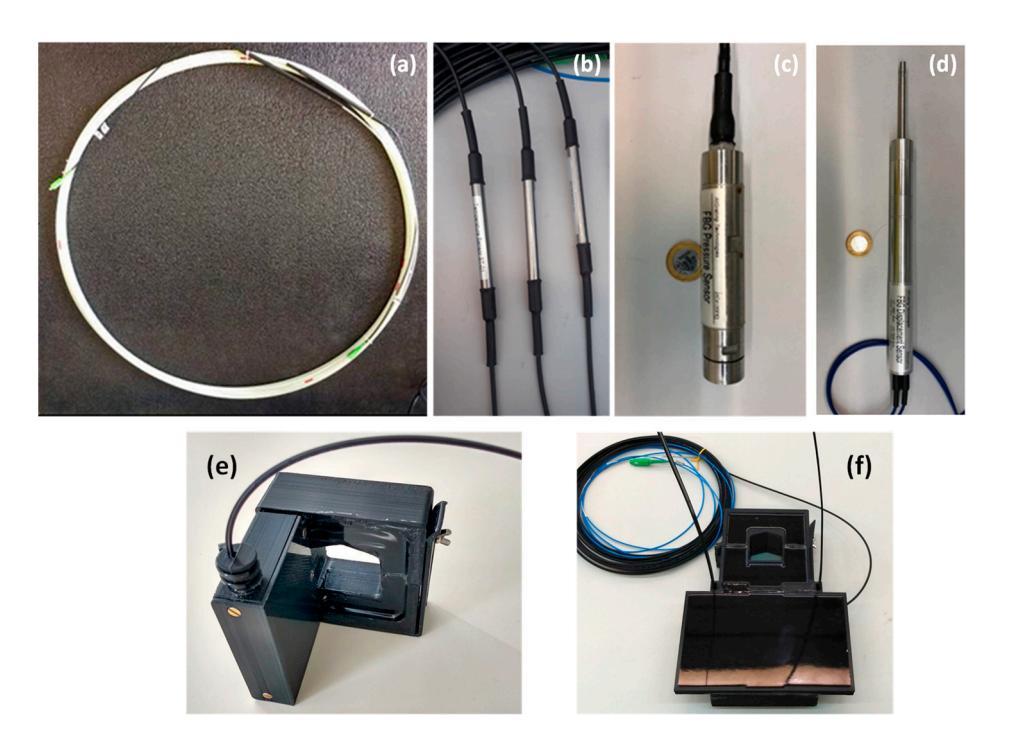
Figure 3. (a) Semi-distributed temperature sensor, (b) temperature sensor, (c) liquid level sensor, (d) intrusion sensor, (e) current sensor, and (f) partial discharge sensor.

The FBG array sensor (Figure 3a) was used for the ampacity evaluation of the mediumvoltage conductors. The sensor array was designed to use optical fiber coated with glass fiber-reinforced polymer (GFRP) to withstand the installation process. To increase the mechanical strength of the FBG array, it was installed in a micro duct. The sensor array used has 2 m FBG spacing.

The FBG temperature sensor was used to measure the external temperature of the pad-mounted transformer. Figure 3b shows the temperature sensor packing.

The FBG liquid level (Figure 3c) was designed to measure up to 2 m liquid height. In addition, the sensor has an FBG temperature sensor used to compensate for the liquid level measurement for the environmental temperature effects. In addition, the FBG temperature sensor allows the evaluation of the temperature in the manhole.

The intrusion sensor is based on the FBG displacement sensor fixed on the manhole entrance to detect the manhole cover displacement. Both liquid level and displacement FBG sensors have been demonstrated in previous field installations [27]. Figure 3d shows the displacement of the FBG sensor packaging.

The current sensor is used to measure the current on the secondary windings (low voltage) of pad-mounted transformers. The sensor package (Figure 3e) is based on a single FBG attached to a Terfenol-D bar as a sensing element [28]. This set is placed in a specially designed optical tray, which in turn is coupled to a package containing two pieces of nanocrystalline ferromagnetic material to concentrate the magnetic field from the electrical current through the conductor. A gap between the two pieces of the nanocrystalline material enables the magnetic field to expand and excite the magnetostrictive bar of Terfenol-D. This setting allows installing the proposed sensor in existing conductors without interrupting the energy deployment. In other words, this design allows using the proposed current sensor in the same way as a conventional current clamp meter. Another advantage is the separation of the magnetic field concentrator packaging (the nanocrystalline holder) from the optical tray where the sensing element is present. Compared with [28], in this new configuration of the sensor, an applied bias was introduced by a permanent magnet, which enables reading the waveform without frequency doubling.

The PD-LD sensor (Figure 3f) was previously demonstrated in [16]. The sensor unit consists of an antenna connected directly to a semiconductor laser diode (LD). In previous works, a power-over-fiber technique was used to properly provide the bias polarization of the laser to have more PD sensitivity. In the current work, we used a current transformer clamp to the medium-voltage cable to provide laser diode bias. The antenna we chose for the sensor obeyed the following requirements: reduced dimensions adjusted for installation next to the medium-voltage connectors, resonance frequency within the spectrum band of the PD measurements (100 MHz), and the largest bandwidth possible. The impedance was adjusted for laser impedance matching. The sensor also has good directivity and it is electrically isolated. The antenna has the following characteristics: dielectric type = FR4 (print circuit), dielectric thickness = 1.6 mm, line width = 1 mm, lines separation = 1 mm, and the total antenna length = 3916 mm. The sensor was packaged with epoxy resin, which provides good mechanical and thermal resistance and electrical isolation. The connection of PD-LD sensors in the same fiber of the FBG sensors each laser of PD-LD sensor operates in a specific coarse wavelength division multiplexing (CWDM) wavelength. Each PD-LD sensor is connected to the fiber using an add-drop multiplexer.

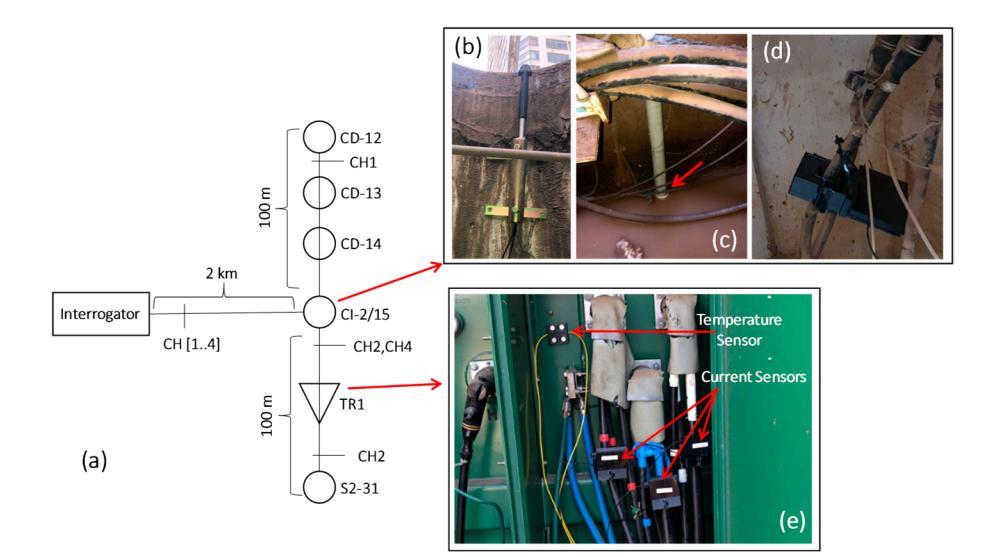
Figure 4. Downtown underground network monitoring, (**a**) single-line diagram, (**b**) intrusion sensor, (**c**) liquid level sensor, (**d**) PD-LD sensor, and (**e**) temperature and current sensors.

Figure 4a shows the single-line diagram of the monitoring system installed at the downtown underground network and the images of the sensors installed in the distribution network. The interrogator was installed in an electrical substation about 2 km from the sensor installation site. The link that connects the interrogator to the sensors network uses aerial optical cables from the electric utility company. One hundred temperature sensors were installed, divided into two FBG array sensors of 100 m each, monitoring 200 m of underground distribution network. An FBG array is responsible for monitoring the path between CI-2/15 and CD-12, passing through CD-14 and CD-13. The other FBG array monitors the path from CI-2/15 to the TR1 transformer. In addition to the duct temperature sensors, liquid level, intrusion, and partial discharge sensors were also installed on CI-2/15 and current sensors on the TR1 pedestal transformer.

Figure 4b shows the displacement sensor installed below the manhole door, while Figure 3c shows the liquid level sensor installed inside a tube in the manhole wall. Figure 3d is a picture of the PD-LD sensor installed near a medium-voltage connector, and finally, in Figure 3e, it is possible to see the temperature sensor fixed on the pad-mounted transformer wall, as well as the current sensors plugged into the low-voltage conductors of phases A, B, and C.

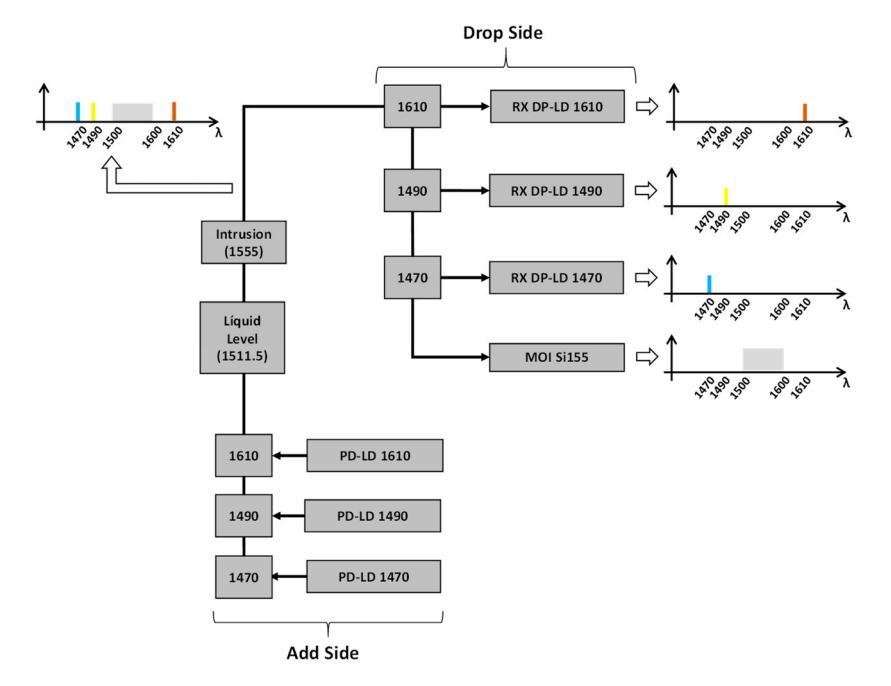
Figure 5. Channel 3 optical configuration with add-drops multiplexing (add-side) and demultiplexing (drop-side).

Due to the limitation of the number of optical fibers and considering the spectral window of the FBG interrogator (1500–1600 nm) in this installation, it was necessary to use additional optical components in the optical network. Add-drops were used to allow the partial discharge sensors (operating in 1470 nm, 1490 nm, and 1610 nm) to share the same optical fiber as the intrusion and liquid level sensors (channel 3 of Table 1). In other words, add-drops were used for the multiplexing of the PD optical signals. Figure 5 shows the channel 3 optical configuration.

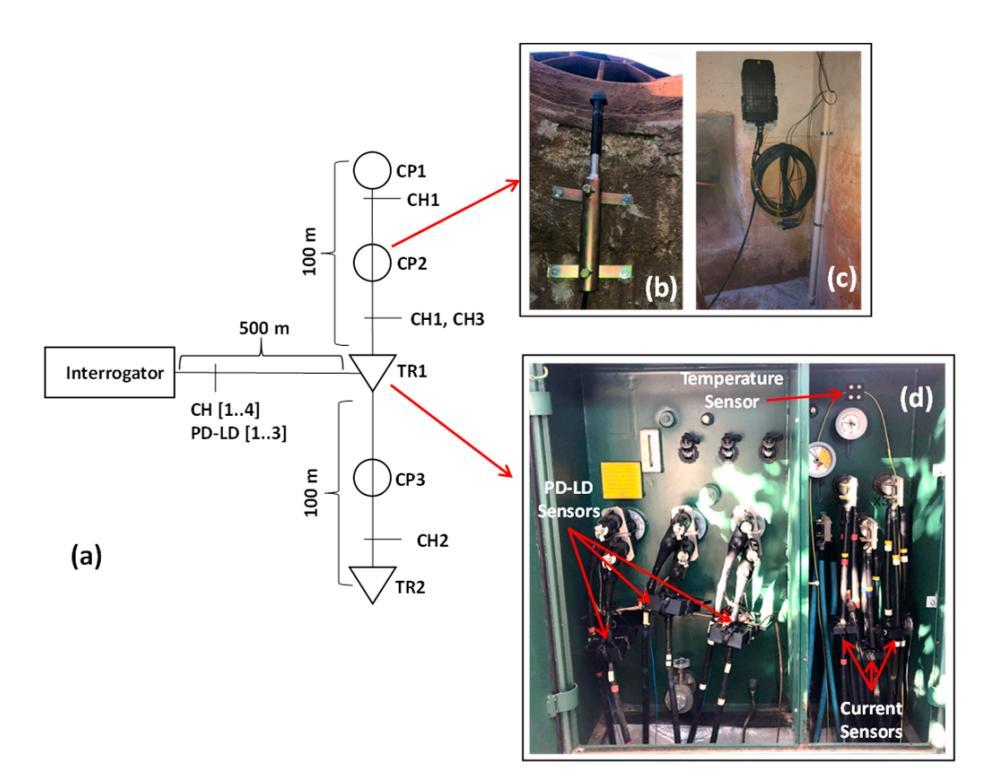
Figure 6. Condominium underground network monitoring, (a) single-line diagram, (b) intrusion sensor, (c) liquid level sensor, (d) PD-LD sensor, temperature, and current sensors.

The single-line diagram of the monitoring system is shown in Figure 6a and the sensor photos in each installation place are shown in Figure 6b–d. In Figure 6b, we show the

intrusion sensor; in Figure 6c, the liquid level sensor; and in Figure 6d, the temperature sensors, the PD-LD, and the current sensors. The interrogator was installed in a control room 500 m from the sensor installation place. As in the previous installation, one hundred temperature sensors were installed, divided into two FBG array sensors of 100 m each, monitoring 200 m of underground distribution. One of the FBG arrays is responsible for monitoring the temperature of the path between the TR1 point and the CP1 point, passing through the CP2 point. The other FBG array monitors the temperature from the TR1 to the TR2 points, passing through the CP3 point. The liquid level and intrusion sensors were installed in the CP2 point, and partial discharge, current, and temperature sensors were installed on the TR1 pad-mounted transformer.

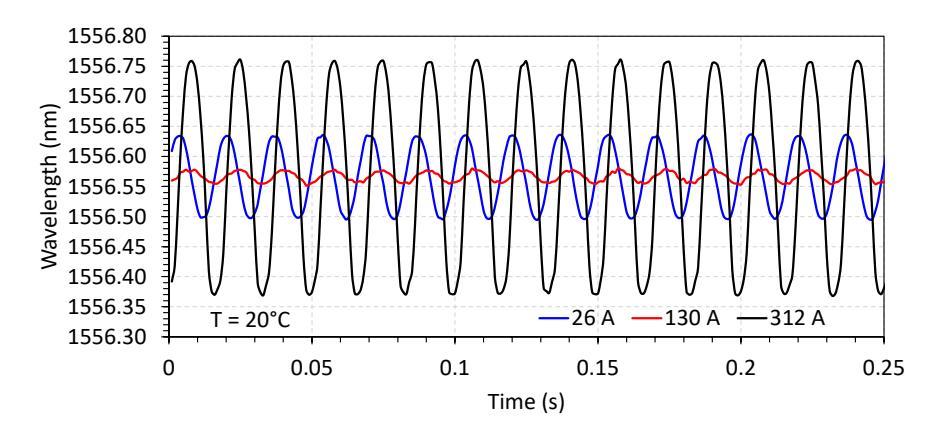
Figure 7. Optical response of FBG current sensor S1 for a fixed temperature of 20 °C and varying the current. In the plot, the current was set to 26, 130, and 312 A.

The characterization of the FBG current sensor follows the procedure previously reported in [28]. In this configuration of the sensor, however, the applied bias by a permanent magnet enables the recovery of the waveform without frequency doubling, as can be seen in Figures 7 and 8. Three optical sensors named S1, S2, and S3 were fabricated and characterized to be applied in each phase of the conductor. Figure 7 shows the response of the current sensor S1 in terms of wavelength for a fixed temperature of 20 °C and varying currents (values of 26, 130, and 312 A, in the plot). In Figure 8, the current was fixed (illustrated for 130 A), and the temperature was varied to 20, 40, and 60 °C.

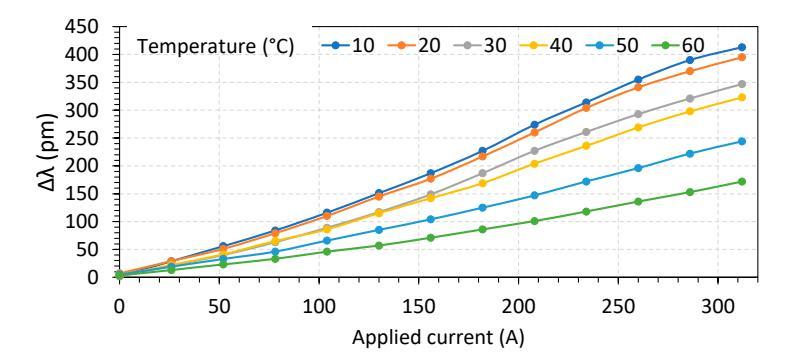
Figure 9. Parameter $\Delta\lambda$ as a function of temperature and applied current.

The characterization was performed by recovering the wavelength waveforms and obtaining the $\Delta\lambda$ and λ min for temperatures varying from 10 °C to 60 °C, in steps of 10 °C, and varying the current from 0 to 312 A in steps of 26 A. The results for sensor S1 are shown in Figure 9 for $\Delta\lambda$ and in Figure 10 for λ min.

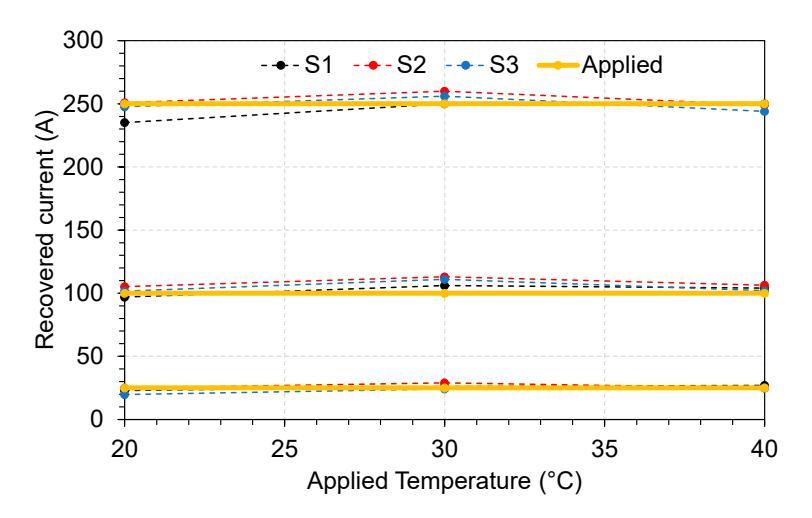
Figure 11. Recovered current for different applied temperatures.

All three sensors S1, S2, and S3 were tested by applying different currents and temperatures using the inverse procedure described in [28]. The currents were set to 25, 100, and 250 A and temperatures to 20, 30, and 40 °C. After applying the mentioned currents and temperatures, the values of $\Delta\lambda$ and λ min were used to calculate the current and temperature. In Figure 11, we show the recovered current values for different applied temperatures. All three sensors responded properly in the tested range and slight values of currents were recovered. We observed that one of the causes of this variation is the positioning of the cable inside the sensor, as there is a gap in the magnetic core. The sensor design was made for a large cable compared with the one used in the laboratory.

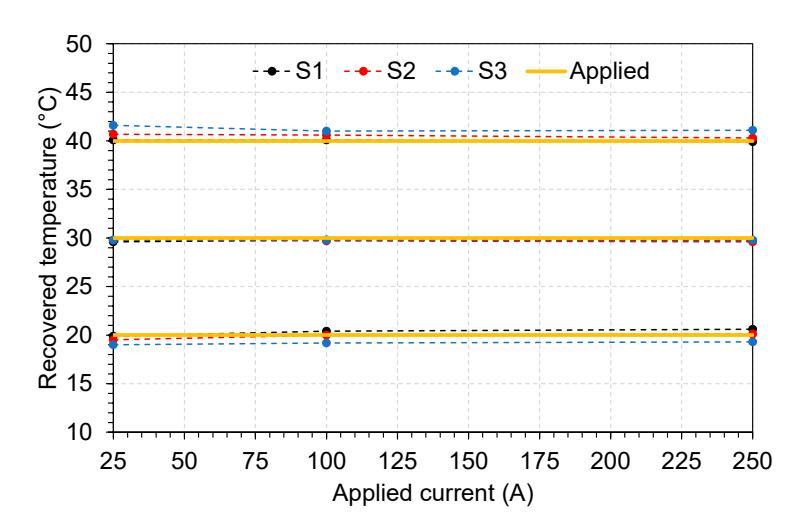
Figure 12. Recovered temperature for different applied currents.

In Figure 12, we plot the recovered temperature for different applied currents. All three sensors show good behavior, with 92% of the recovered values lying within ± 1 °C.

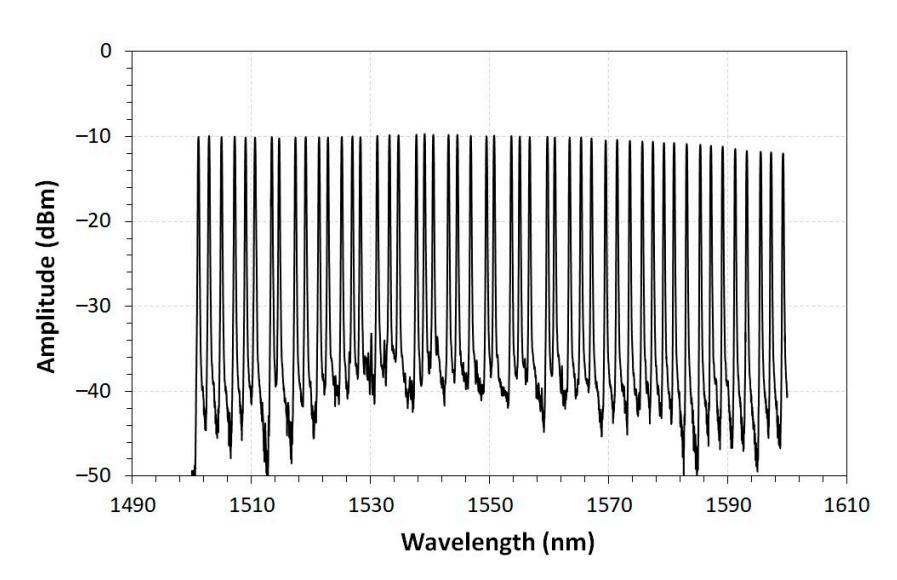
Figure 13. FBG array spectrum with 50 points of temperature measurement.

The characterization of the commercial FBG array was obtained by using an FBG interrogator. The FBG array spectrum with 50 peak wavelengths is shown in Figure 13. As can be seen, the 50 FBGs inscribed in the FBG fiber array are almost equally spaced by 2 nm, starting from 1500.5 nm to 1598.5 nm. The spectrum is well balanced with an almost flat response with a maximum deviation of 2.7 dB in the entire range.

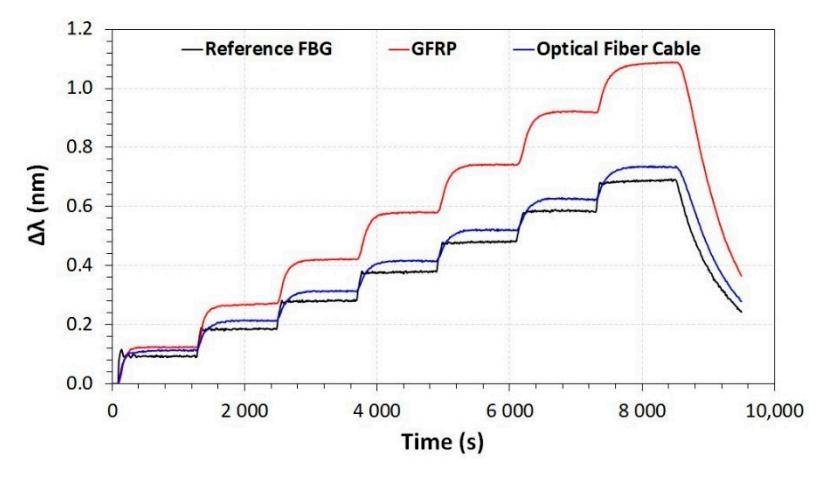
Figure 14. Wavelength shifting as a function of elapsed time for different FBG array cables.

The characterization proceeded with the measurements of the wavelength shifting with the applied temperature inside a climatic chamber. The temperature was varied from 0 to 70 °C. Inside the climatic chamber, two FBG array cables were tested, one with GFRP and the other inside a conventional optical fiber cable. A reference FBG was also used as a comparison. Figure 14 shows the results of the wavelength shift as a function of elapsed time for these different FBG array cables and reference FBG. As can be seen, the reference FBG and the FBG array in a conventional optical fiber cable have close wavelength shift results, with the FBG array having a slower heating process. On the other hand, the FBG array with GFRP resulted in higher wavelength shifting—in other words, the GFRP FBG array has greater temperature sensitivity.

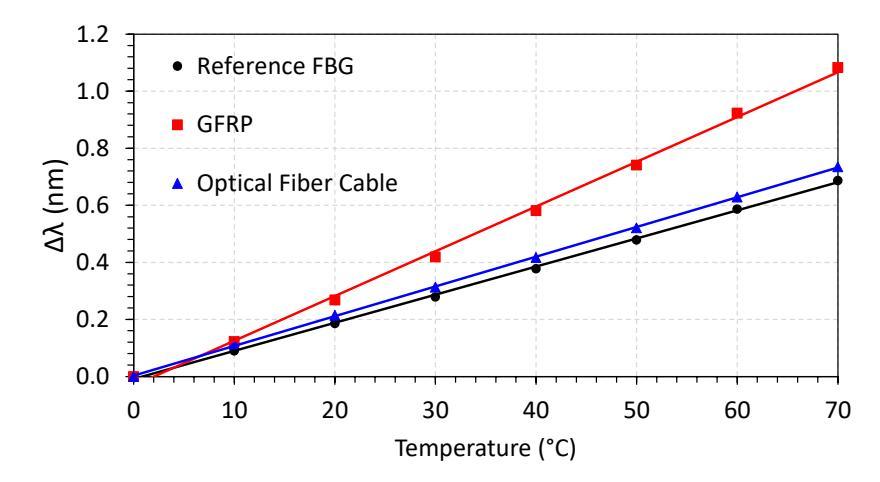
Figure 15. Wavelength shifting as a function of temperature for different FBG array cables.

This fact can be better understood by referencing Figure 15. In this figure, the wavelength shifting is displayed as a function of applied temperature after stabilization time. As can be seen, the reference and optical fiber cable have almost the same behavior, while the GFRP has a higher angular coefficient (sensitivity). The sensitives are 0.0098, 0.010, and 0.015 nm/°C for the reference FBG, optical fiber cable, and GFRP FBG array cable, respectively.

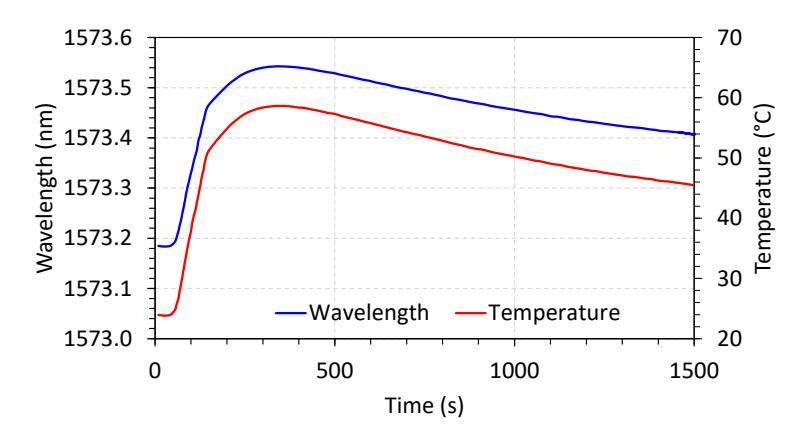
Figure 16. Wavelength displacement and correspondent temperature as a function of time.

The punctual temperature sensor was characterized using a thermal cycle of heating and natural cooling. The wavelength shifting was compared with a reference temperature sensor (thermocouple), and the result is shown in Figure 16.

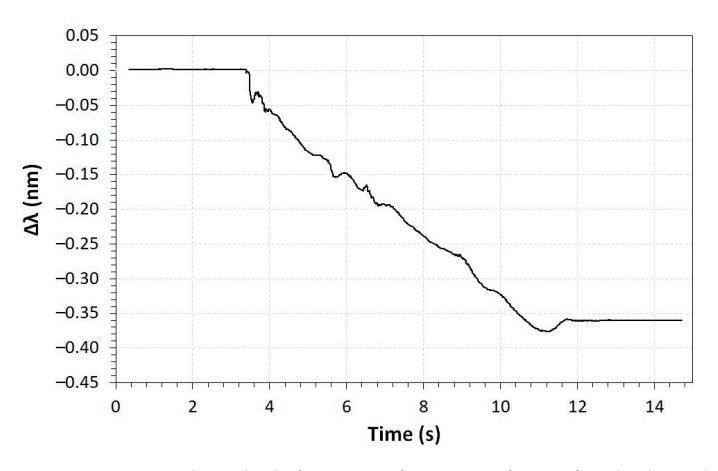
Figure 17. Wavelength shifting as a function of time for the liquid level sensor.

Another characterized sensor was the liquid level sensor, in which the wavelength shifts as a function of time when increasing the water level from 0 to 1.5 m, as is shown in Figure 17. The wavelength shifting is negative and reaches -0.36 nm for a water column level of 1.5 m.

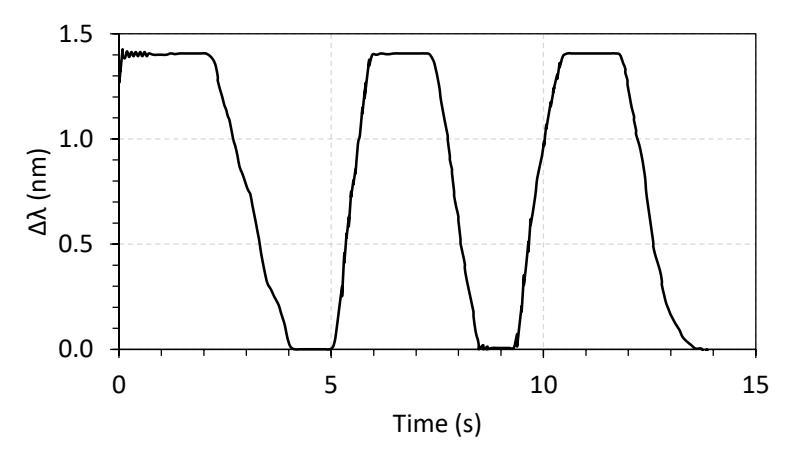
Figure 18. Wavelength shifting as a function of time for the intrusion sensor.

Finally, the intrusion sensor was tested by performing three displacement compressions of 50 mm, resulting in a wavelength shift of 1.4 nm, as shown in Figure 18. This wavelength shifting is more than sufficient to detect a state of intrusion during an opening of the manhole. This sensor will work through threshold detection. In other words, if the initial wavelength shifts more than a predefined value, an intrusion is reported.

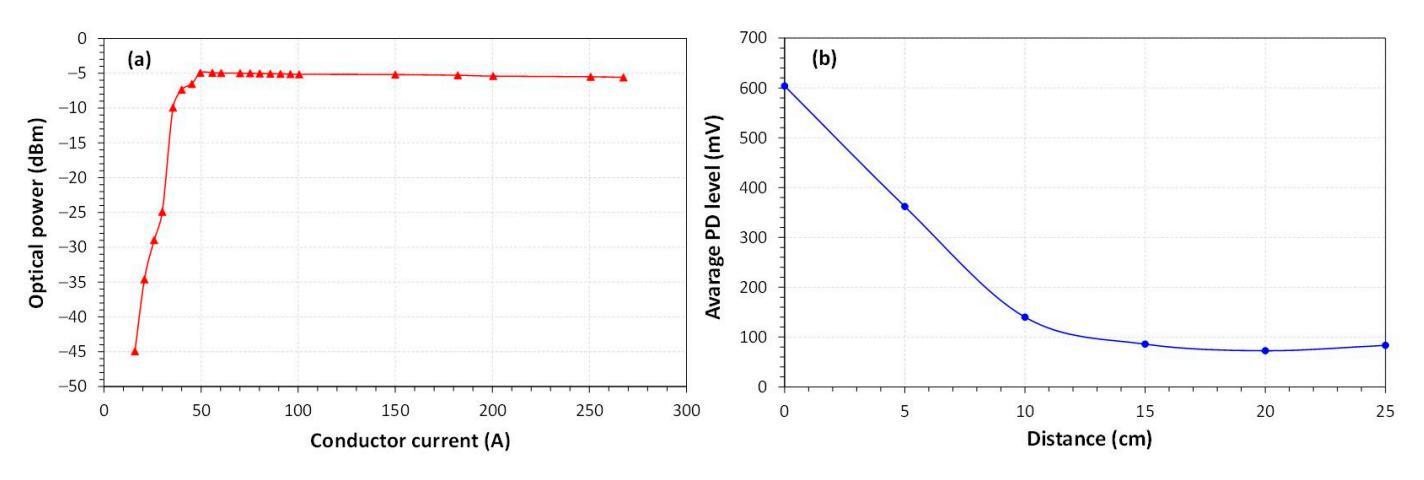
Figure 19. PD-LD sensor behavior: (**a**) optical power as a function of conductor current; (**b**) average PD level as a function of distance.

The homemade PD-LD sensor was characterized in terms of optical power as a function of conductor current and in terms of average PD level as a function of the distance of the PD source. As shown in Figure 19a, the sensor will be operational if the conductor current is above 50 A, resulting in a constant optical power emission of -5 dBm. The sensor operates up to 50 cm from the PD source (in the air, with no obstacles), as shown in Figure 19b. Therefore, the distance from the suspicious PD source to the sensor must be taken into account where the sensor is placed.

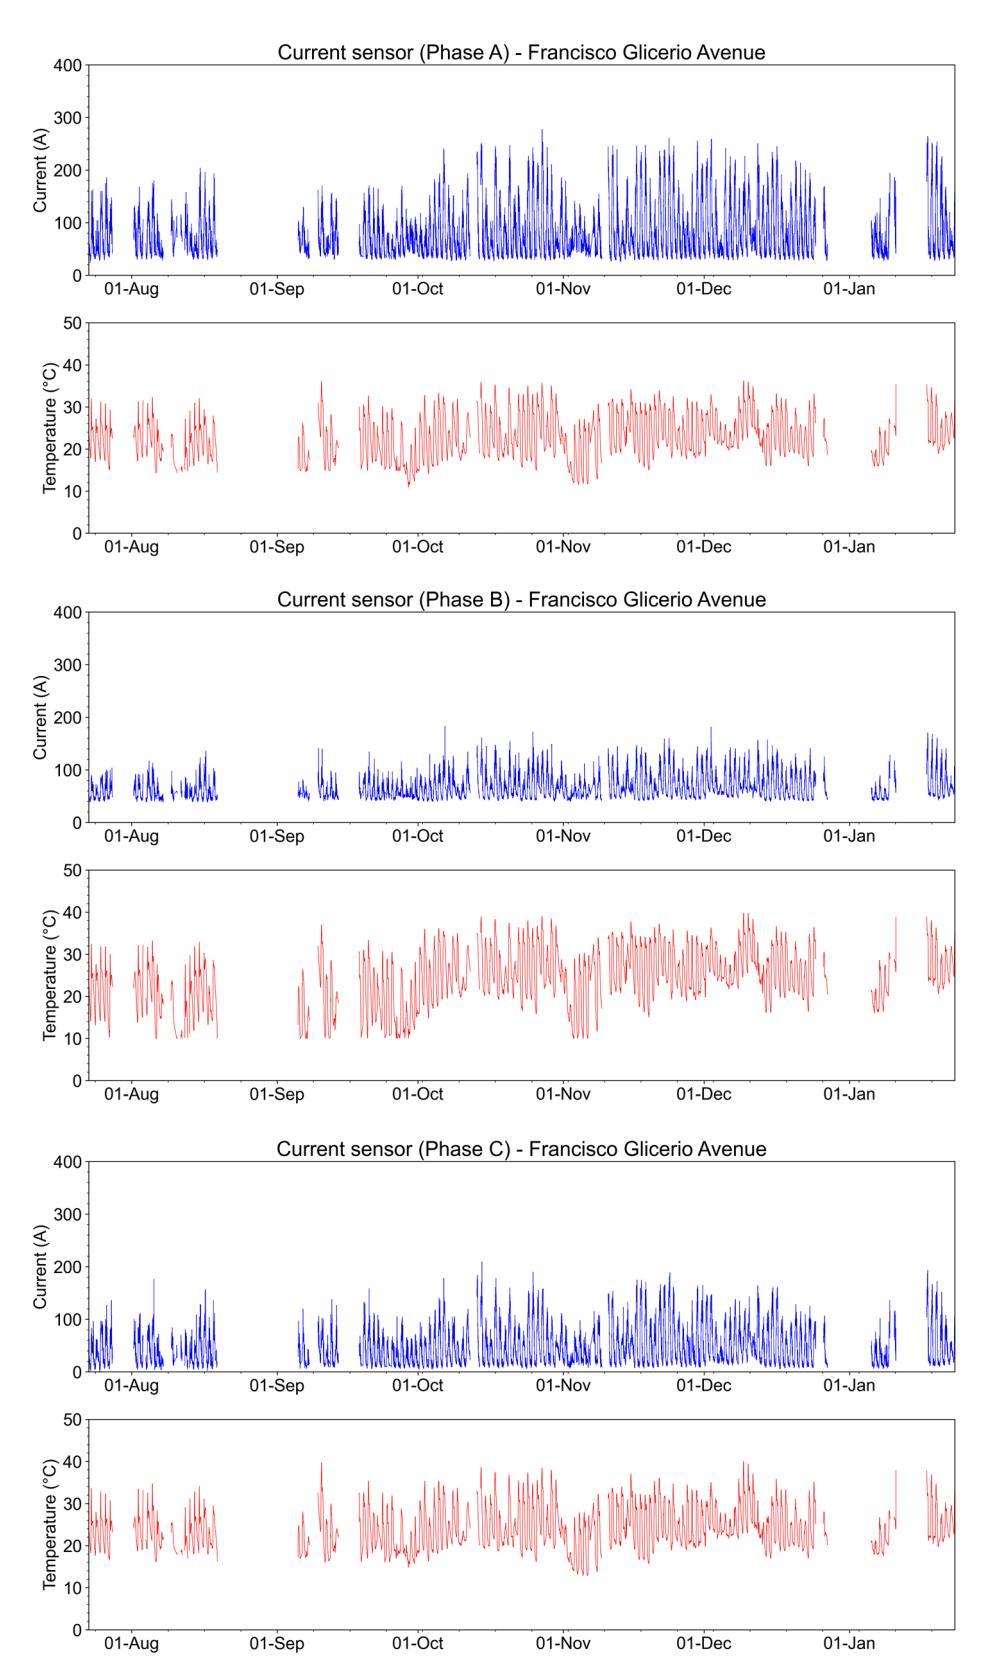
Figure 22. Current and temperature in the secondary winding of the transformer from the end of July 2022 to January 2023.

The measurements of currents and temperatures in the three secondary phases of the transformer in the downtown underground distribution network of the Francisco Glicerio Avenue installation are shown in Figure 22.

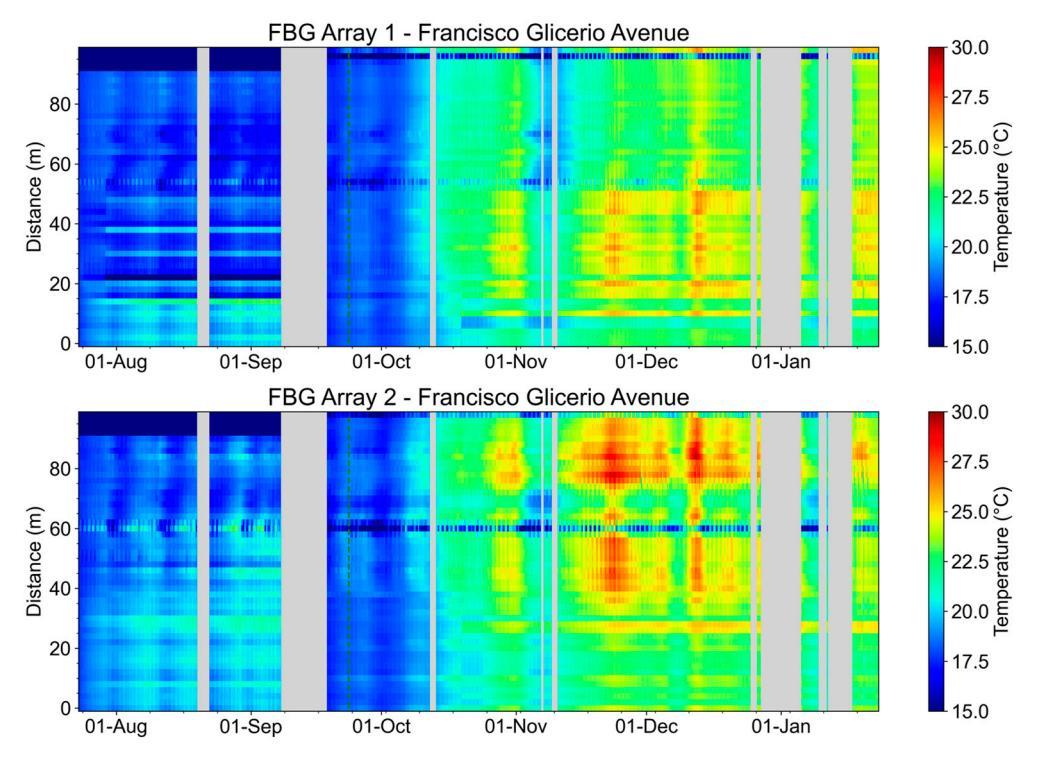
Figure 23. FBG Array 1 and FBG Array 2. Measurements from August 2022 to January 2023. The beginning of the spring in the southern hemisphere is also indicated by the dashed green line.

Figure 23 shows the evolution of the temperature measurements of the FBG Arrays 1 and 2. We highlight that at the beginning of spring in Brazil (09/23), there is an increase in the temperature measured by the FBG array.

Figure 23 also shows the evolution of the temperature measurements of FBG Array 2. As in the previous case, an increase in the temperature is observed at the end of October after the beginning of the spring. It is also possible to notice in Figure 23 the periodic variation in the temperature measured close to 60 and 98 m. These points correspond to the pad-mounted transformer and the manhole S2-31.

According to Brazilian standards [29], the maximum current supported by the conductor is a function of the internal duct temperature, and above 20 °C, the maximum current supported by the conductor must be reduced to avoid conductor damage (this standard is based on [30,31]). Therefore, temperature monitoring in an underground network optimizes the use of the legacy network and postpones investment in new underground networks.

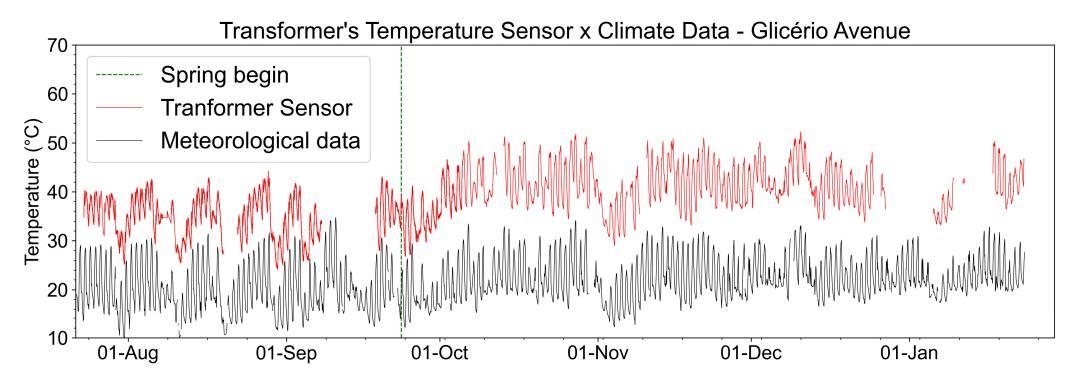
Figure 24. Recovered temperature on the surface of the TPU300 transformer #6 compared with meteorological data of the period. The beginning of spring in the southern hemisphere is also indicated by the dashed green line.

Figure 24 shows the temperature measurements taken on the surface of the TPU300 transformer during the analyzed period. The transformer temperature variations are mainly linked to the variation in the environmental temperature, shown in the fast variations in the measurements in Figure 24.

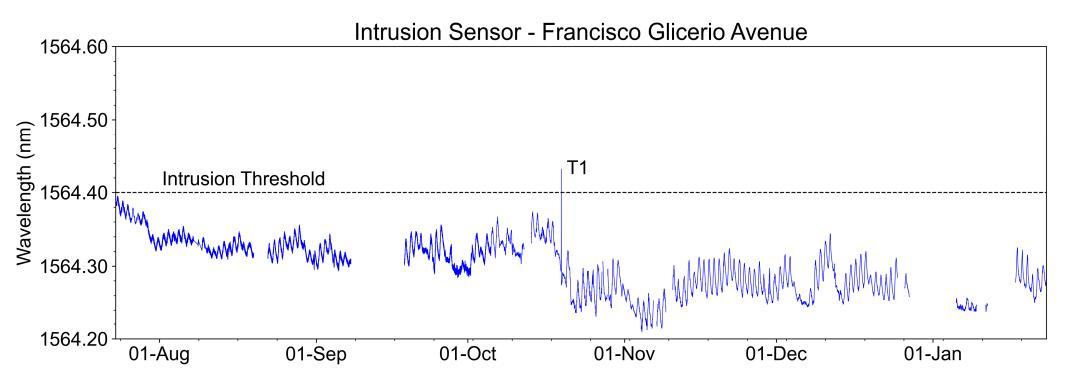
Figure 25. Recovered wavelength of the intrusion sensor at Francisco Glicerio Avenue with one intrusion test event on October 19th, event T1.

Figure 25 shows the temporal evolution of the intrusion sensor measurements (wavelengths captured from August 2022 to January 2023). We highlighted in the graph the event T1, where there was an intrusion test with the opening of the manhole cover. It is observed that the wavelength exceeded the threshold established for intrusion detection.

The continuous amplitude variations in the measured signal are due to the environmental temperature variation. This sensor was installed below the cover of the manhole CS-2/15, a more sensitive area for the environmental temperature variation. Even with these variations, the sensor did not present false failures during the evaluated period.

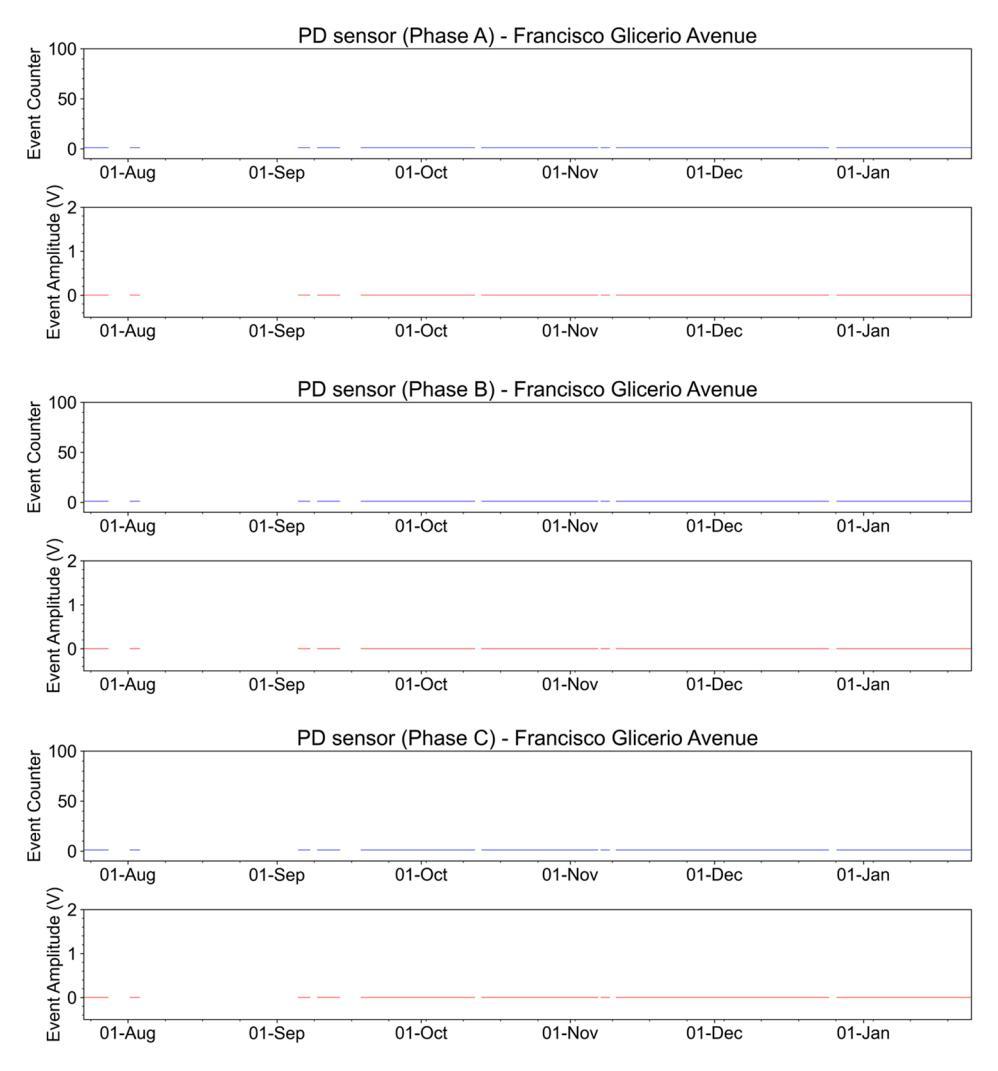
Figure 27. Event counter and amplitude for partial discharge measurements on Francisco Glicerio Avenue from the end of July 2022 to January 2023.

In conclusion, as is shown in Figure 27, during the evaluation period, no partial discharge events were observed in any of the three monitored phases.

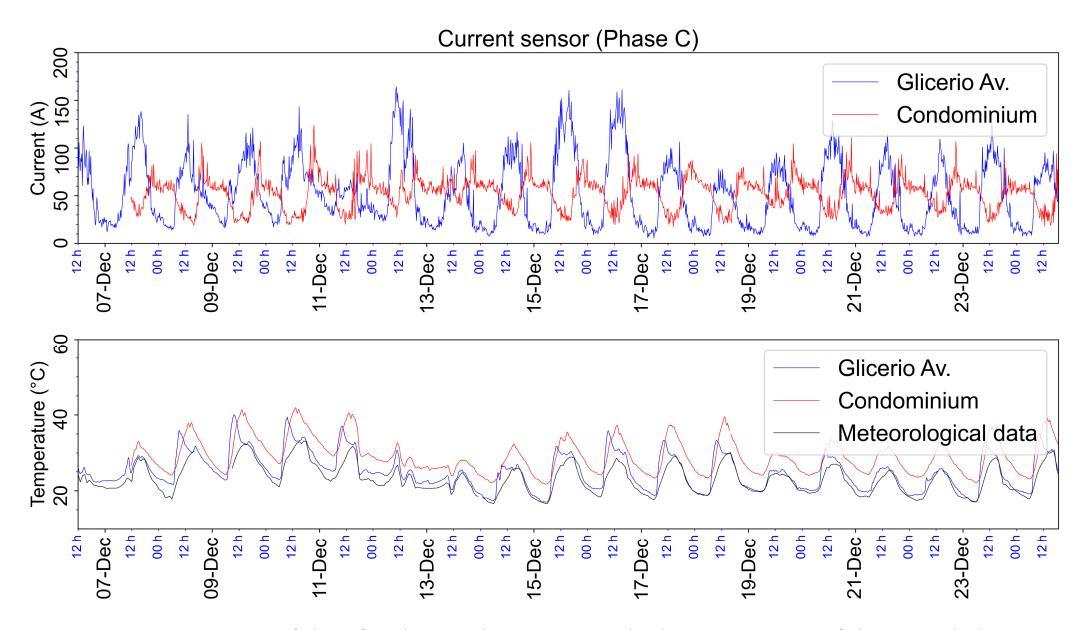
Figure 29. Comparison of data for the condominium and Glicerio Avenue of the recorded current and temperature in the secondary of the transformer (Phase C) from the end of July 2022 to January 2023. Also shown are the meteorological data.

In Figure 29, we compare the current and temperature acquired at the condominium and on Glicerio Avenue. As can be seen, the current in both places is not in phase. This behavior is explained by the difference in load activity at these sites. The higher consumption occurs at night at the condominium when people return from work activities to their homes and use showers and air conditioners. Conversely, Glicerio Avenue is a commerce place where higher consumption occurs during the day. Regarding the temperature, we observe that both installation places mimic the data obtained from a meteorological station in the metropolitan area of the city.

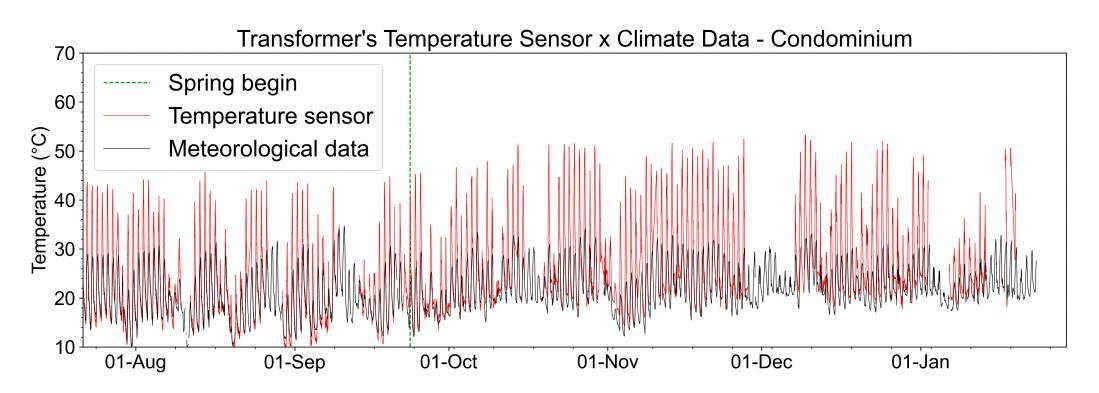
Figure 31. Recovered temperature on the surface of Transformer 1 compared with meteorological data of the period. The beginning of spring in the southern hemisphere is also indicated.

Figure 31 shows the temperature measurements performed on the surface of Transformer 1 during the analysis period. The transformer temperature variations are mainly linked to the environmental temperature variation for seasonal and daily periods, as can be shown in Figure 31 (for example, the increase in temperature after the beginning of the spring, as indicated by a dotted green line).

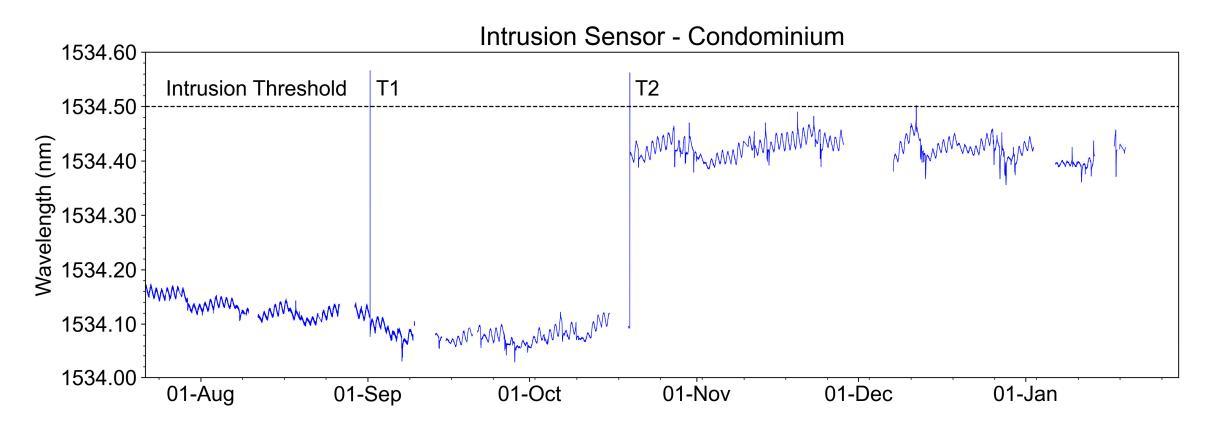
Figure 32 shows the temporal evolution of the intrusion sensor measurements (wavelengths captured from August 2022 to January 2023). We highlighted in the graph the events T1 and T2, where there were two intrusion tests with the opening of the manhole

cover, above where the sensor was installed. It is observed that the wavelength exceeded the threshold established for intrusion detection.

The continuous amplitude variations in the measured signal are due to the environmental temperature variation. This sensor was installed below the cover of the manhole CP2, where the environmental temperature variation is more evident. Even with these variations, the sensor did not present false failures during the evaluated period.

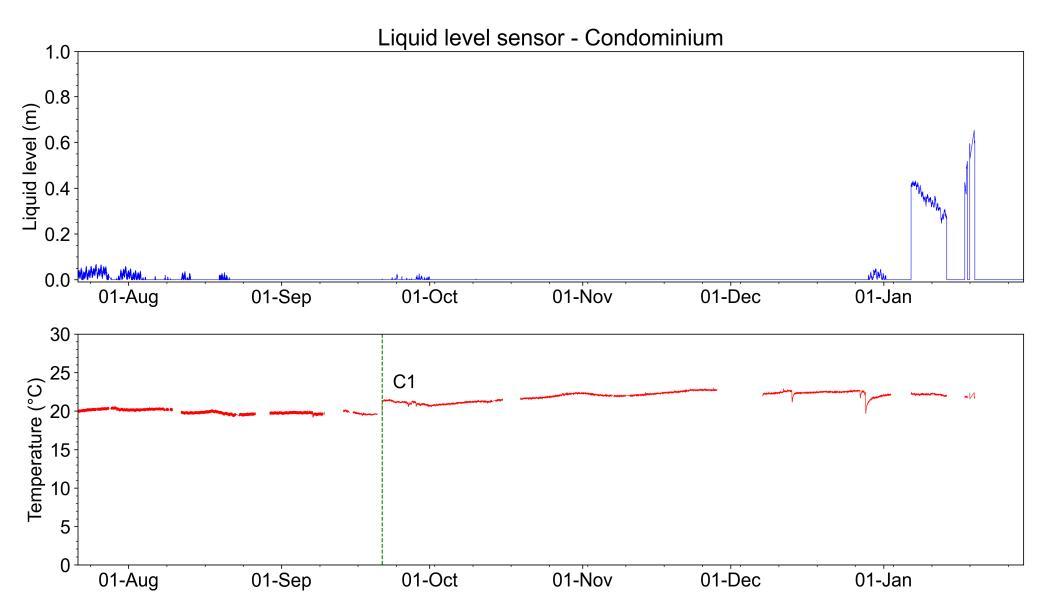
Figure 33. Recorded liquid level and temperature measurements from August 2022 to January 2023.

Figure 33 shows the measurements of the liquid level sensor (in meters) and its temperature from August 2022 to January 2023. During almost all this time, the liquid level in the manhole remains under 0.10 m, meaning that the manhole was empty. Regarding the measured temperature, during all this analyzed time, the temperature was close to 20 °C. We highlighted in the graph of Figure 33 a correction for the temperature measurement (C1). The temperature adjustment was made using a calibration instrument. The temperature was measured in the sensor location through a thermocouple. The measured temperature was compared to the system measurement. The difference found was +1.7 °C. Compensation was made by adding +1.7 °C to the system measurement. The liquid level exceeded the 0.10 m level two times during the entire period of monitoring. These events are associated with intense rains in January 2023.
