Article Multi-Parameter Optical Monitoring Solution Applied to Underground Medium-Voltage Electric Power Distribution Networks

Abstract: This work presents a multi-parameter optical fiber monitoring solution applied to an underground power distribution network. The monitoring system demonstrated herein uses Fiber Bragg Grating (FBG) sensors to measure multiple parameters, such as the distributed temperature of the power cable, external temperature and current of the transformers, liquid level, and intrusion in the underground manholes. To monitor partial discharges of cable connections, we used sensors that detect radio frequency signals. The system was characterized in the laboratory and tested in underground distribution networks. We present here the technical details of the laboratory characterization, system installation, and the results of 6 months of network monitoring. The data obtained for temperature sensors in the field tests show a thermal behavior depending on the day/night cycle and the season. The temperature levels measured on the conductors indicated that in high-temperature periods, the maximum current specified for the conductor must be reduced, according to the

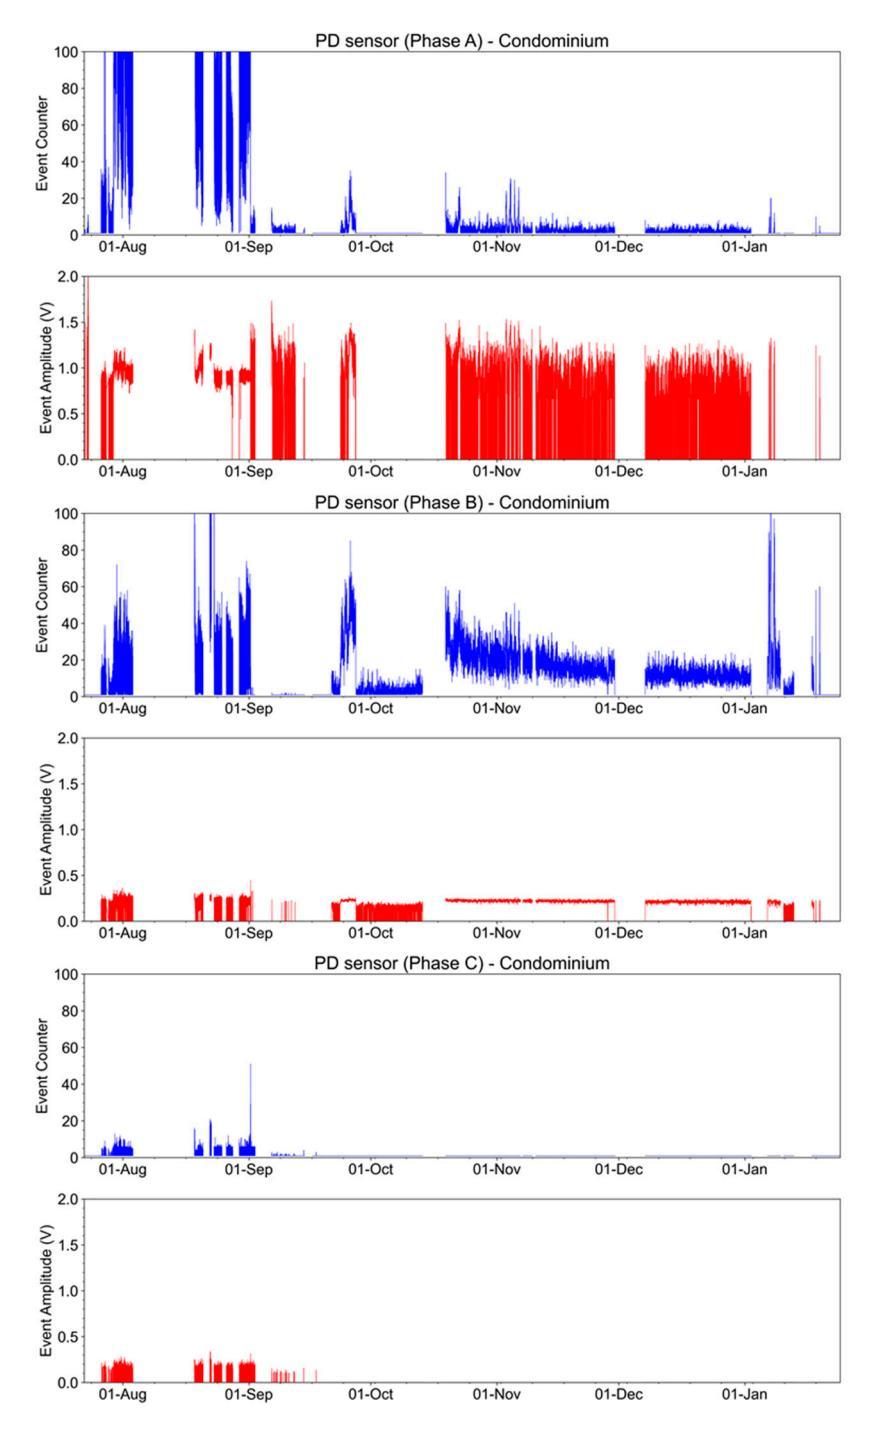
Figure 34. Event counter and amplitude for partial discharge measurements at the condominium from the end of July 2022 to January 2023.

measured. In this evaluation, the absence of optical power in all sensors was also verified, indicating that the sensor's laser was not operating above the threshold. The currents of the conductors where the partial sensors were installed were 1.3 A, 1.4 A, and 2.0 A for phases A, B, and C, respectively. However, the levels of discharge in the medium-voltage connectors used to connect to the transformers were high enough to be detected by the sensors, as shown in Figure 34. The discharges are more intense in phases A and B in terms of events and amplitude.

In September 2022, the detection level threshold was increased to reduce the intrinsic interferences. The data have been considered in the analysis from this month. It can be observed that some periods of higher levels of discharges were detected mainly in phase B during January 2023.
