Article Detection, Verification and Analysis of Micro Surface Defects in Steel Filament Using Eddy Current Principles, Scanning Electron Microscopy and Energy-Dispersive Spectroscopy

Abstract: In the current industrial revolution, advanced technologies and methods can be effectively utilized for the detection and verification of defects in high-speed steel filament production. This paper introduces an innovative methodology for the precise detection and verification of micro surface defects found in steel filaments through the application of the Eddy current principle. Permanent magnets are employed to generate a magnetic field with a high frequency surrounding a coil of sensors positioned at the filament's output end. The sensor's capacity to detect defects is validated through a meticulous rewinding process, followed by a thorough analysis involving scanning electron microscopy (SEM) and energy-dispersive spectroscopy (EDS). Artificial defects were intentionally introduced into a sample, and their amplitudes were monitored to establish a threshold value. The amplitude signal of these created defect was identified at approximately 10% FSH, which corresponds to a crack depth of ab

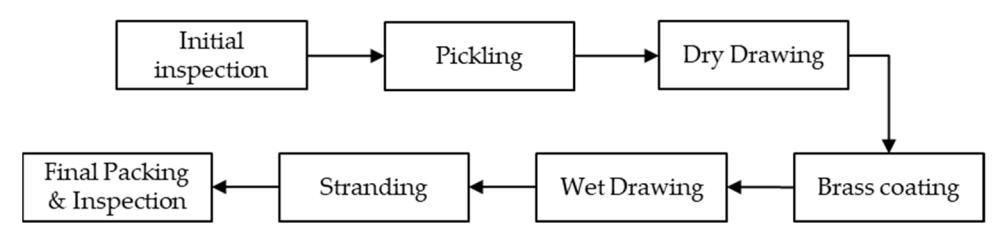
Figure 1. Steel filament manufacturing procedure.

Copyright: © 2023 by the authors. Licensee MDPI, Basel, Switzerland. This article is an open access article distributed under the terms and conditions of the Creative Commons Attribution (CC BY) license (https:// creativecommons.org/licenses/by/ 4.0/). process in which they are subjected to multi-pass drawing using a wet lubricant. Finally, the wires are pulled into spools at the end of the wet drawing process. The individual steel wires are then stranded together to form a steel cord, as shown in Figure 1.

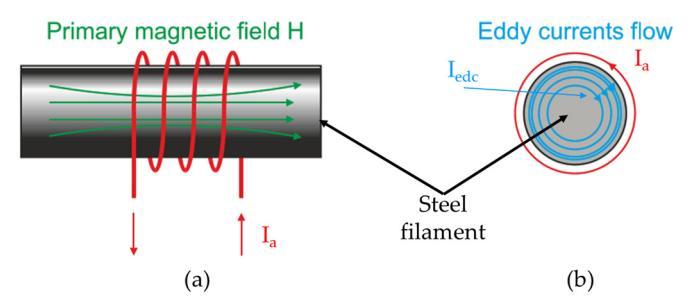
Figure 2. (a) Encircling coil with steel filament; (b) eddy current induced around steel filament.

The Eddy current is established based on the principle of electromagnetism as the basic for carrying out experiments [34]. An encircling test coil was utilized to monitor the micro surface defects of the steel wire during the wet-drawing process. The electrical inspection signals are generated by the electromagnetic interaction between the test coil and steel filament when this filament passed through the coil. When the test coil is activated by an alternating current I_a , it produces an alternating magnetic field H, in turn inducing an eddy current I_{edc} in the steel filament, as shown in Figure 2 [9].

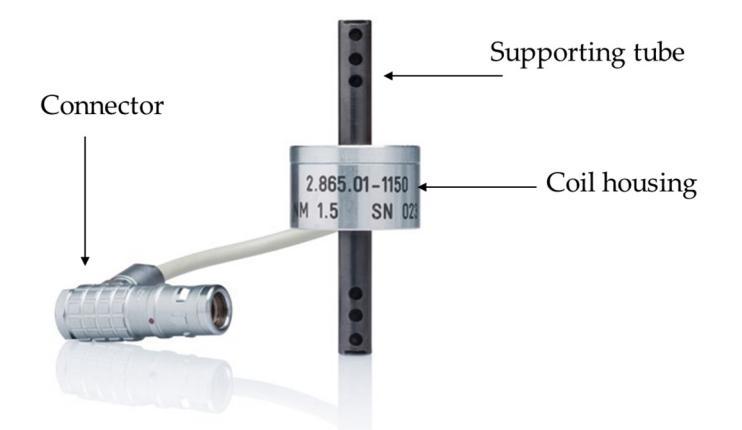
Figure 3. Encircling sensor coil.

A Defectomini sensor system from Foerster was used in the experiment. The test coil (sensor type 2.865.01-1050) consists of a coil housing with supporting tube on each side and the centrally positioned coil housing stores the coil unit, as illustrated in Figure 3. The connector is connected to the pre-amplifier, which is linked to the instrument (Defectomat CI).

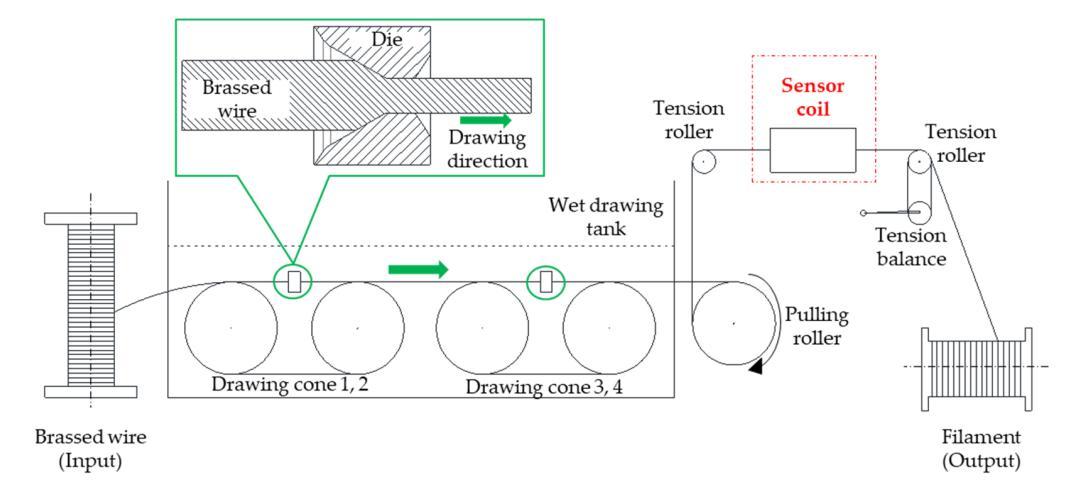
Figure 4. Wet-drawing process and sensor coil position.

A set of encircling sensors was placed on the top of wet-drawing machine, as shown in Figure 4, where the filament went through the sensor during the drawing process. The input material for the drawing process was steel wire of 1.90 mm diameter, which passed through the drawing machine, where it was reduced in diameter via a multi-die system in the wet lubricant tank. The output of the drawing process was the filament, which is inspected for quality using the eddy current sensor.

The sensor coil was situated between two tension rollers at the machine's output end, which was precisely aligned with the wire path. It was linked to a pre-amplifier, and the resulting signal was subsequently directed to the instrument, as depicted in Figure 5. This instrument was employed to define the criteria for a non-defective product.

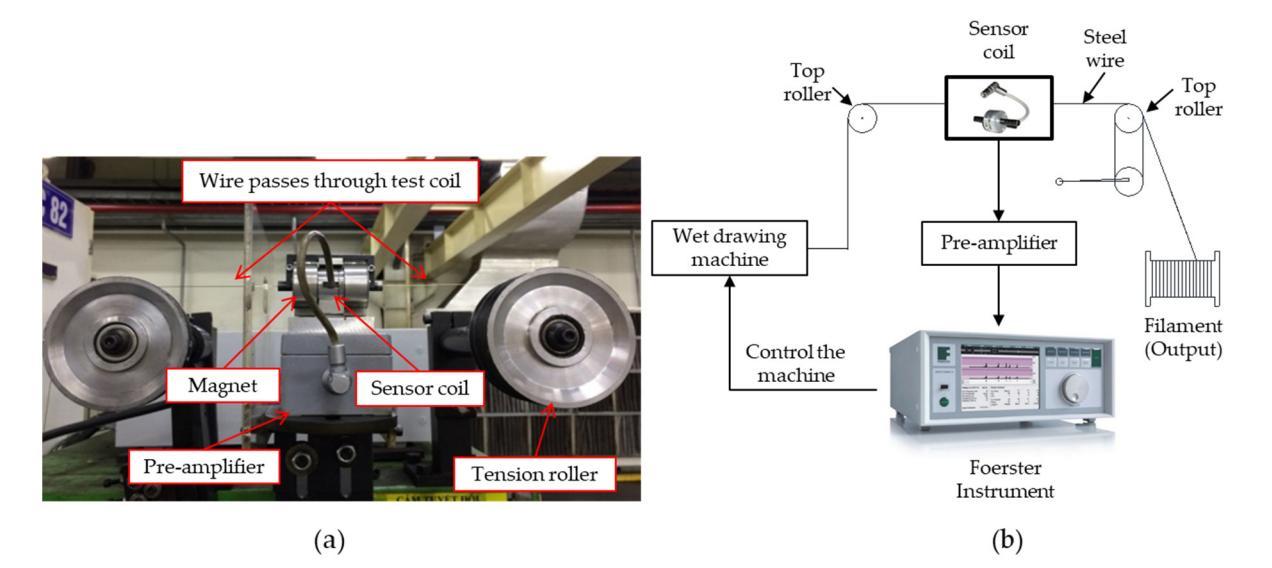
Figure 5. (a) Sensor installation on a wet-drawing machine; (b) experimental setup diagram.

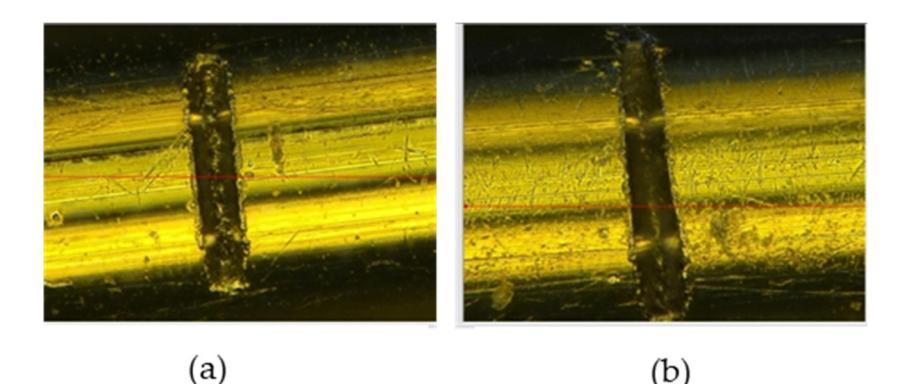
Figure 6. Artificial cracks under scanning electron microscope (SEM). (**a**) Crack's depth of 20 μm; (**b**) crack's depth of 80 μm.

Table 1 and Figure 6 display the introduction of artificial cracks at depths of 20 and 80 μ m onto the surface of a 0.38 mm filament sample, which were measured using the reference red line in Figure 6.

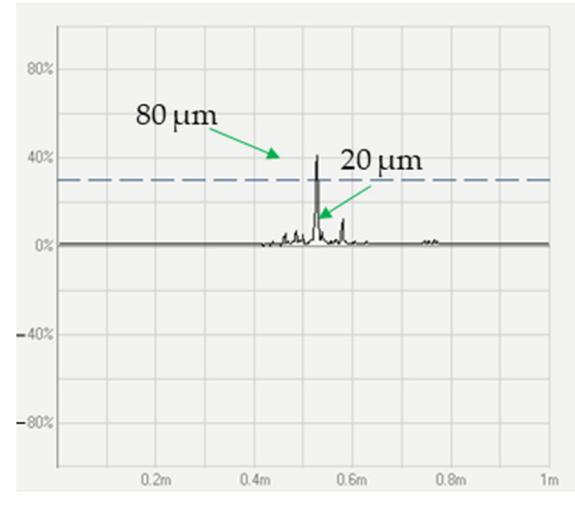
Figure 7. Amplitude signals of created cracks with the depth of 20 μm and 80 μm.

The specimen containing the created cracks was stretched and placed through the sensor in order to monitor the amplitude signal. The frequency was controlled at maximum level of 1000 kHz to identify the surface defects. Consequently, the amplitude signals of the introduced defects amounted to around 10% and 41% of the full-screen-height (FSH) amplitude for depths of 20 and 80 μ m, respectively. Additionally, noise was also observed along with the defects, with a level of 3% attributed to the rusting of the wire, and the dotted line shows the reference threshold at 30% FSH, as illustrated in Figure 7.

If the threshold value is set at 10% FSH to identify the defects with a depth of 20 μ m, the sensor will detect any defects containing cracks deeper than 20 μ m during the experiment. Based on the testing results, the threshold of amplitude signal was set of 10% FSH to stop the machine when desired defect appears.

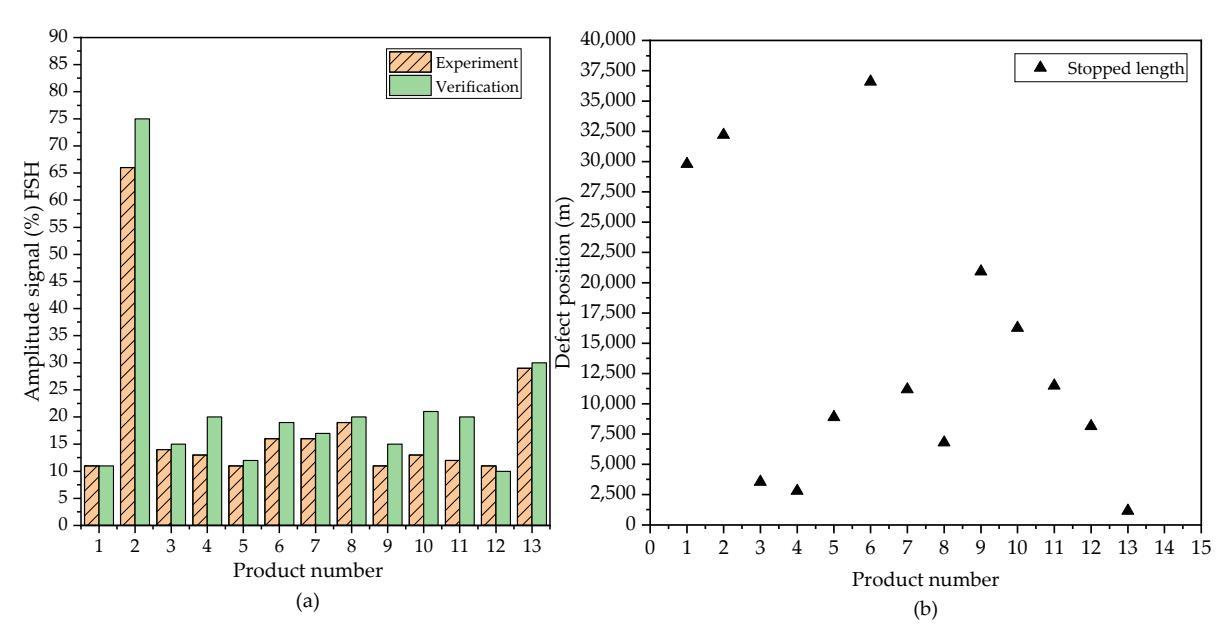
Figure 8. (a) Comparison of the amplitude signals for defects during production and verification; (b) Position of defects on unacceptable products.

Figure 8a illustrates the accurate detection of the identified flawed samples. The disparity was minimal, and the amplitude signals for most defects falls within the range of 10% to 35%, except for a single defect for which the amplitude signal significantly exceeded the others, with an average around 70%.

Figure 8b illustrates the position of the micro surface defects where the sensor system stopped the machine upon detecting the defect exceeding a depth of 20 μ m. Surface defects manifest randomly along the length of each sample.

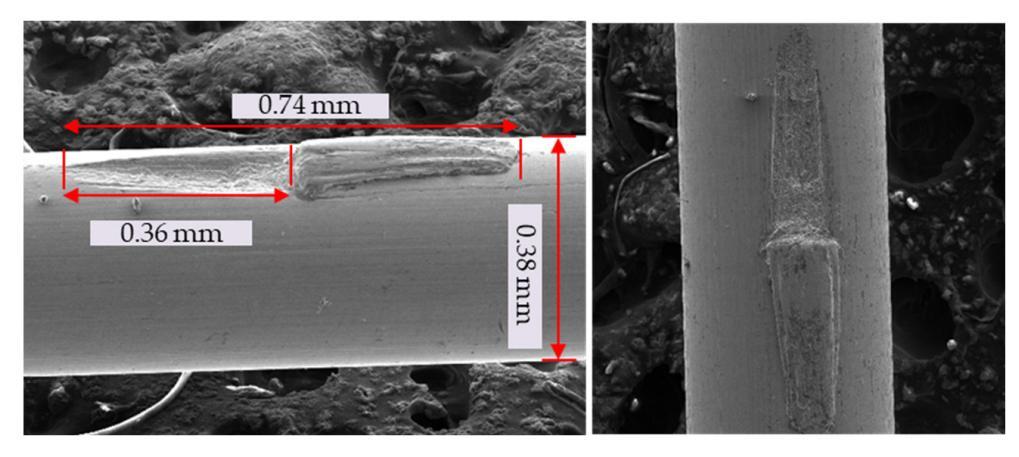
Figure 9. Surface defect in filaments imaged under SEM.

After detecting micro surface scratches, the machine ran for an additional 26 m before coming to a complete stop. By identifying the excess length and rewinding it backward using the sensor coil, the same signals were captured and compared with those recorded in the system for the previous specimen. Eventually, surface defects in steel filament were confirmed and clarified under a microscope, as indicated in Figure 9.

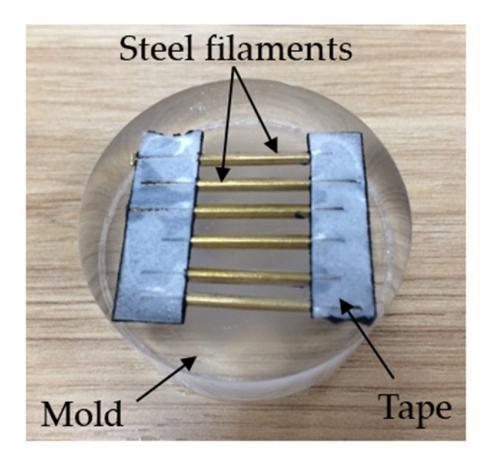
Figure 10. Steel filaments containing surface defects.

Under an optical microscope, the components containing the defect were sectioned into smaller fragments and affixed in parallel with tape prior being placed into a mold, as depicted in Figure 10.

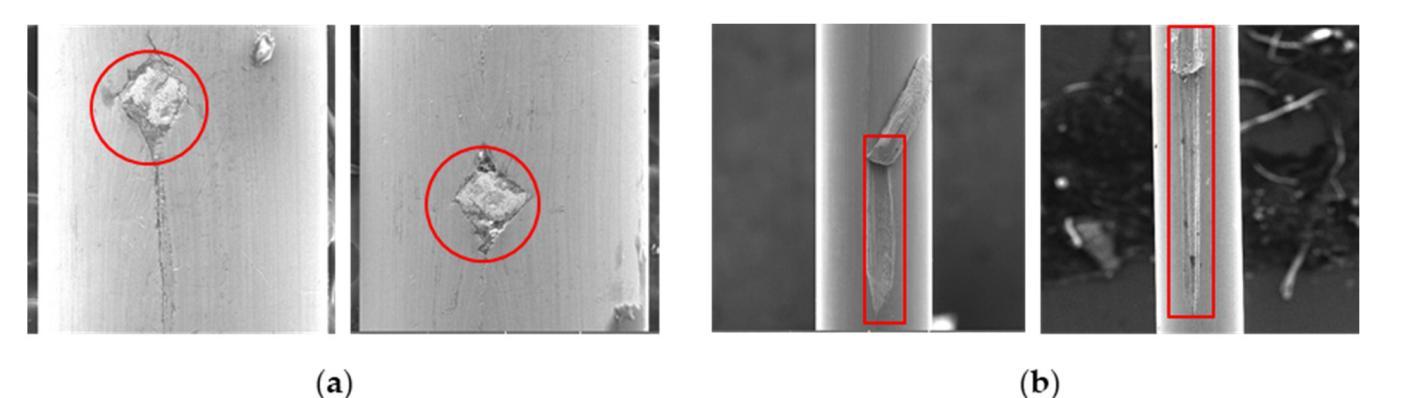
Figure 11. Typical types of surface defects shown in red frames: (a) inclusion defects; (b) scratch defects.

Figure 11a shows a unique defect containing tungsten carbide (WC) inside. On the other hand, Figure 11b illustrates the outcome of scratches, allowing for the prediction of the start and end points of such scratch defects. Most of these defects resembled the pattern shown in Figure 11b.

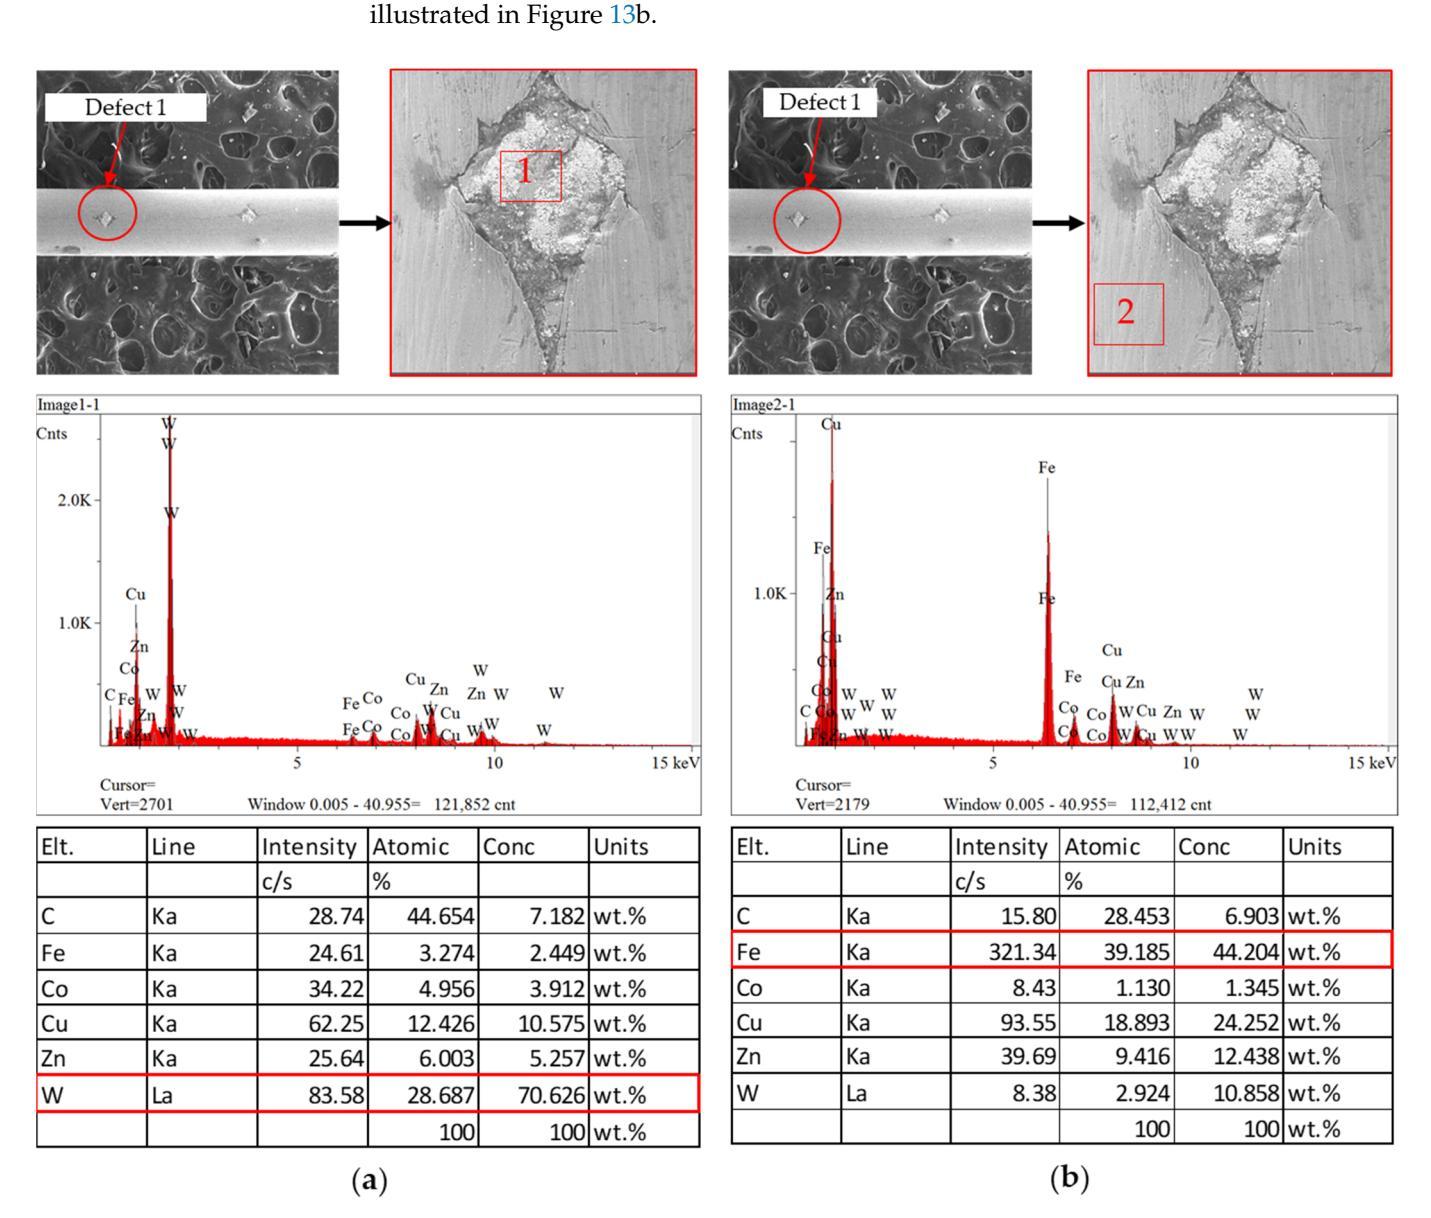
Figure 12. Results of EDS analysis for inclusion defect 1. (a) Inside of defect; (b) outside of defect.

In order to compare the different materials inside and outside the inclusion defects, EDS analysis was performed on both regions, and it was repeated for the second defect on the same sample. As illustrated in Figure 12a, tungsten carbide is the main material inside the defect, while iron (Fe) is the main ingredient outside of the defect as shown in Figure 12b. The EDS results show that this defect was caused by the external source from which the tungsten carbide originated. To verify the abnormal material adhered to the inclusion defect, EDS was performed again on the second defect, and the same result was obtained when tungsten carbide was found to be the main factor inside the defect, as shown in Figure 13a, while no abnormal material was found on the outside of the defect, as

Considering the fact that tungsten carbide is utilized to produce dies for the drawing process, it is likely for the broken pieces of dies to become stuck inside the steel wire during the drawing process due to the high hardness of tungsten carbide compared to that of steel. Additionally, the drawing process takes place under high pressure and in a single direction, making it easier for the broken die pieces to insert into the surface of the steel filament. Therefore, the primary reason for the inclusion defect containing tungsten carbide is likely due to the broken dies during the drawing processes.

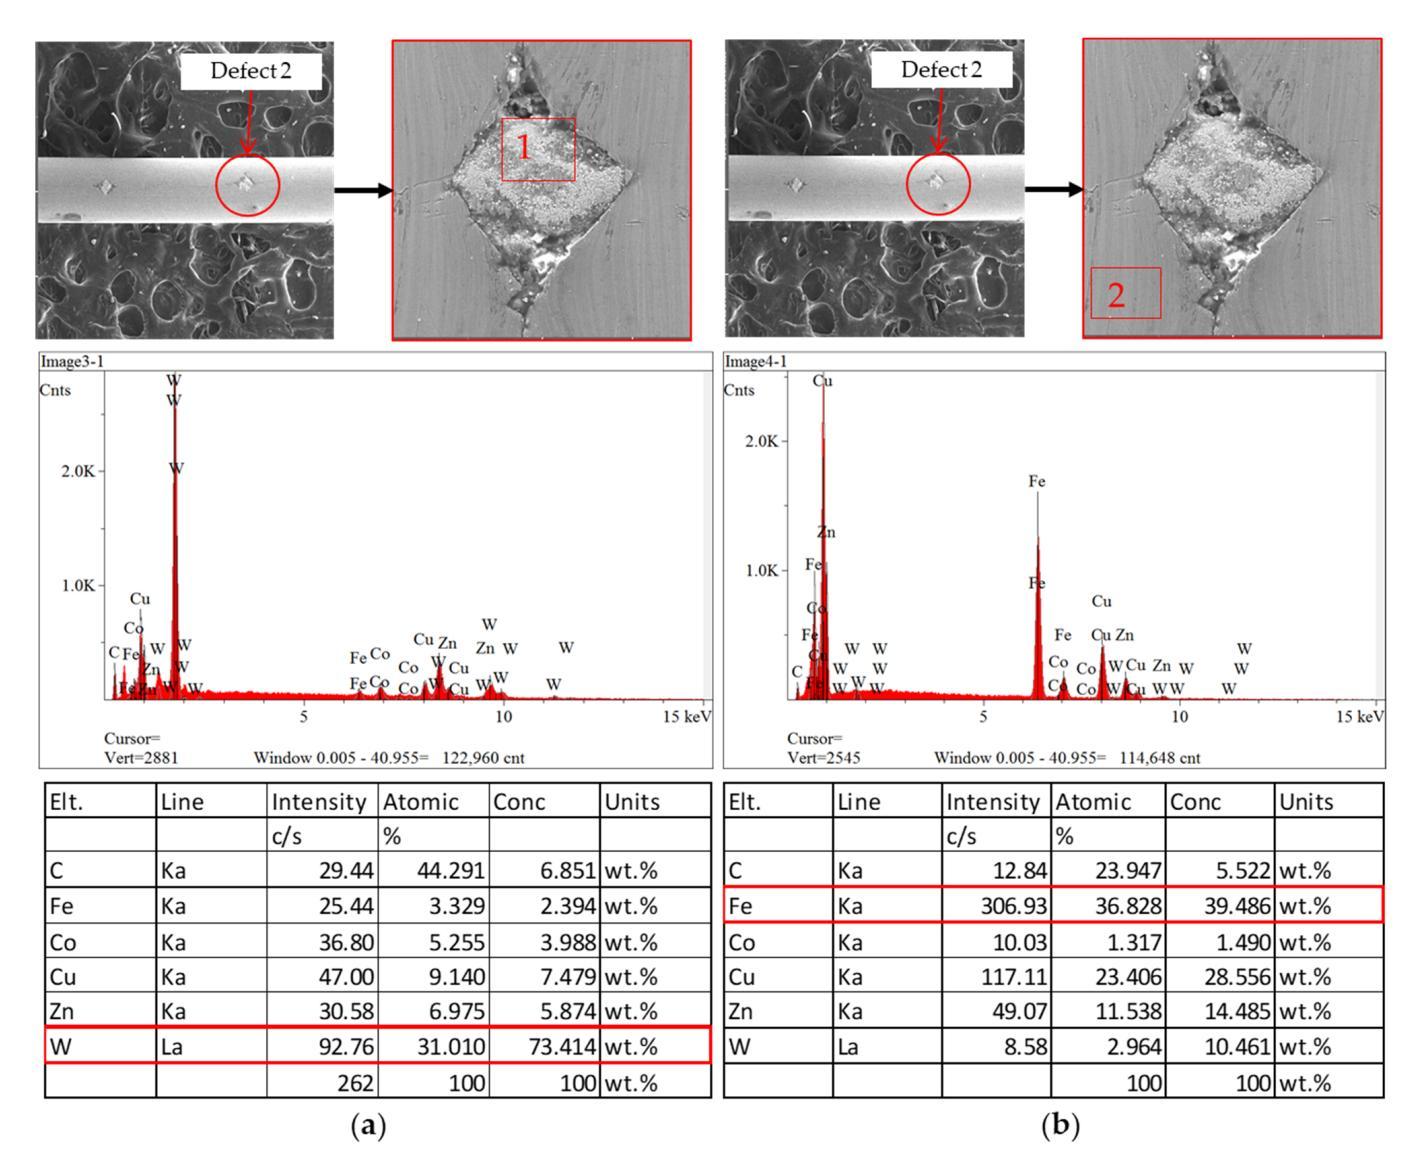
Figure 13. Results of EDS analysis for inclusion defect 2. (a) Inside of defect; (b) outside of defect.

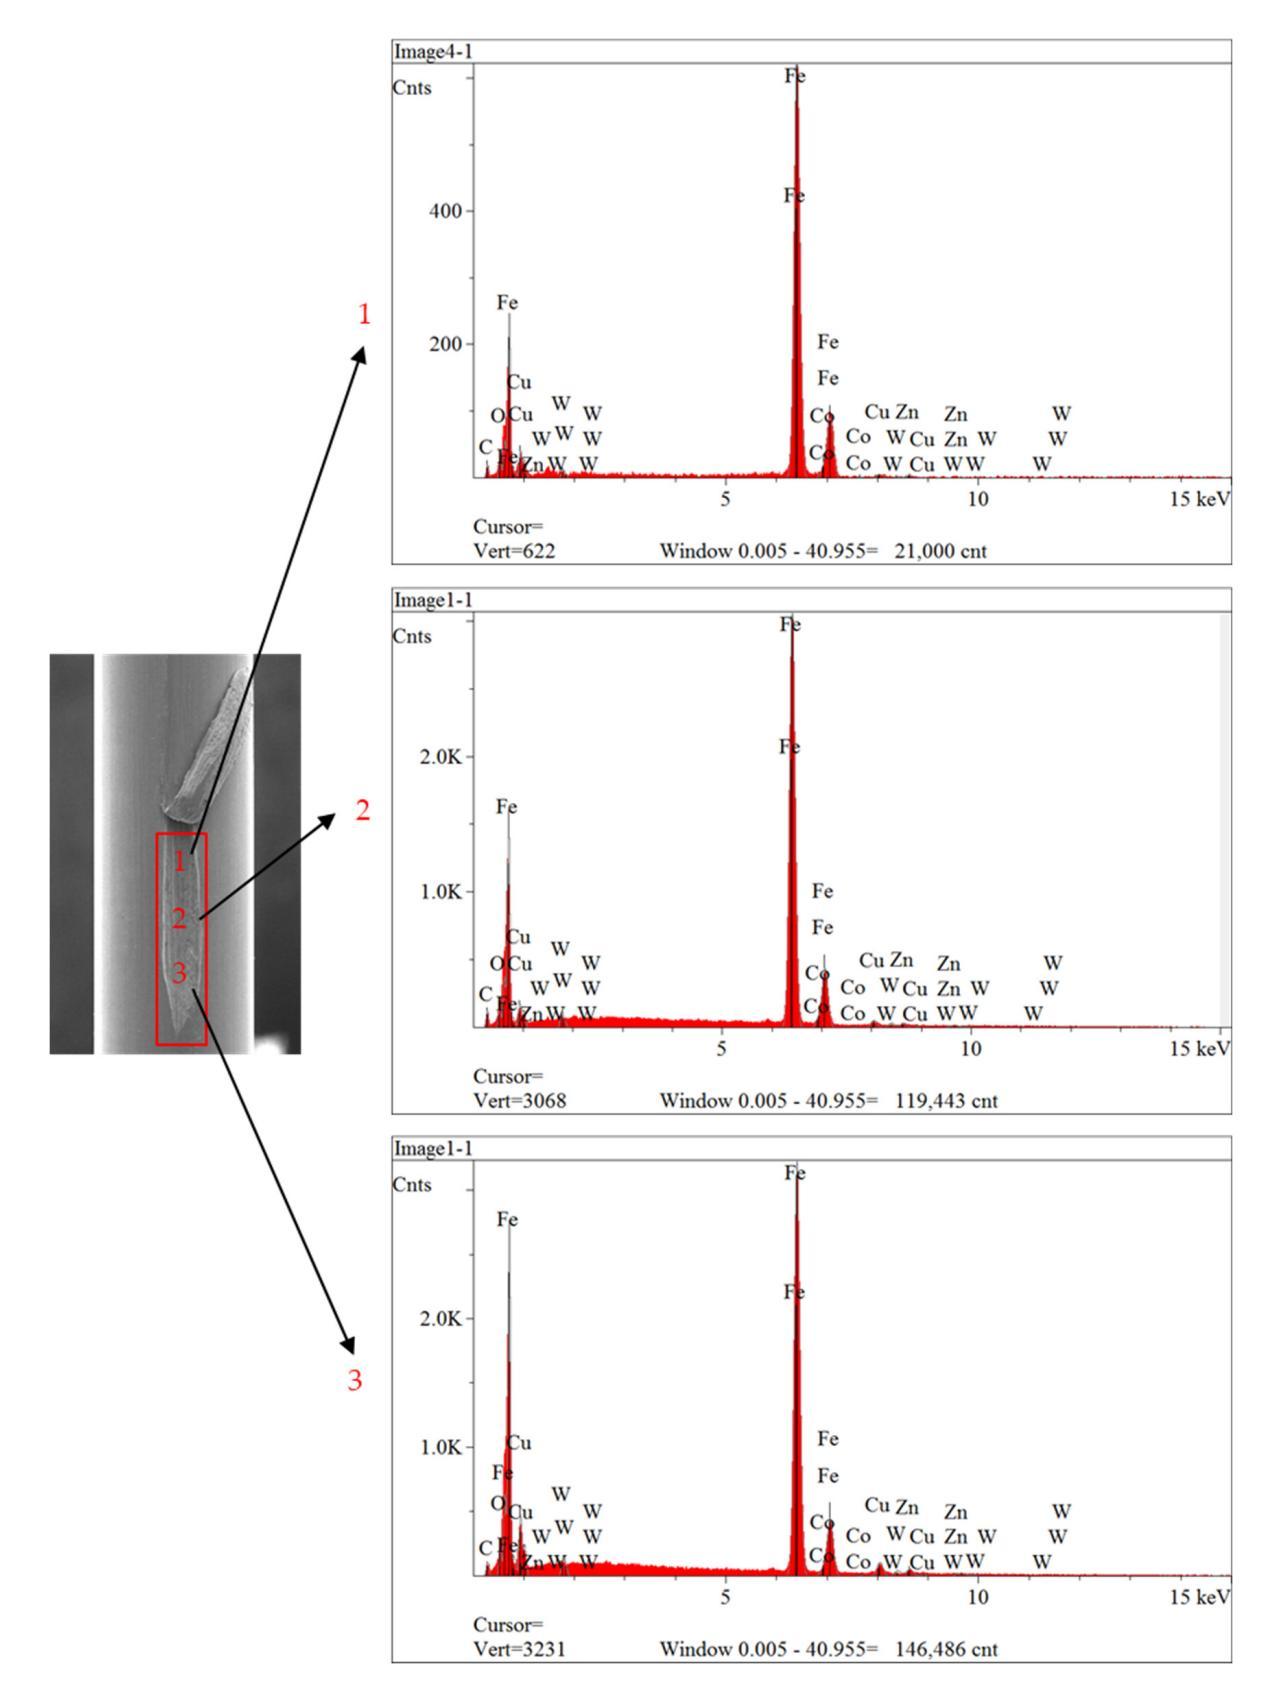
Figure 14. Results of EDS analysis inside of scratch defect.

The analysis was conducted two times at three places (1, 2 and 3) inside and outside (normal region) the scratch defect, as shown in Figures 14 and 15. It can be seen from results of the analysis that brass was absent from all regions inside the scratch, as illustrated in Figure 14. However, brass was still present on the surfaces of the normal area, as indicated in Figure 15. Therefore, these surface scratches were caused during the wet-drawing process.

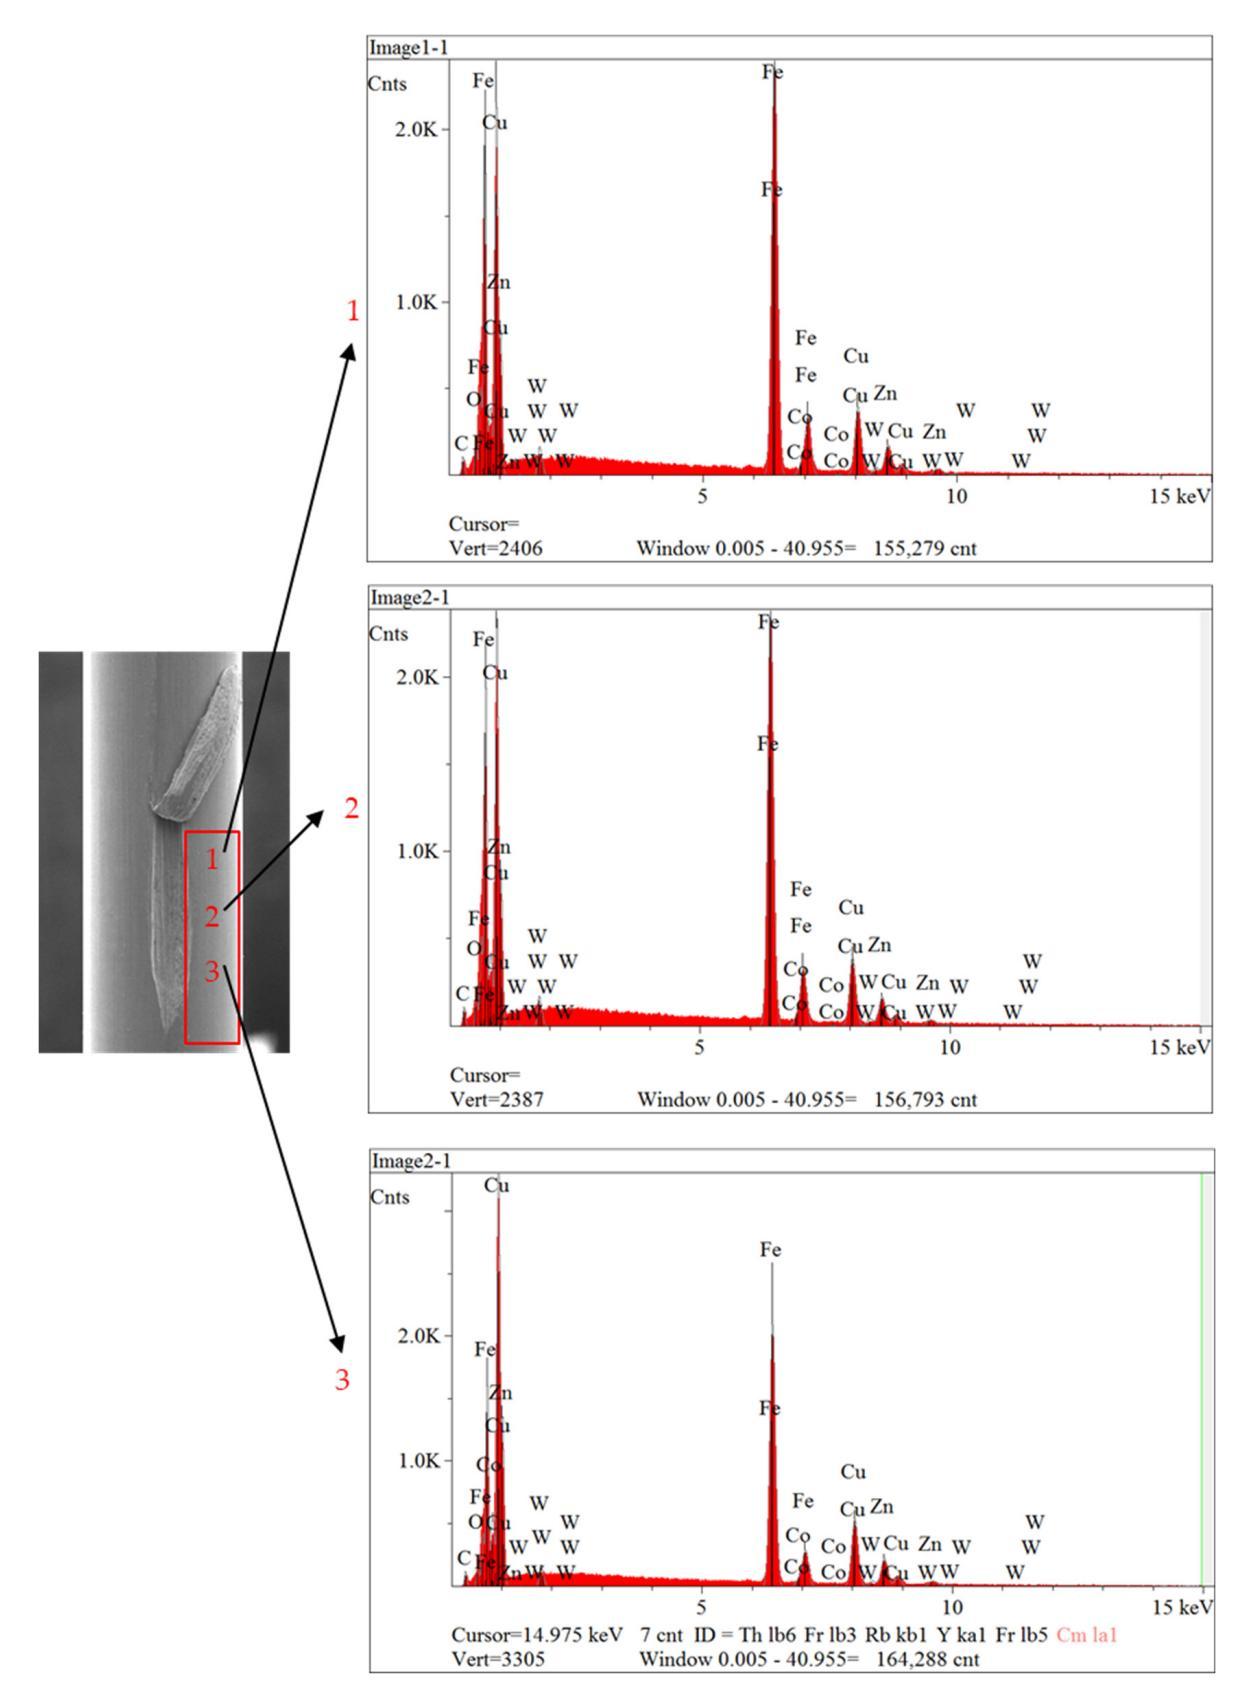
Figure 15. Results of EDS analysis outside of scratch defect.
