Article The Effects of Infilled Walls on Seismic Performance of RC Frame Structures with Eccentrically Placed Open Corridor

Keywords: RC frame; earthquake; shaking table; infilled walls; eccentrically placed open corridor

Citation: Wang, B.; Guo, X.; Xuan, Y.; Fan, X.-Q.; Chen, B. The Effects of Infilled Walls on Seismic Performance of RC Frame Structures with Eccentrically Placed Open Corridor. *Sustainability* **2022**, *14*, 5299. https://doi.org/10.3390/su14095299

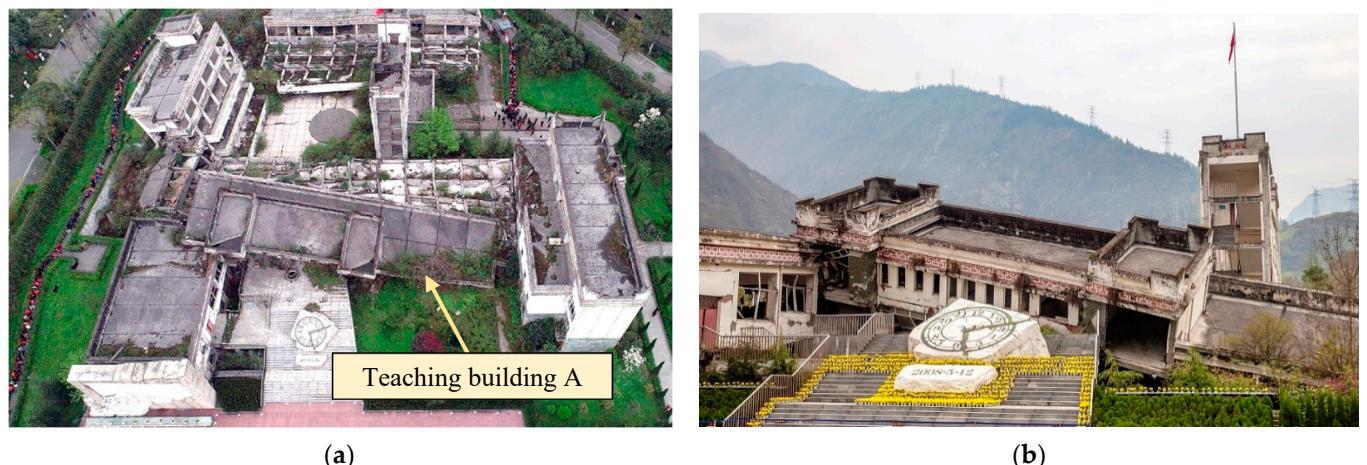
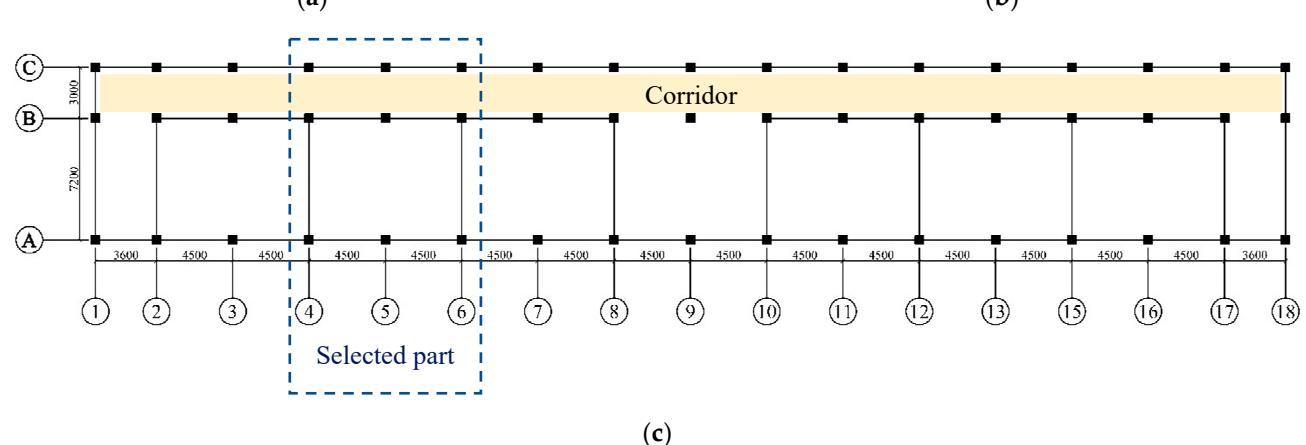
Figure 1. The teaching building A of Xuankou Middle School after earthquake (quoted from Visual China Group). (a) Scene of Xuankou middle school after earthquake. (b) The collapsed teaching building A. (c) The layout of the structure (unit: mm).

In the 2008 Wenchuan earthquake, the collapsed buildings in Xuankou Middle School were all RC frames with an eccentrically placed open corridor, and they all collapsed towards the side of the window rather than the corridor side. However, the office building with an inner corridor did not collapse, as shown in Figure 1. It shows that the eccentrically placed open corridor may be a key factor leading to the unbalanced layout of the teaching building, and then the layout changes the seismic failure mechanism of structure. Teaching building A, one of the collapsed buildings, was selected for the experiment. The prototype building was completed and put into use in 2007. The structural seismic design was carried out in accordance with Code for Seismic Design of Buildings (GB50011-2001). The fortification intensity was 7 degrees. There are 5 floors in the structure; the height of the first floor is 4.05 m. Figure 1c shows the layout of the first floor, and the part from axis 4 to axis 6 was selected for experimental study.

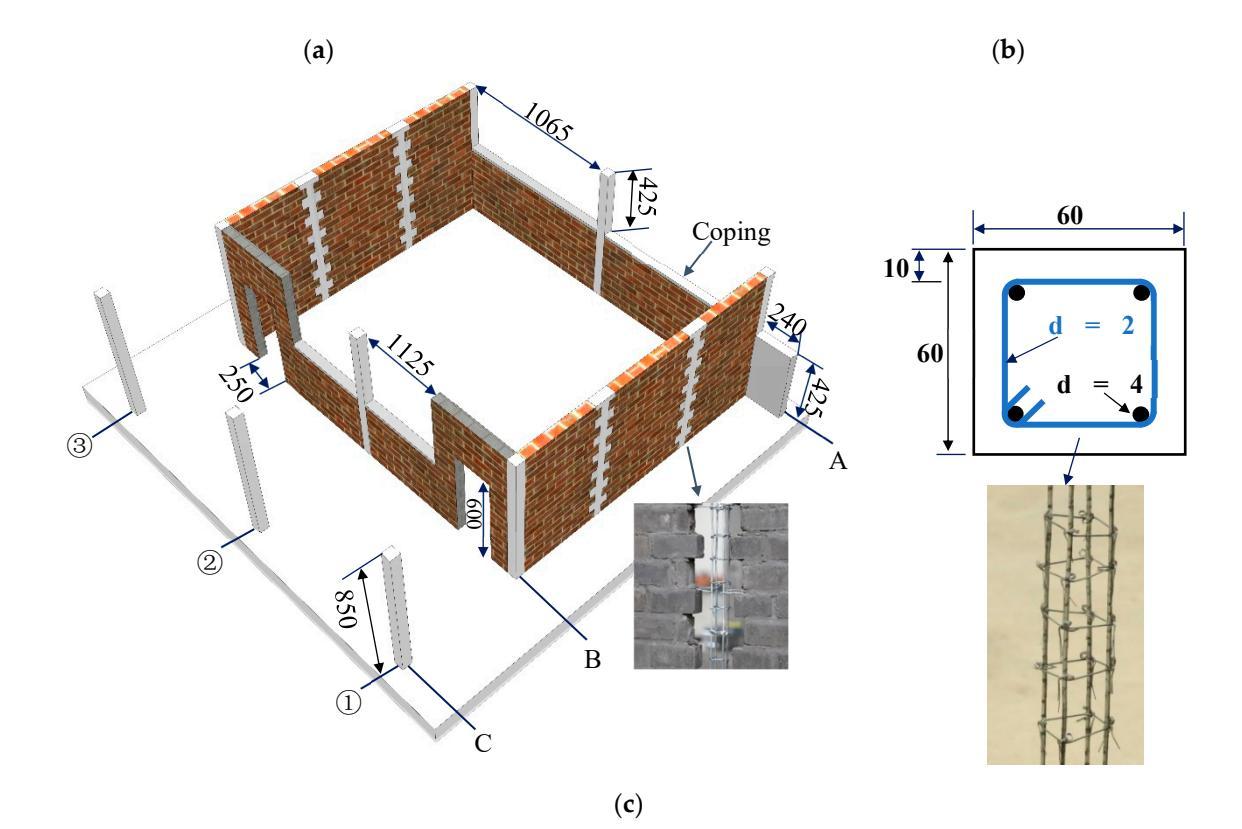
Figure 2. The structural information of model. (**a**) Measurements of model (unit: mm). (**b**) Photo of model. (**c**) The structural arrangement and reinforcement of each column (unit: mm).

In consideration of the size and load-bearing limitations of the shaking table, only the two-span of the teaching building from the first floor to the third floor were selected for simulation, and a shaking table test model, the height of whose single floor is 900 mm, was therefore designed with a scale of 1/4. In the model, there were 9 frame columns each with a clear height of 850 mm, and the size of each column was 60×60 mm; 4 galvanized iron wires with a diameter of 4 mm were configured as stressed steel bars, and the iron wires were scored so as to simulate the mechanical performance of ribbed steel bars. The stirrup was simulated by iron wires with a diameter of 2 mm and a spacing of 50 mm.

For the purpose of truly simulating the interaction between the infilled wall and the frame column, a full-brick infilled wall was arranged transversely and two half-height continuous infilled walls with a height of 405 mm were arranged longitudinally in line with the original construction drawings. According to the actual constructional details, a reinforced concrete coping of 20 mm was also set on the upper part of the infilled walls with a window opening. The infilled walls of the model were built with small grouting blocks, and two constructional columns were set in the transverse wall to ensure its integrity, and a pair of tie bars with a diameter of 2 mm was set every three blocks (150 mm) in the wall and is extended into the constructional columns and frame columns to ensure the effective connection of the wall and the column. Since the mechanical behaviour and damage patterns of frame columns during earthquakes were mainly observed in this test, frame beams were therefore not installed. Figure 2 shows the model construction drawing, internal arrangement and model appearance.

In addition, considering that the position of the middle span of the structure was simulated in this test, a low RC wall with the same height as that of the half-height continuous infilled wall was set beside the side column of the window opening in order to ensure that the side column at the bottom of the model could still be subjected to the restriction of the longitudinal half-height continuous infilled walls.

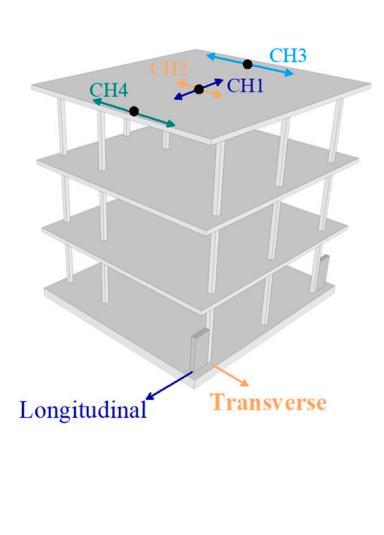
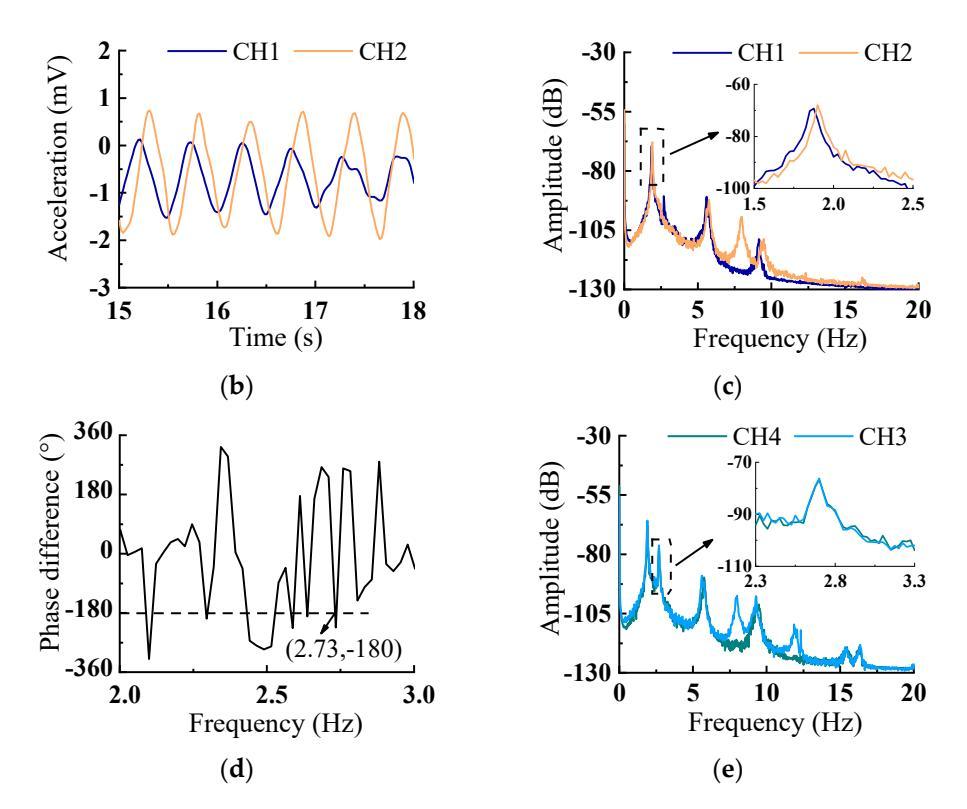
Figure 3. Microseism tests of RC structure without infilled walls. (a) Sensor location. (b) Time history. (c) Auto-power spectrum. (d) Phase spectrum difference of CH3 and CH4. (e) Auto-power spectrum.

Figure 3b,c show, respectively, the acceleration time history and the auto-power spectrum obtained by the sensor at the centre of the top layer before the wall was built. (Without consideration of the acceleration, the unit will not be converted temporarily, and the coordinate of the time history is indicated by the voltage value in mV.) It can be seen from the above figures that the longitudinal natural frequencies of the first and second modes of the model are 1.88 Hz and 5.58 Hz, respectively, while the transverse ones are 1.90 Hz and 5.72 Hz, respectively. At this time, the longitudinal or transverse lateral stiffness of the structure is only provided by frame columns with equal sections as the model is not built with infilled walls. Hence, the natural frequencies in two directions are relatively close.

Figure 3e represents the auto-power spectrum, which shows that the torsion frequency of the model is about 2.73 Hz, obtained by two acceleration sensors in the same direction at the edge of the top layer. It can be concluded from the Fourier phase difference curve of the two acceleration signals (CH3 and CH4) shown in Figure 3d that the phase difference at the frequency 2.73 Hz is -180° , indicating that the value of the torsion frequency identified in the auto-power spectrum is credible.

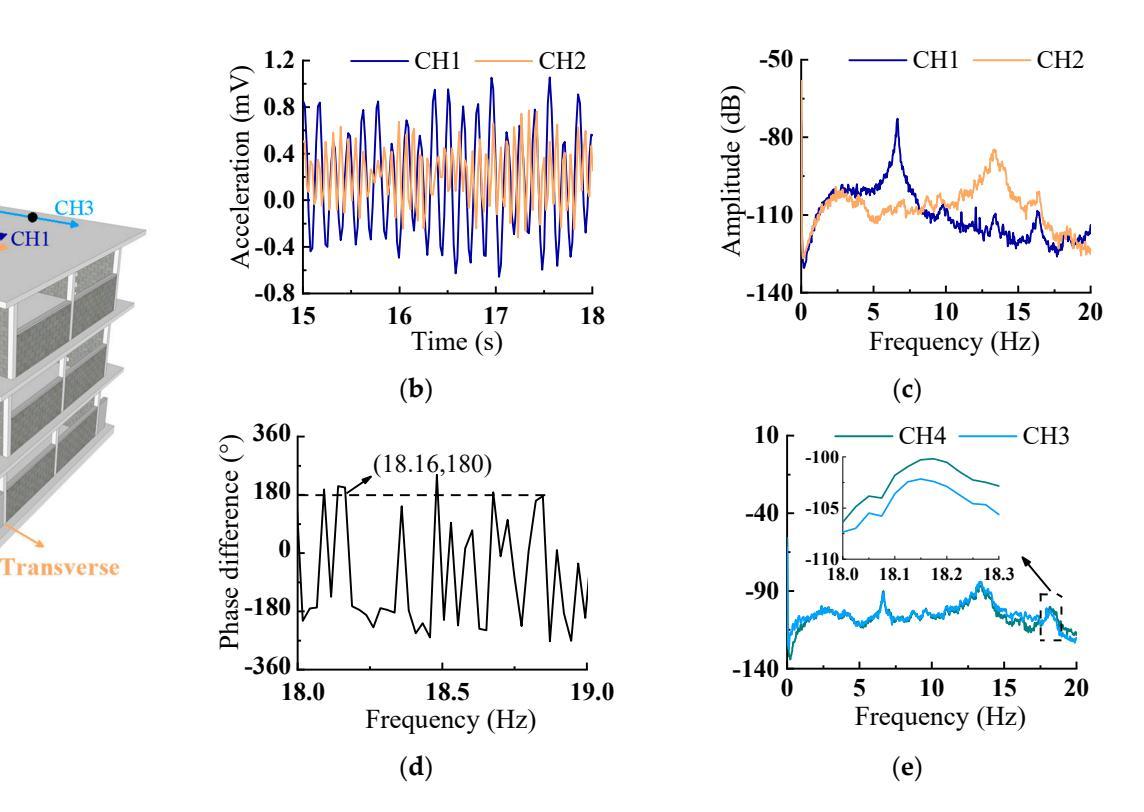
Figure 4. Microseism tests of RC structure with infilled walls. (a) Sensor location. (b) Time history. (c) Auto-power spectrum. (d) Phase spectrum difference of CH3 and CH4. (e) Auto-power spectrum.

Figure 4 shows the natural frequency with the walls laid. The time history at the centre of the top layer of the model is shown in Figure 4b, and its corresponding auto-power spectrum is shown in Figure 4c. It can be seen that the values of longitudinal and transverse fundamental frequency increase to 6.65 Hz and 13.40 Hz, respectively, after the infilled walls are built. Obviously, this can be attributed to the full-brick infilled wall in the transverse direction. Although an infilled wall is also installed in the longitudinal direction, door and window openings with a large area (see Figure 2) were opened, leading to the weakening of the longitudinal lateral stiffness and a lower longitudinal fundamental frequency, which is only about a half of the transverse fundamental frequency. Figure 4e demonstrates not only the same transverse fundamental frequency as that obtained by the centre sensor, but also the torsion frequency of the model, which is 18.16 Hz. Figure 4d further proves the reliability of the obtained torsion frequency from the phase difference. The torsion frequency increased by 6.65 times compared with that when the wall is not built. Such a large increase in torsion frequency is caused by the constraint of the transverse full-brick infilled wall on the model torsion. Figure 5 displays the comparison of the fundamental frequency and torsion frequency of the model with and without infill walls. It also shows that once the infilled walls are built, the overall stiffness of the frame is improved and the natural frequency is significantly improved. In particular, the stiffness of the transverse infilled wall is very large, which will restrain the transverse deformation and the torsion of the structure to a certain extent; the transverse and torsional frequency increase more than the longitudinal one.

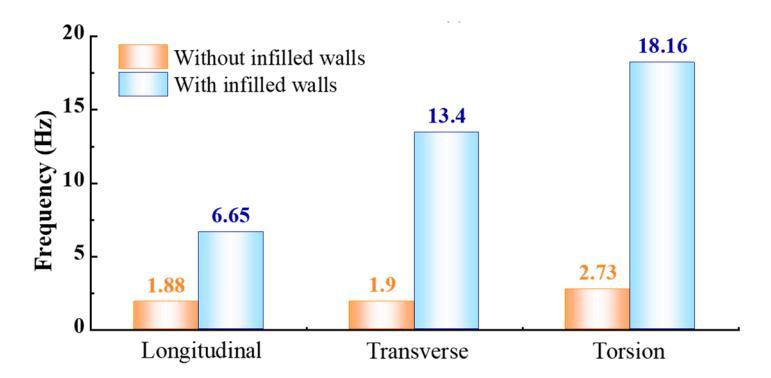
Figure 5. Comparison of structure frequency with or without infilled walls.

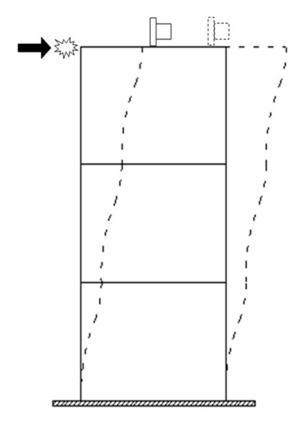
In general, the impulse response of the structure can be obtained by percussion. As shown in Figure 6, the specific method is as follows: tap the top floor with square timbers, and obtain the longitudinal and transverse impulse response of the structure through the acceleration sensor arranged at the centre of the top floor. The sensor layout scheme used in the percussion test is the same as that shown in Figures 3a and 4a.

Figure 6. Percussion test.

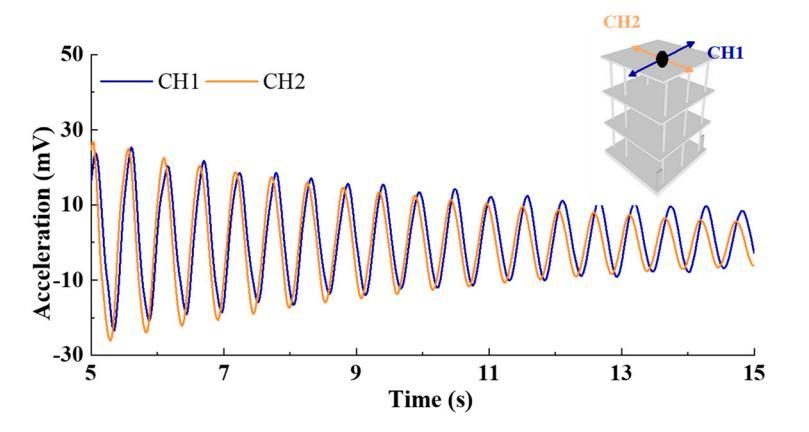
The impulse response before the infilled wall is built obtained by tapping the top floor longitudinally and transversely along the model is shown in Figure 7. It shows that the longitudinal and transverse fundamental frequency of the structure are basically equal, which is consistent with the conclusion drawn from the previous pulsation test. Simultaneously, the attenuation speeds of the longitudinal and transverse acceleration are only slightly different, which illustrates that the damping ratios of the structure in two directions are also relatively close. According to Equation (1), where over j cycles the motion decreases from A_i to A_{i+j} , the longitudinal and transverse damping ratios of the structure are 1.05% and 1.33%, respectively.

Figure 7. Attenuation curve of acceleration of frame without infilled walls.

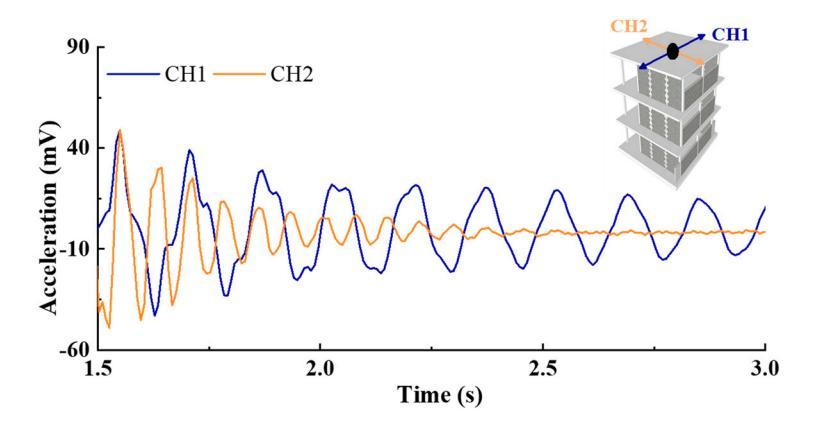
After the infilled wall was built in the model, the same percussion test was carried out on the structure. Figure 8 shows the obtained longitudinal and transverse response. Obviously, the frequency of the structure in the transverse direction is almost twice that in the longitudinal direction according to the time history, which is also highly consistent with the result of the pulsation test. Meanwhile, the attenuation speed of the transverse acceleration is significantly higher than that of the longitudinal one, indicating that the transverse damping ratio of the structure is much larger than that of the longitudinal one after the infill wall is built. Calculated in accordance with Formula (1), the longitudinal and transverse damping ratios are 1.61% and 3.26%, respectively. Figure 9 shows that the damping ratio increases due to the friction between the infilled wall and the frame column or inside the infilled wall. Furthermore, the frictional energy consumption caused by slight deformation is high because of the full-brick infilled wall in the transverse direction. Therefore, the damping ratio is much larger than the longitudinal one.

Figure 8. Attenuation curve of acceleration of frame with infilled walls.

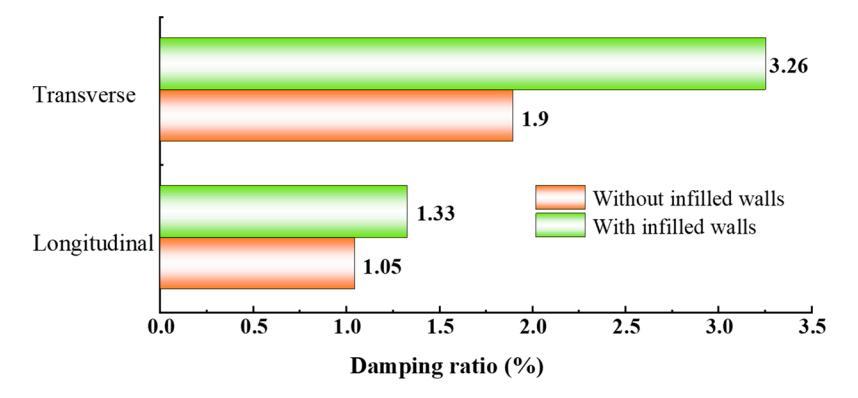
Figure 9. Comparison of structure damping ratio with or without infilled walls.

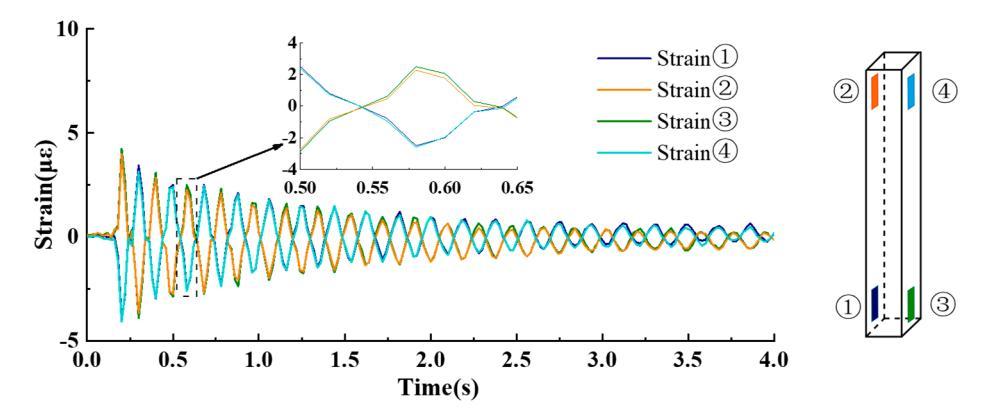
In order to verify the reliability of the strain, multiple strains were arranged at the upper and lower ends of each column. Figure 10 is the strain time history comparison of the upper and lower ends of the column C2 at the bottom layer. This shows that the amplitude and phase of each strain measuring point on the same column behaves normally, which satisfies the deformation characteristics of the frame column, as shown in Figure 11. Specifically, strains on the contralateral side are the same in value but opposite in direction, while strains on the diagonal line are the same both in value and phase. The strain of other columns also possesses such characteristics under careful inspection.

Figure 10. Comparison of strain obtained from one column.

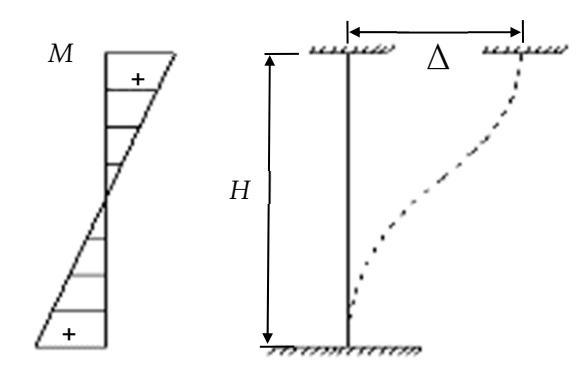
Figure 11. Deformation characteristics of bottom columns.

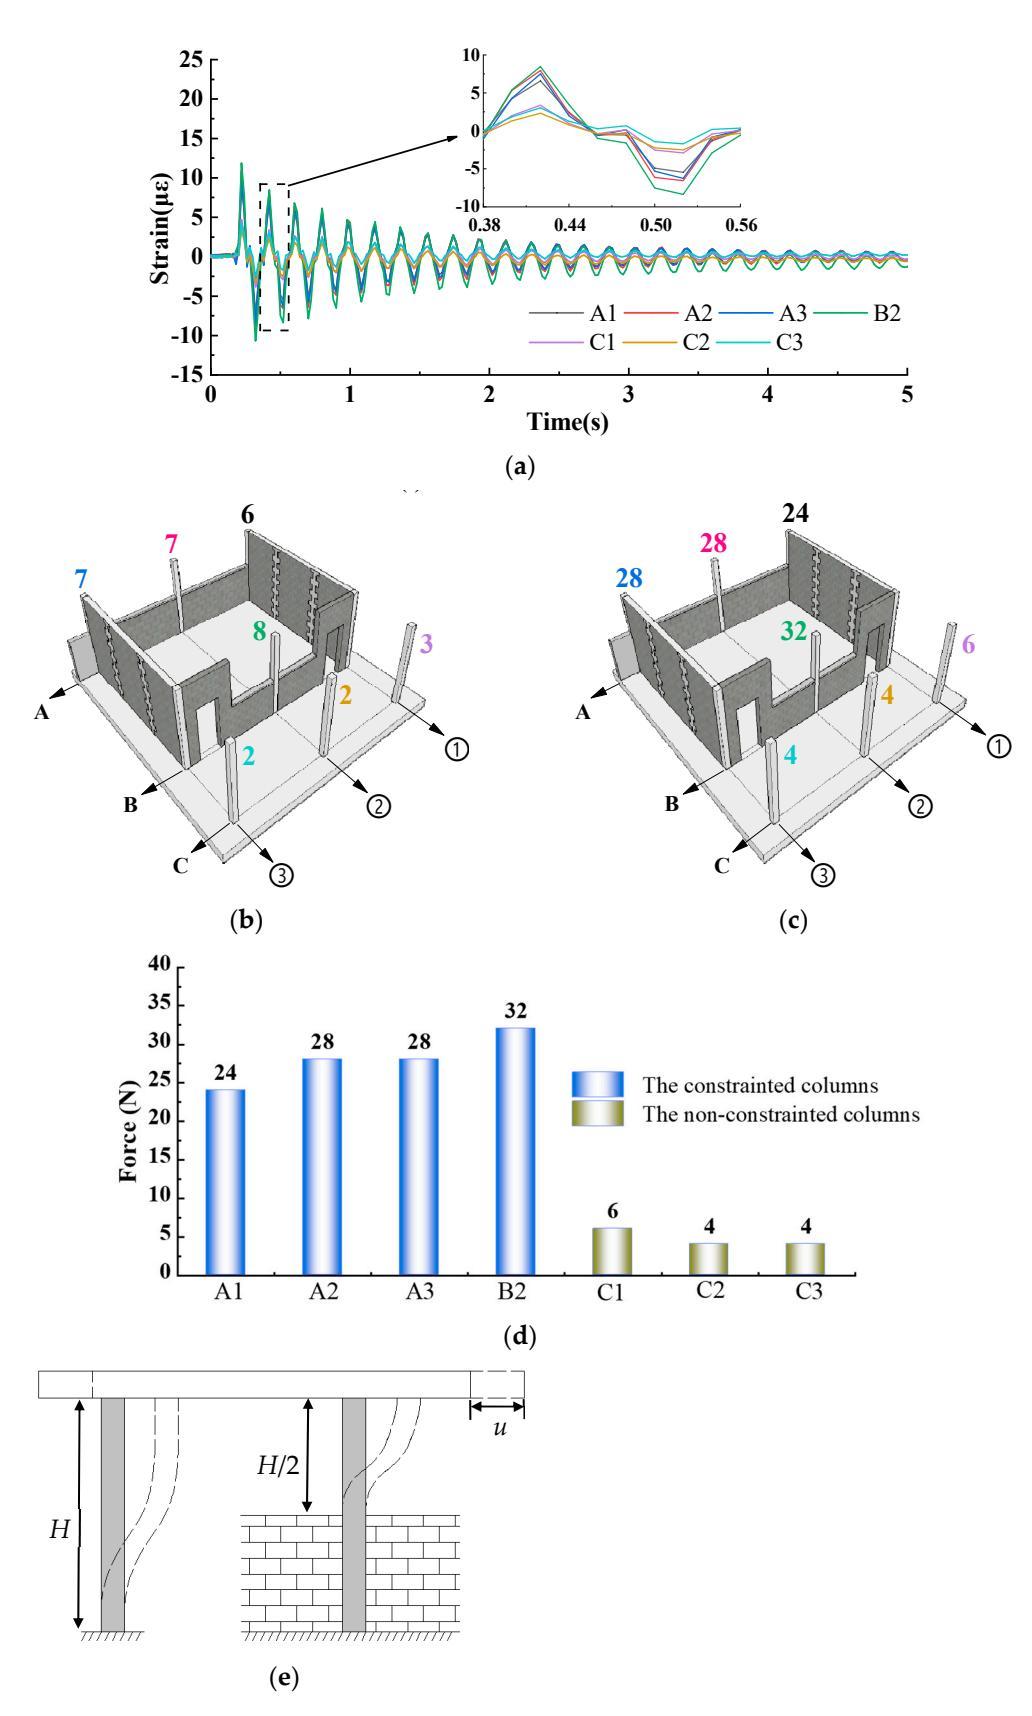
Most of the structural damages of the building start with the failure of the bottom column during an earthquake. Consequently, this test focuses on the impact of the infilled wall on the seismic performance of the bottom column. Figure 12a illustrates the strain t of the upper end of each column on the bottom floor when the top floor slab is struck longitudinally, and the peak strain of each column at t = 0.42 s is selected and marked on the schematic diagram shown in Figure 12b. It can be seen that the strains at the end of the columns (A1, A2, A3, B2) constrained by the longitudinal half-height continuous infilled wall are all within 6 to $8\mu\epsilon$, while those at the end of the unconstrained columns (C1, C2, and C3) are only within 2 to $3\mu\epsilon$, which indicates that the strain at the end of the column constrained by the longitudinal half-height continuous infilled wall is 2 to 4 times that of the unconstrained column for the reason that the column between windows is constrained by the half-height continuous infill wall, and its effective height shortens while stiffness increases, as shown in Figure 12e.

Figure 12. Comparison of strain, internal force distribution and deformation pattern of columns in different constraint condition. (a) Time history of strain on top of columns. (b) Strain of bottom columns at t = 0.42 s (unit: $\mu\epsilon$). (c) Shear force of bottom columns at t = 0.42 s (unit: N). (d) The internal forces distribution of bottom columns at t = 0.42 s. (e) Deformation pattern of columns with or without infilled walls.

When the structure does not undergo torsion and only translates along the longitudinal direction, the shear force is distributed according to the stiffness and then highly concentrated on the restrained column, making it easier to form a plastic hinge. Additionally, the internal force distribution between the frame columns at the bottom is then obtained from Equation (2), as shown in Figure 12c,d. It can be found that the shear forces of the columns (A1, A2, A3, B2) constrained by the longitudinal half-height continuous infilled wall reach 24 to 32N, respectively, while those of the unconstrained columns (C1, C2, C3) are only 4 to 6N, which shows that the shear force of the constrained column is 4 to 8 times that of the unconstrained column under the same lateral displacement.

ε denotes the strain at the end of the column, which is determined according to Figure 12b;

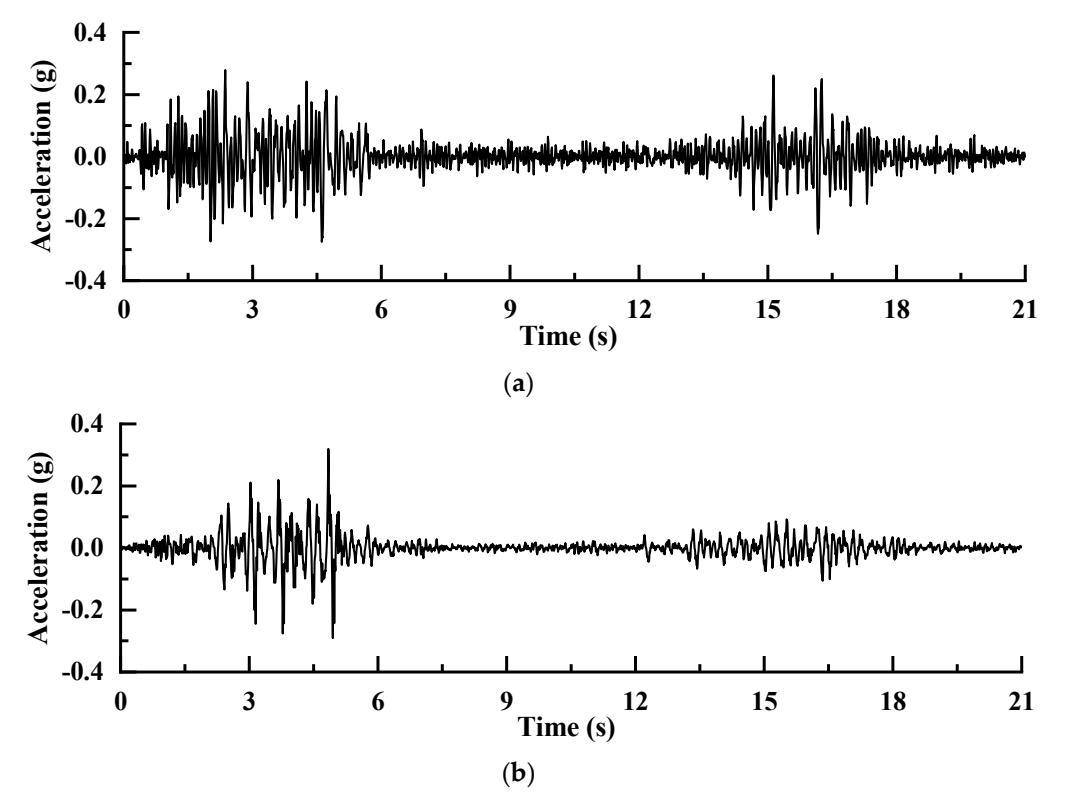
Figure 13 demonstrates the acceleration time history, the original record of which can date back to the Wolong seismic wave of the Wenchuan earthquake, obtained by the longitudinal and transverse sensors deployed on the platform. The figure shows that the longitudinal and transverse peak accelerations of the platform are 0.28 g and 0.32 g,respectively.

Figure 13. The acceleration of the shaking table. (a) Longitudinal. (b) Transverse.

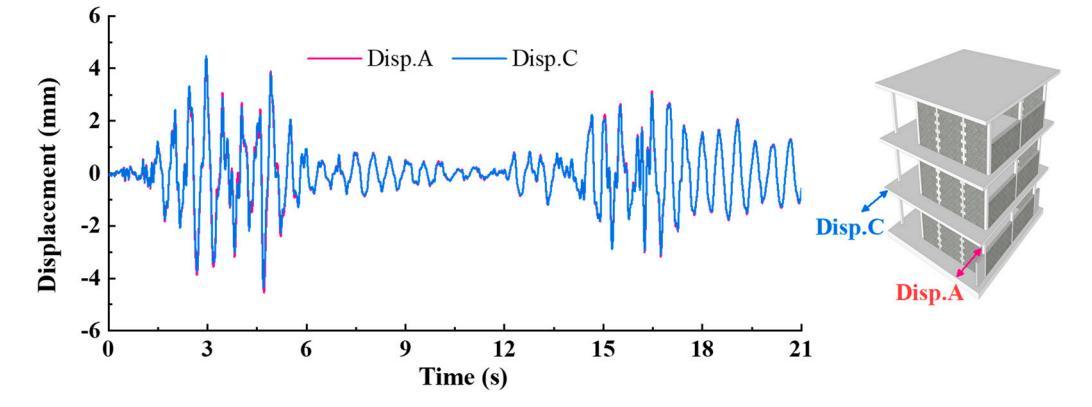
For the purpose of observing whether the torsion of the structure occurs under bidirectional seismic inputs, a set of high-precision displacement sensors (Disp. A and Disp. C) are placed on the bottom floor of the structure. If torsion occurs, the signal will then show the characteristics of the opposite phase.

Figure 14 shows that the signals obtained by the two longitudinally arranged sensors are completely coincident with equal magnitude and the same phase, which indicates that the structure only translates in the longitudinal direction without torsion under the action of a bidirectional earthquake, satisfying the prerequisite of the seismic shear force distributed by the lateral stiffness of the members.

Figure 14. Comparison of displacement of axis A and C in earthquake.

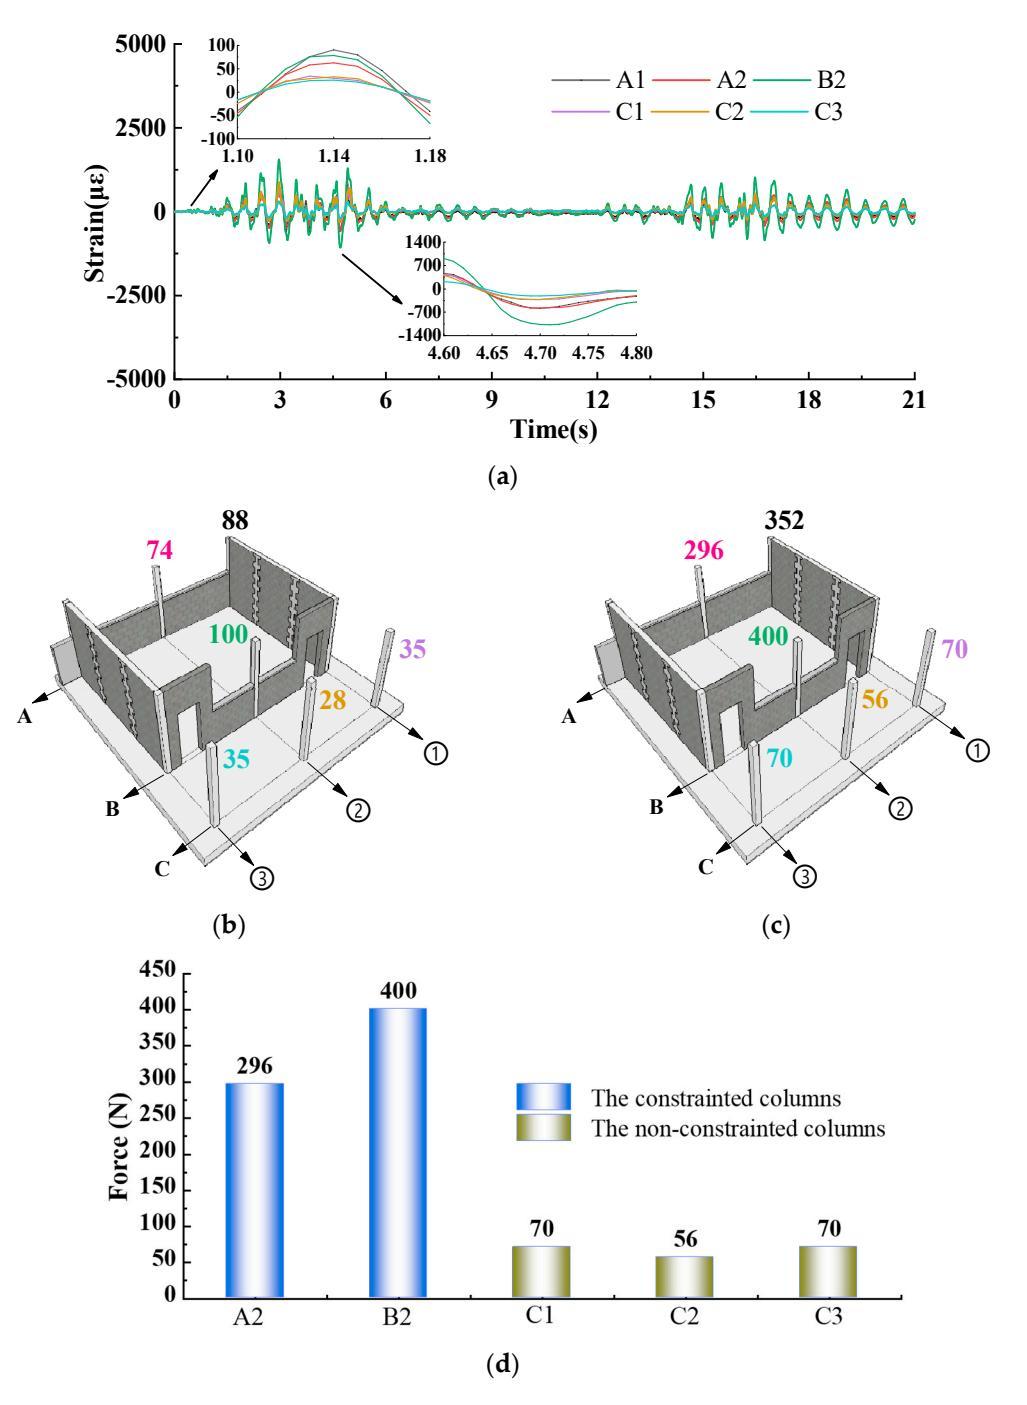
Under the bidirectional seismic inputs, the strain of the bottom column is obtained. The strain shown in Figure 15a is selected for analysis to verify whether conclusions obtained from the percussion pulse excitation are consistent with the internal force distribution under the earthquake. The figure exhibits that the peak strain of each column at the initial

The strain of the upper section of each column in Figure 15a is marked in Figure 15b; then, the schematic diagram of the internal force distribution can be calculated according to Formula (2), as shown in Figure 15c. (The strain gauge at the end of column A3 does not work normally, so its relevant information is not marked in the diagram). It can be seen that the strains of the columns (A1, A2, and B2) constrained by the longitudinal half-height continuous infilled wall reach 74 to 100 $\mu\epsilon$, respectively, with corresponding transverse shear forces of 296 to 400N, while those of the unconstrained columns (C1, C2, and C3) are only 28 to 35 $\mu\epsilon$, respectively, with seismic shear forces of 56 to 70N. Apparently, as is shown in Figure 15d, the conclusions drawn from the bottom column of the structure under the seismic action and the percussion pulse excitation are highly consistent; namely,

the strain of the bottom column constrained by the half-height continuous infill wall is 2 to 4 times that of the unconstrained one, while the seismic shear force assigned to the former is 4 to 8 times that assigned to the latter.

Figure 15. Comparison on strain and internal force distribution of columns in different constraint condition in earthquake conditions. (a) Time history of strain on top of columns in earthquake. (b) Strain of bottom columns at t = 1.14 s (unit: $\mu\epsilon$). (c) Shear force of bottom columns at t = 1.14 s (unit: N). (d) The internal forces distribution of bottom columns at t = 1.14 s.

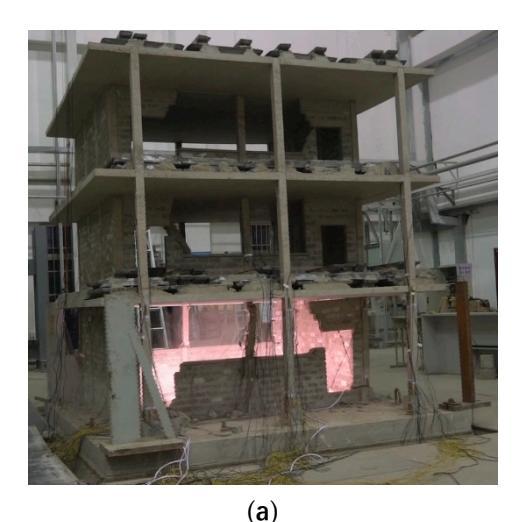
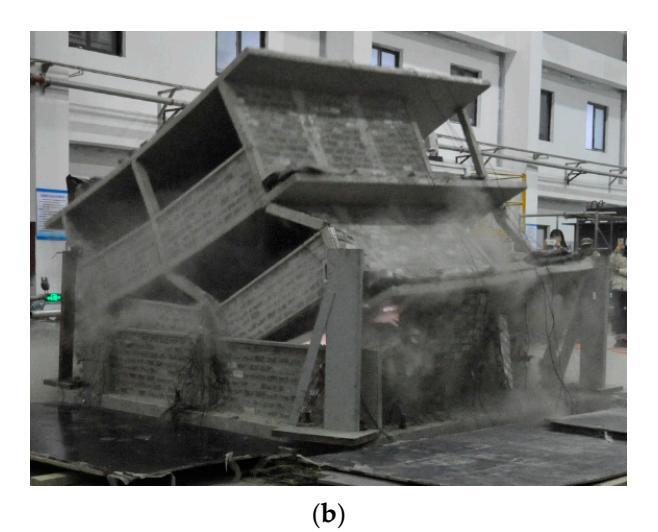
Figure 16 shows the destruction of the structure near the collapse. As can be seen from the figure, the damage occurs mainly on components of the bottom layer instead of the second and above ones since the vertical load and seismic shear force of components of the bottom layer are both greater than those of the upper layers. The transverse full-brick infill wall has a large lateral stiffness, which restrains the transverse deformation of the structure under the earthquake and causes a severe shear failure to occur when experiencing a large earthquake.

Figure 16. The restrained column takes the lead in bearing failure, resulting in collapse of the structure. (a) The restrained columns are seriously damaged. (b) The structure collapses.

In addition, there are damages of different degrees shown at the ends of the bottom columns. In particular, such damages often occur in the window column constrained by the half-height continuous infilled wall before the corridor column. Generally speaking, the shear span ratio can reflect the difficulty of the shear failure of the structure to a certain extent. Even if the window column is constrained by the half-height continuous infill wall, its shear span ratio by calculation is $3.5 (\lambda > 2)$, which indicates that it is still a long column, and its damage pattern is curved, which is consistent with the experimental results.
