Article The Masterful Water Engineers of Machu Picchu

Kenneth R. Wright

Keywords: Machu Picchu; Inca; ancient water engineering; hydraulics

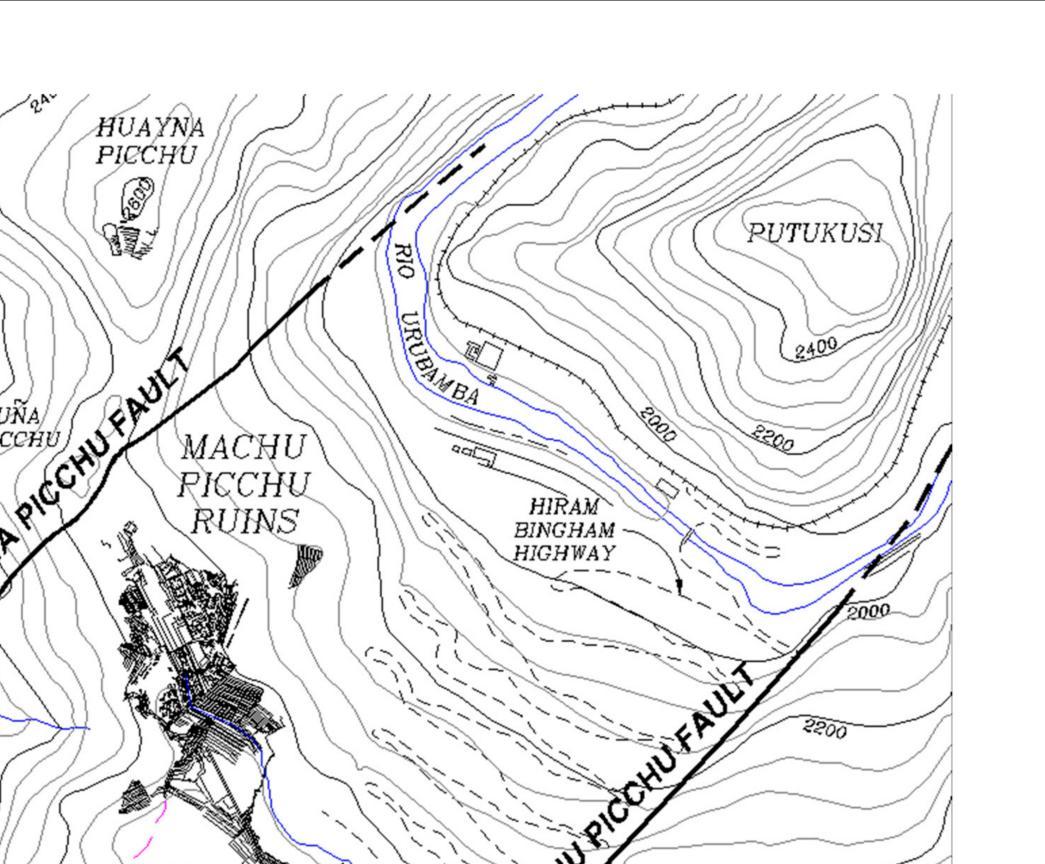
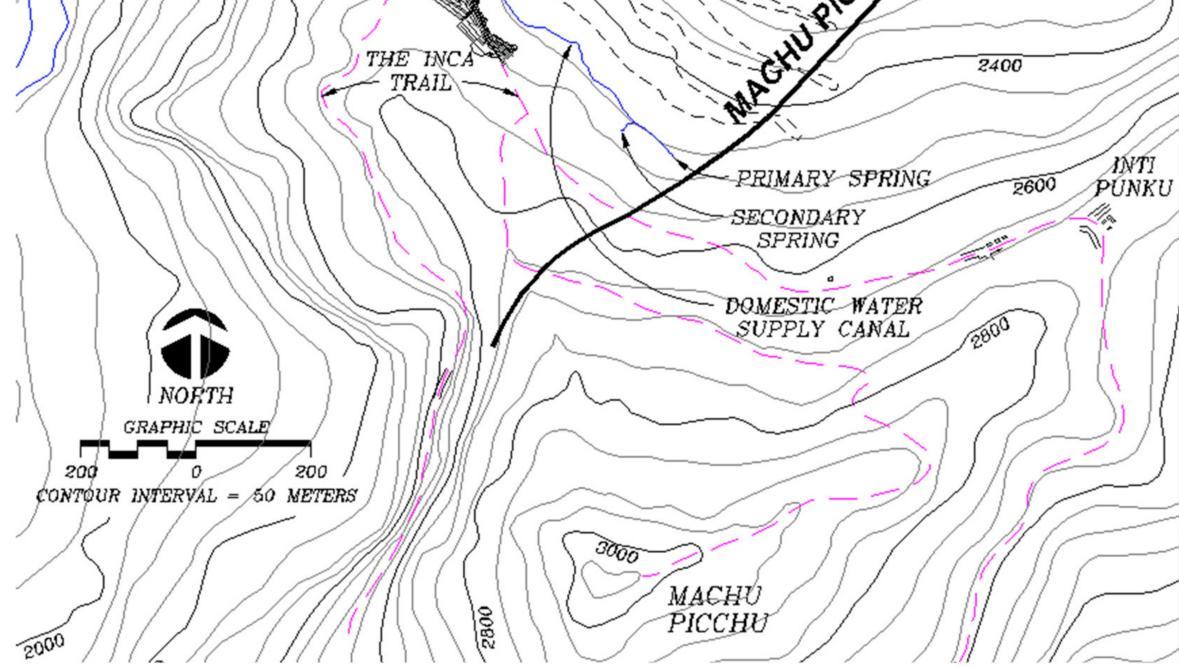
Figure 2. Machu Picchu lies between two faults. (Reproduced from Machu Picchu: A Civil Engineering Marvel [5], with permission from ASCE, the publisher.)

The ridge-top site of Machu Picchu, at an elevation of 2430 m, lies between two regional geologic faults (Figure 2), and is a steep 450 m above the Urubamba River. These faults formed a graben upon which Machu Picchu was built, and which relates to the up thrusted twin peaks of Huayna Picchu and Machu Picchu to the north and south at 13°9′ south of the Equator in the headwaters of the Amazon River basin. Machu Picchu experienced moderate temperature variations and high annual rainfall of approximately 2000 mm, as shown in Table 1 [5].

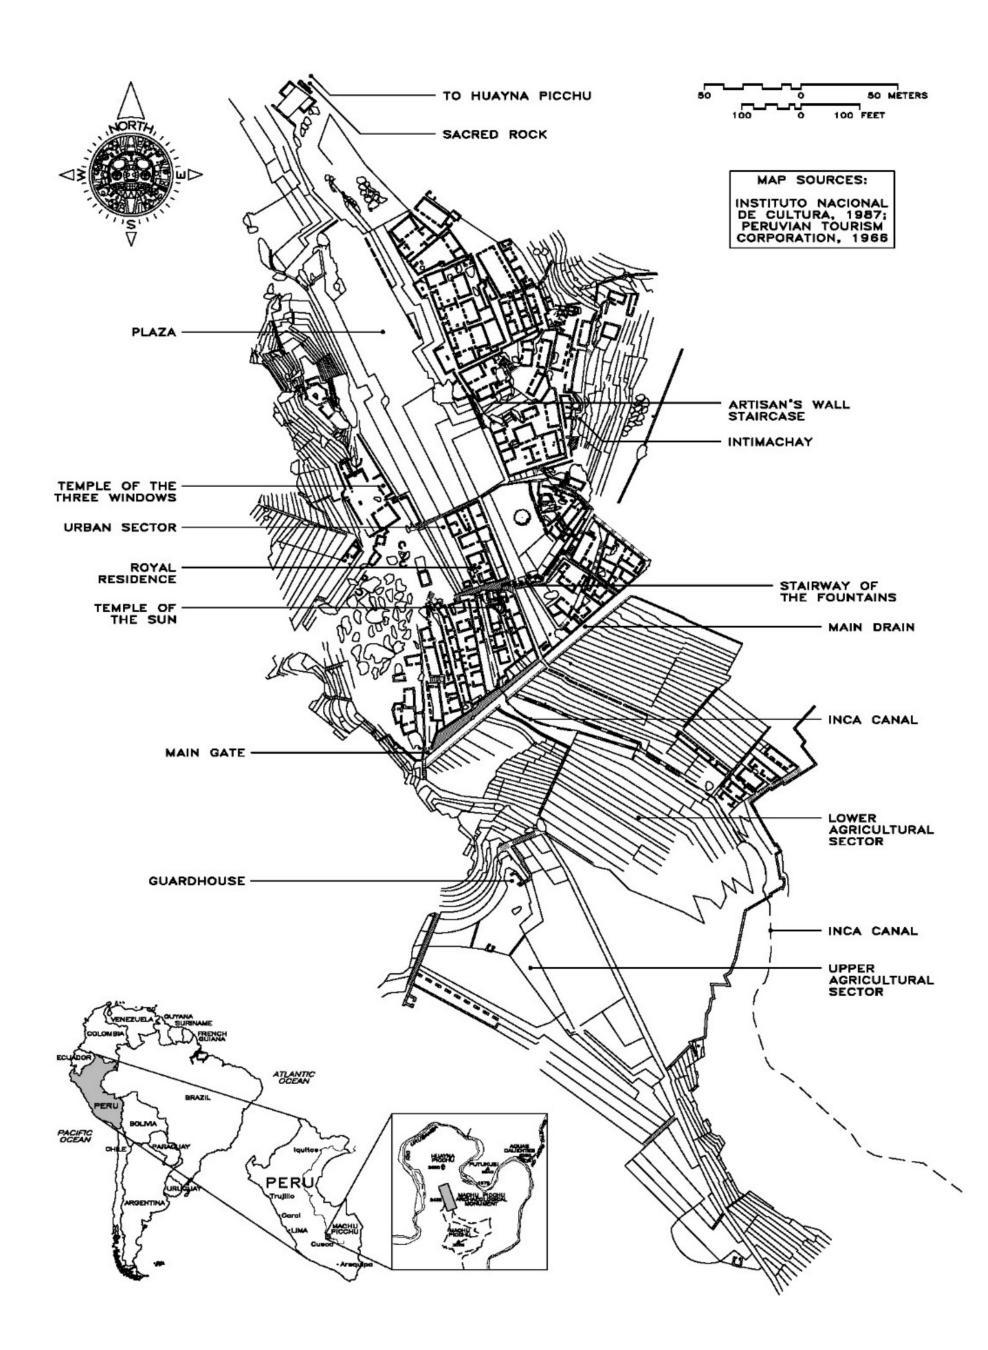
Figure 3. Site map showing layout and key features of Machu Picchu site.

The rainfall, typical ground slopes of 50 percent, local faulting, and soils that are prone to landslides presented the Inca engineers with many challenges to overcome. Overcome them they did, for Bingham's 1912 photographs and descriptions show Machu Picchu to have been nearly free of damaging landslides and failed foundations after 340 years. It is known, however, that the Inca did experience some failures such as a large earth slide near the Main Drain (Figure 3 shows the layout of Machu Picchu and key features such as the Main Drain).

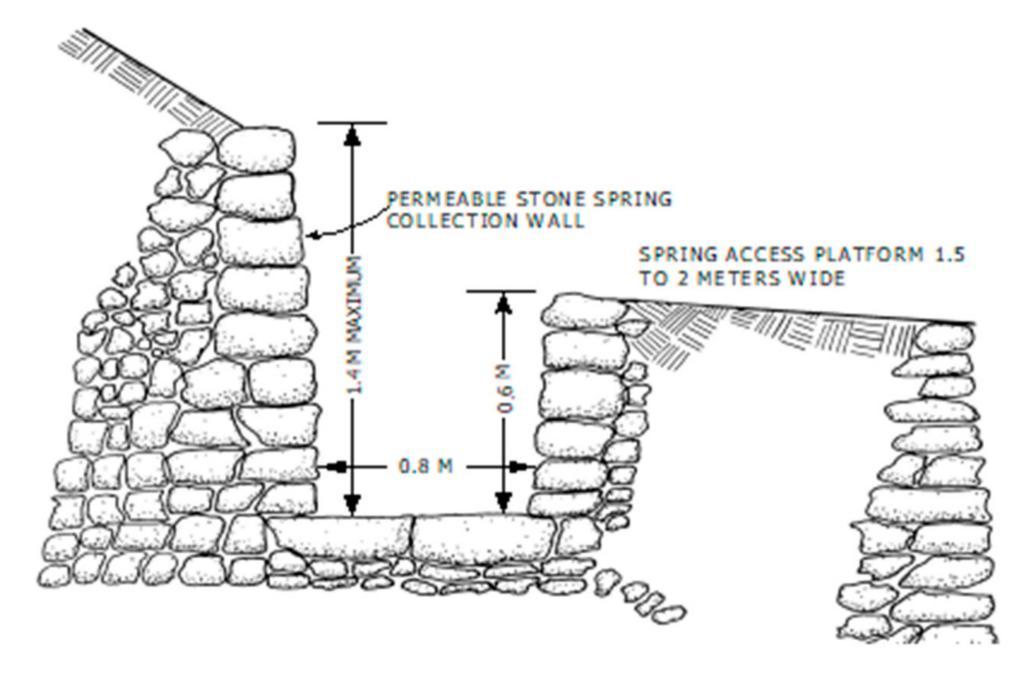
Figure 4. Cross-section of the Inca Spring collection system, which enhanced the domestic water supply for Machu Picchu. The yield of the spring was maximized by a permeable stone wall set into the steep hillside and a collection trench, which in turn fed the canal shown below (Reproduced from Machu Picchu: A Civil Engineering Marvel [5], with permission from ASCE, the publisher.)

The Machu Picchu geologic fault caused fracturing and crushing of the adjacent hard granite rock, which in turn resulted in a natural spring water source on the north slope of Machu Picchu Mountain. [5]. The Inca, using a clever groundwater interception structure (Figure 4), carefully developed this spring, which then fed a long domestic water supply canal (Figure 5). The canal traversed the steep mountainside on a narrow terrace formed by a sturdy and well-founded wall—in some places, 4 m in height. The canal, 749 m in length, was built at an engineered slope with a typical hydraulic cross-section of 13 cm \times 12 cm, making it capable of handling up to 300 L per minute. The measured spring yield is 23 to 125 L per minute, as shown in Figure 6.

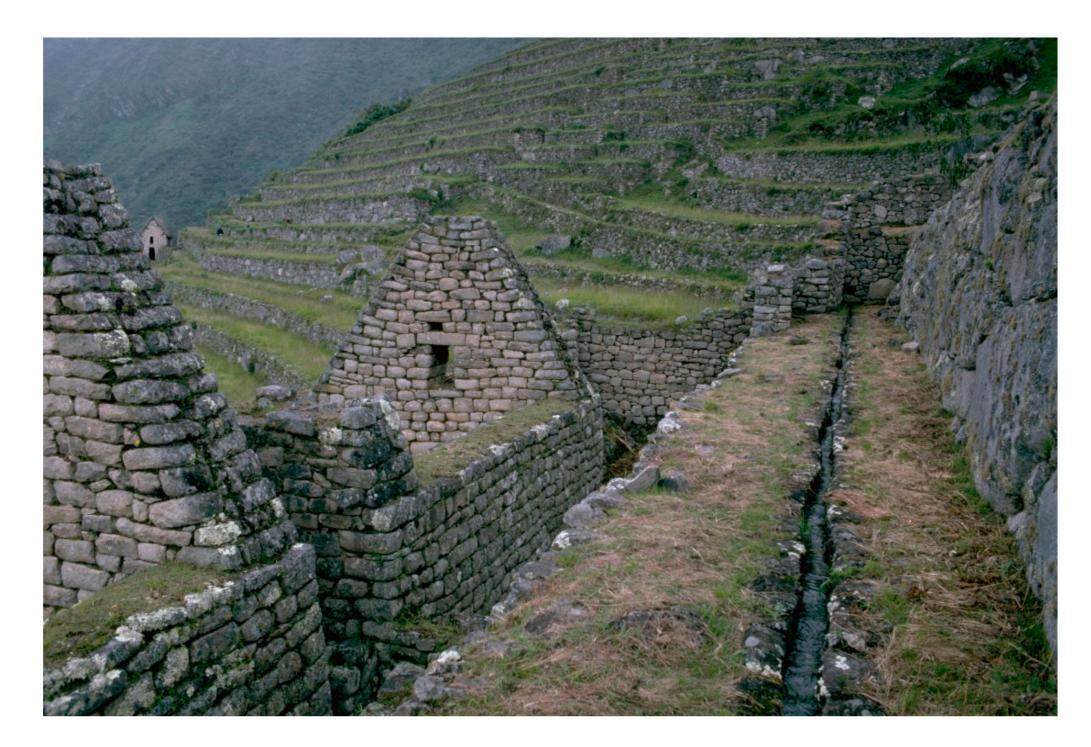
Figure 5. The canal at Machu Picchu runs past grain storehouses on a finely constructed terrace.

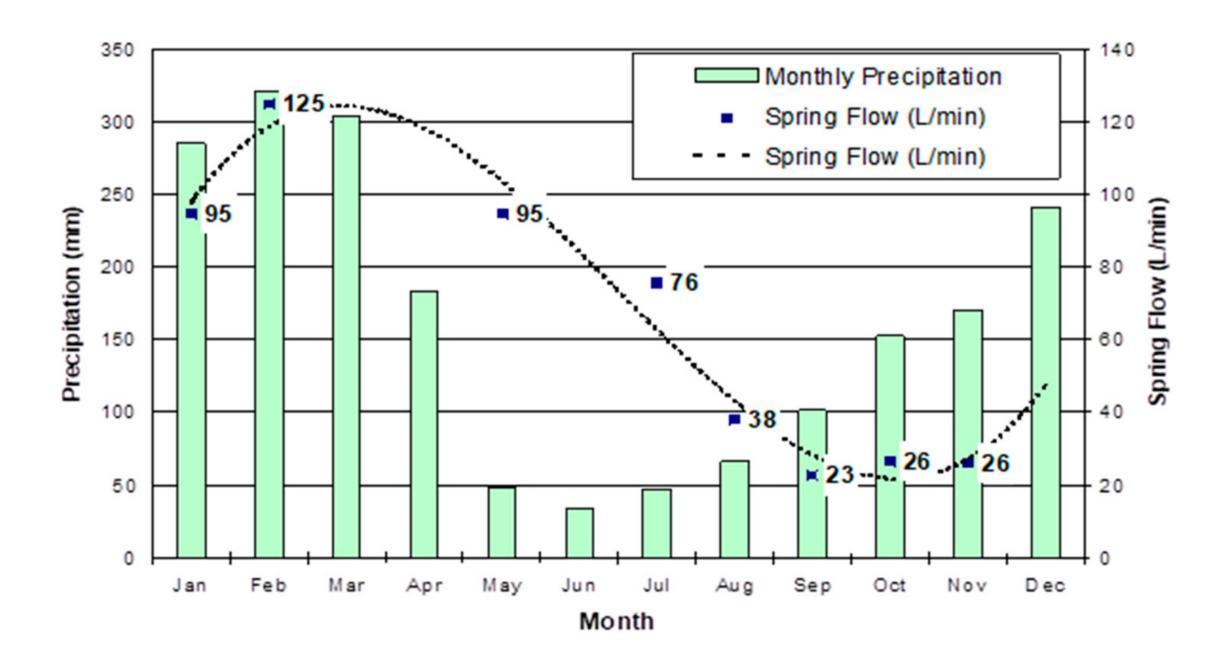
Figure 6. Variations of Inca Spring flow by season. The green bars indicate average precipitation while the squares represent average seasonal measurements of spring flow. The dotted line shows interpolated spring flow, representing a lag time of several months. Based on interpretations of Quelccaya ice cap data [6], modern precipitation data correspond closely with estimated precipitation during the period of Machu Picchu occupation. (Reproduced from Machu Picchu: A Civil Engineering Marvel [5], with permission from ASCE, the publisher.).

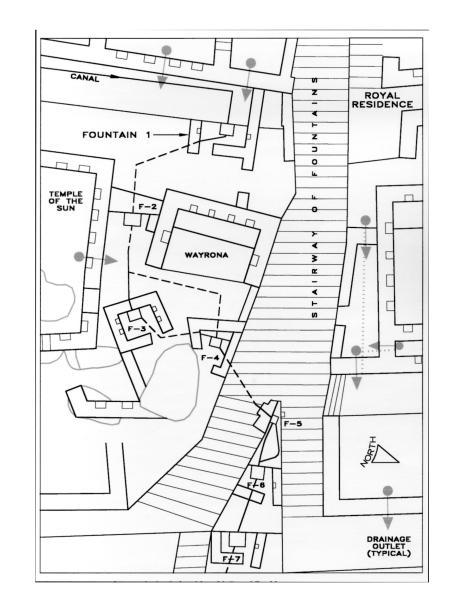
Figure 7. Map of canal and fountains showing relationship to Royal Residence. Fountain #3 (F-3) is the Sacred Fountain. (Reproduced from Machu Picchu: A Civil Engineering Marvel [5], with permission from ASCE, the publisher.)

The Inca canal delivered its water supply by gravity to Fountain #1 at an elevation of 2437 m, which then defined the location of the entrance to the Royal Residence, allowing the emperor to have first use of the pure spring water. Here, the Temple of the Sun, the Sacred Fountain, and the Wayrona were also built. Additionally, incorporated into the special complex were Fountains #2 through #6 (Figure 7).

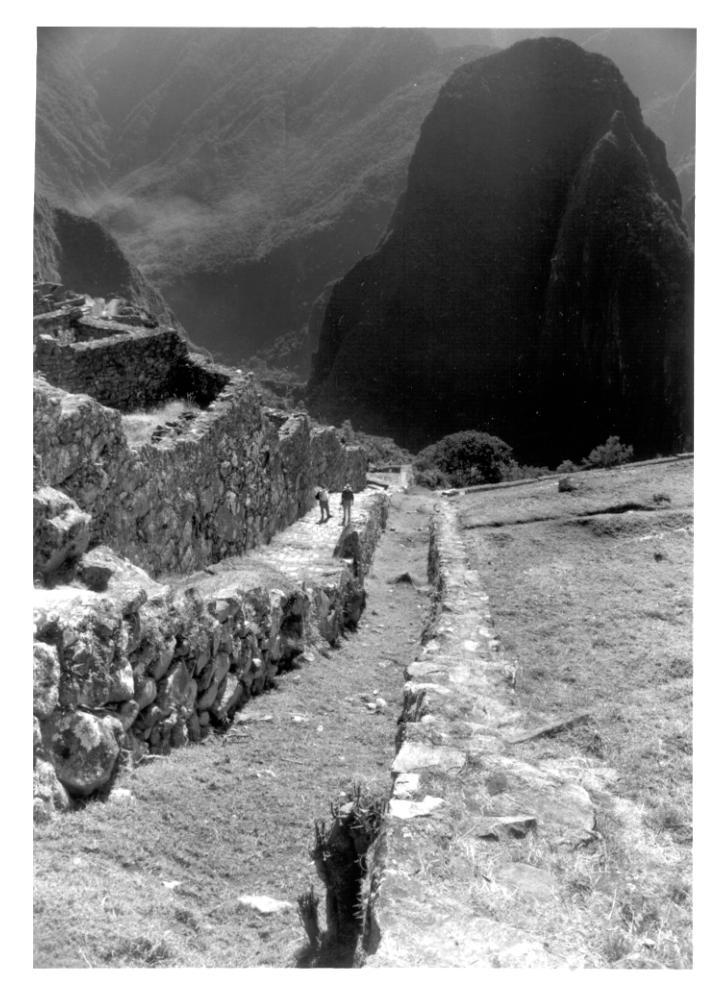
Figure 8. The main drain or "dry moat" was the route for wastewater to exit the Machu Picchu site. The wastewater flowed to the rainforest below, where lush vegetation minimized the erosive potential of the drainage.

Downhill, another ten fountains were constructed in series for domestic water supply purposes with the last fountain being a private water supply accessible only from the Temple of the Condor. The remaining water was then carried in a buried conduit and then an open channel for discharge as waste into the Main Drain (a.k.a. Dry Moat) (Figure 8).

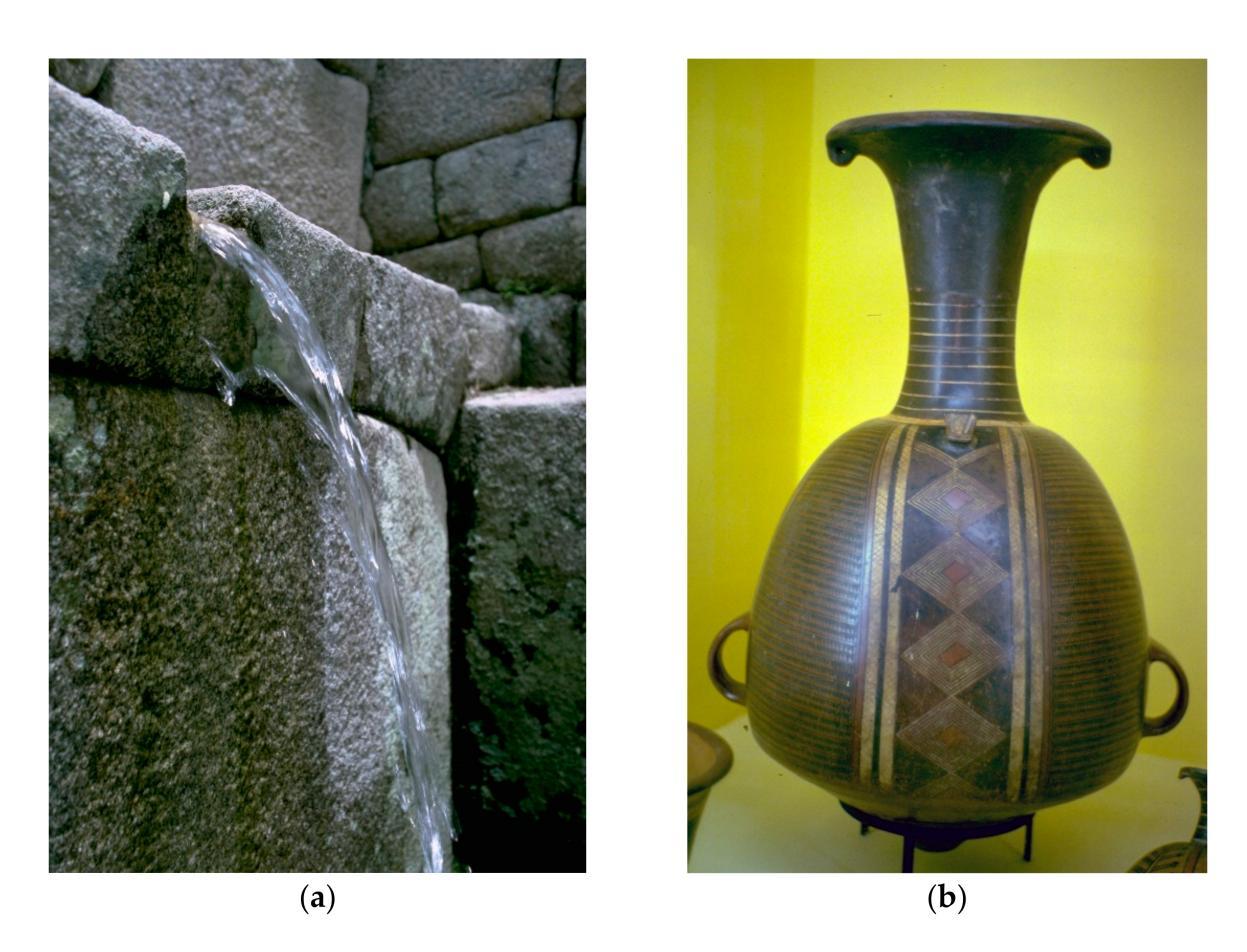
Figure 9. Inca engineers designed water jets that were sized perfectly for the range of flows (**a**) and which allowed for clay Inca water jugs known as aryballos (**b**) to easily be filled.

The fountains of Machu Picchu are well engineered for the volume and flow of water provided by the Inca Canal. The approach channels were carefully carved to create a jet that would allow for the filling of Inca water vessels called aryballos (Figure 9). The hydraulic design of the fountains allowed for reasonable operation for a flow of between 10 and 100 L per minute. At flows of more than 100 L per minute, a control orifice in Fountain #4 would reject excess water for overflow down the granite stairway of the fountains [5].

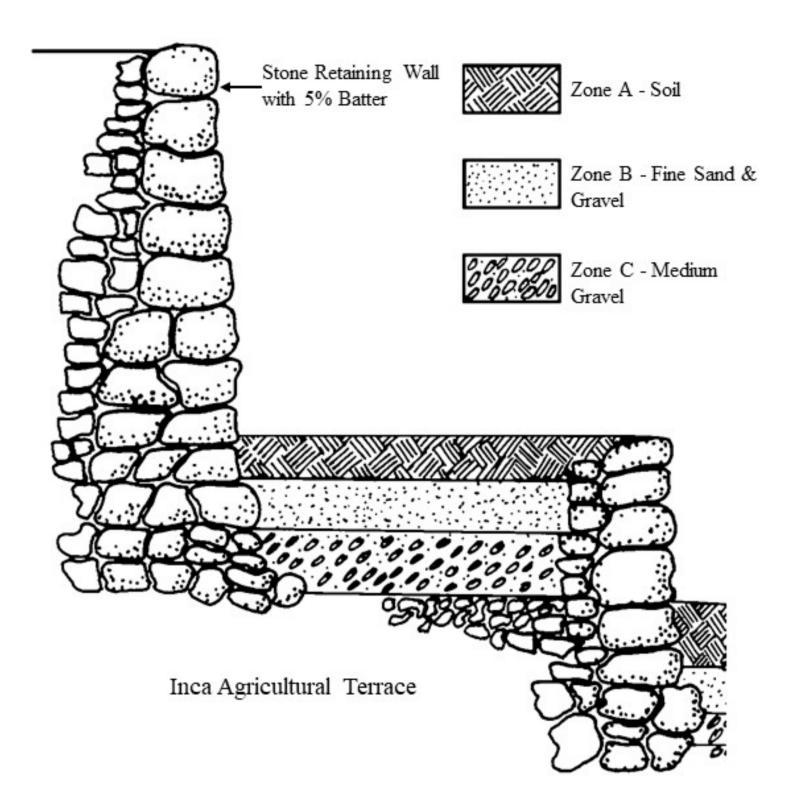
Figure 10. Good subsurface drainage in the agricultural terraces ensured that much of the rainfall percolated down into the permeable zone. (Reproduced from Machu Picchu: A Civil Engineering Marvel [5], with permission from ASCE, the publisher.)

Nowhere are the fruits of good drainage, erosion control, and soil stewardship more evident than at Machu Picchu. The terraces were found by Bingham to be free from erosion and sedimentation even after nearly 400 years of lying unattended because the Inca engineers were as good at engineering substructure as they were at engineering the beautiful walls for which they are known. Narrow, steep terraces climb up every possible slope, including the Intiwatana pyramid and the crown of Huayna Picchu, to keep soil in its place and erosion at bay. Figure 10 shows the typical subsurface drainage employed in the fill between the terrace walls.

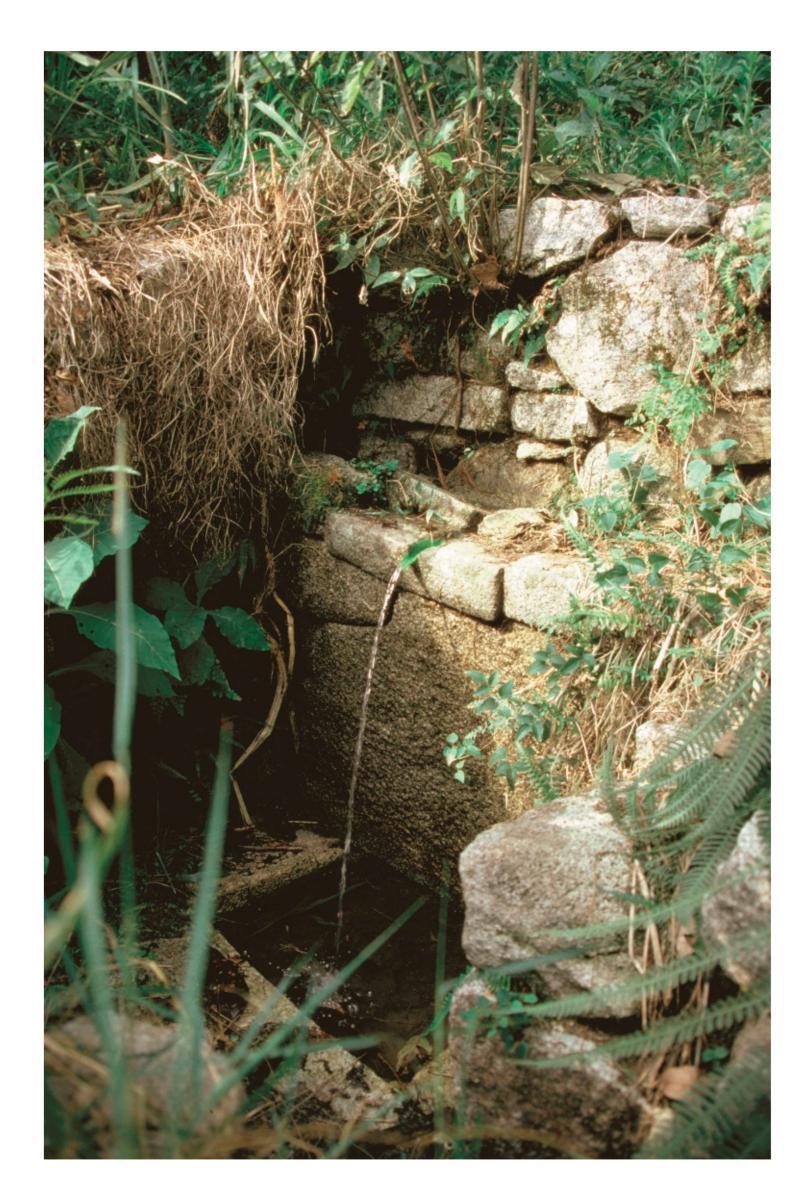
Figure 11. This long-buried fountain along the Inca Trail still operated after centuries of neglect. This photograph was taken a year after it was uncovered during East Flank trail clearing.

During our East Flank excavations, we unearthed two ceremonial fountains, which sprang into life and flowed again after the debris was removed (Figure 11). To assure that the two ceremonial fountains would not overflow during periods of excessive water yield, a hydraulic bifurcation was built upstream of the upper fountain so that excess water would be diverted into a stone-formed conduit for discharge to an adjacent drainage channel. This is evidence that the Inca engineers understood the fundamental mechanics of water flow, and that they had the ability to enhance the hydraulic operation of the fountains to account for periods of low flow.
