# Experimental and Numerical Investigation into Active–Passive Behavior and Shear Resistance of Anchored Rock Joints

To elucidate the active–passive reinforcement mechanisms of rock bolts and the evolution of shear strength in anchored rock joints, this study integrates theoretical analysis, laboratory direct shear tests, and numerical simulations to investigate the deformation and failure characteristics of fully grouted, end-anchored, and prestressed bolted specimens. The results show that bolt reinforcement can be classified into prestress-dominated active action and dislocation-induced passive action. The shear strength curve of anchored rock joints exhibits four distinct stages with increasing shear displacement: initial slip, elasticity, yielding, and softening. Fully grouted bolts fail primarily by tensile–shear fracture, enabling a rapid increase in shear strength at small displacements. In contrast, end-anchored bolts undergo S-shaped bending and form symmetrical plastic hinges on both sides of the joint, sustaining resistance under large displacements albeit with lower peak strength. While the laboratory tests experimentally clarified the distinct failure modes and passi

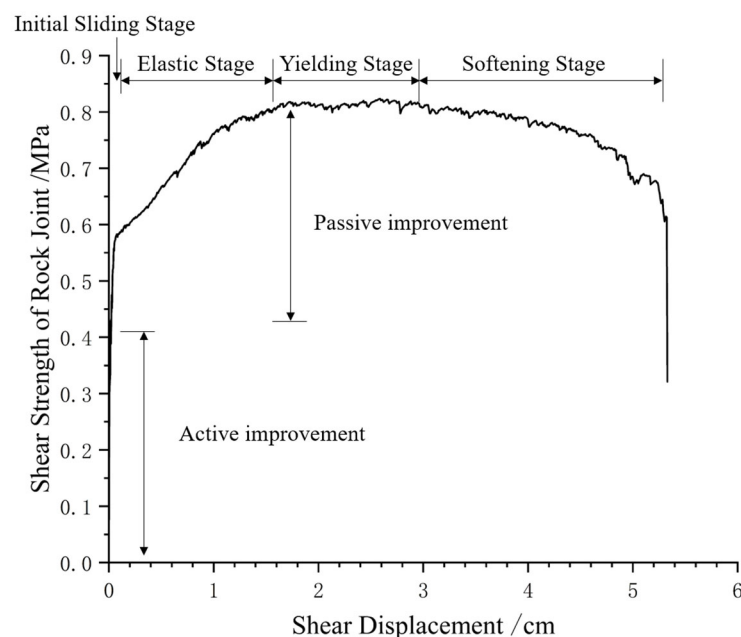
Based on the origin of stress generation within the bolt, the reinforcement effect is classified into active action and passive action. Active action refers to the enhancement of shear strength induced by bolt pre-stress prior to any displacement. Passive action refers to the enhancement induced by the dislocation of the rock joints themselves. As the rock joint dislocates, the shear strength curve can be divided into four distinct stages: initial slip, elastic stage, yielding stage, and softening stage, as illustrated in Figure 1.

**Figure 1.** Shear strength variation in bolted rock joints.

In summary, the primary characteristic of active action is the provision of immediate shear strength prior to the movement of rock joints, effectively controlling early-stage dislocation. In contrast, passive action is characterized by the increase in bolt axial force resulting from local deformation caused by ongoing dislocation, thereby continuously enhancing shear strength as the displacement progresses.

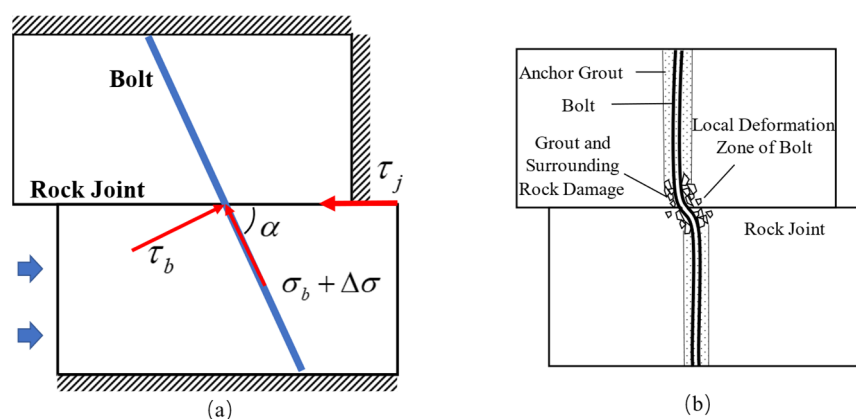
With the dislocation of the rock joints, the force condition of the bolt is shown in Figure 2. Among these parameters:

**Figure 2.** Schematic diagram of bolt reinforcement mechanism acting on the rock joints. (a) Macro-mechanical model showing the force state. (b) Micro-damage model showing grout and bolt deformation.

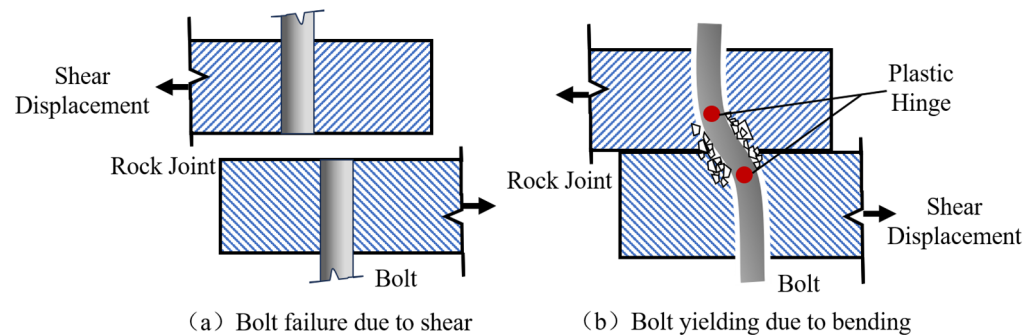
Shear failure occurs when the local damage to the grout at the rock joints is negligible or very limited. In this scenario, as the surrounding rock displaces, shear forces dominate, leading to the direct cutting of the bolt shank, as illustrated in Figure 3.

**Figure 3.** Failure modes of bolts at rock joints: (a) shear failure, where the bolt is fractured across the rock joints; (b) bending yield, where a plastic hinge is formed in the bolt due to bending deformation.

Bending yield occurs with increasing shear displacement, accompanied by progressive damage to the grout near the rock joints. When the damage range of the grout reaches or exceeds  $5d$  (where  $d$  is the bolt diameter), plastic hinges form on both sides of the rock joints, as shown in Figure 3. At this stage, further dislocation does not increase the shear strength of the rock joints, indicating that the bolt has reached its limit state and is considered to have failed.

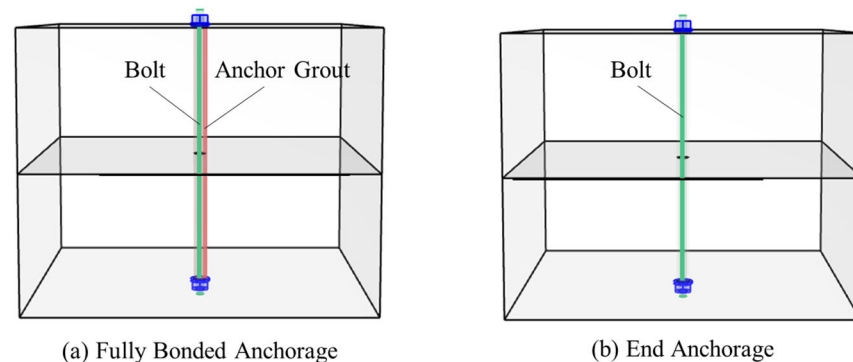
Two anchorage scenarios were investigated in this study: fully grouted anchorage and end-anchorage, as illustrated in Figure 4. For the fully grouted specimens, the borehole was first filled with epoxy-based rebaring adhesive, followed by the insertion of the bolt, installation of the washer, and tightening of the nut. For the end-anchored specimens, the bolt was inserted directly into the borehole without filling the entire hole, and then the washer was installed, and the nut was tightened to secure the bolt.

**Figure 4.** Schematic diagram of specimens with different anchoring conditions.

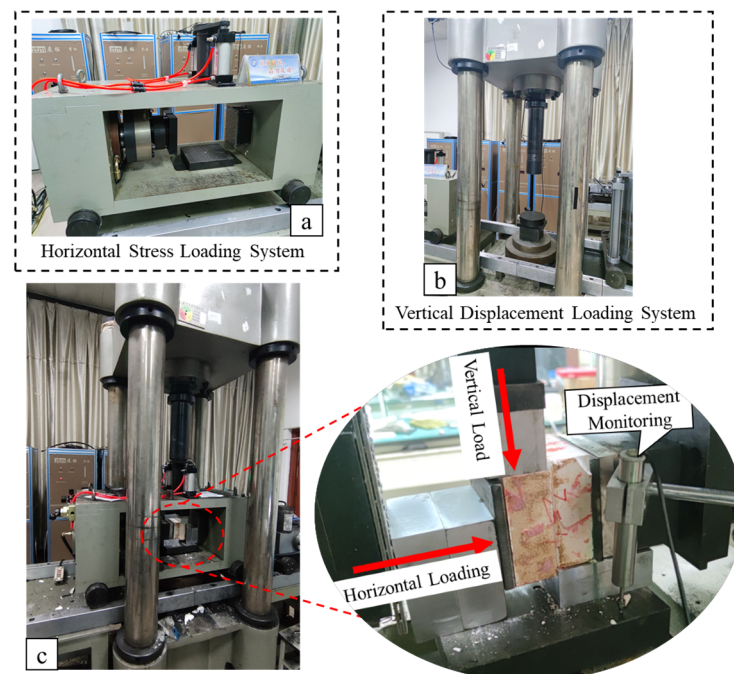
**Figure 5.** Test system and loading method. (a) Horizontal loading system for applying normal stress to the rock joint. (b) Vertical loading system for inducing rock joint dislocation. (c) RLJW-2000 machine and close-up of the bolt-joint configuration within the shear box.

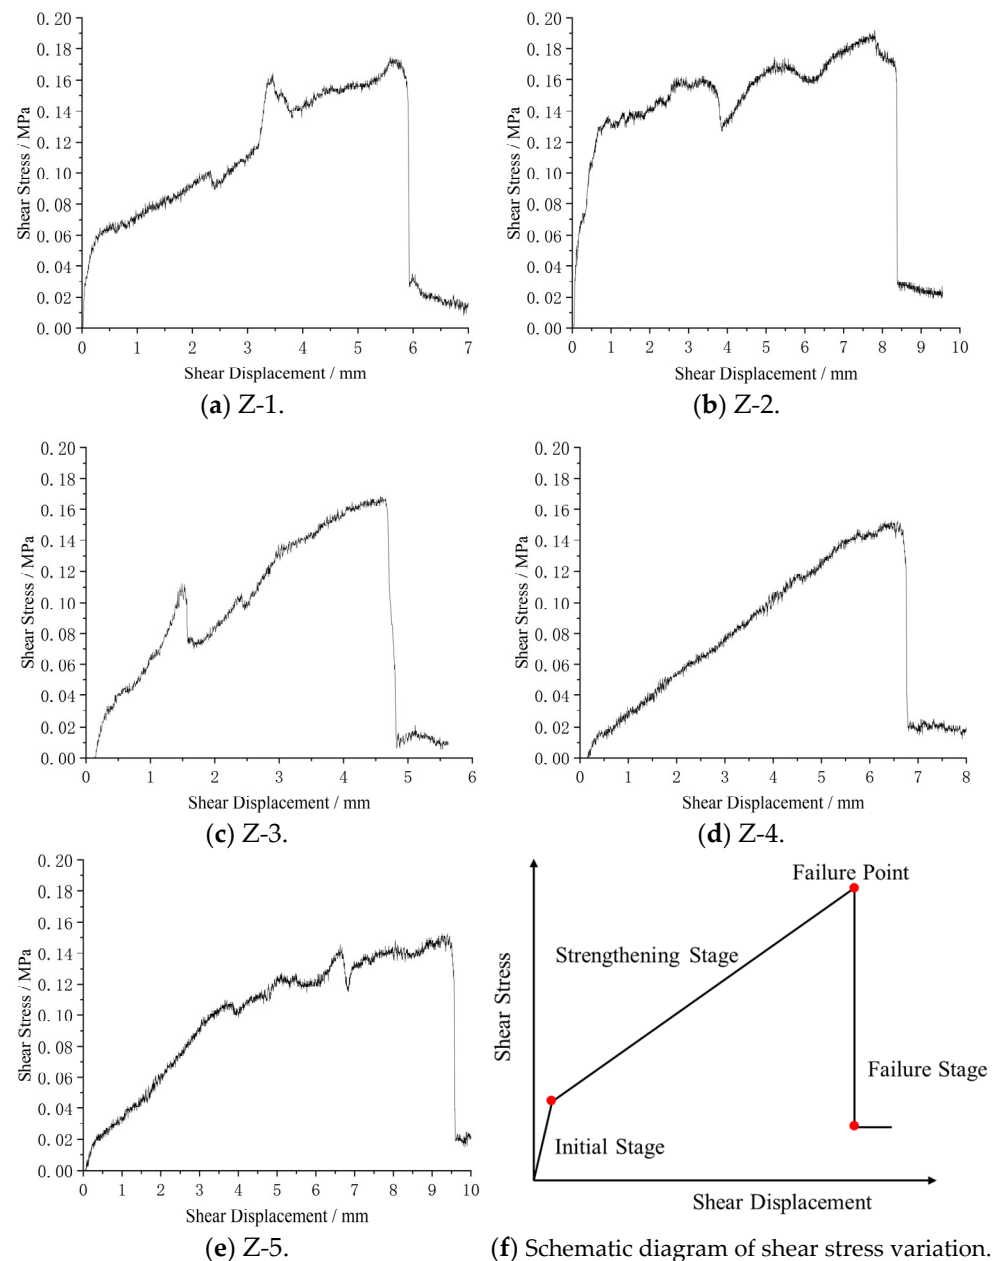
Under fully grouted conditions, the variation curve of the rock joints shear stress with dislocation is shown in Figure 6. It can be observed that the shear stress curve can be divided into three distinct stages:

1. Initial Stage: The shear stress increases sharply with shear displacement, exhibiting a steep slope.
2. Strengthening Stage: Compared to the initial stage, the growth rate of shear stress slows down, showing a relatively reduced slope.
3. Failure Stage: The bolt within the rock joints fractures, leading to a rapid drop in shear stress. The residual shear stress corresponds to the inherent shear strength of the rock

joints ( $\tau_j$ ). At this point, the increment of shear strength provided by the bolt ( $\Delta\tau$ ) is quantified as the difference between the peak stress and  $\tau_j$ .

**Figure 6.** The variation curve of shear stress of the rock joint under a full-anchor condition.

Second, the abrupt fluctuations observed in the shear stress curves (Figures 6 and 8) are attributed to the rotation of the rock joints induced by bolt deformation. Although horizontal constraints were applied, the tilting of the specimen altered the angle between the loading platens (Figure 17), leading to sudden variations in the normal stress perpendicular to the rock joints and causing mutations in the shear stress curves. Ideally, the RLJW-2000 testing machine utilizes servo control to maintain constant horizontal stress. However, in practice, the angular misalignment between the horizontal platens resulting from the specimen's tilt significantly affected the normal stress during shear displacement. Consequently, maintaining a strictly constant normal stress throughout the test proved challenging.

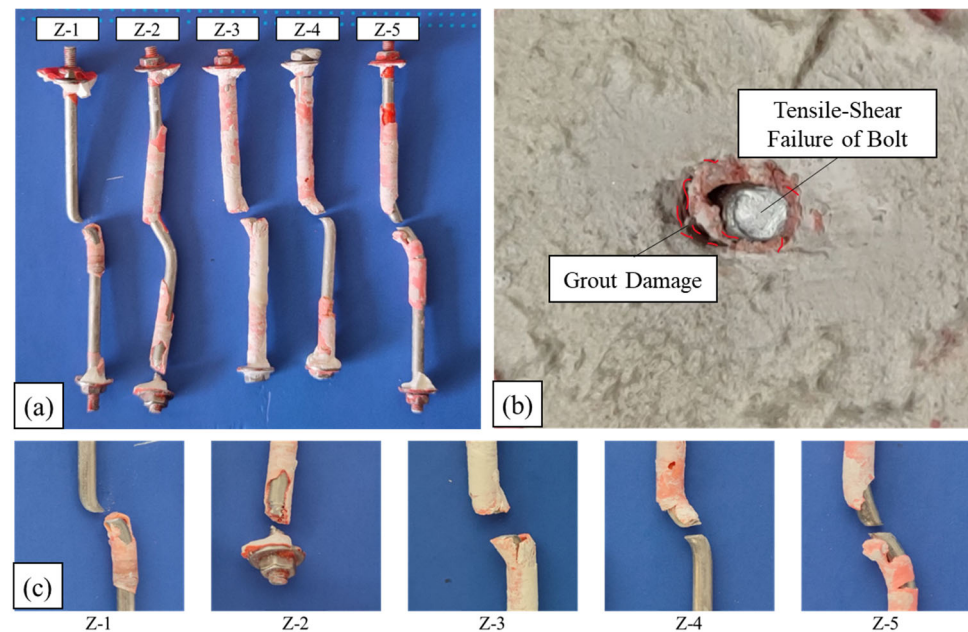
With the dislocation of the rock joints, damage to the surrounding rock and grout near the joint releases the constraint on the bolt, subjecting it to a tensile-shear coupled stress state and ultimately leading to tensile-shear fracture. As illustrated in Figure 7, specimens Z-1, Z-3, Z-4, and Z-5 exhibited smooth and flat fracture joints, indicative of shear-dominated tensile-shear fracture. In contrast, Specimen Z-2 fractured near the bolt end with evident necking, indicating a tension-dominated tensile-shear fracture. The lengths of the local deformation zones for these five specimens were 3.72 mm, 10.95 mm, 6.33 mm, 5.89 mm, and 11.13 mm, respectively. Notably, as the fracture of Z-2 occurred outside the rock joints deformation zone, it was treated as an outlier and excluded from the statistical analysis. Based on the remaining four groups, the average length of the local deformation zone was calculated to be 6.7675 mm.

**Figure 7.** Failure characteristics of fully grouted bolts at rock joints: (a) overall failure modes of bolts in the fully anchored condition; (b) localized tensile-shear fracture of the bolt at the rock joints; (c) detailed views of the bolt fracture morphology.

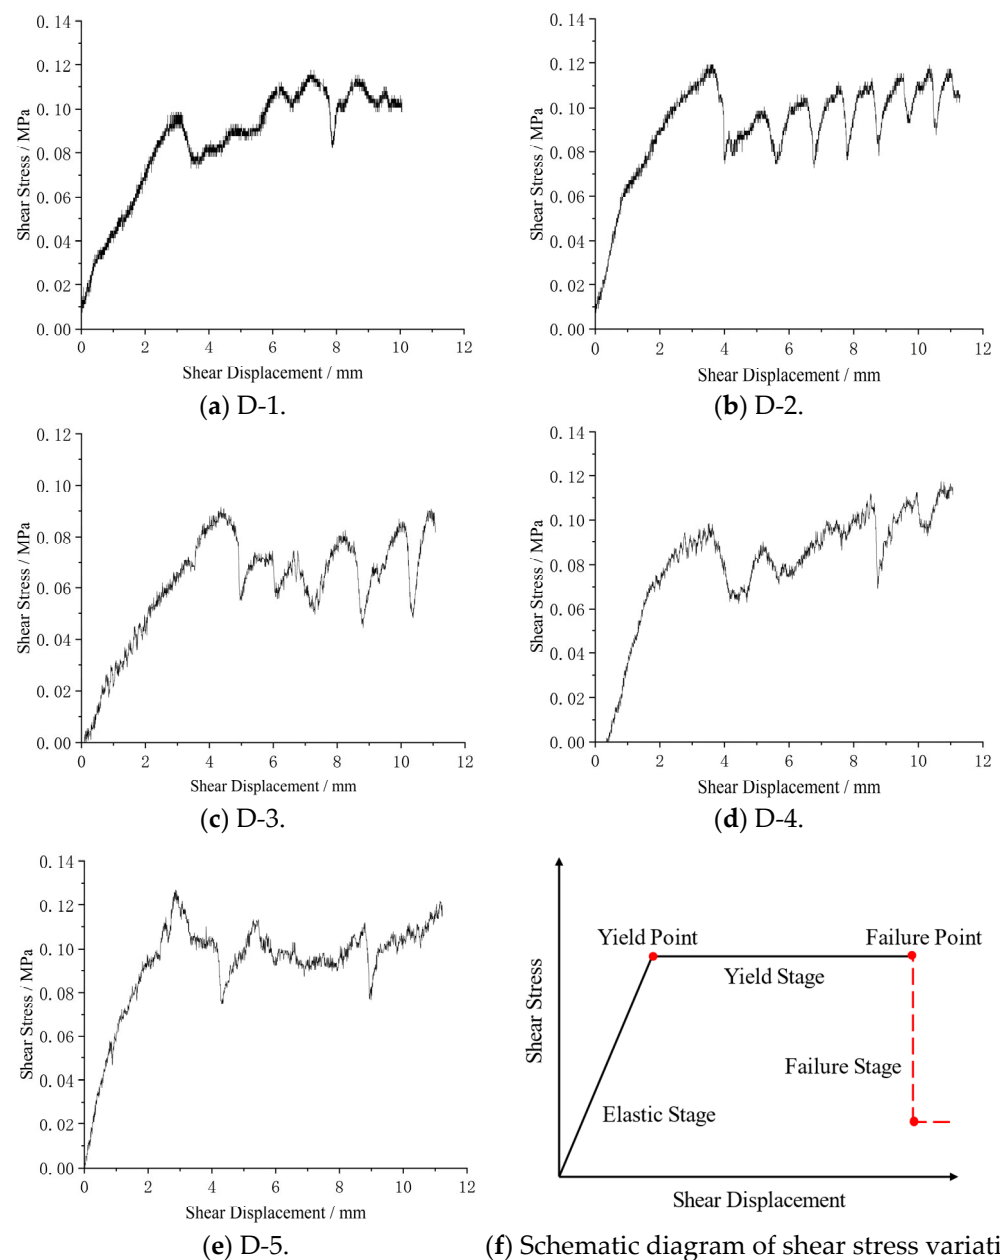
Under end-anchored conditions, the variation curve of the rock joint's shear stress with dislocation is shown in Figure 8. The subsequent failure stage shown schematically in Figure 8f is therefore inferred based on numerical simulations, rather than being directly observed in the physical tests. Unlike the fully grouted specimens, the shear stress curve exhibits only two stages:

**Figure 8.** The change curve of shear stress of a rock joint under end-anchoring. Note: In (f), the solid line represents experimentally obtained data; the dashed line indicates the inferred failure stage extrapolated from numerical simulations, as the physical test was terminated at the 12 mm displacement limit before bolt fracture occurred.

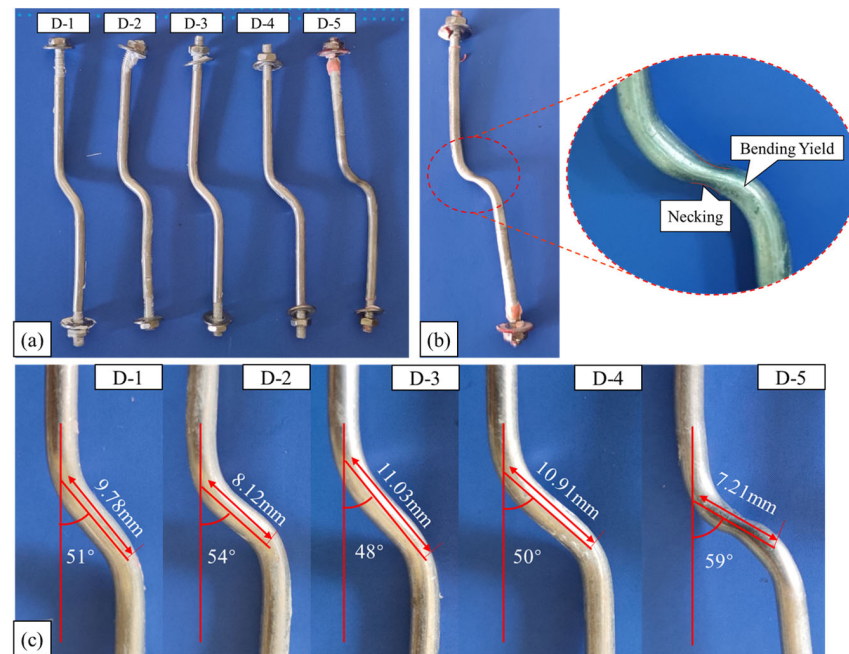
The deformation characteristics of the end-anchored bolts are shown in Figure 9. The deformation is primarily concentrated near the rock joints, manifesting as an S-shaped bending pattern, with the failure mode identified as bending yield and the formation of two symmetrical plastic hinges on either side of the plane. Compared to fully grouted bolts, the deformation zone at the rock joints is significantly larger. For specimens D-1 to D-5, the bending rotation angles were measured as 51°, 54°, 48°, 50°, and 59°, respectively, while the corresponding distances between the plastic hinges were 9.78 mm, 8.12 mm, 11.03 mm, 10.91 mm, and 7.21 mm. During bending yield, the bolt segment between the plastic hinges undergoes tensile deformation, exhibiting evident necking along the bolt shank.

**Figure 9.** Failure form of end-anchored bolt: (a) bending failure mode of the bolt; (b) necking phenomenon at the bending yield section; (c) detailed views of the bent regions with specific dimensions.

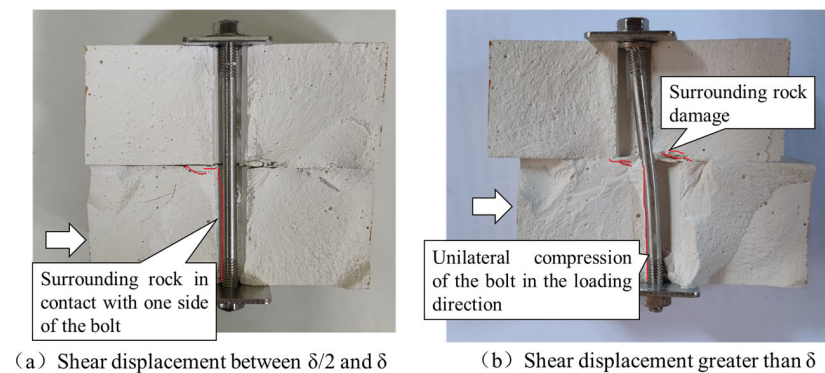
**Figure 10.** Mechanical behavior of end-anchored bolts under shear displacement ( $\delta$ : Radial clearance).

Under end-anchored conditions, a gap exists between the bolt and the borehole wall, leaving the bolt initially unconstrained. As the rock joints begin to dislocate, the surrounding rock comes into contact with one side of the bolt when the shear displacement reaches 1 mm (Figure 10a), initiating bolt deformation under shear. With continued dislocation beyond 2 mm, the bolt contacts the rock mass on the opposite side of the joint (Figure 10b). Given that the bolt stiffness is significantly higher than that of the rock mass, damage occurs at the contact points, forcing the bolt to bend locally near the rock joints and manifesting as bending yield with pull-out failure characteristics. If the dislocation continues until the bolt reaches its plastic limit, it would fracture, causing the shear stress to drop to the residual strength ( $\tau_j$ ). However, due to the 12 mm displacement limit of the RLJW-2000

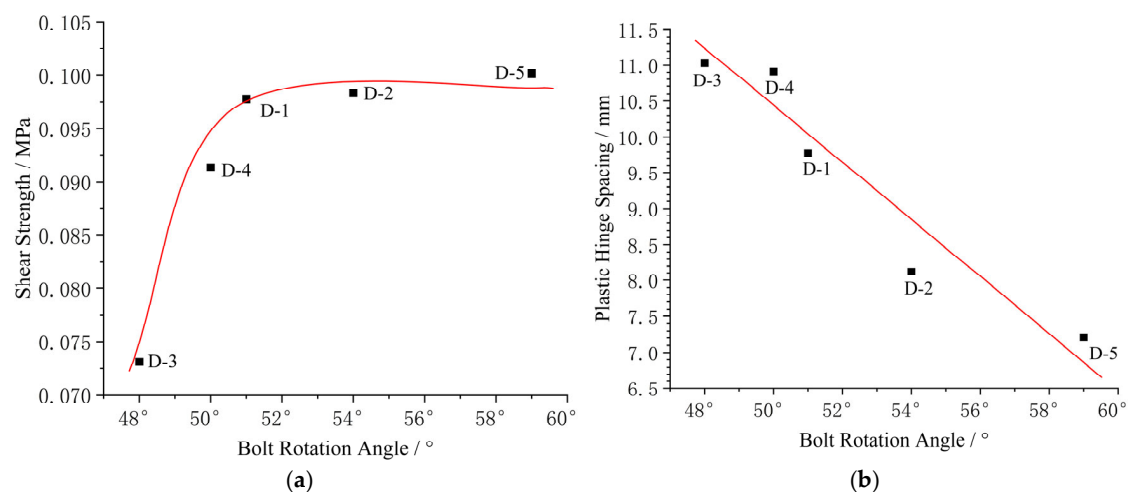
To further investigate the interaction between bolt deformation and rock joint mechanics, the correspondence between the bolt rotation angle and the shear strength is plotted in Figure 11a. The fitted curve exhibits an inflection point at approximately  $50^\circ$ . When the rotation angle is less than  $50^\circ$ , the shear strength increases proportionally with the angle. However, once the angle exceeds  $50^\circ$ , the shear strength stabilizes at approximately 0.975 MPa, indicating that the bolt has entered the yielding stage. Similarly, the relationship between the rotation angle and the plastic hinge spacing is shown in Figure 11b. A clear inverse relationship is observed: as the rotation angle increases, the spacing between the

plastic hinges decreases. Consequently, a smaller plastic hinge spacing corresponds to a larger rotation angle, which in turn results in a higher shear strength of the rock joints.

**Figure 11.** Relationship between bolt rotation angle and mechanical properties: (a) shear strength, and (b) plastic hinge spacing.

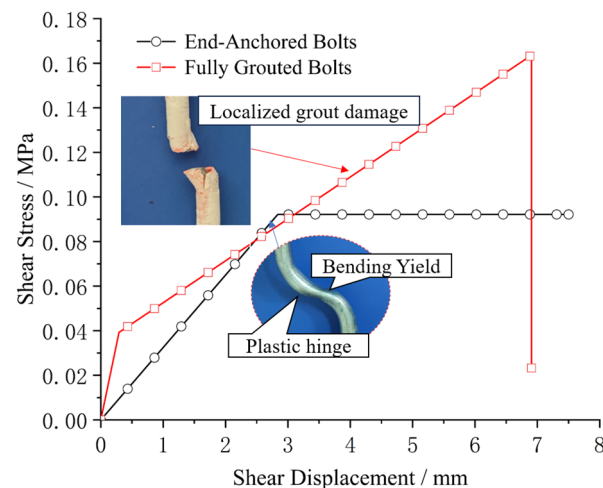
The preceding analysis revealed distinct shear stress responses: the fully grouted specimens exhibited a three-stage curve, while the end-anchored specimens displayed a two-stage curve. These curves were simplified to illustrate the variation in shear stress under increasing displacement, as shown in Figure 12. Under fully grouted conditions, the slopes of all stages are steeper than those of the end-anchored case, enabling a rapid increase in shear strength at relatively small displacements. Conversely, although the end-anchored configuration provides a lower rate of strength enhancement, it offers superior ductility. After reaching the bending yield, the bolt does not fail immediately; instead, it continues to provide resistance against rock joints' dislocation even under large shear displacements.

**Figure 12.** Shear stress-displacement curves of rock joints for end-anchored and fully grouted bolts.

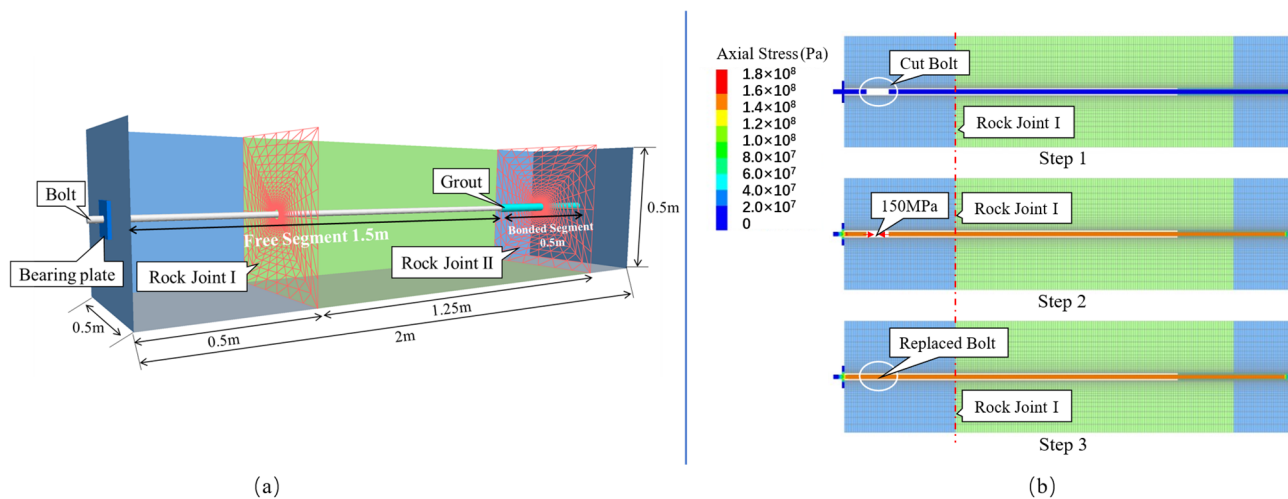
A complete rock bolting system comprises the bolt body, grout, bearing plate, and nut. Based on the presence of grout filling within the borehole, the bolt is functionally divided into the anchorage segment and the free segment. To investigate the evolution of shear strength in anchored rock joints under various anchorage conditions, a three-dimensional numerical model was developed using FLAC3D 6.0. The rock mass, bolt, and grout were simulated using solid elements. The interactions at the bolt–grout and grout–rock interfaces were captured using interface elements governed by the Coulomb friction law, with the mechanical parameters assigned according to Tables 4–6; a numerical model was developed (Figure 13a). The model simulated the surrounding rock as sandstone, the bolt as HRB335 rebar, the bearing plate as Q235 steel, and the grout as epoxy resin. The rock joints were idealized as a smooth, unfilled discontinuity, with a pre-stress of 150 MPa applied to the bolt.

**Figure 13.** Numerical model for the bolted rock mass with two rock joints and steps for applying prestress. (a) Model setup. (b) Prestress application procedure (Steps 1–3).

The application of pre-stress was achieved through a three-step procedure:

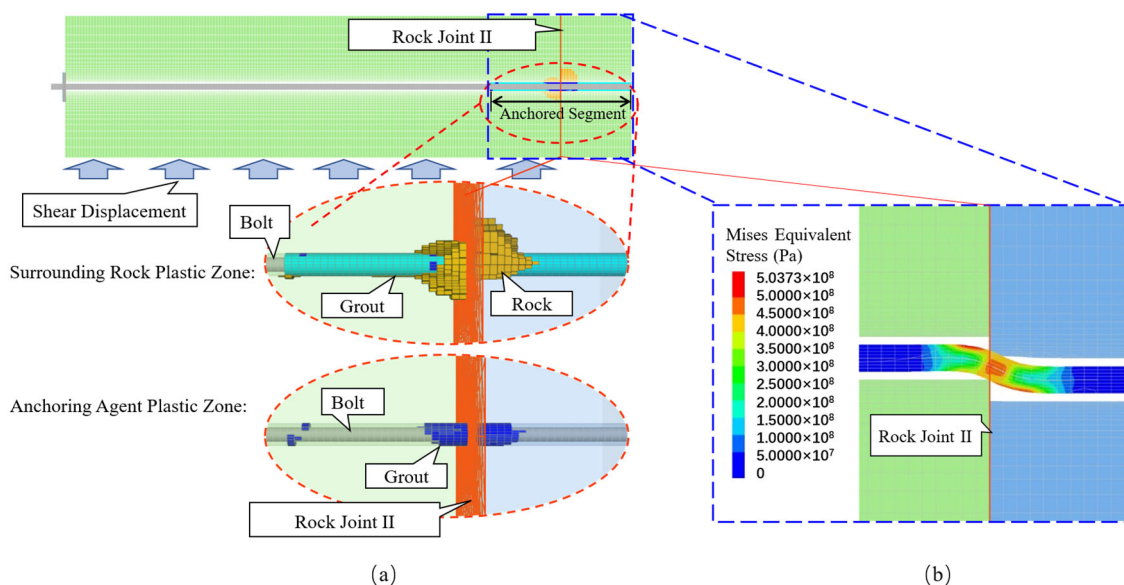
With continued dislocation, damage accumulates in the rock mass and grout near the rock joints. As shown in Figure 14a, plastic zones develop in both media; the yellow zone represents rock plasticity, and the blue zone represents grout plasticity. The deformation zone of the bolt coincides closely with the extent of the grout damage. When the bolt reached its ultimate strength, the Mises stress distribution (Figure 14b) revealed that the deformation was primarily concentrated near the rock joints, forming a symmetric S-shape centered on the joint, with a deformation length of 10.84 cm. The Mises stress peaked at the intersection of the bolt and the rock joints and decreased to zero away from the joint. This confirms that the bolt fails in shear preferentially at the rock joint location under shear dislocation.

**Figure 14.** Mechanical response analysis of the bolted rock mass. (a) Plastic zone distribution indicating the interaction between the surrounding rock and the anchoring agent. (b) Mises equivalent stress distribution highlighting stress concentration at the bolt-grout interface.

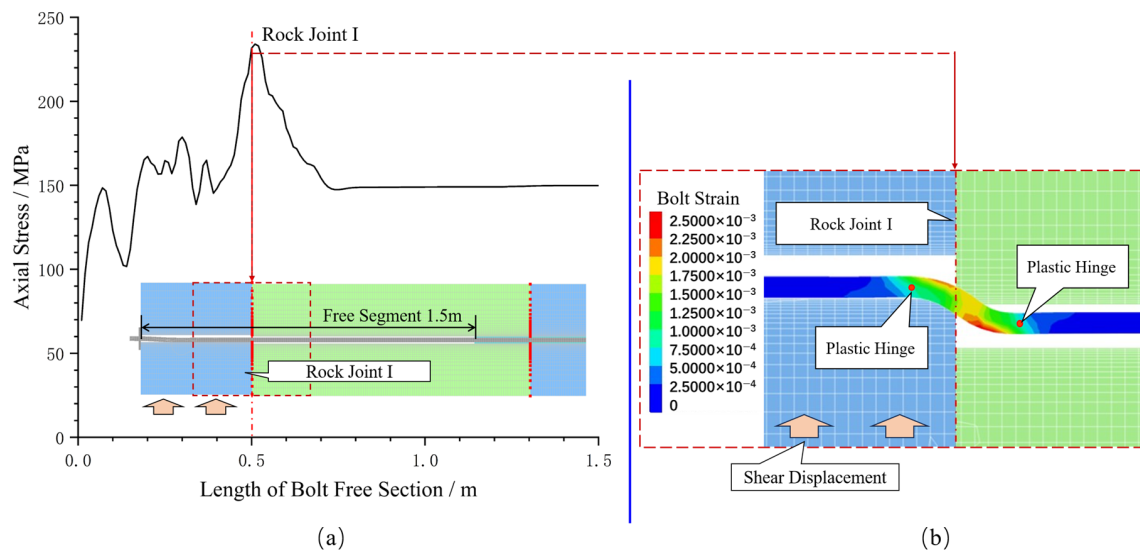
Upward displacement loading was applied to the region left of rock joint I to simulate two scenarios: without pre-stress and with pre-stress. Without pre-stress, the bolt yielded in bending and formed a plastic hinge when the shear displacement reached 2.41 cm. The bolt eventually fractured when the displacement increased to 11.45 cm. Conversely, with a pre-stress applied, bending yield occurred at a smaller displacement of 1.63 cm. The axial stress distribution along the bolt length (Figure 15) showed that the stress peaked near the

rock joints, reaching a maximum of 234.54 MPa. Under the pre-stressed condition, the bolt fractured at a displacement of 5.23 cm.

**Figure 15.** Mechanical response of the bolt under shear loading. (a) Axial stress distribution along the free section. (b) Axial strain distribution indicating the development of plastic hinges at the joint interface.

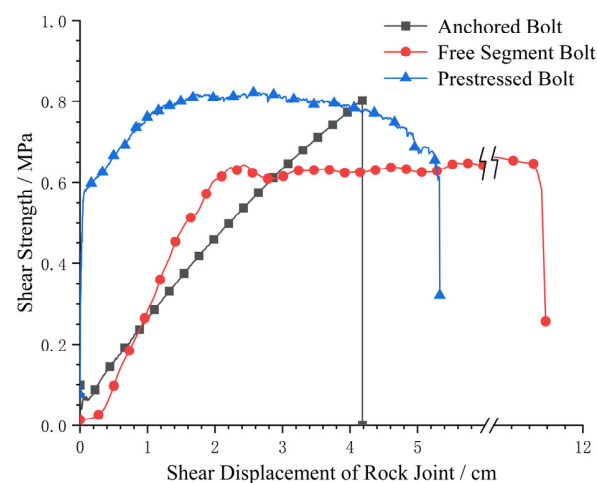
The average displacement and contact stress of the interface nodes were statistically analyzed. The variation in shear stress with rock joint dislocation is shown in Figure 16. For the grouted segment, the bolt fractured in tensile-shear coupling when the shear displacement reached 4.18 cm, enhancing the shear strength by 0.8024 MPa. For the free segment, the bolt yielded in bending at a displacement of 2.41 cm, providing a strength enhancement of 0.6433 MPa. The numerical curves exhibit a consistent trend with those obtained from the laboratory tests. For the pre-stressed bolt, bending yield occurred at a displacement of 1.63 cm, with the shear strength increasing by 0.8095 MPa. In this case, the pre-tensioning force contributed 0.5634 MPa, while the passive bolt action contributed 0.2461 MPa, accounting for 30.40% of the total strength enhancement. Numerical simulations revealed that the effective shear area influenced by the bolt is 97,513 cm<sup>2</sup>, while the cross-sectional area of the bolt is 314 cm<sup>2</sup>. Based on these values, the area ratio  $\eta$  was calculated to be  $3.22 \times 10^{-3}$ . Utilizing Equations (1)–(6), the shear strength enhancement of the rock joint provided by the bolt under various anchorage conditions was determined, as summarized in Table 7.

**Figure 16.** Comparison of shear stress variation curves of the rock joint under different anchorage conditions from numerical simulation.

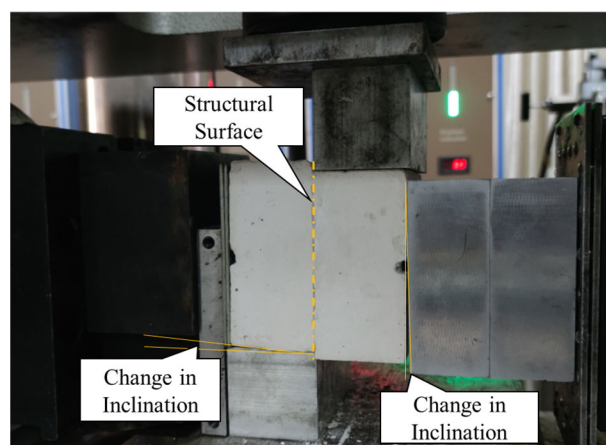
**Figure 17.** Experimental setup showing the evolution of the inclination angle during the loading process.
