# Remote Sensing and Environmental Monitoring Analysis of Pigment Migrations in Cave of Altamira's Prehistoric Paintings

Vicente Bayarri <sup>1,2</sup> , Alfredo Prada <sup>3</sup>, Francisco García <sup>4,\*</sup> , Carmen De Las Heras <sup>3</sup> and Pilar Fatás <sup>3</sup>

**Citation:** Bayarri, V.; Prada, A.; García, F.; De Las Heras, C.; Fatás, P. Remote Sensing and Environmental Monitoring Analysis of Pigment Migrations in Cave of Altamira's Prehistoric Paintings. *Remote Sens.* **2024**, *16*, 2099. <https://doi.org/10.3390/rs16122099>

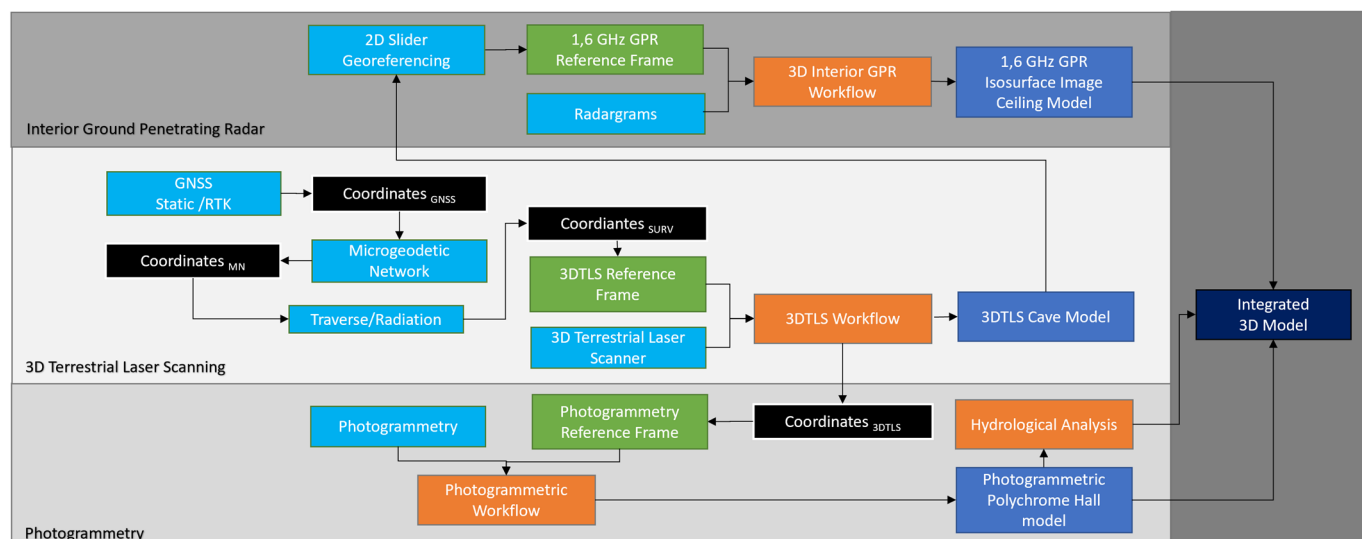
**Figure 4.** General workflow scheme followed in this study.

Integrating data into the model (Figure 4) begins with establishing a reference frame using the precision of the Global Navigation Satellite System (GNSS) [46,47]. At first, in 2013, Topcon Hyper II receivers [48] were used to establish a geodetic reference system aligned with the European Terrestrial Reference System 1989 (ETRS89). Evaluating observed phase changes, aided by Topcon Tools 8.2 software [49], yielded a reference frame with an average accuracy of 1.7 cm for determining the coordinates of exterior cave vertices by using the method described in [50].

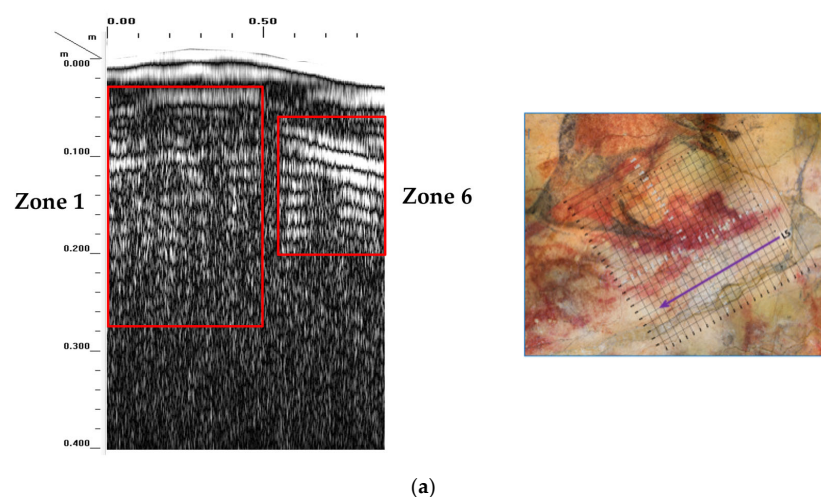
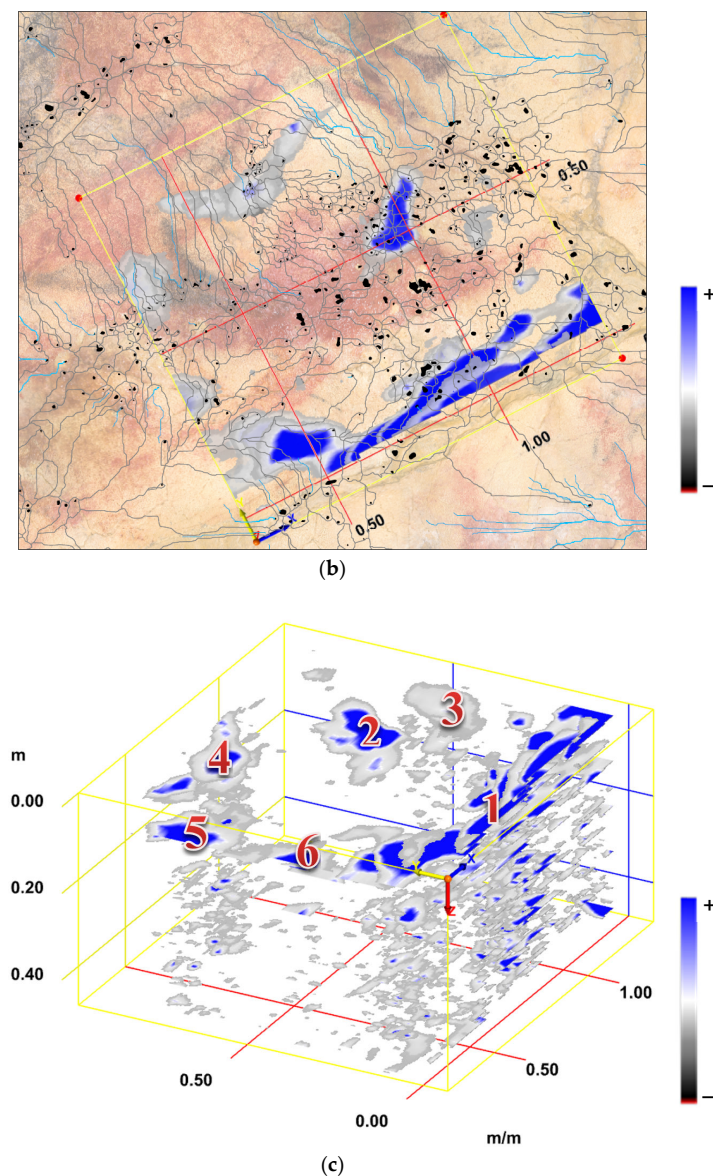
**Figure 9.** (a) Reflection profile L5 (greyscale amplitudes) showing high-amplitude and strong reflections due to water, interpreted as the presence of moisture within the Polychrome Layer (highlighted in red rectangles: zones 1 and 6). (b) Areas of water/moisture: Superimposition of the sections of the first 36 cm. In blue the areas with higher presence and in white the areas with lower presence. (c) The 6 areas of high moisture mapped in the 3D isosurface model in ALT1 (highlighted with red numbers).

In the ALT1 control zone, after processing GPR data, six high-moisture zones were detected, each with different characteristics (Figure 9b,c):

- Moisture Zone 1 is strongly associated with the geometry of the central fracture mapped in the 2017/2018 campaigns. This moisture accumulation is parallel to the central fracture and reaches a depth of 36 cm (Figure 9a). Moisture Zone 1 results from the moisture concentration in areas adjacent to the central fracture due to the dam effect generated by the injection of cement mortar applied over the entire development of this large fracture crossing the Ceiling from west to east (Figure 2a). The antenna information shows the existence of discontinuities in the mortar, indicating partial degradation, disintegration, or deterioration at certain points. Additionally, the antenna indicates that the depth of this injected filling from the early last century presents a variable thickness.

- Moisture Zone 2 is closely associated with drip points ALT1\_1, ALT1\_2, and ALT1\_4 as shown in Figure 7b, between 3 cm and 5 cm deep. Its highest moisture concentration is at a depth of 3 cm.

- Moisture Zone 3 is between 2 cm and 12 cm deep. Its highest moisture concentration is at a depth of 2 cm.
- Moisture Zone 4 is associated with the vertical fractures mapped in the 2017/2018 campaigns and projected into the belly of the large bison associated with our ALT1 control zone. It ranges from 2 cm to 36 cm deep.

- Moisture Zone 5 is between 6 cm and 12 cm deep. Its highest moisture concentration is at a depth of 7 cm.
- Moisture Zone 6 is between 6 cm and 19 cm deep. Its highest moisture concentration is at a depth of 6–7 cm (Figure 9a).

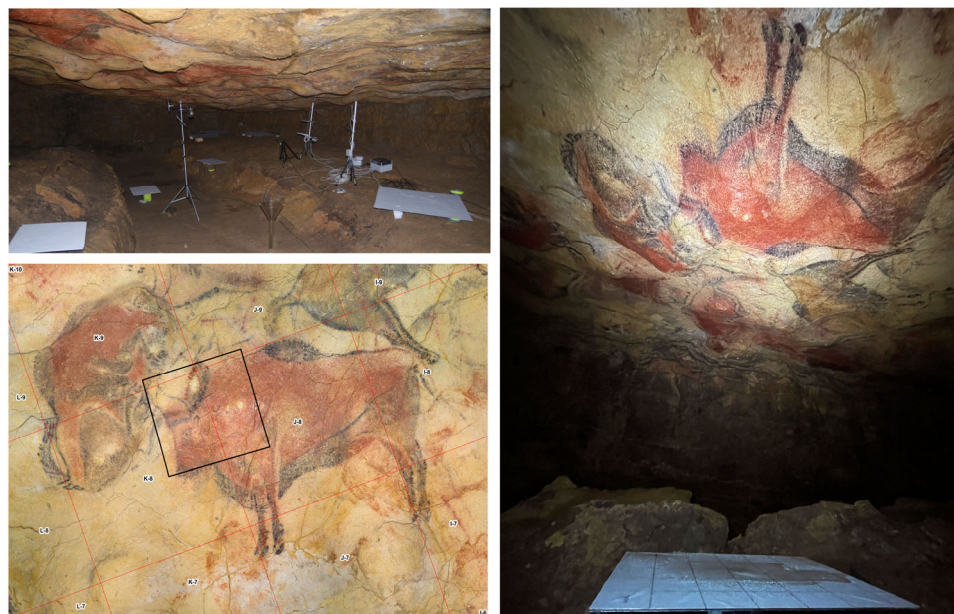
**Figure 12.** Location of the different witnesses located on the floor of the Polychrome Hall. Witness covering a series of drips located on the hump and head of one of the large polychrome bison.

To ensure the accuracy and validity of hydrographic calculations, a rigorous validation process has been executed. The results are compared with real field observations or through orthoimages, thus verifying the accuracy of the calculated drip points. This verification step is essential to affirm the fidelity of the 3D model predictions, aligning virtual representations with real geological features. In this verification process, information obtained through the so-called “witnesses” located on the floor of the Polychrome Hall is also important (Figure 12). These witnesses, covering an area of  $1 \times 1$  m, are made of rigid material formed

from two thin aluminum sheets joined to a solid polyethylene core and lined with a 100% synthetic fabric made of high-density polyethylene fibers, which are lightweight, durable, breathable, and resistant to water, abrasion, and bacterial penetration. The witnesses are georeferenced, allowing the documentation of any dripping from a specific area of the Ceiling surface. Their information, combined with the aforementioned hydrological study, determines the origin of clay, limestone, and pigment drag deposits. This valuable information is transferred to a series of tables that inform us of the dynamics and periodicity of these events [103].
