# Influence of an Extended Domestic Drinking Water System on the Drinking Water Quality

Ljiljana Zlatanović <sup>1,2,\*</sup>, Aleksandra Knezev <sup>3</sup>, Jan Peter van der Hoek <sup>1,2,4</sup> <sup>b</sup> and Jan H. G. Vreeburg <sup>5</sup>

**Keywords:** domestic drinking water systems; fire sprinklers; water quality; water temperature; water stagnation

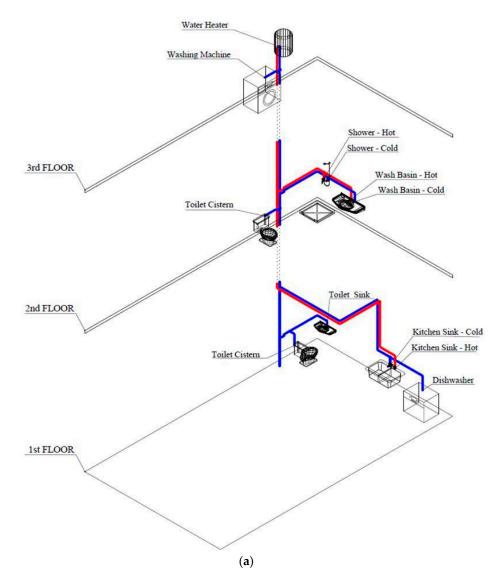
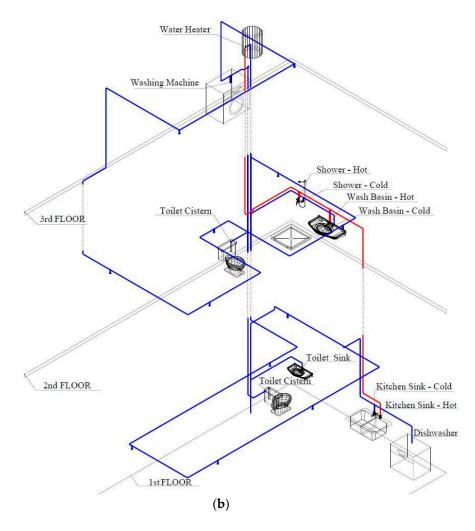
Figure 1. Cont.

To study the impact on water quality of added plumbing for the installation of residential fire sprinkler heads to a conventional DDWS, two full-scale DDWSs, a conventional (CS) and an extended (E-S) DDWS, were built (Figure 1 and Supplemental Figure S1) and operated for 430 days, applying the stochastic water demand patters at each tap. The experimental rigs were constructed by a licensed plumber, using readily available material—copper, manufactured in accordance with European Standard EN 1057. The configuration of the CS complied with the Dutch home plumbing codes NEN 1006 [26], while the ES contained additional loops of 22 mm diameter piping on each floor for the fire sprinkler system accommodation.

**Figure 1.** Axonometric scheme of the test rigs: (a) Conventional system (CS); (b) Extended system (ES). Blue line—cold water, red line—hot water. 1st floor: Guest toilet taps—toilet cistern and toilet sink; kitchen taps—cold and hot and dishwasher. 2nd floor: Bathroom taps—toilet cistern, shower taps—cold and hot, wash basin taps—cold and hot; 3rd floor: Washing machine tap. Vertical copper tube of 22 mm diameter—carrying cold water to the upper floors, vertical copper tube of 15 mm—delivering hot water from a 50 L water heater and copper tubing's of 15 mm—supplying cold and hot water from the vertical pipes to the 11 plumbing fixtures (solenoid valves). CS—The total length of the pipes was 48.6 m and the volume of the plumbing rig was ~6 L. ES has additional loops of 22 mm diameter piping on each floor, and the total length of the piping in the extended system was 116 m and the volume was ~ 29 L.

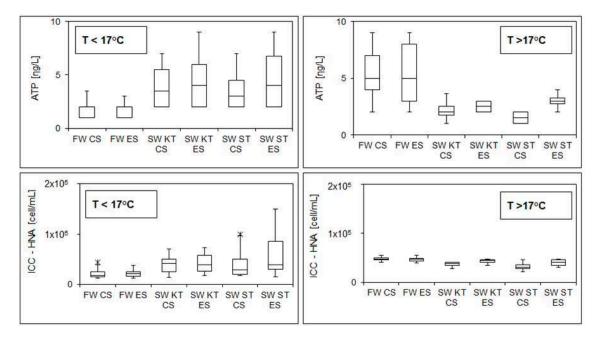
The same trend was observed with ATP and FCM measurements, but here, the tipping point was found to be 17 °C. Figure 5 gives an overview of ATP and ICC-HNA concentrations in fresh and stagnant water samples from the conventional and the extended DDWS.

The statistical differences between the ATP and ICC-HNA concentrations in the fresh water samples for both investigated DDWSs were non-significant. The mean values of ATP and ICC-HNA concentrations in fresh water samples with temperatures lower than 17 °C were  $1.85 \pm 0.78 \text{ ng/L}$  and  $2.1 \times 10^4 \pm 0.7 \times 10^4 \text{ cell/mL}$ , respectively. The average ATP and ICC-HNA concentrations in fresh samples with drinking water temperatures higher than 17 °C were  $5.1 \pm 2.4 \text{ ng/L}$  L and  $4.6 \times 10^4 \pm 0.5 \times 10^4 \text{ cell/mL}$  respectively. In this research, most of the changes in measured cell concentrations after the overnight stagnation experiments were observed for ICC—HNA fraction, while ICC—LNA fraction remained stable.

**Figure 5.** ATP (**up**) and ICC-HNA (**down**) concentrations in fresh water (FW) and stagnant water (SW) in the conventional (CS) and extended system (ES) at the kitchen tap (KT) and shower tap (ST). Number of fresh samples (inlet, kitchen and shower) = 48. **Left**: Temperature of fresh water < 17 °C, number of fresh samples = 36, number of stagnant samples per tap = 12, SD<sub>ATP</sub> < 4%, SD<sub>ICC</sub> < 4%. **Right**: Temperature of fresh water >17 °C, number of fresh samples = 12, Number of stagnant samples per tap = 4; \*—outliers.

Overnight stagnation was also found to promote microbial viability, as an increase of up to 8-fold in ATP levels was measured, when the temperature of fresh water was lower than 17 °C (Figure 5 top left). This observation coincides with the findings from a previous study on induced microbial viability in terms of increased ATP after overnight stagnation of water in DDWSs [20]. However, when the temperature of fresh water was higher than 17 °C, up to 9-fold reduction in ATP concentrations

was observed (Figure 5 top right). The same trend was found in the ICC-HNA subgroup, which is accountable for the most important part of the bulk activity in stagnant water [20]; i.e., up to a 4 fold increase in ICC-HNA levels was observed if the fresh water temperature was below 17 °C (Figure 5 bottom left), and up to 40% of reduction in ICC-HNA levels was found if the fresh water temperature was above 17 °C (Figure 5 bottom right). The observed increase in the HNA fraction of the intact cells might explain the higher ATP concentrations in the stagnant water samples. One study demonstrated that higher HNA content could be related to the elevated ATP concentrations [48], because HNA bacteria are generally bigger cells holding a 10-fold higher ATP-per-cell content than LNA bacteria [49].

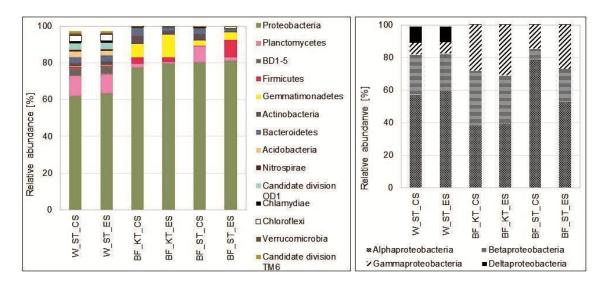
*Proteobacteria* were found to be the predominant phyla in both water and biofilm samples, varying from 61% to 81% (Figure 6 left). In the water samples, *Proteobacteria* consisted of 57% of *Alphaproteobacteria*, 25% of *Betaproteobacteria*, 7% of *Gammaproteobacteria* and 10% of *Deltaproteobacteria* (Figure 6 right). Among the remaining phyla in the water samples, *Plancomycetes* were the second most dominant bacteria, accounting for 10% of the total, while the abundances of *BD1-5*, *Candidate division OD1*, *Chloroflex*, *Acidobacteria* and *Bacteroidetes* were <3%. Slightly different composition of *Protobacteria*, 11–24% of *Gammaproteobacteria*. Biofilm samples also had slightly different abundances of the remaining phyla, i.e., 3–12% of *Gemmatimonadetes*, 0.1–9% of *Firmicutes*, 1–4% of *Bacteroidetes*.

**Figure 6. Left**: Relative abundance of bacterial phyla. **Right**: Relative abundance of *Proteobacteria* classes in water from shower tap samples (W\_ST) and biofilms (BF) sampled from kitchen (KT) and shower taps (ST) in conventional (CS) and extended system (ES).

*Proteobacteria* were the most dominant phyla in both water and biofilm samples, and their abundance varied from 61% to 80% (Figure 6 left). Bacterial communities of the biofilms in the conventional and extended DDWSs were similar to the communities reported in earlier research [48,64–66], dominating by *Alpha-, Beta-* and *Gammaproteobacteria* (Figure 6 right). Among the other phyla, sequences related to bacteria *Firmicutes* were dominant (~9%) in the biofilm extracted from the shower pipe biofilm in the extended system. The higher abundance of the obligate anaerobes *Firmicutes* is probably because the water refreshment rate in the extended system is lower than in the conventional, which agrees with the observation from a recent study in which more *Firmicutes* were found under static water flow conditions [55]. A high level of similarity at the genus level between fresh water and biofilm communities, 98% and >70–94% respectively (Figure 7) indicates that the extension of the copper DDWS did not significantly affect either the microbial quality of fresh water or the biofilm composition in the examined DDWSs.

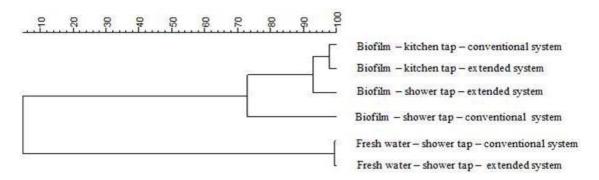
A distance analysis (Unweighted Pair Group Method with Arithmetic Mean method—UPGMA), presented in Figure 7, shows that there is a high similarity between the fresh water samples and biofilms for both systems at the genus level, >98% and >70–94% respectively.

Figure 7. UPGMA Pearson correlation for the biofilm and water samples at genus level.
