A Comparative Study of the Effects of the 1872 Storm and Coastal Flood Risk Management in Denmark, Germany, and Sweden

Caroline Hallin ^{1,2,*}

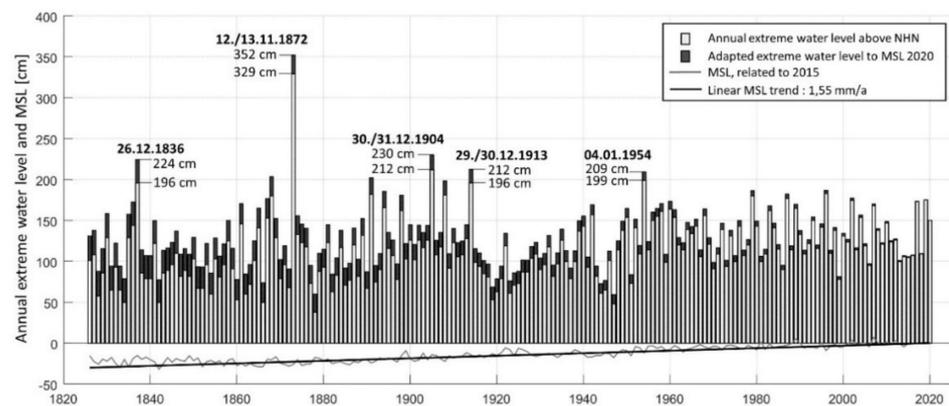
Figure 1. Annual extreme water level above NHN (German reference datum), annual extreme water levels adopted to MSL in 2020, MSL, and MSL trend at Lübeck-Travemünde gauge station for the period 1826 to 2020. The figure is based on data from Jensen and Töppe, and Kelln [14–16].

In 1872, a disastrous storm event affected the countries bordering the western parts of the south Baltic Sea. At the Danish, German, and Swedish coasts, around 300 people died, and more than 15,000 people lost their homes in the German state Schleswig-Holstein alone [11,12]. The water level variations in the south Baltic Sea are usually affected by modest surges due to wind setup. However, during the 1872 storm, the water levels in, e.g., Travemünde, Germany, locally rose to 3.3 m above normal sea level at that time [13,14]. This record-breaking event was more than a meter higher than all other events that have been observed at this station since it has started operating in 1826 (Figure 1).

On November 13th in 1872, an extreme storm event—often referred to as the 1872 storm—caused severe flooding along the coasts surrounding the western parts of the south Baltic Sea (Figure 2). The peak water levels during the 1872 storm were by far the highest on record, exceeding the observed water levels of the area in the last 100 years by more than a meter [30] (Figure 1).

In the gauge records (Figure 1), the 1872 storm stands out as a singularity, and there are large differences in the estimates of the return period. Estimates of the return period on the German Baltic coast range from 180–200 years [38], 1000–2500 years [15], up to 3400–10,000 years [39]. In Sweden, the return period was estimated to 7000 years using a generalized extreme value (GEV) model based on 100 years of water level observations [33]. In Denmark, the return period was far over 1000 years in analyses by the Danish Coastal Authorities [40].

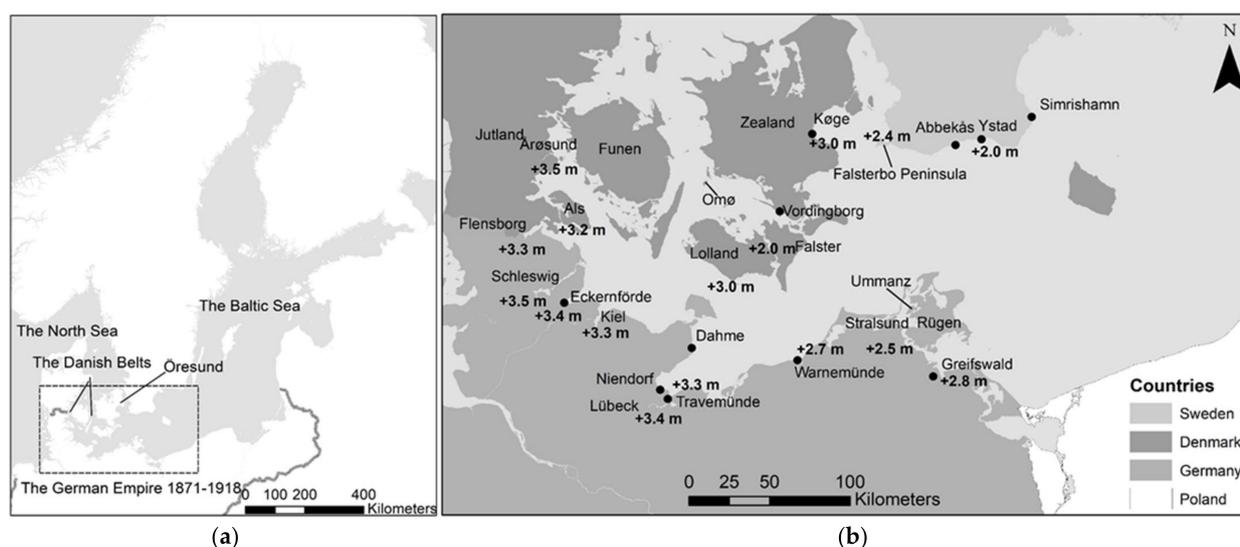
Figure 2. (a) Overview of the Baltic Sea basin. The land boundaries of the German Empire as in 1872 are indicated. (b) Overview of the affected area during the 1872 storm and the measured or reconstructed peak water levels along the coasts.

More specifically, during the 1872 storm, the still water level in Germany reached up to 3.3 m above normal sea level at that time in Travemünde, Kiel, and Flensborg, 3.4 m in Lübeck and Eckernförde, 3.5 m in Schleswig, 2.8 m in Greifswald, 2.7 m in Warnemünde, and 2.5 m in Stralsund [15,31]. In Denmark, the highest observations were made in Årøsund at the southeast coast of Jutland, at 3.5 m above normal sea level at that time, and in Als, at 3.2 m [31,32]. In Køge, on the east coast of Zealand, and Kramnitze Grab, Lolland, the peak water level reached 3.0 m above normal sea level at that time, and in Nykøbing, Falster, 2.0 m [32]. The peak water level at Falsterbo Peninsula in Sweden has been estimated to 2.4 m above normal sea level at that time, based on a flood mark and eyewitness stories [33]. From Ystad harbour on the Swedish south coast, there is an observation of 2.0 m above normal sea level at that time [34].

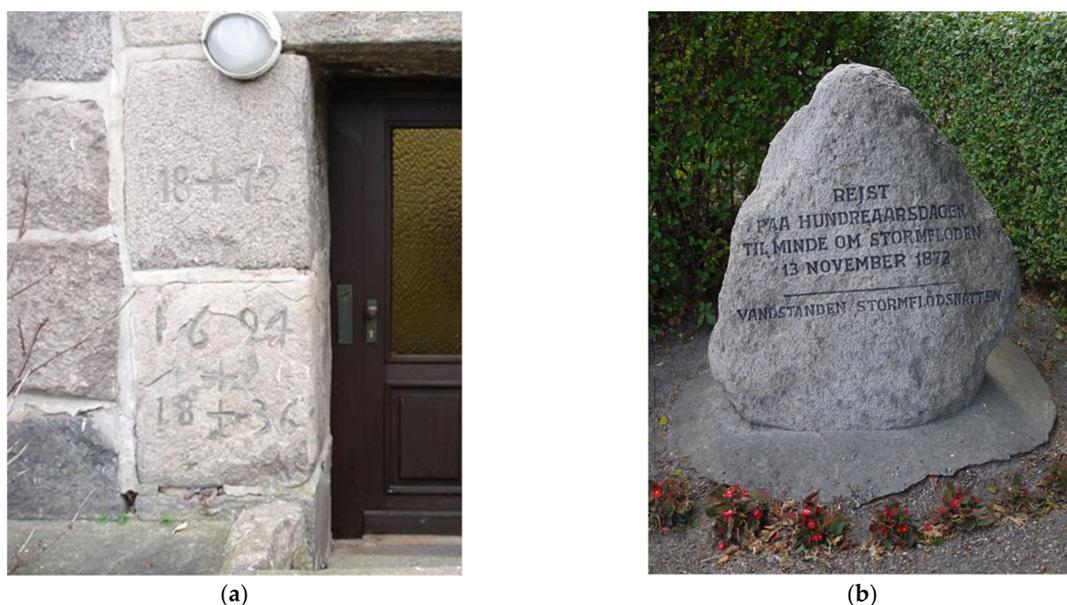
Figure 3. (a) Flood marks from 1694, 1836, and 1872 on a building in Schleswig, Germany. Photo: R. Sedlatschek; (b) Flood mark at Gedesby church (Gedser, Denmark) to memorize the 100th anniversary of the 1872 storm surge. Photo: Wikipedia.org.

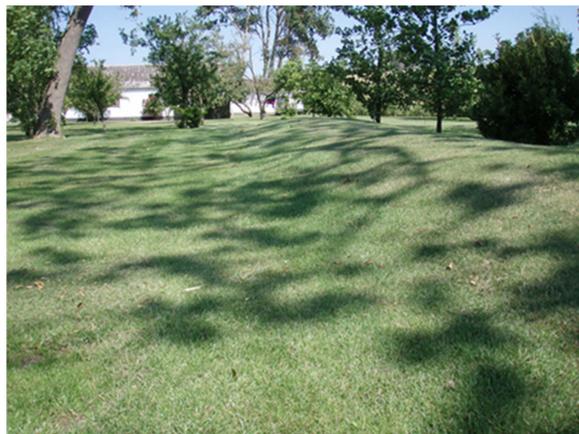
Figure 5. Remnants of a dike on the Danish island of Omø constructed after the 1872 storm, but later partly removed. Photo: Per Sørensen.

Along the Danish coast, other minor dikes were built to protect against a similar storm. However, as time passed without any storm surges reaching close to the 1872 storm surge level, flood risk awareness diminished. For example, the dike on the island of Omø that was constructed after the 1872 storm surge was later partly removed (Figure 5).
