Article

Study on the Instability Activation Mechanism and Deformation Law of Surrounding Rock Affected by Water Immersion in Goafs

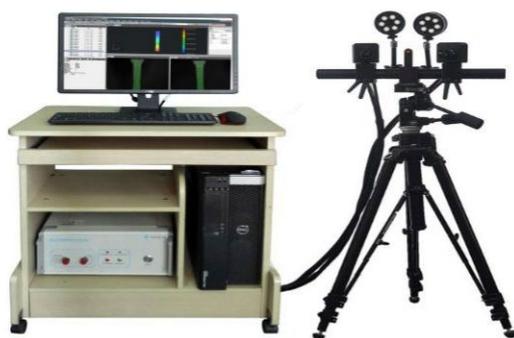
Figure 5. Non-contact video strain displacement precision measurement system.

The experiment was primarily conducted to observe the displacement of the rock seam. Strain monitoring was carried out by using the ISM-CONTR-VG5-2DB series non-contact video strain displacement precision measurement system (Imetrum, Bristol, UK) (Figure 5). The system uses a camera to collect surface images of a specimen during the deformation process, and it uses speckle recognition technology to accurately track the movement between points on the measured object. A patented sub-pixel image recognition algorithm was used to perform ultra-high-resolution strain, rotation, and displacement measurements. It supports a measurement range up to 100 m, a maximum distance of 1000 m, and 2D displacement resolution of 0.01 mm within 10 m. Seven measurement lines (Figure 4) were designed and arranged in the rock seam, and the distance to the coal seam from the top to the bottom of each measurement line was 1200, 800, 600, 400, 300, 200, and 100 mm, numbered as lines BA, BB, BC, BD, BE, BF, and BG, respectively. The distance between measurement points of each line was 100 mm.

After the model was dried and finalized, waterproof observation points were arranged on the surface according to the measurement point arrangement chart. The measurement points facilitate mobile monitoring of the entire process of similar model strip mining and water immersion experiments in extraction goaf s, using the photogrammetry monitoring system to obtain rich displacement data. The 2D displacement resolution of the photogrammetric monitoring system was 0.01 mm within 10 m.

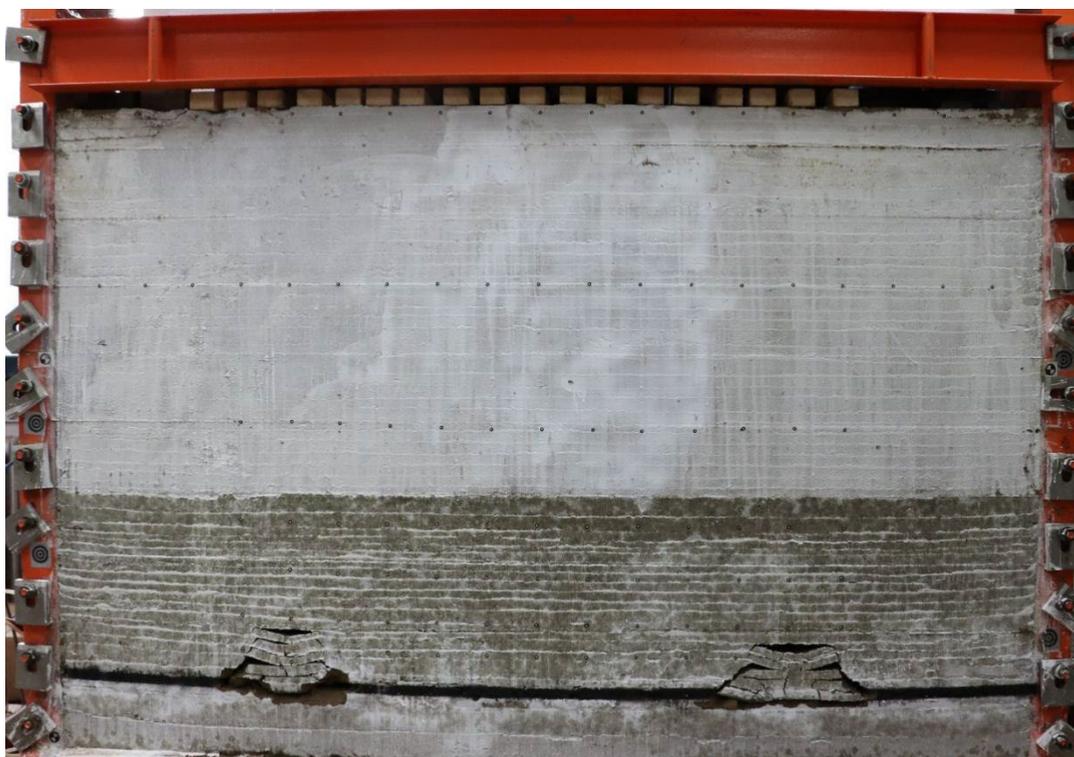
Figure 6. Overburden failure of strip mining.

After the strip working face was mined, the roof rock layers on the left and right sides of the strip working face fell and fractured one after the other. Subsequently, two fracture zones developed independent of each other; the overlying rock developed into medium-grained sandstone, and the height of the fracture zone was approximately 15 m. The fracture zone had an approximately trapezoidal outline, and a stress arch was formed above it. The stress arch supported most of the self-weight load of the overburden rock above, controlled its movement and deformation, and transferred its stress to the foot of the arch, i.e., above the coal pillars on both sides of the goaf. Consequently, stress was concentrated in the coal pillars on both sides of the goaf. The overburden damage in the strip working face is shown in Figure 6.

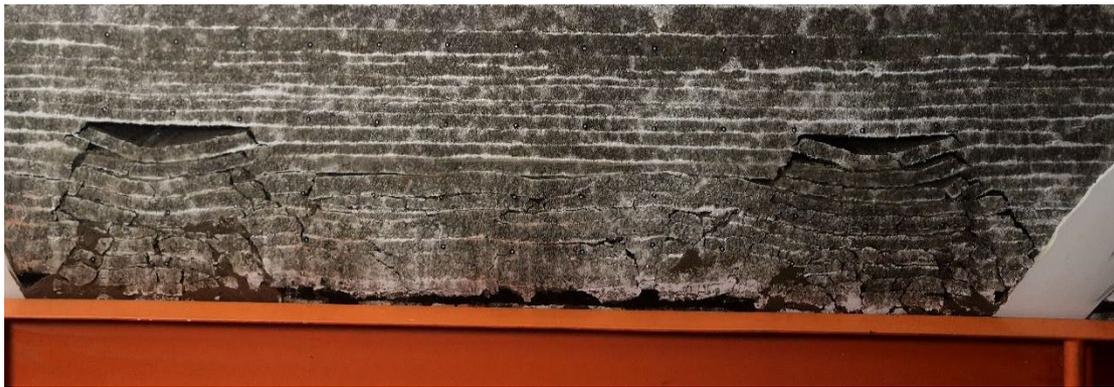
Figure 11. Overburden damage pattern of coal pillar destabilization affected by water immersion in the strip goaf.

Under the continuous immersion of water in the coal pillar, shear failure occurred on both sides of the coal pillar from the outside to the inside. The width of the core area of the coal pillar gradually decreased until it was inadequate to support the load weight of the overlying rock. Overall instability failure occurred, and the strips on both sides were connected to each other, forming a saddle-like overall cracking zone (Figure 11). The overlying rocks underwent large overall subsidence, forming a subsidence basin with a large middle and small sides (Figure 12). The subsidence at measurement point BE12 in the overburden changed abruptly from 0.30 to 1.63 m (Figure 10); subsequently, the increment of overburden subsidence leveled off with time.
